Byron Station Unit 2  
Facility Operating License No. NPF-66  
NRC Docket No. STN 50-455

Subject: Byron Station, Unit 2, 60-Day Response to First Revised NRC Order EA-03-009, "Issuance of First Revised NRC Order (EA-03-009) Establishing Interim Inspection Requirements for Reactor Pressure Vessel Heads at Pressurized Water Reactors"

**“Byron Generating Station Outage – B2R13  
Reactor Vessel Head Penetration Examination”**

**WDI-PJF-1303451-FSR-001**

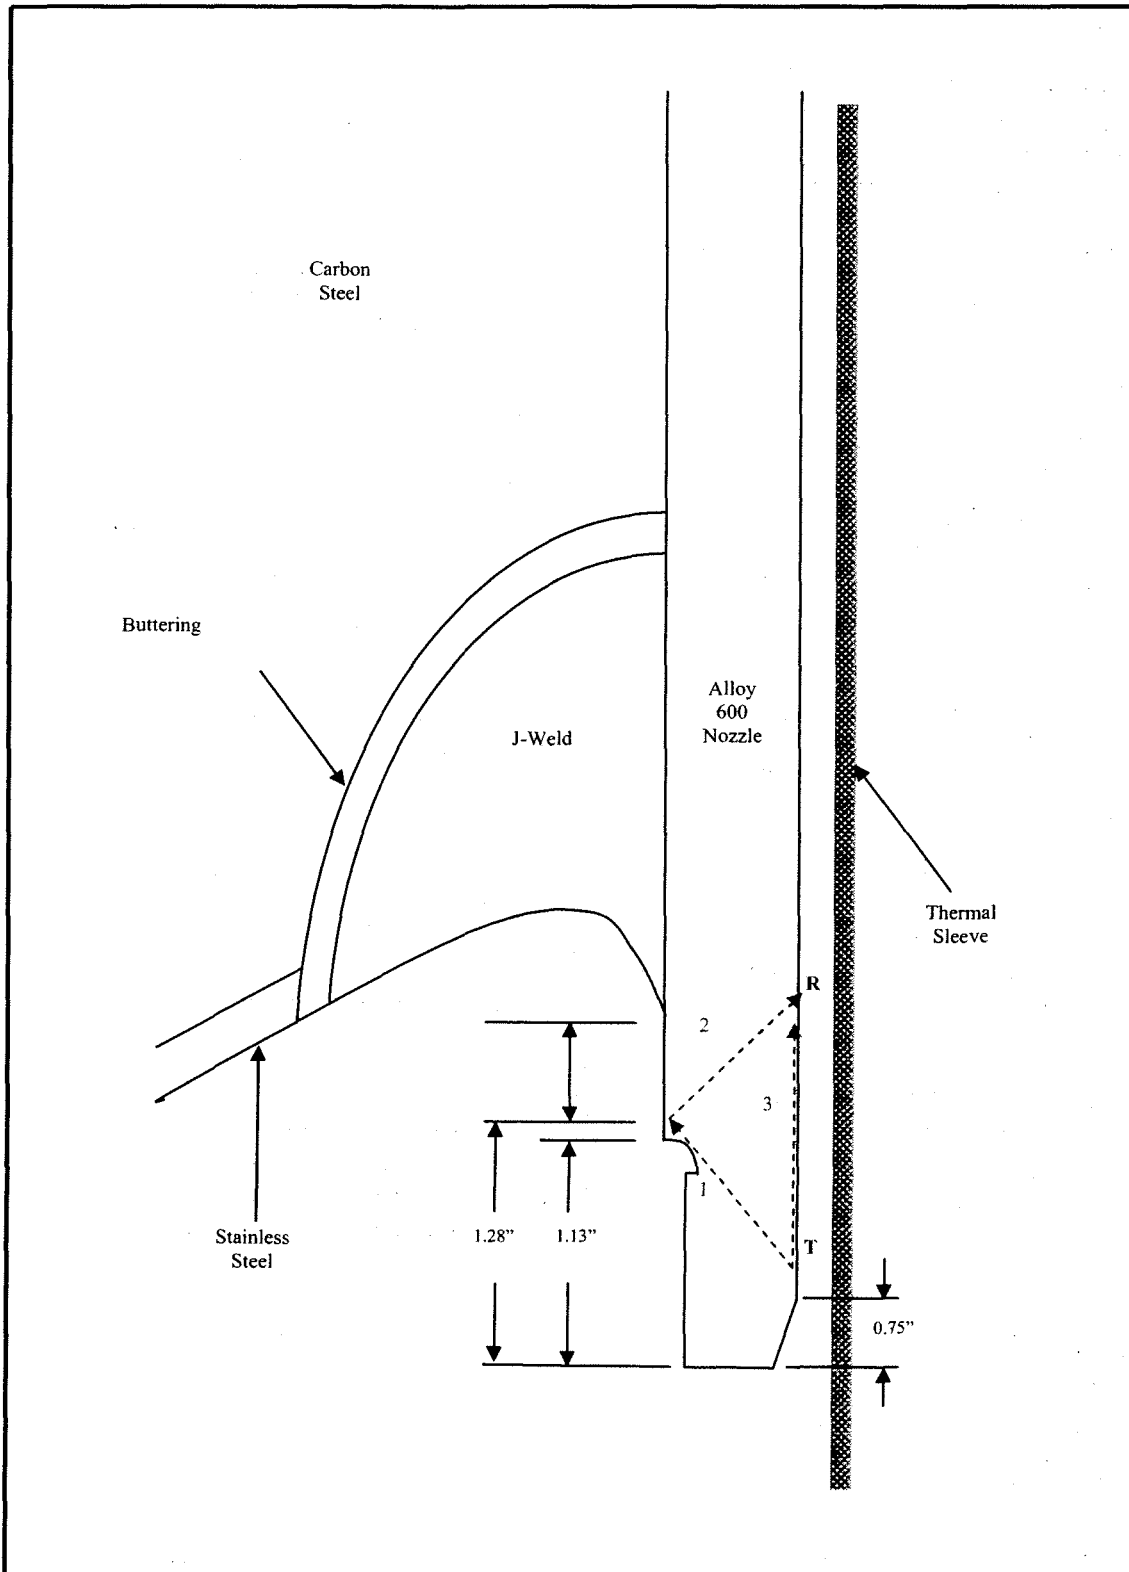
Figure 4.1 – Not to scale

The ID surfaces of the penetration tubes are chamfered at a 20° angle from the bottom of the tube to an elevation of 0.756". The threads on the tube OD surfaces and chamfer on the ID surfaces represent geometric conditions which limit examination coverage near the bottoms of the tubes.
