**U.S. Department of Energy
Office of Legacy Management**

2004 Annual Site Inspection and Monitoring Report for Uranium Mill Tailings Radiation Control Act Title I Disposal Sites

December 2004

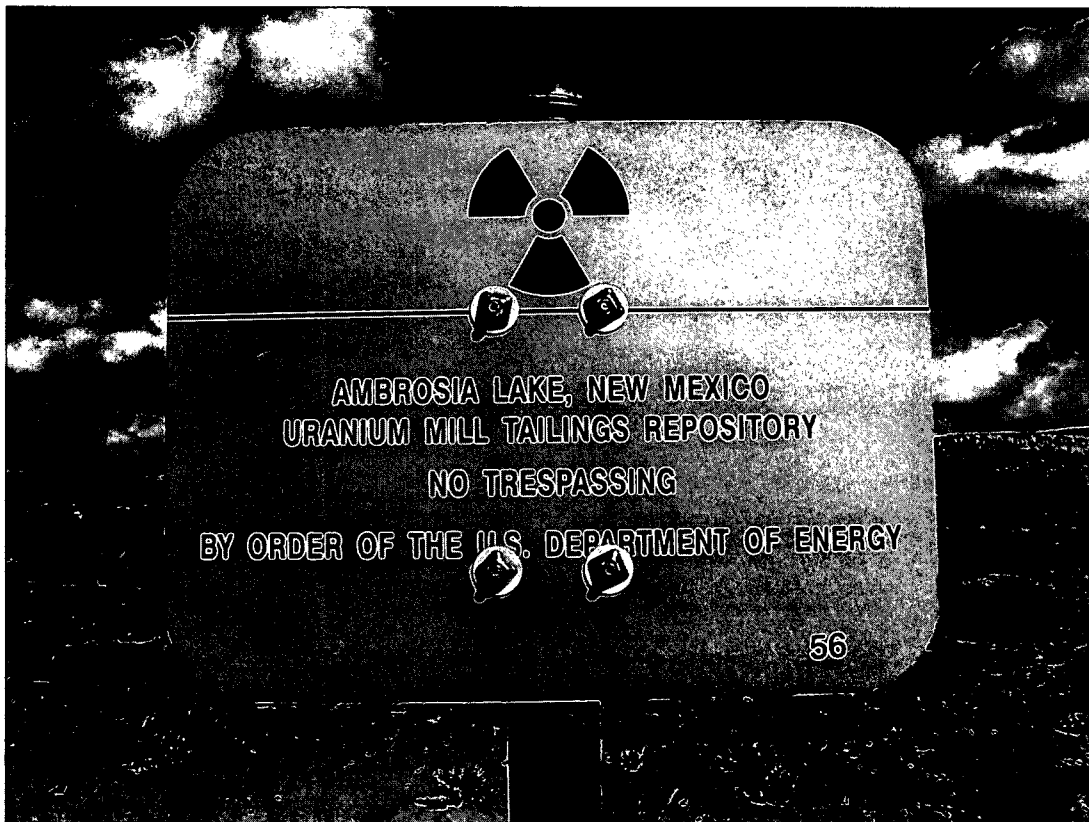
The entrance and all perimeter signs were in good condition (PL-1). Wind has eroded sandy soil from around the base of perimeter sign P12, but the post is stable. Posts for perimeter signs P1 through P10 include mining restriction warning signs.

AMB 9/2004. PL-1. Perimeter sign P56 near the southeast corner of the disposal cell.

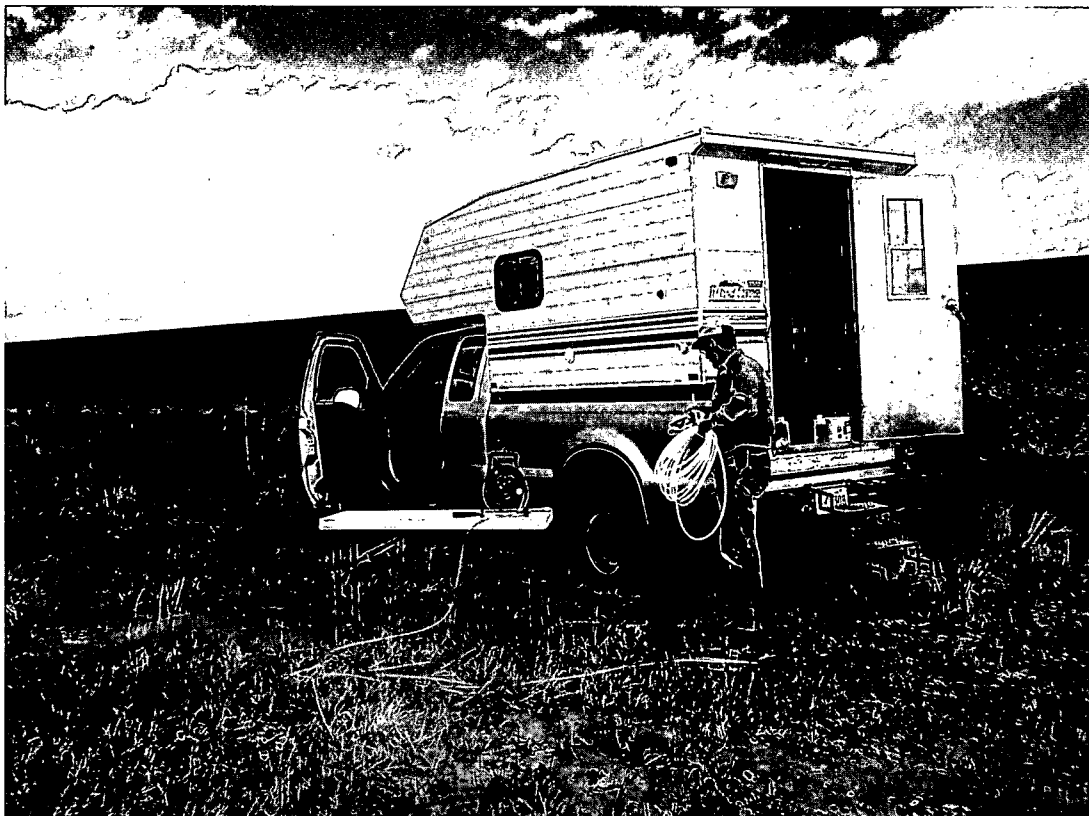
Monitor Wells—Two monitor wells (MW-0675 and MW-0678) are present. Both wells were sampled at the time of the inspection (PL-2). Sampling activities indicated that sediment is present in both wells and the above-ground well security vault for MW-0678 was damaged but secure. The wells will be cleaned out and the vault will be replaced prior to the next sampling event.

AMB 9/2004. PL-2. Ground water sampling at monitor well MW-0675.

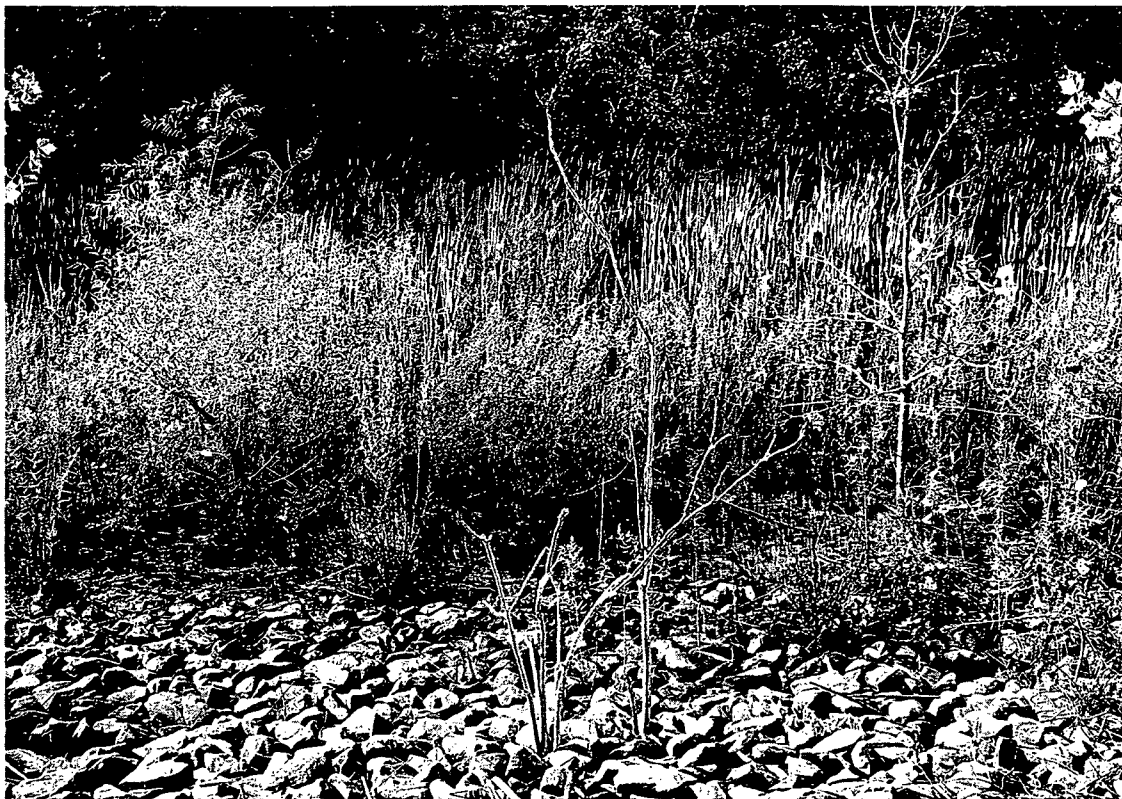
BUR 9/2004. PL-2. Standing water and flood watermarks on the plants in the slough.

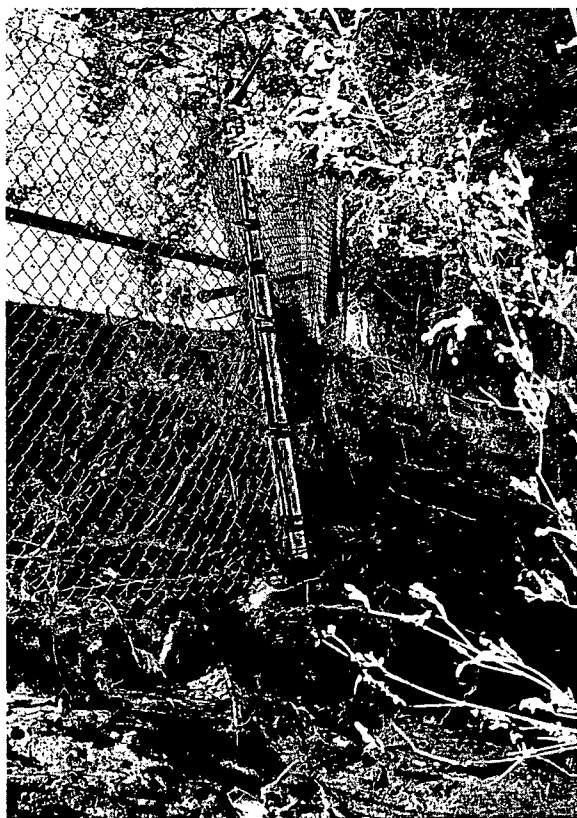
CAN 9/2004. PL-1. Damaged fence corner post caused by flooding.

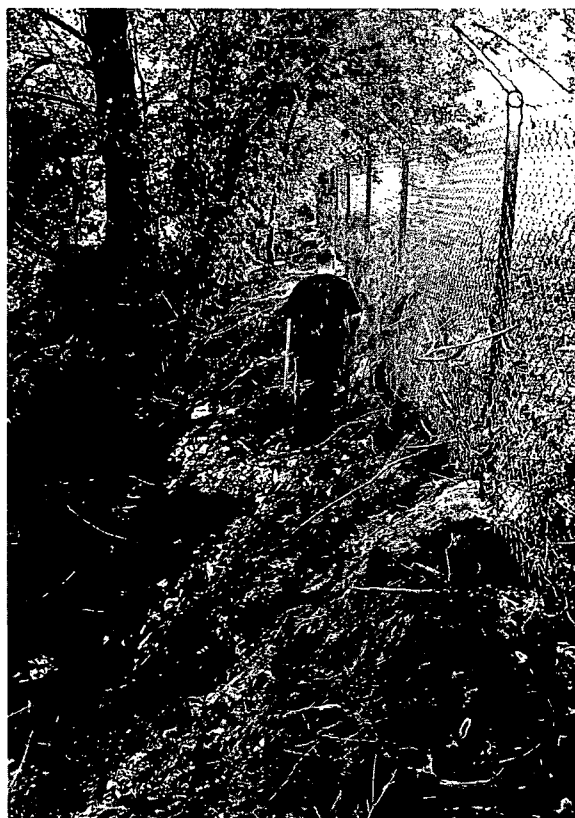
CAN 9/2004. PL-2. Stream bank erosion along the north fence line.

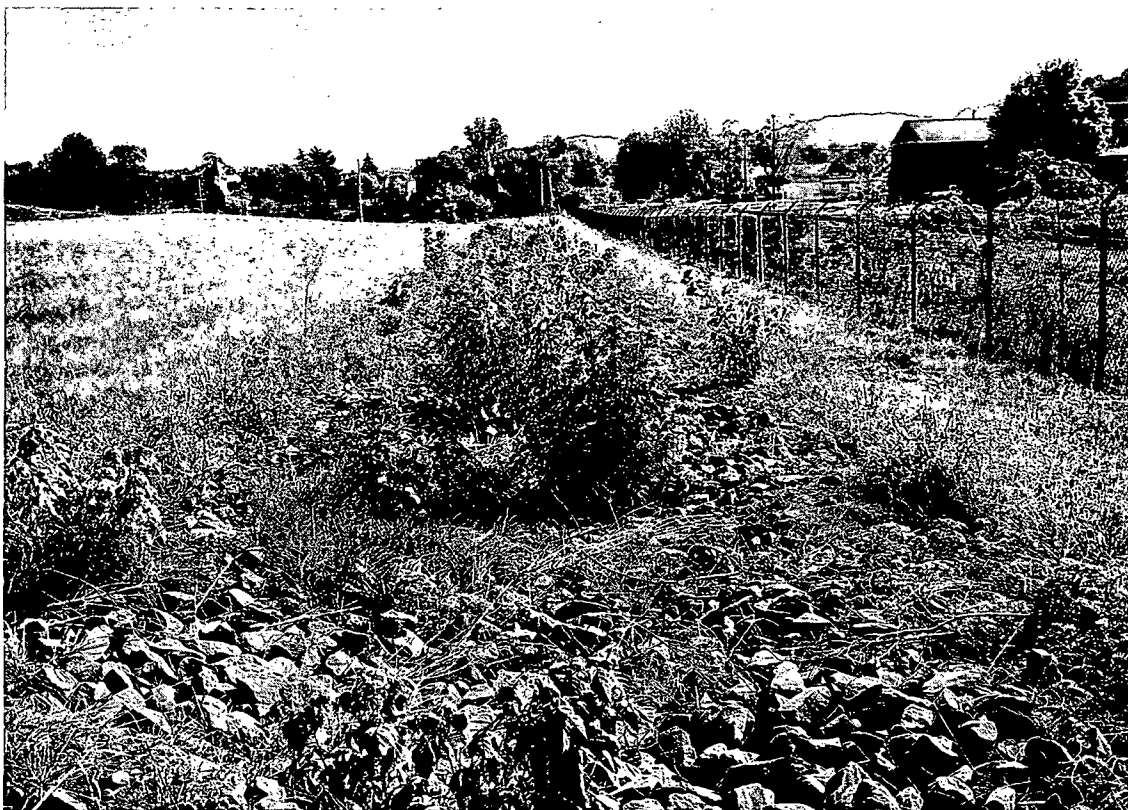
CAN 9/2004. PL-3. Vegetation encroachment in the perimeter ditch along the south property boundary.

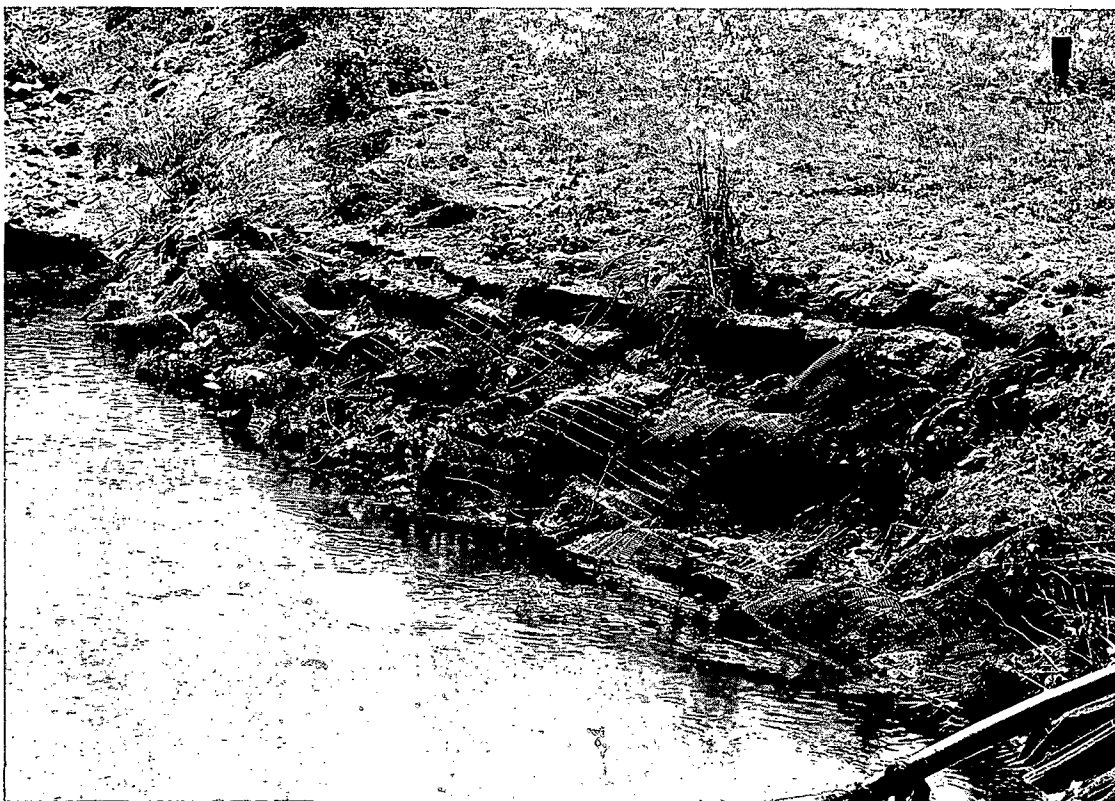
CAN 9/2004. PL-4. Stream bank erosion along Area C.

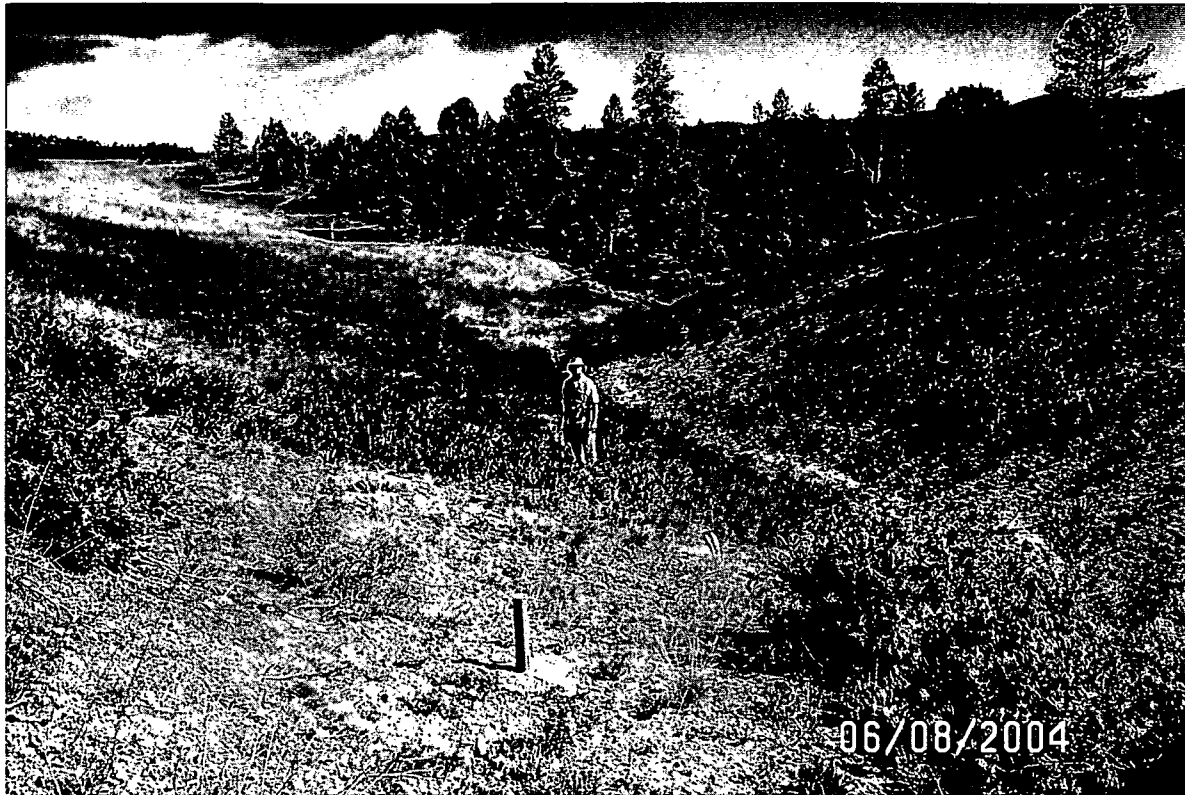
DUR 6/2004. PL-1. Inspector marks the location of missing boundary monument BM-6; the north witness corner is in the foreground.

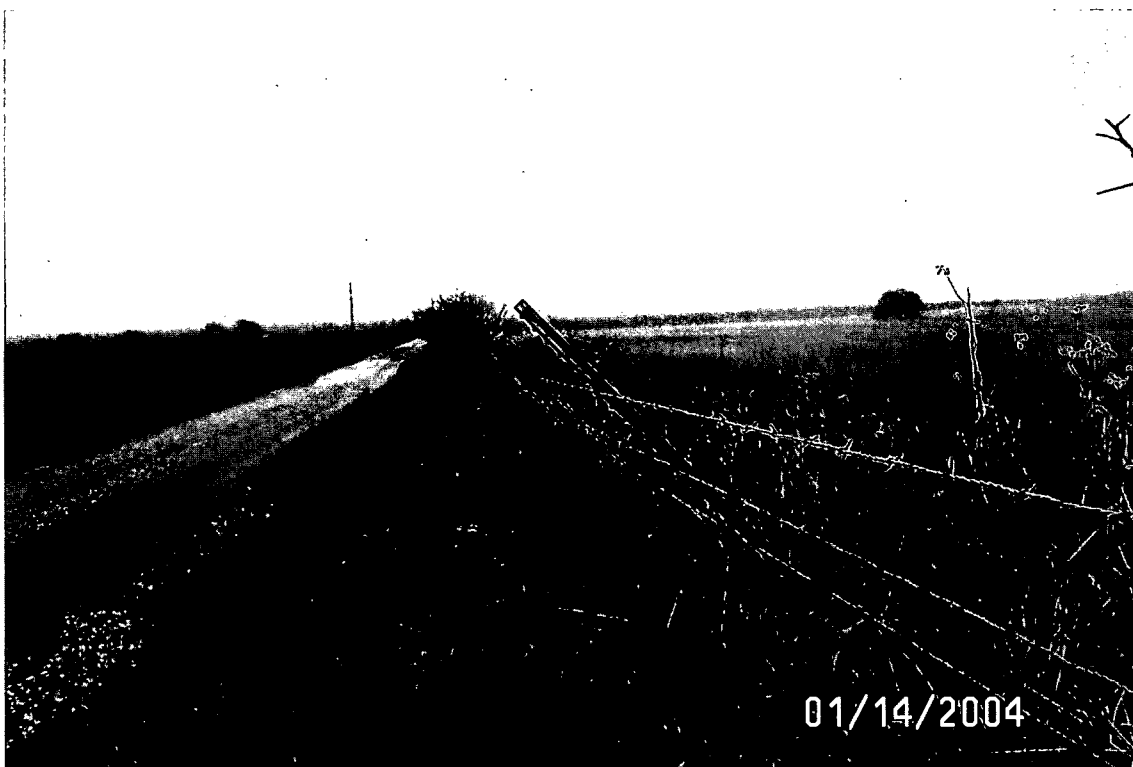
FCT 1/2004. PL-1. Section of perimeter fence leaning outward, located near perimeter sign P38 along County Road 202.

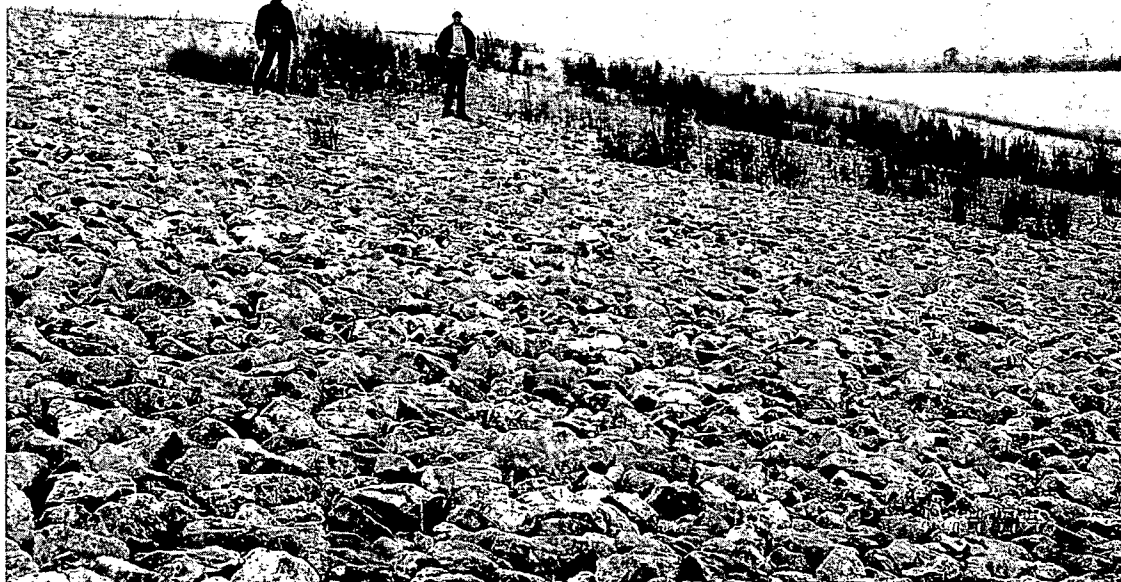
FCT 1/2004. PL-2. Typical vegetation growth found on the side slopes of the disposal cell.

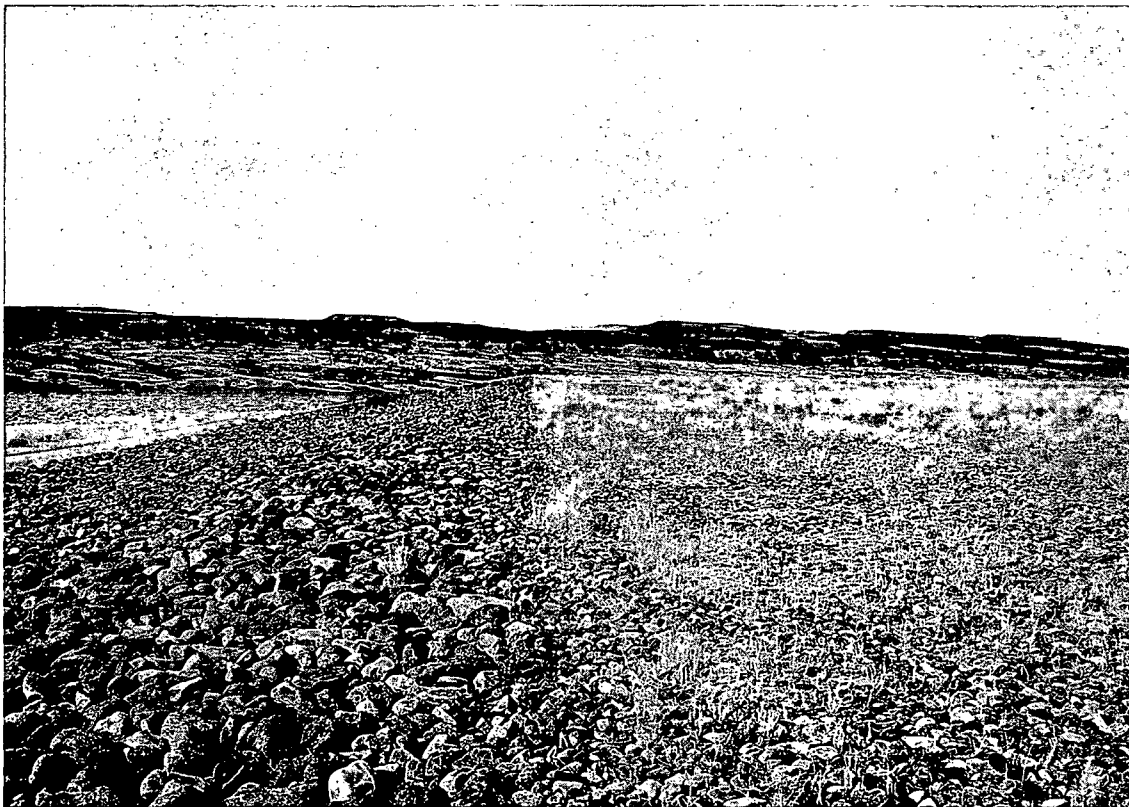
GRJ 3/2004. PL-1. Southern edge of the disposal cell cover and the south side slope showing the excellent condition of the rock cover and the distribution of vegetation.

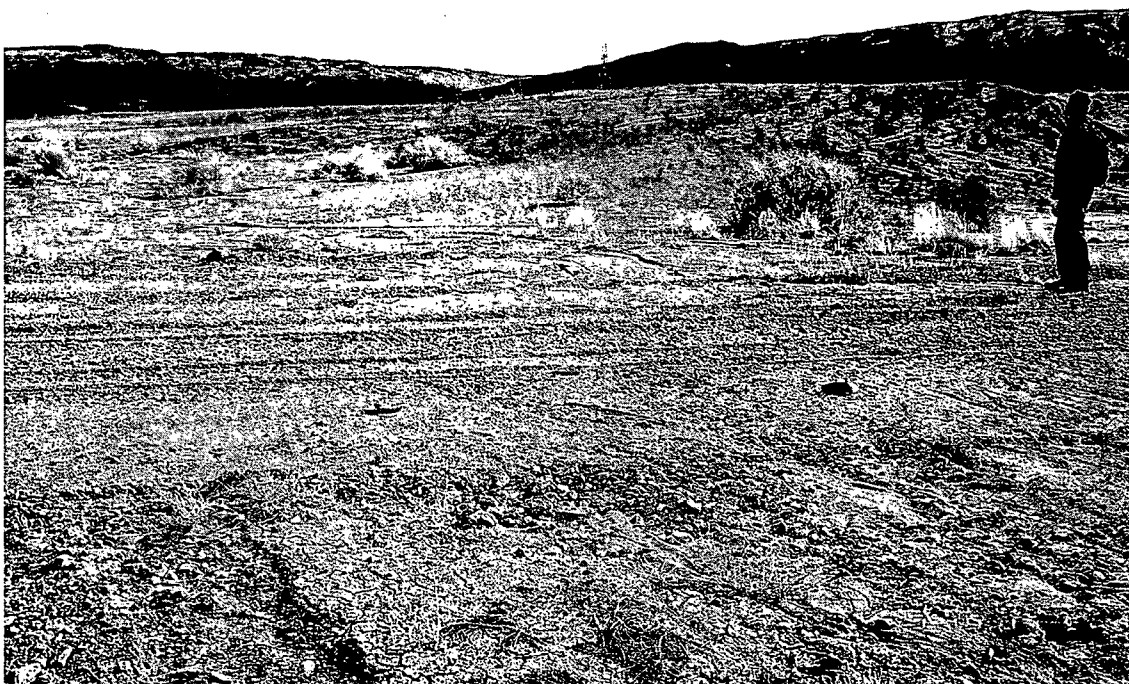
GRJ 3/2004. PL-2. An area where sediment-laden sheet flow crossed a site road and discharged into the adjacent south diversion channel.

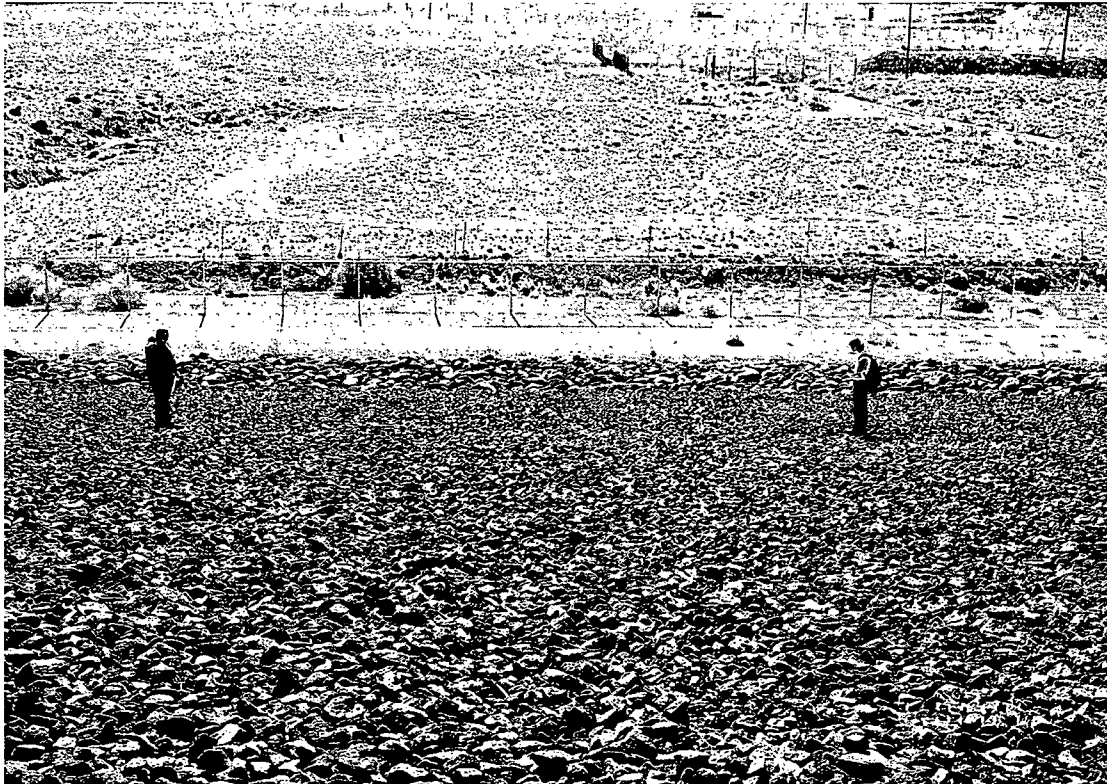
GRN 3/2004. PL-1. Inspectors standing in a slight depression area near the base of the southeast side slope of the disposal cell.

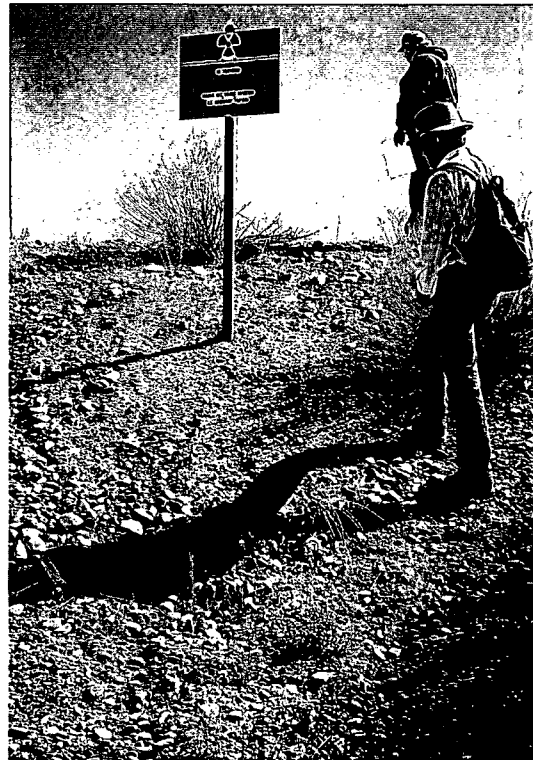
GRN 3/2004. PL-3. Repairs made to erosional rills at perimeter sign P4.

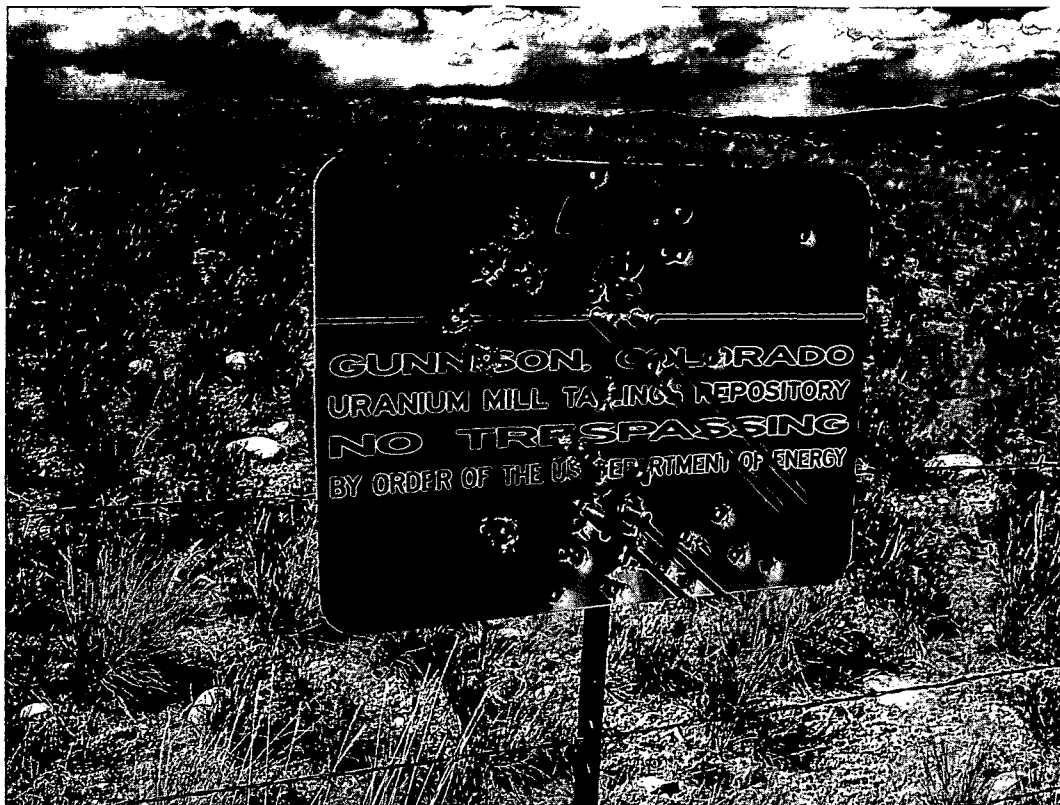
GUN 5/2004. PL-1. Damaged perimeter sign P41 near the site access road.

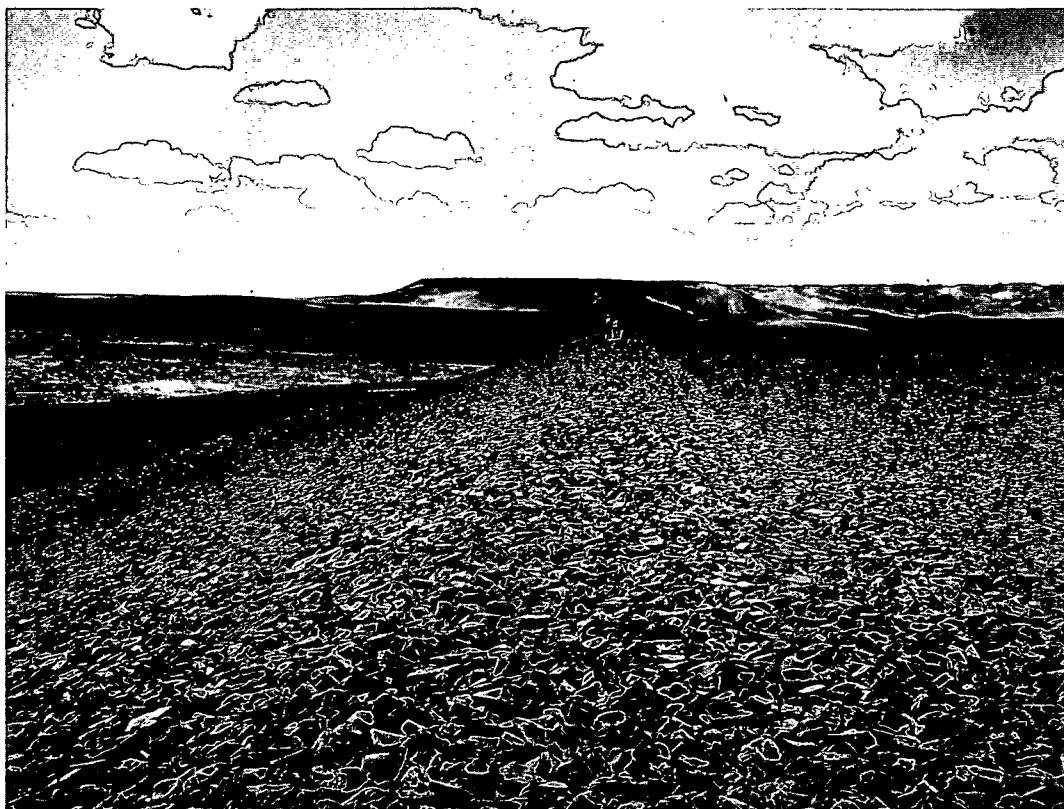
GUN 5/2004. PL-2. Southwest portion of the cell showing the excellent condition of the cell top and the southwest side slope.

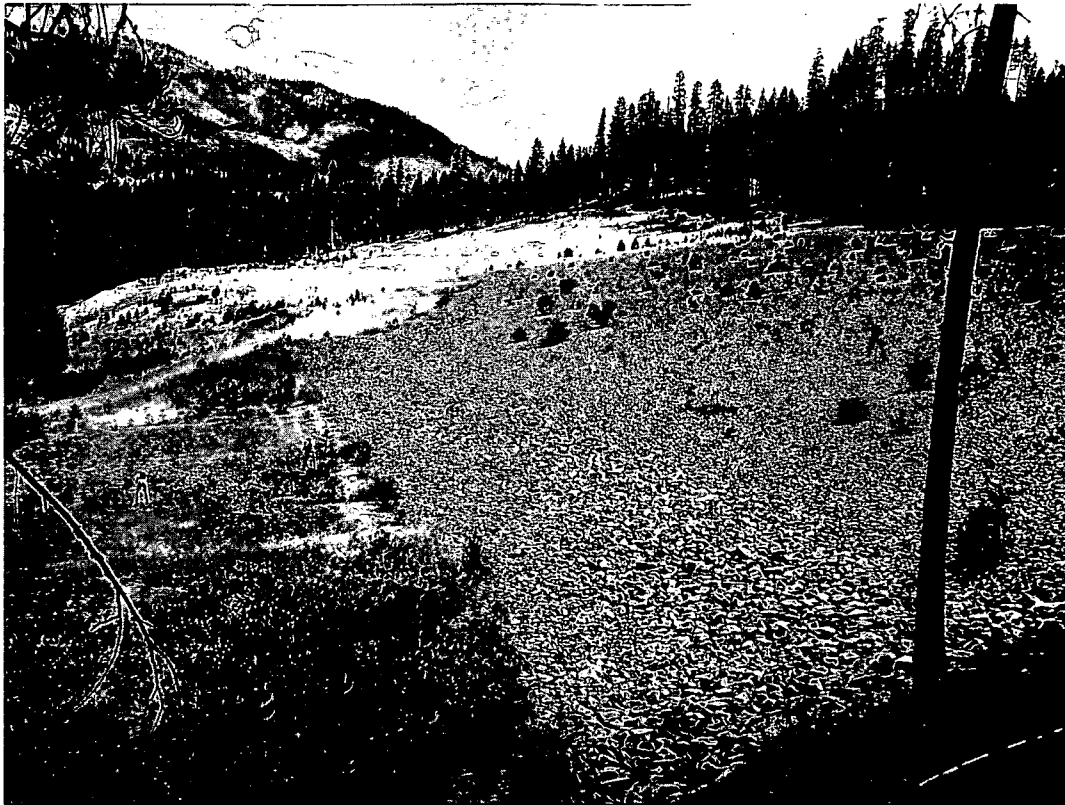
LOW 6/2004. PL-1. Excellent condition of the disposal cell side slope and west apron.

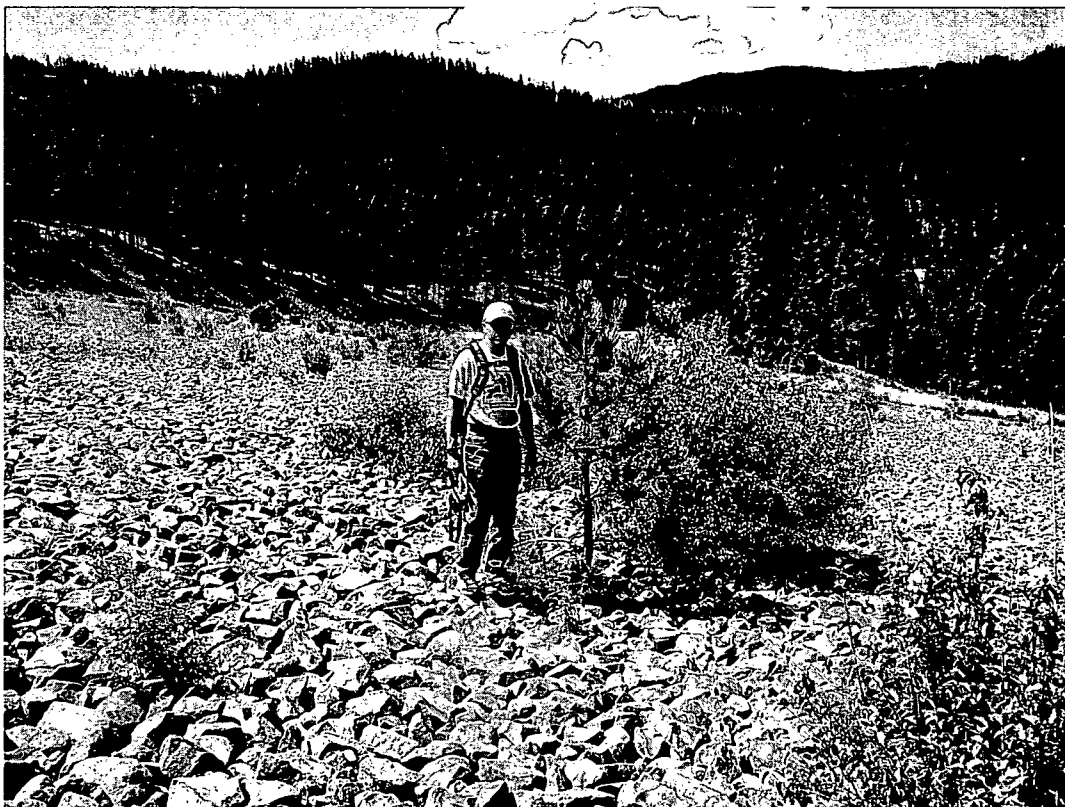
LOW 6/2004. PL-2. Vegetation growth on the disposal cell cover.

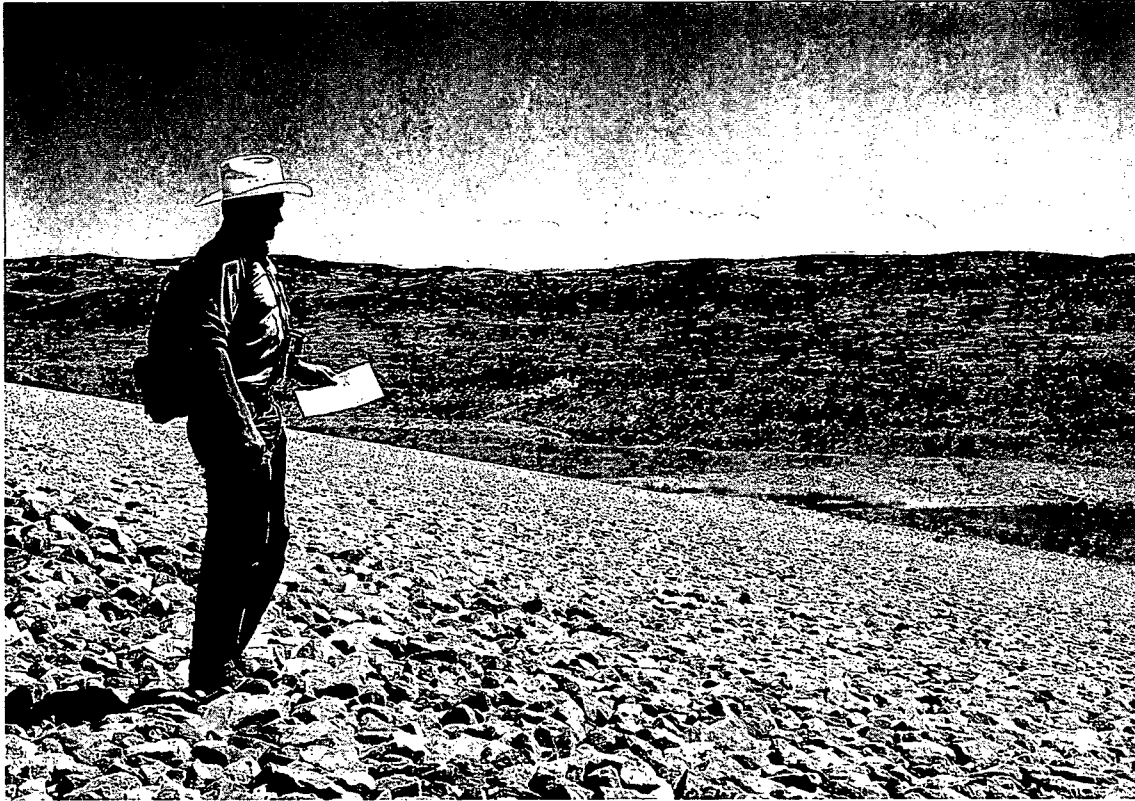
MAY 8/2004. PL-1. Rock-armored side slope at the east corner of the disposal cell.

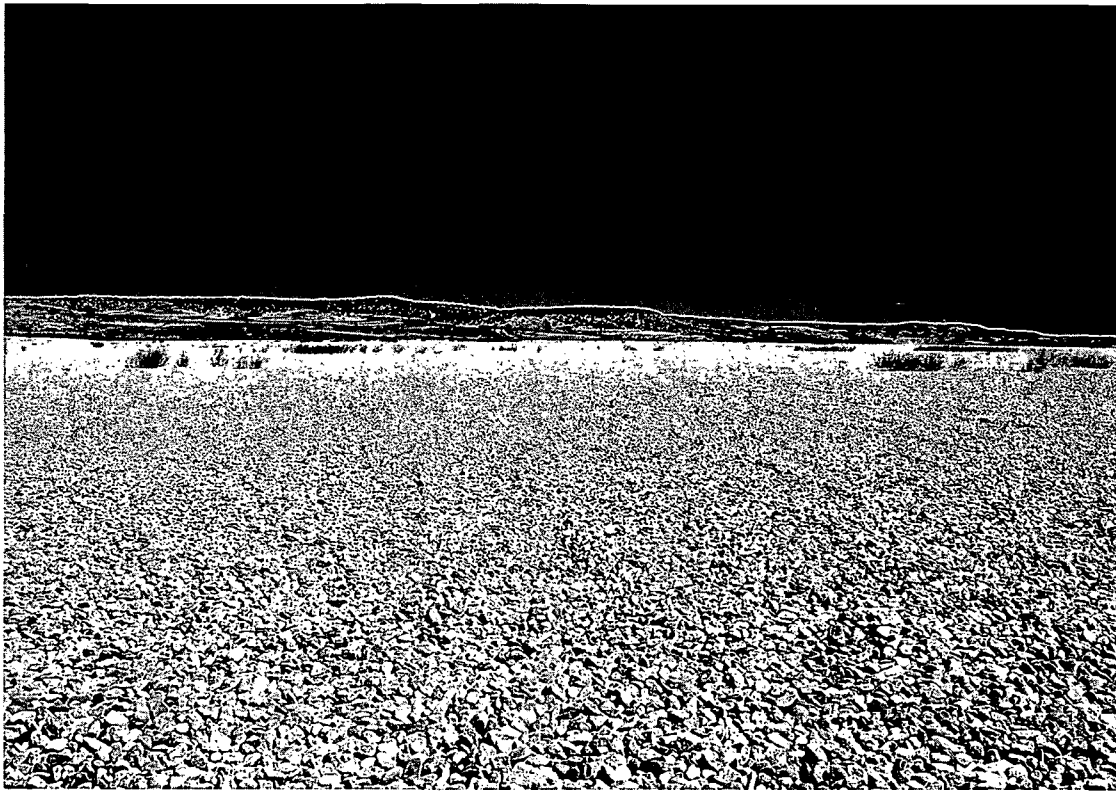
MAY 8/2004. PL-2. Typical distribution of vegetation found growing on top of the disposal cell.

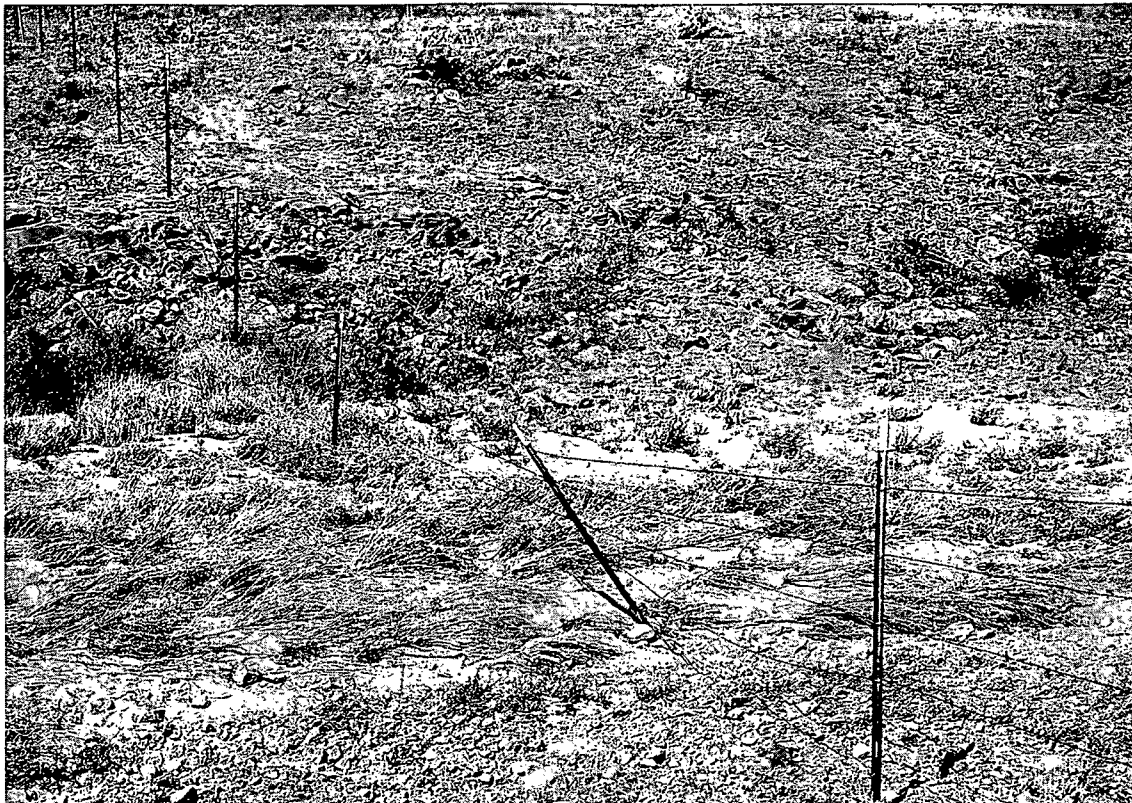
HAT 9/2004. PL-1. Perimeter fence damage at the outfall of West Ditch.

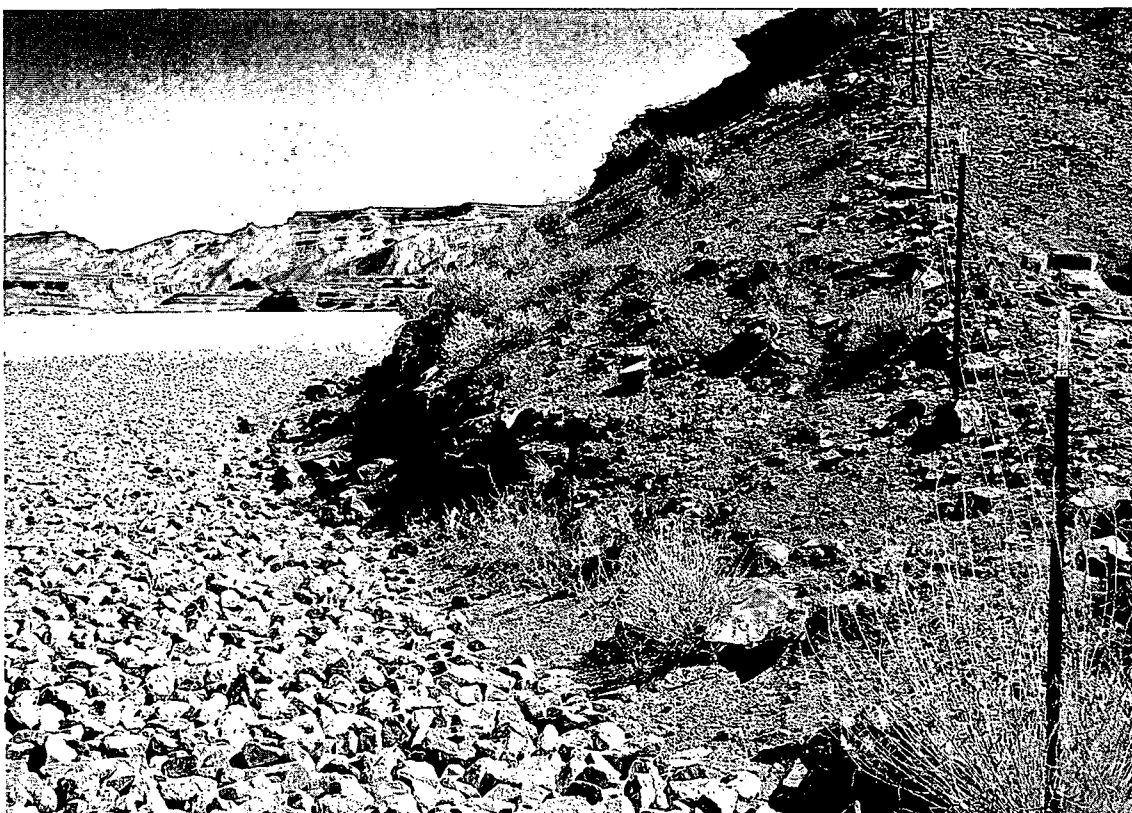
HAT 9/2004. PL-2. Rock debris along the edge of the south apron.

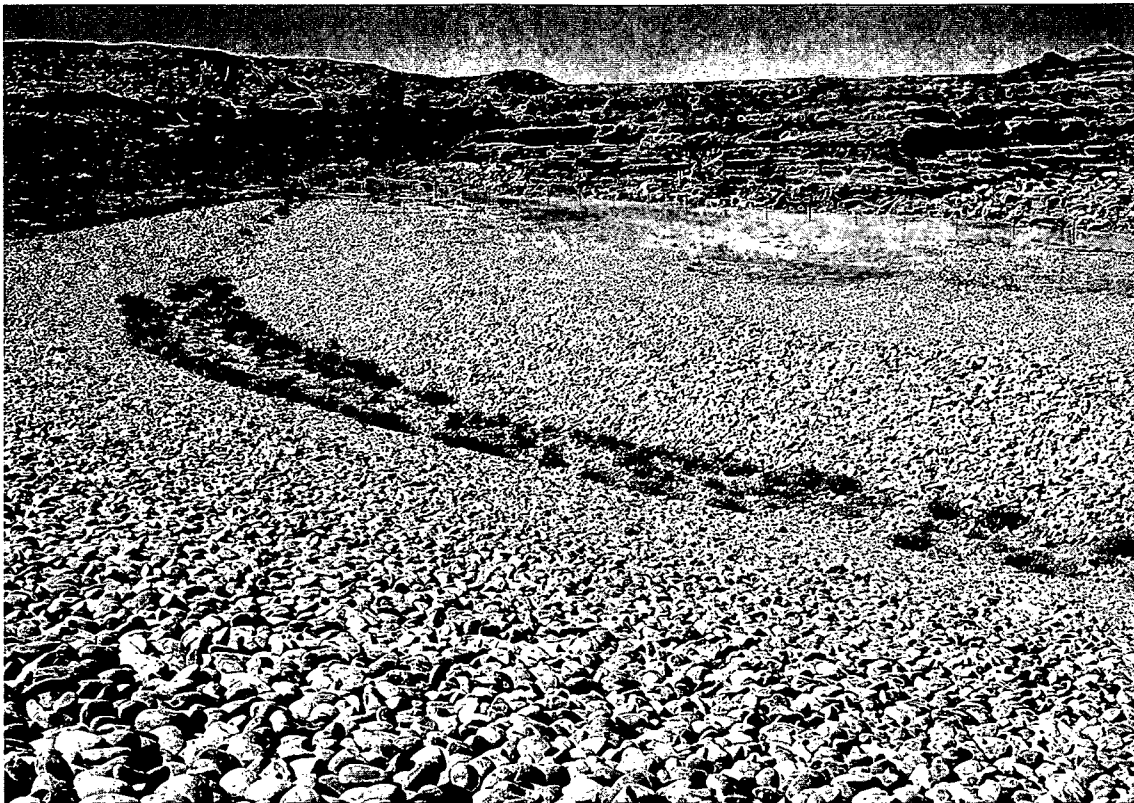
HAT 9/2004. PL-3. Minor sediment accumulation and associated plant growth in West Ditch.

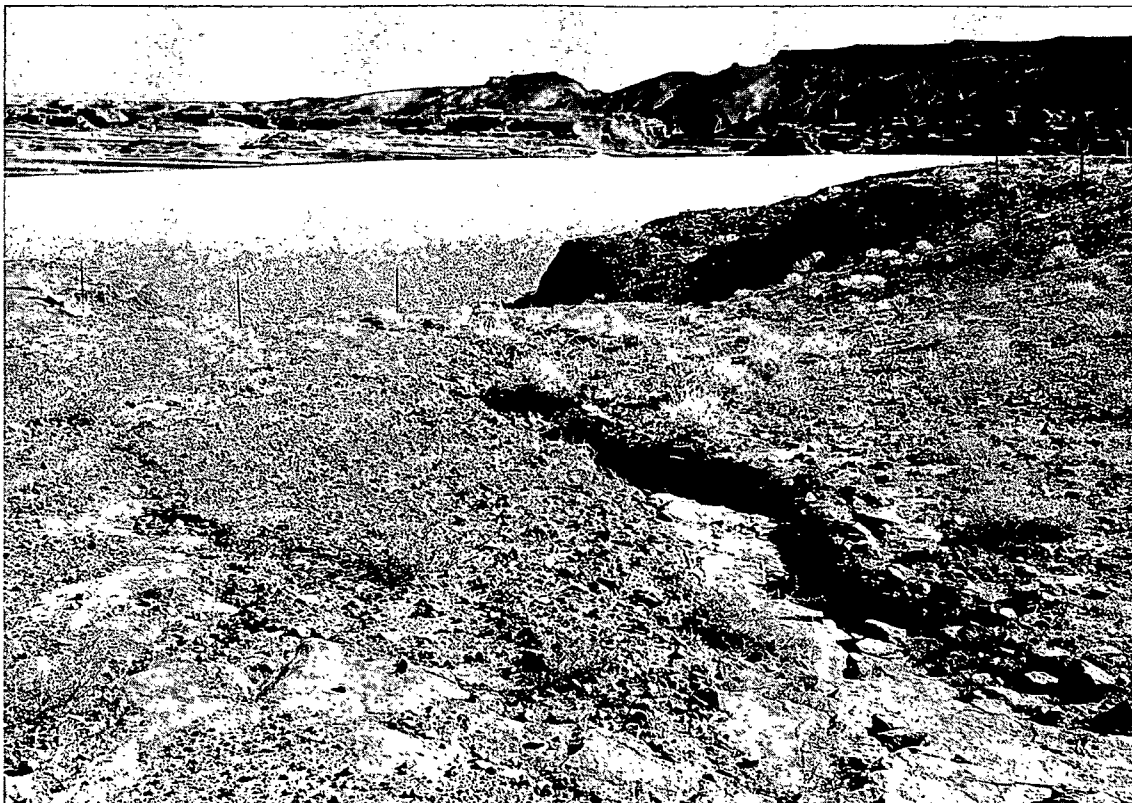
HAT 9/2004. PL-4. Stabilizing rills and gullies upstream of Southwest Ditch.

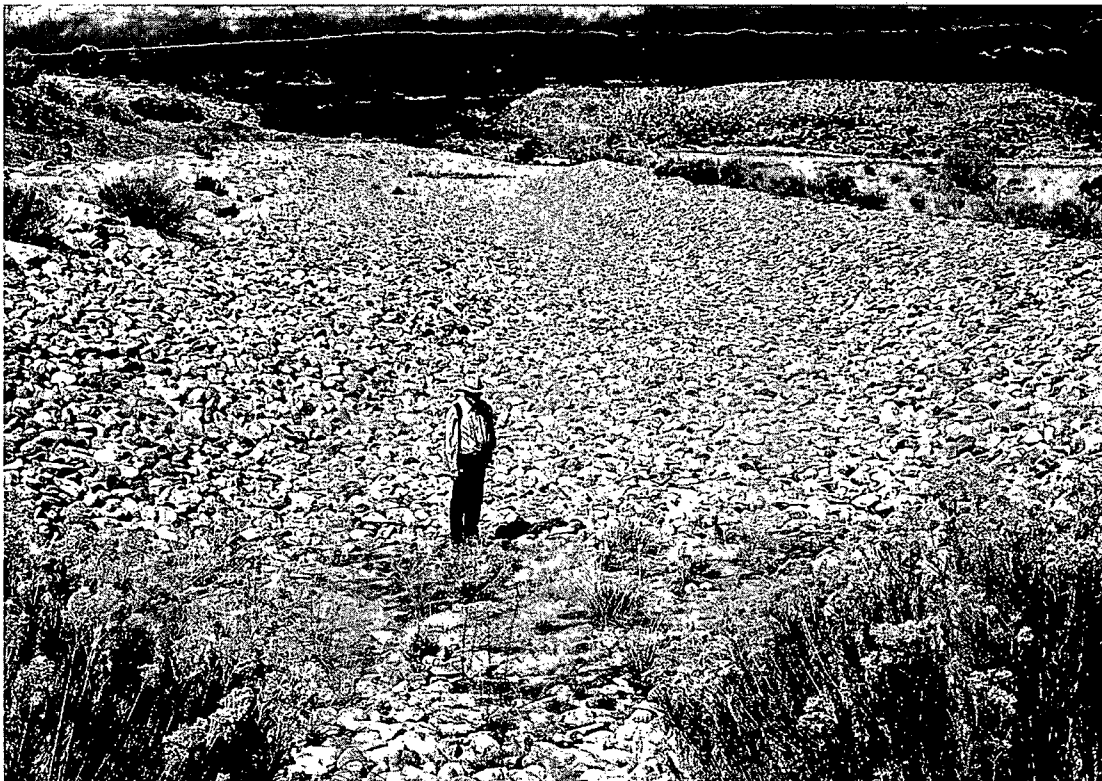
NAT 4/2004. PL-2. Minor sedimentation and plant growth in the upstream end of the interceptor channel.

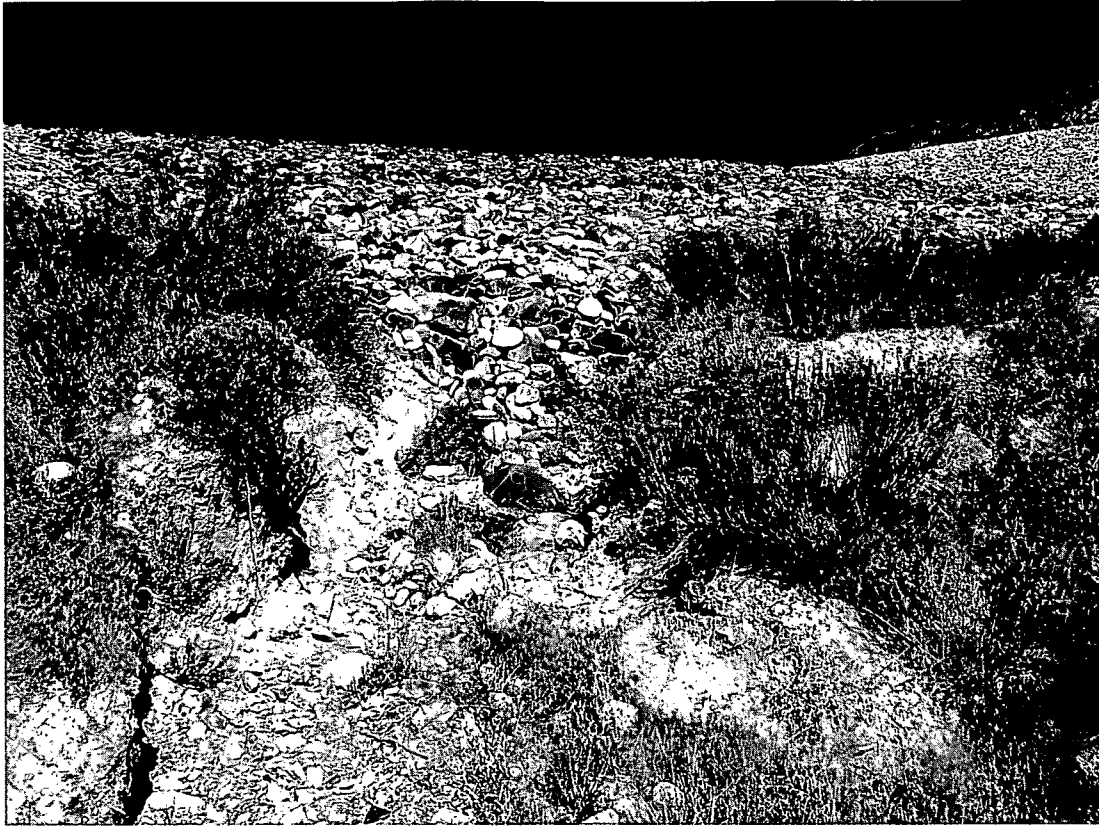
RFL 8/2004. PL-3. Self-armoring at the toe ditch outlet.

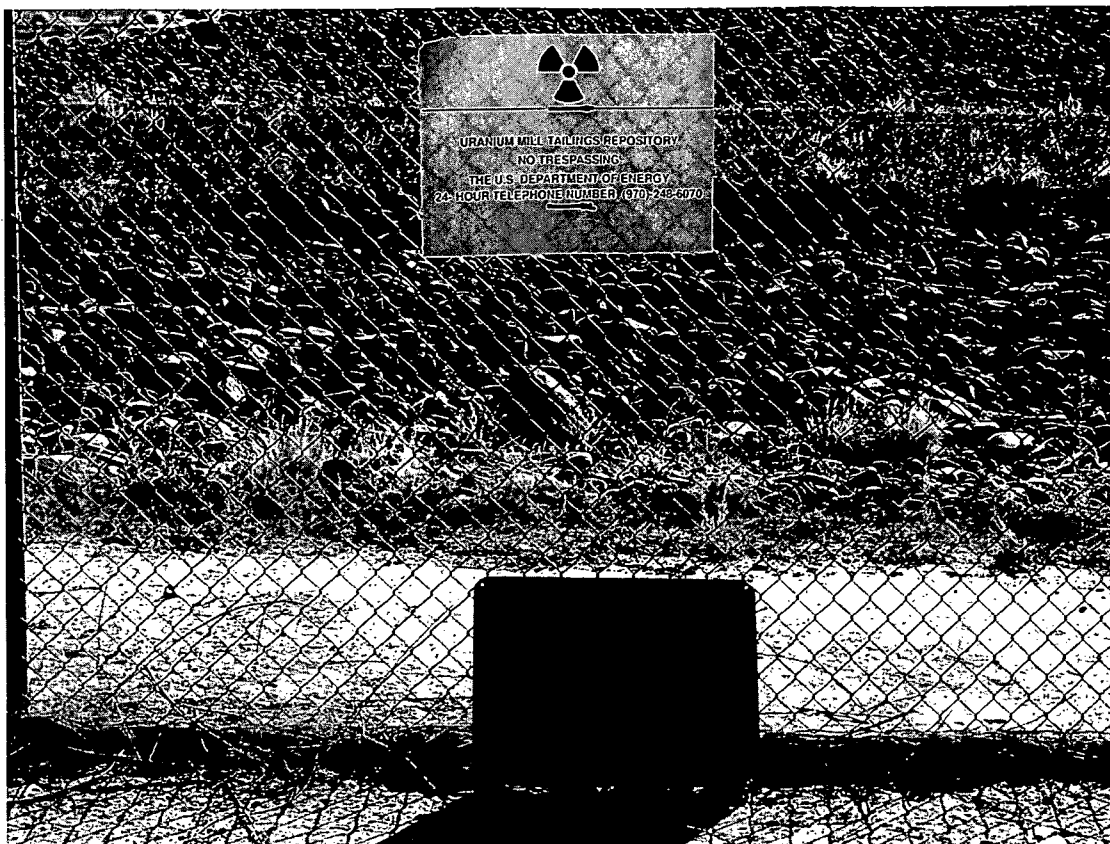
SLC 3/2004. PL-1. New perimeter sign P5.
