**U.S. Department of Energy
Office of Legacy Management**

2004 Annual Site Inspection and Monitoring Report for Uranium Mill Tailings Radiation Control Act Title I Disposal Sites

December 2004

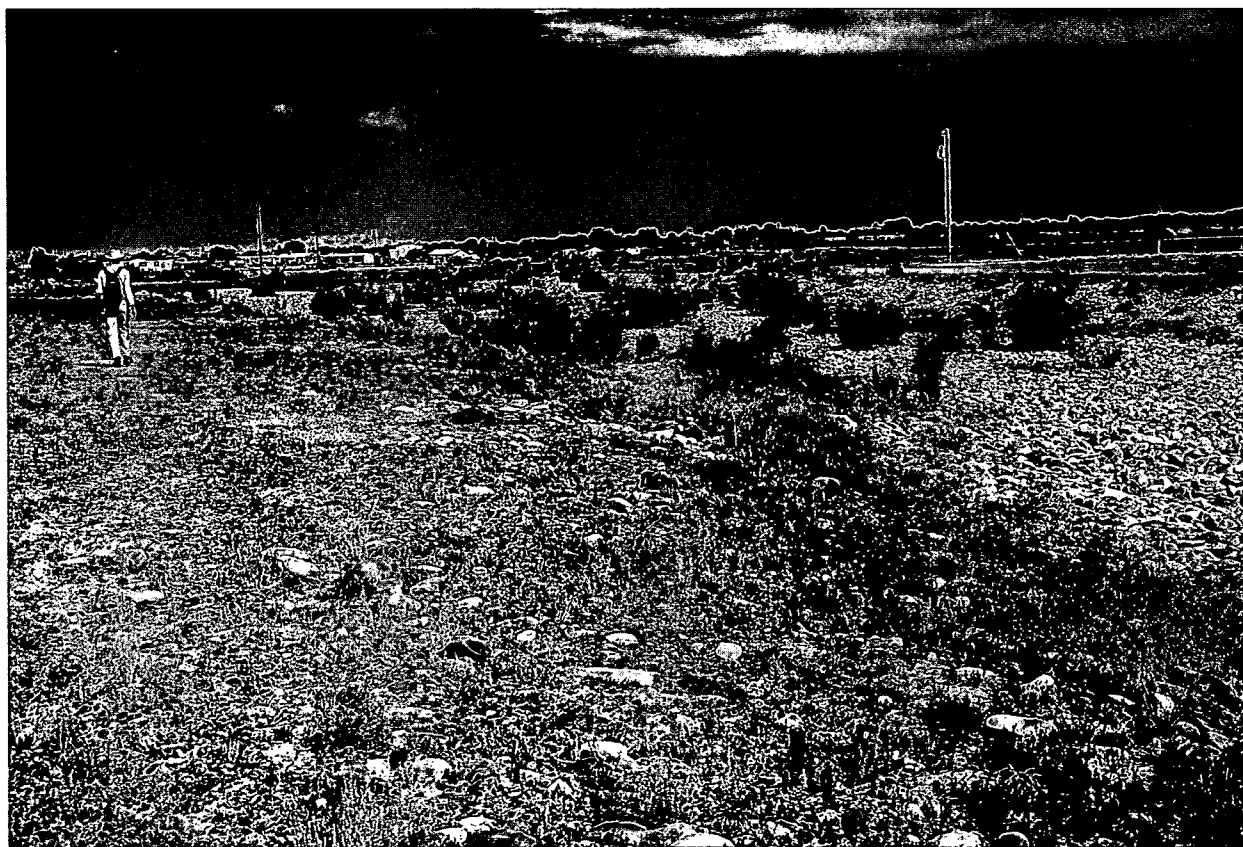
SHP 6/2004. PL-1. Woody vegetation in the upstream end of the outflow channel.

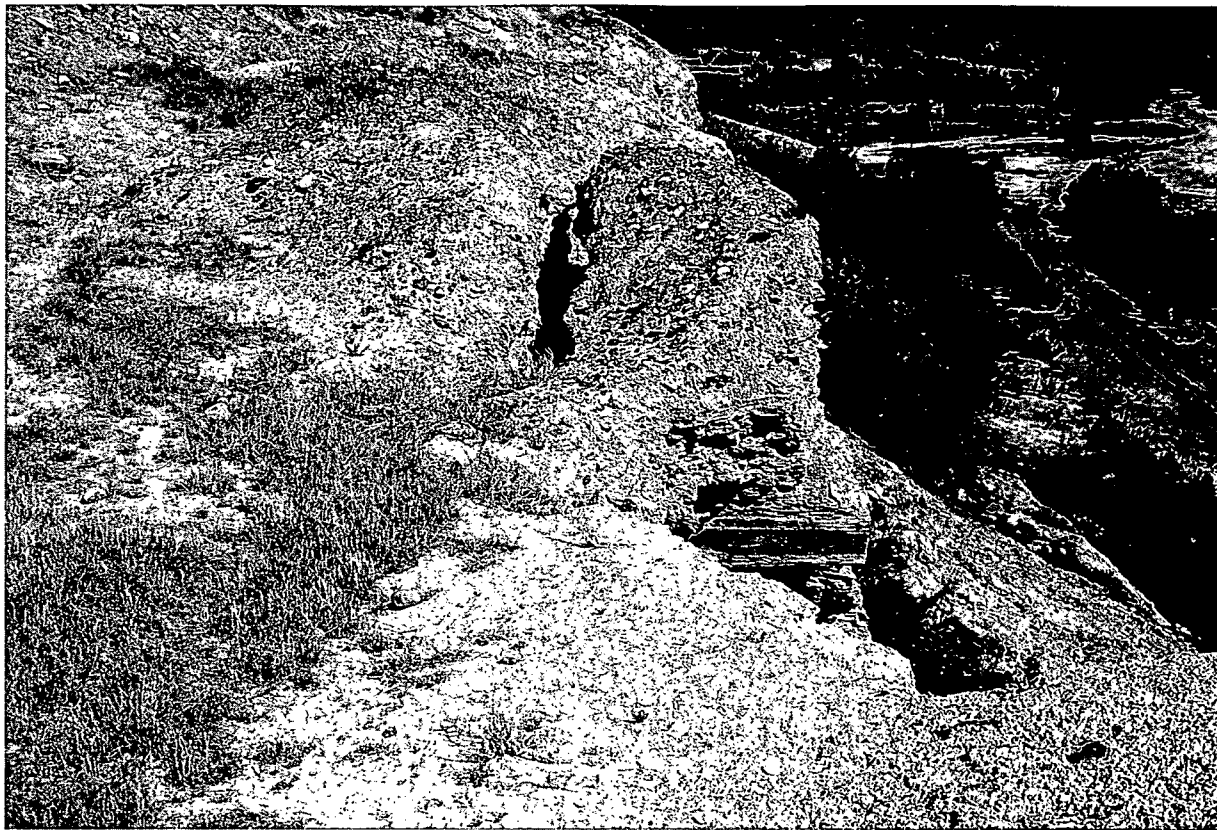
SHP 6/2004. PL-2. Natural sloughing of material along the terrace escarpment.

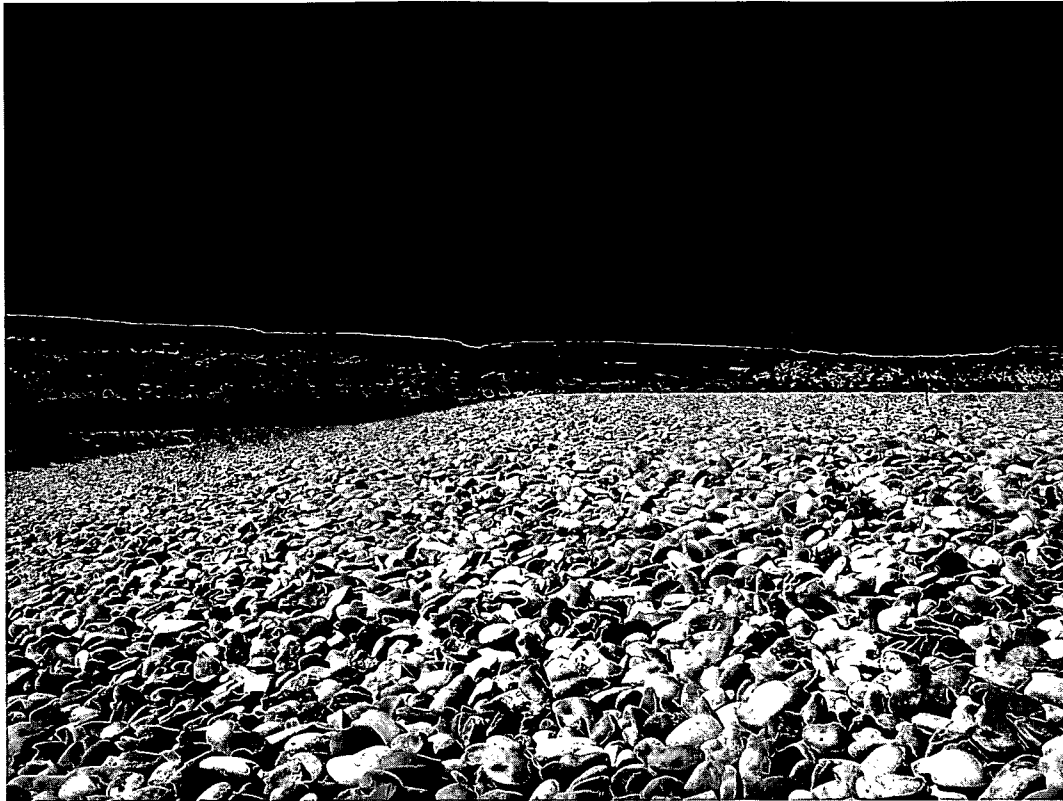
SRK 4/2004. PL-1. View showing integrity of rock-covered surfaces along the southeast side of the disposal cell.

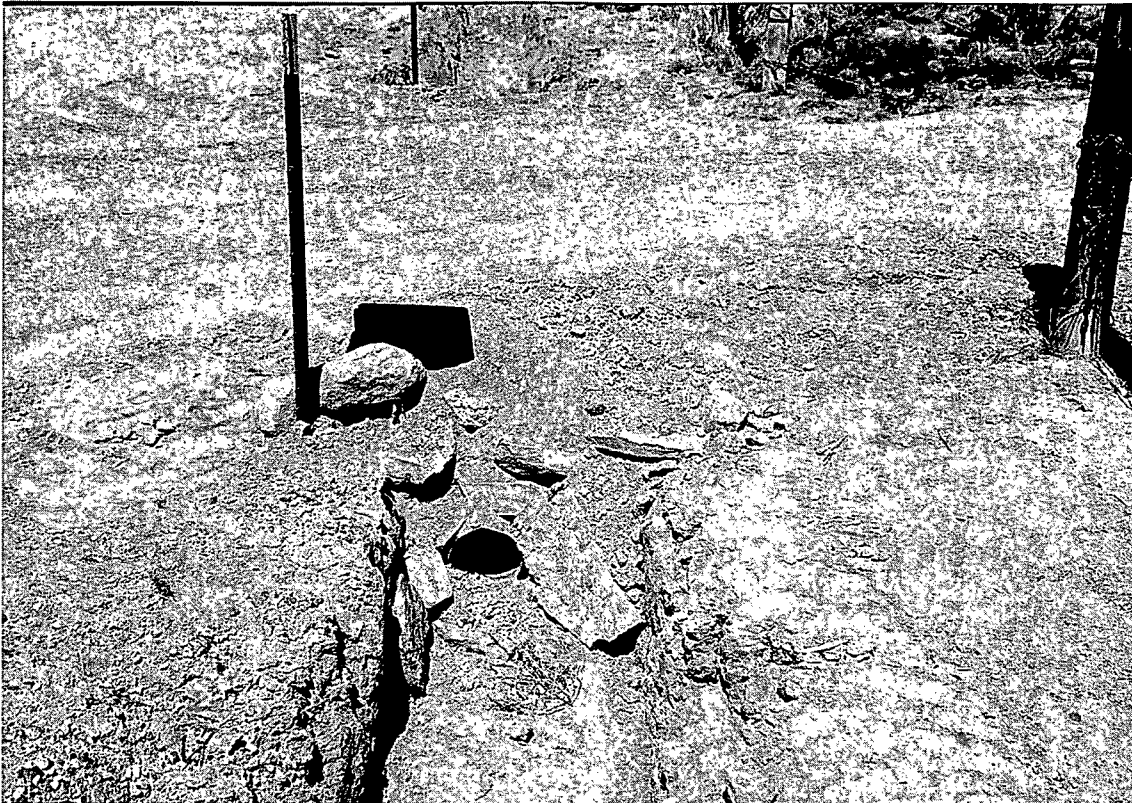
SRK 4/2004. PL-2. New 8-inch diameter culvert and regraded road at the site entrance following erosion repair.

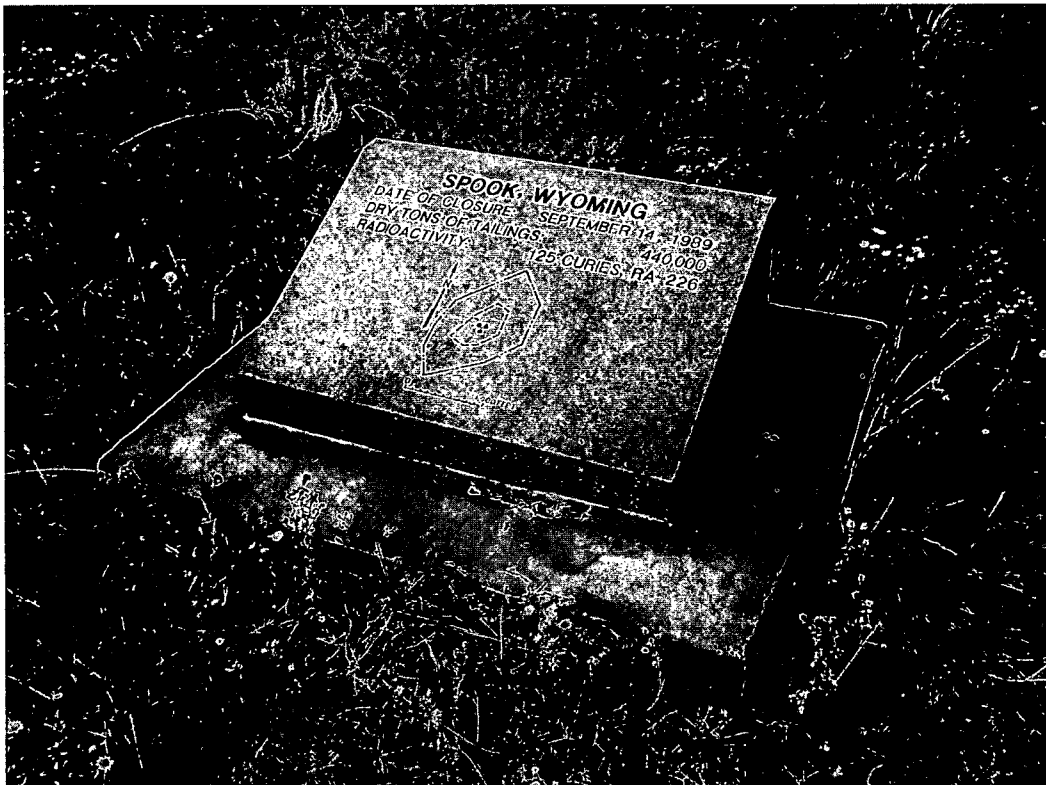
SPK 8/2004. PL-1. Site marker SMK-1, showing spalling concrete on its base.

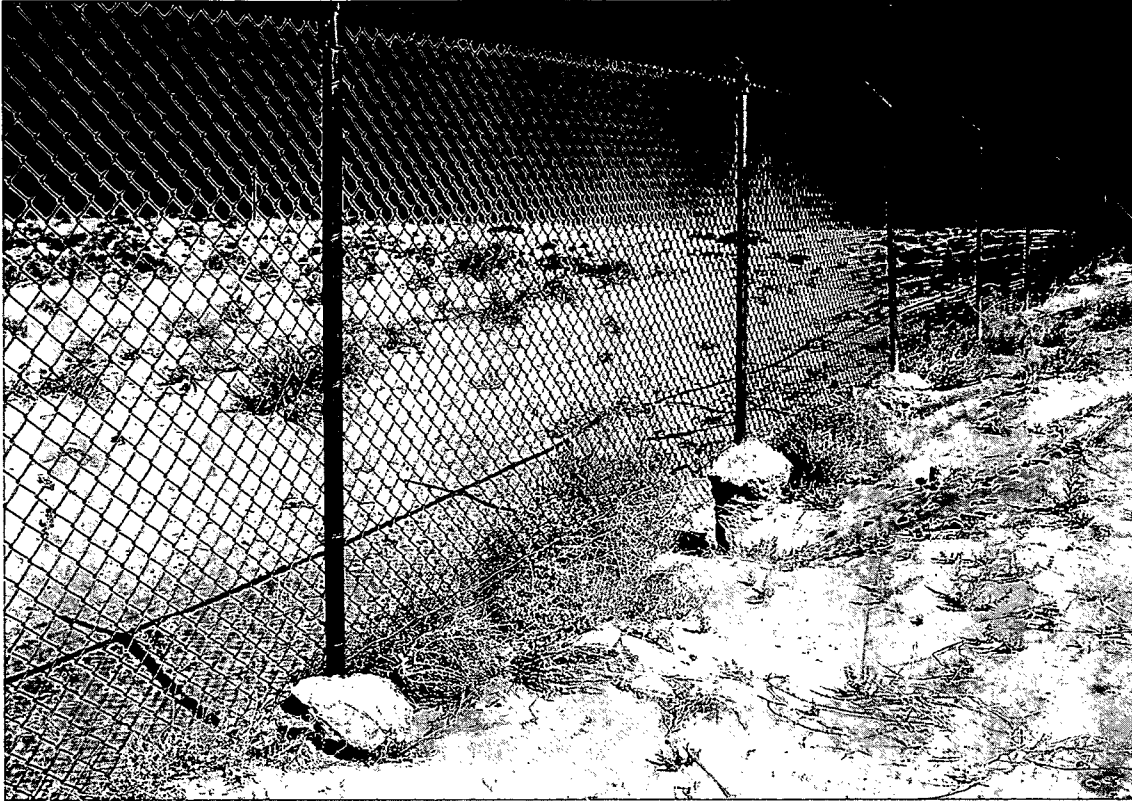
TUB 9/2004. PL-1. Gap at the base of the security fence due to wind erosion.

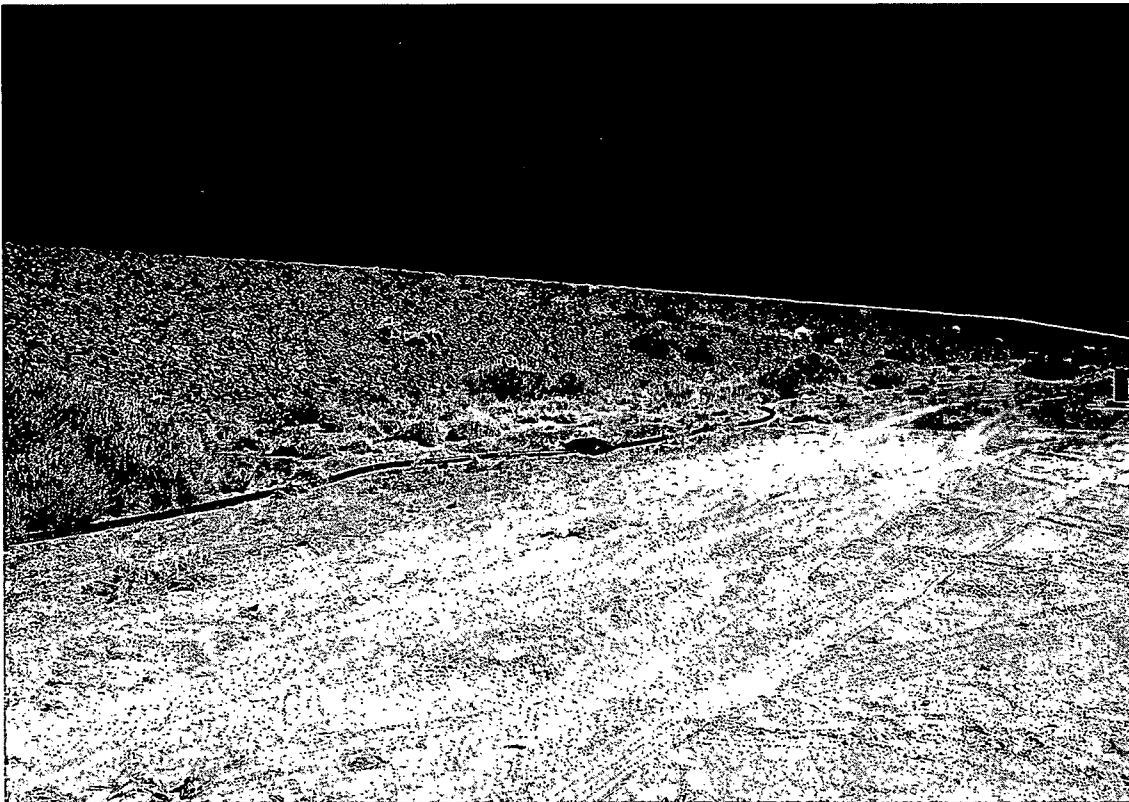
TUB 9/2004. PL-2. Vegetation encroachment on the south side slope of the disposal cell.

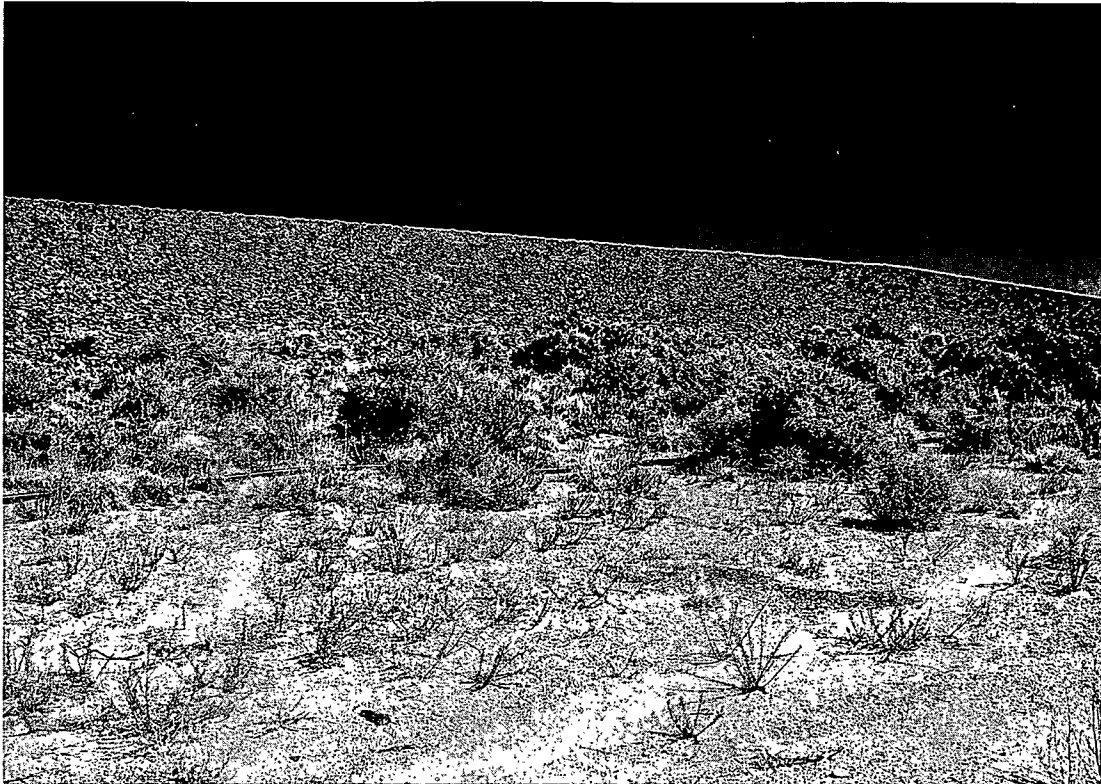
TUB 9/2004. PL-3. Vegetation encroachment and sand accretion along the base of the south side slope of the disposal cell.

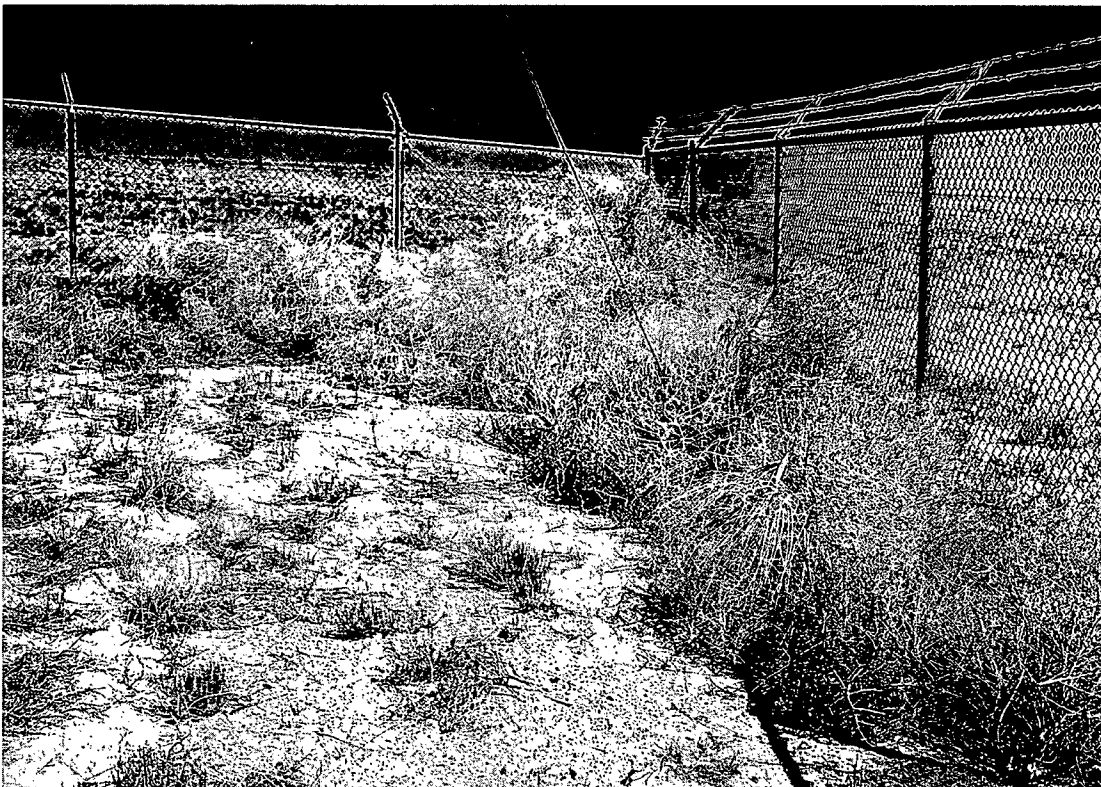
TUB 9/2004. PL-4. Tumbleweeds and windblown sand deposits in the northeast corner of the site.
