**NEW ENGLAND COALITION, INC.'S (NEC) SUPPLEMENT TO OPPOSITION
TO ENTERGY'S MOTION FOR SUMMARY DISPOSITION OF NEW
ENGLAND COALITION CONTENTION 3 (STEAM DRYER)**

SECOND DECLARATION OF ULRICH WITTE

INR-IVVI-VYR26-07-10- Steam Dryer Interior HB-V04

Indication Notification Report

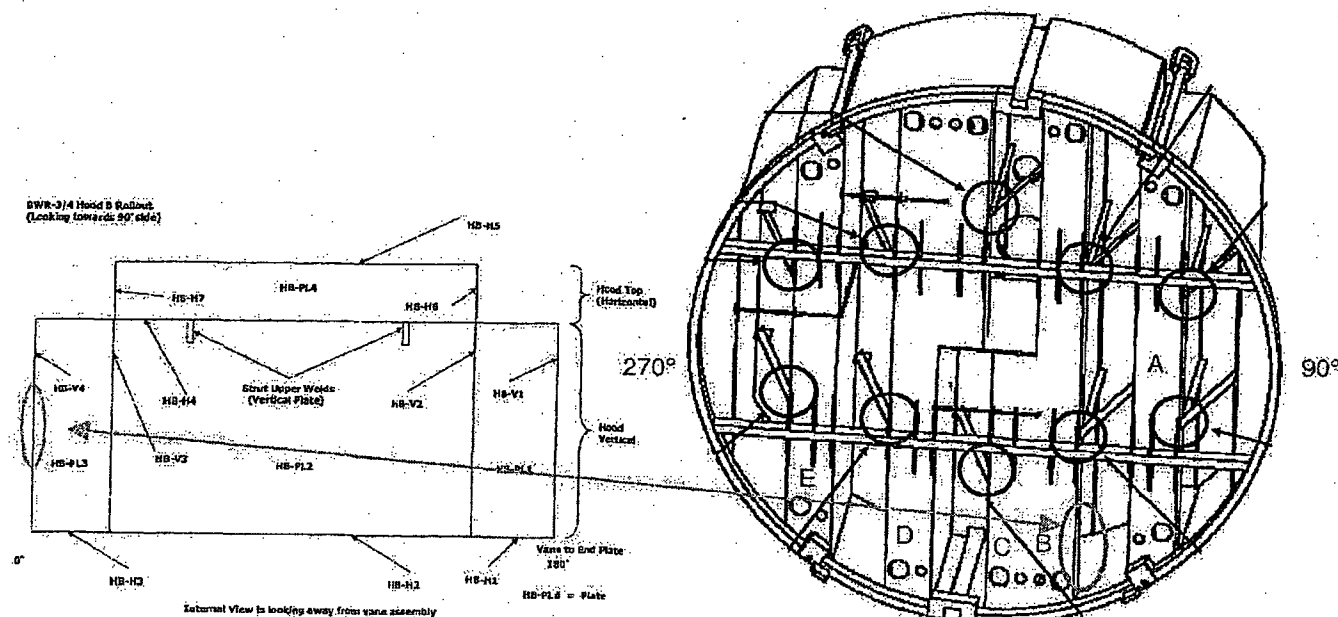
Sketch on the left shows the weld map rollout. The sketch on the right shows a bottom view of the dryer.

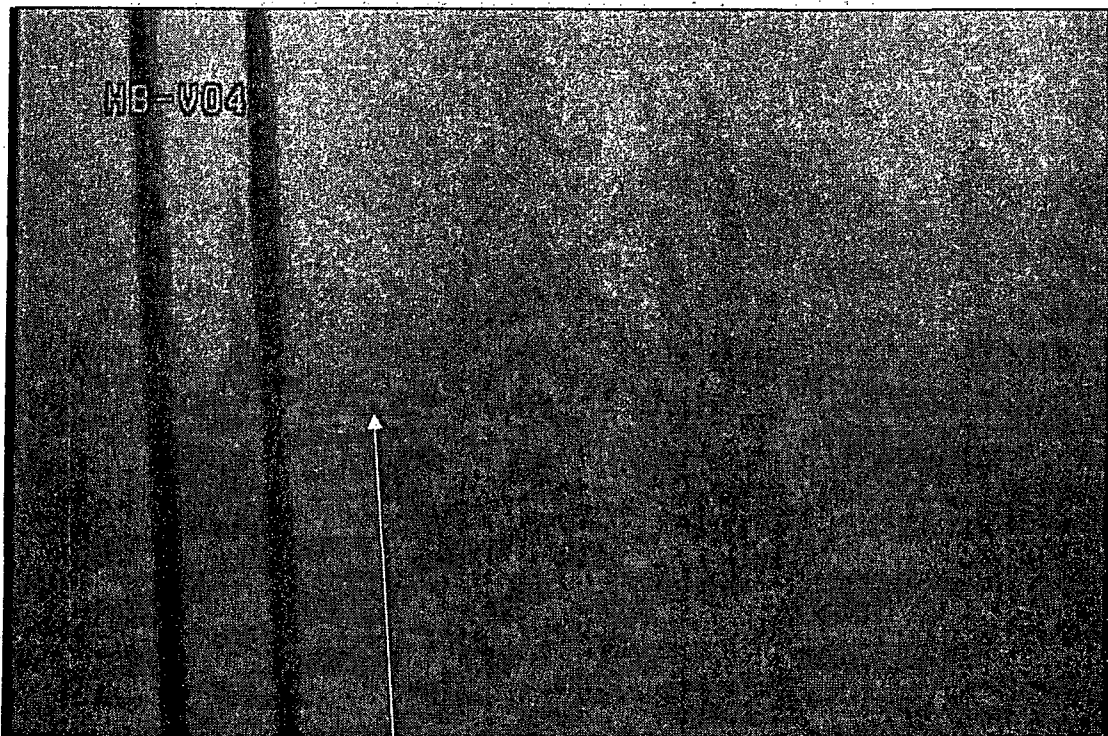
This 2007 photo is of the 1st indication from top down (Correlates to RFO25: 1st indication).

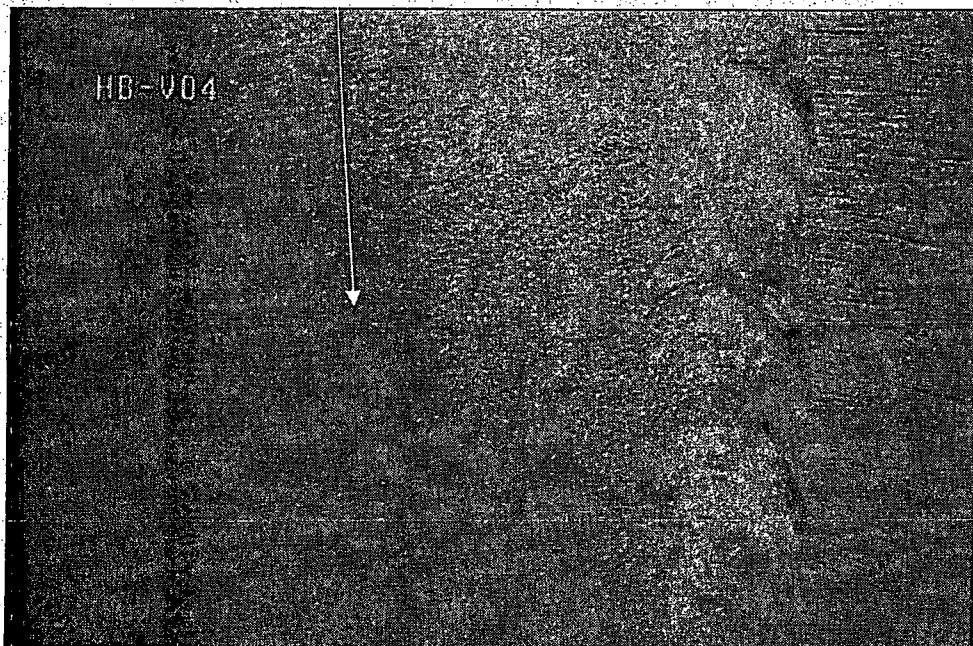
This 2007 photo is a close-up of the 1st indication (Correlates to RFO25: 1st indication).

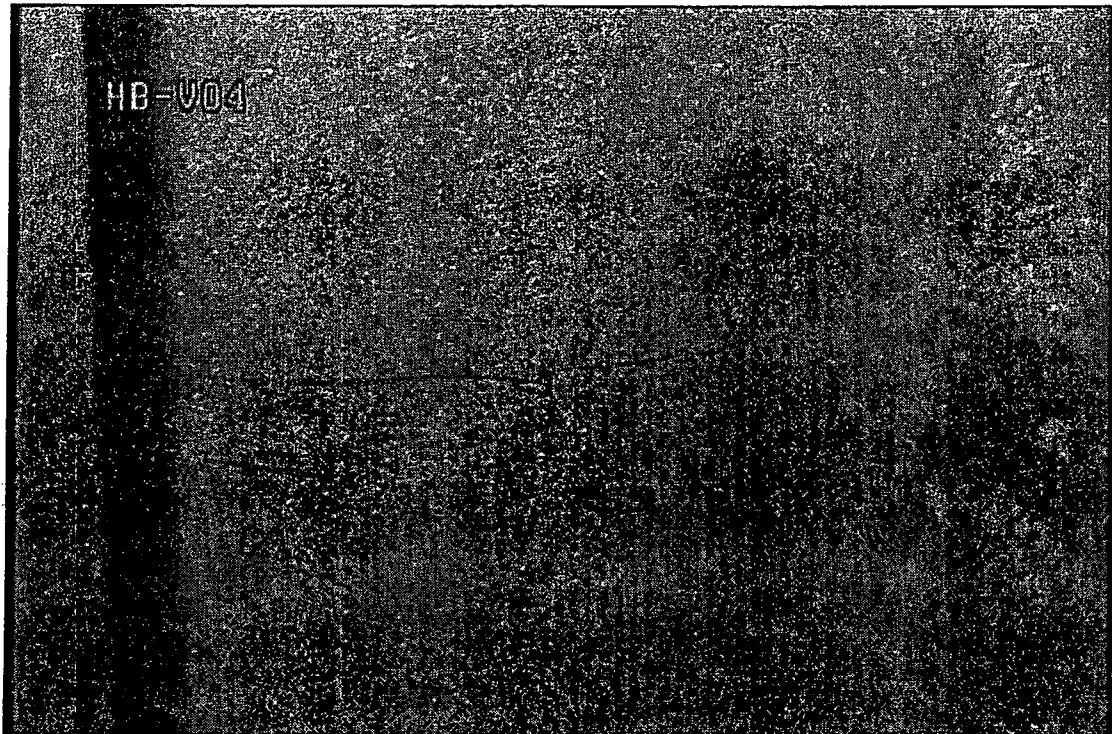
This 2007 photo is the 2nd indication (Correlates to RFO25: 2nd indication).

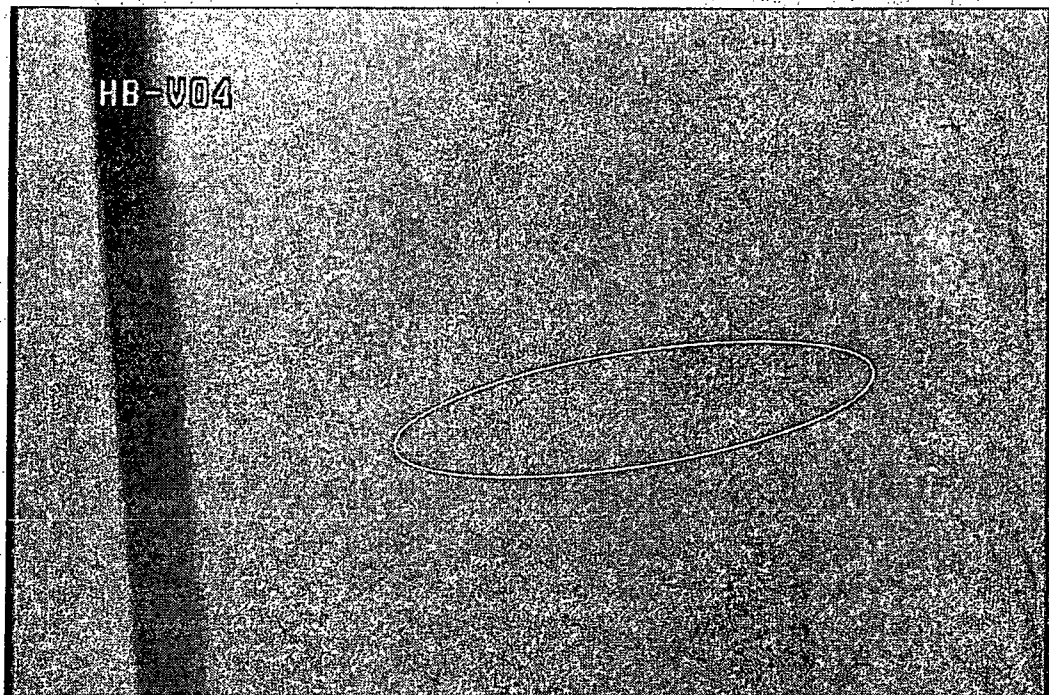
This is a 2007 photo of the 3rd indication and is a new RFO26 indication.

One new indication was found adjacent to weld HB-V04, located on bank B at the 0° end and is labeled as the 3rd indication on INR-IVVI-VYR26-07-10 Rev.1 (Reference 2). This indication is of similar appearance, orientation and size as those previously seen. Because of this it is being treated similar to those indications identified in RFO25. The remainder of indications on the steam dryer listed as References 1-10 were previously identified and show no signs of growth. These indications are acceptable to leave as is per GE evaluation GENE-0000-0047-2767 (Reference 11) performed in RFO25. Therefore, the one new indication described above is the only one requiring an evaluation.

GE's evaluation in RFO25 cites IGSCC as being the likely cause of most of the indications previously observed. This is based on the jagged appearance and location in the weld heat affected zone (HAZ). The unit end plates may have cold work resulting from cold forming. Cold working Type 304 material can promote initiation of stress corrosion cracks when exposed to the BWR environment. The dryer unit end plates are located in the dryer interior and are not subjected to any direct main steam line acoustic loading. Continued growth is unlikely because all of these indications appear to have stopped without propagating into the vertical weld; this is indicative of IGSCC behavior as opposed to fatigue, since weld material is more resistant to IGSCC. The flanges have experienced a near infinite number of fluctuating load cycles and if fatigue driven, more significant cracking is likely to have occurred after many years of operation. IGSCC in steam dryers has been typically limited in depth and length since in many cases it is caused by cold work or weld induced residual stress.

The new indication was evaluated by Code Programs, see the attached document. The evaluation accepts the indication as is with no repair required. The steam dryer will be inspected per the same scope in RFO27 and RFO28 per letter BVY 04-097, therefore the area of this indication will be inspected again during the next two outages.

The dryer unit end plates flaw assessment is based on the following factors: (1) it is a highly redundant structure and there is no structural consequence of the cracking and (2) postulated significant flaw extension leading to the flaw reaching the full section of the channel geometry would not create the opportunity for loose parts. Field experience supports this as-is operation decision in the context that the indications will be re-inspected at the next outage. It is recommended that the new visual indication given in Reference 2 be accepted as is. Repair is not recommended.

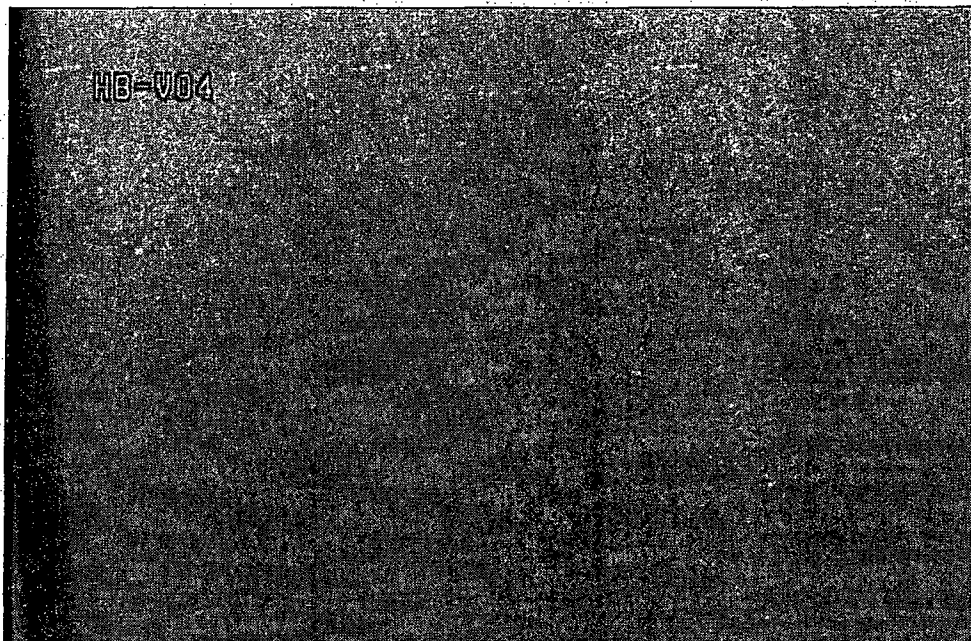
This is a 2007 photo of the 4th indication (Correlates to RFO25: 3rd indication)

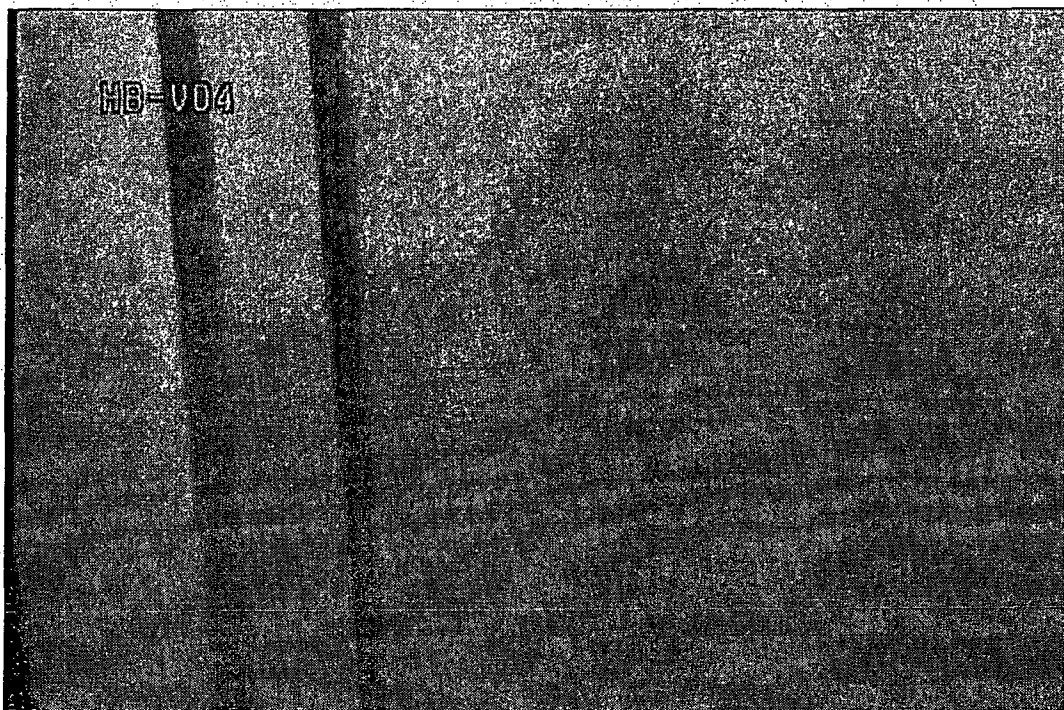
This is a 2007 photo of the 5th indication (Correlates to RFO25: 4th indication).

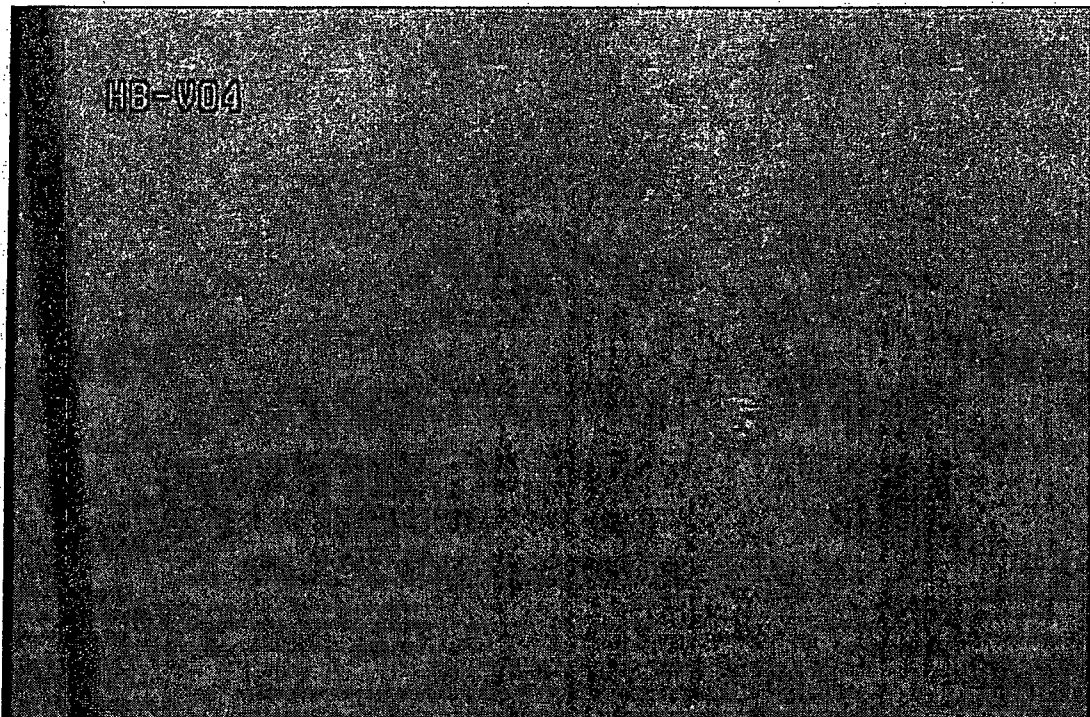
This is a 2007 photo of the 6th indication (Correlates to RFO25: 5th indication).

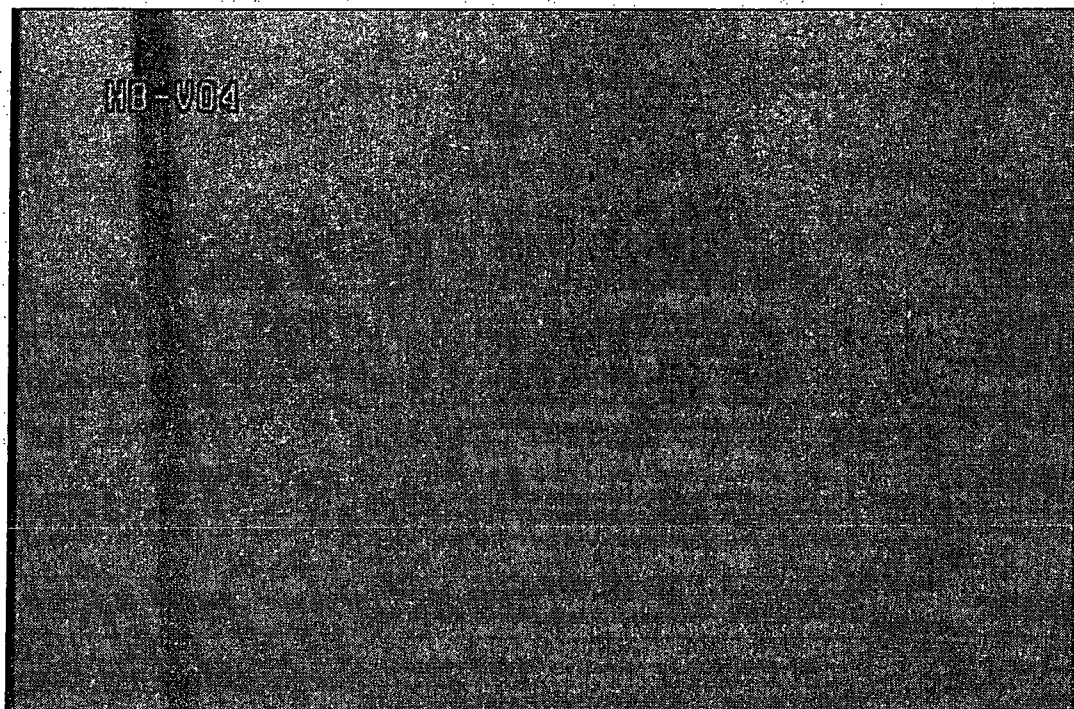
This is a 2007 photo of the 7th indication (Correlates to RFO25: 6th indication).

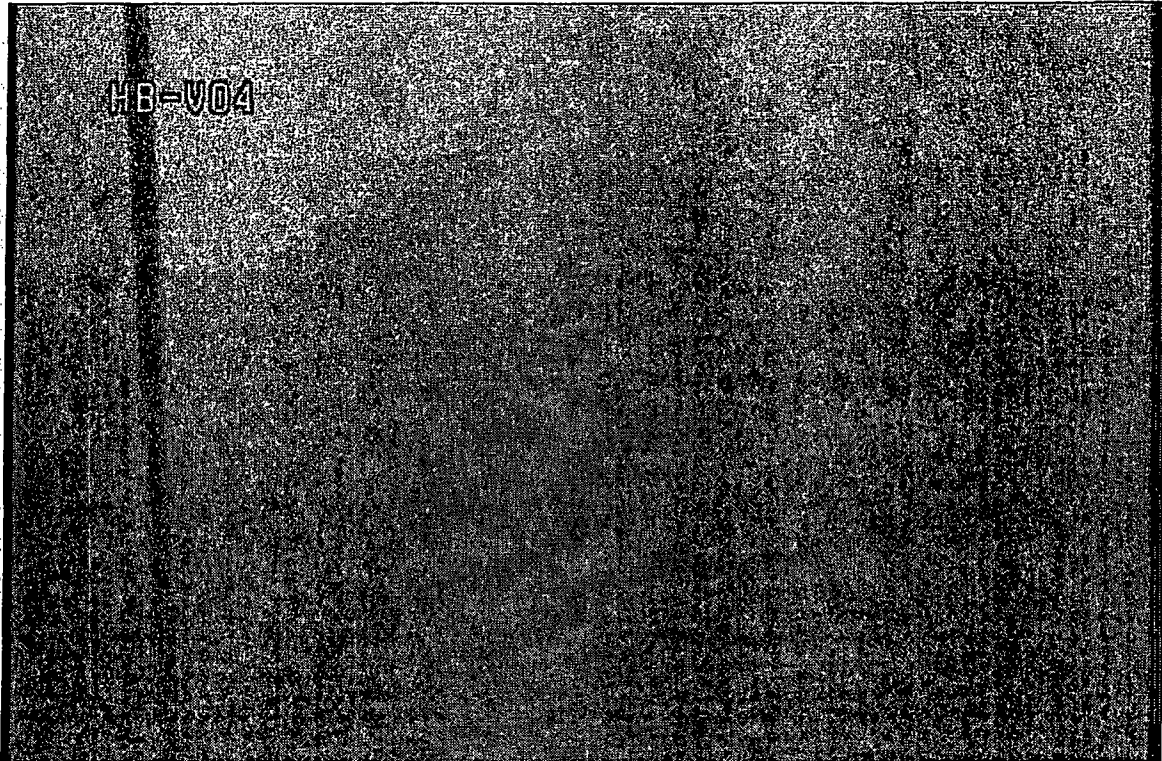
This is a 2007 photo of the 8th indication (Correlates to RFO25: 7th indication).

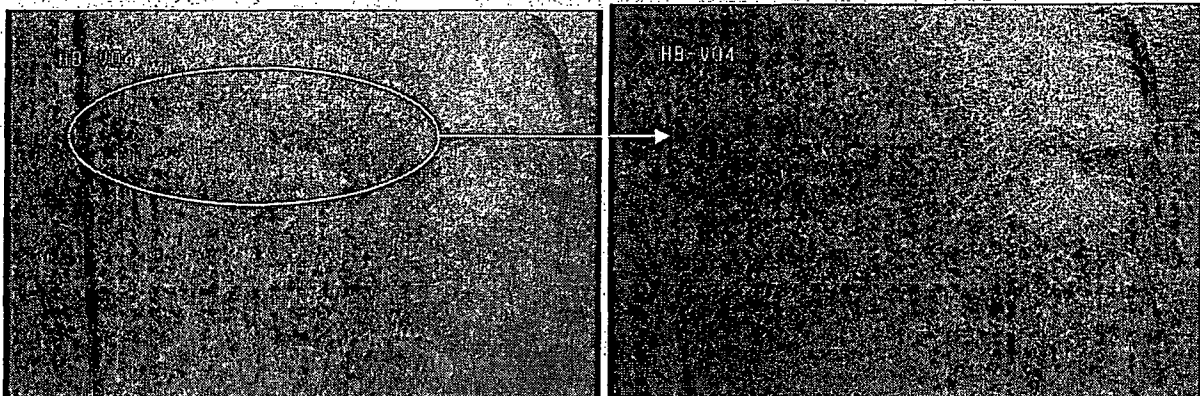
These 2007 photos show a linear indication and change of lighting and show a non-relevant indication (Correlates to RFO25: 9th indication).

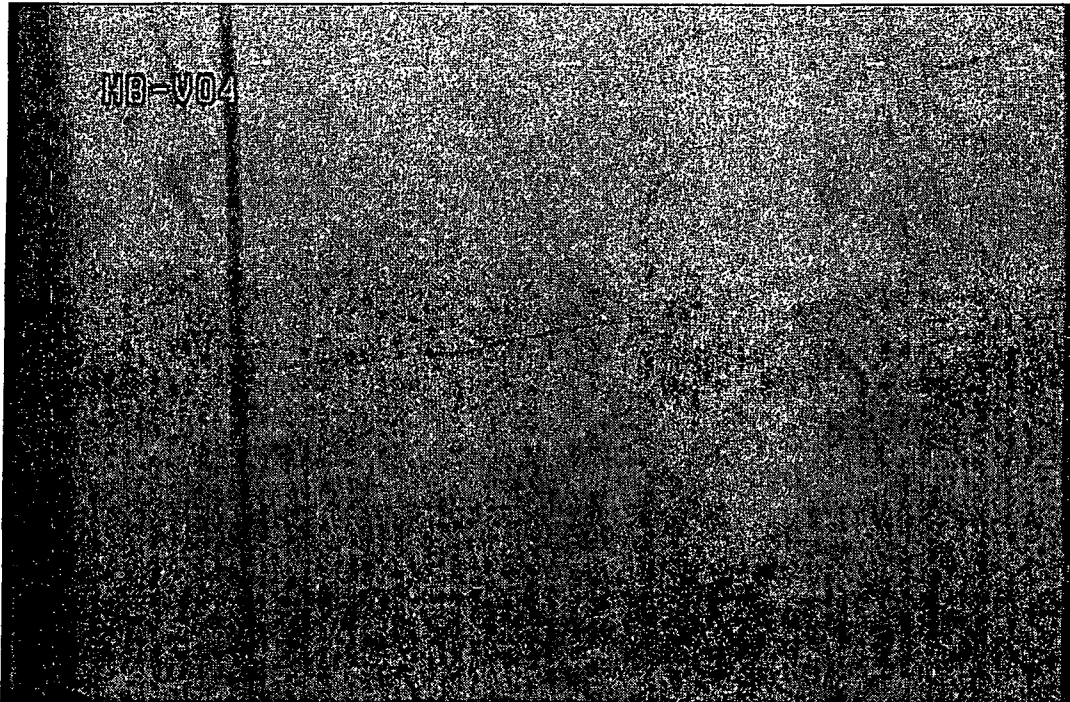
This is a 2007 photo of the 9th indication (Correlates to RFO25: 10th indication).

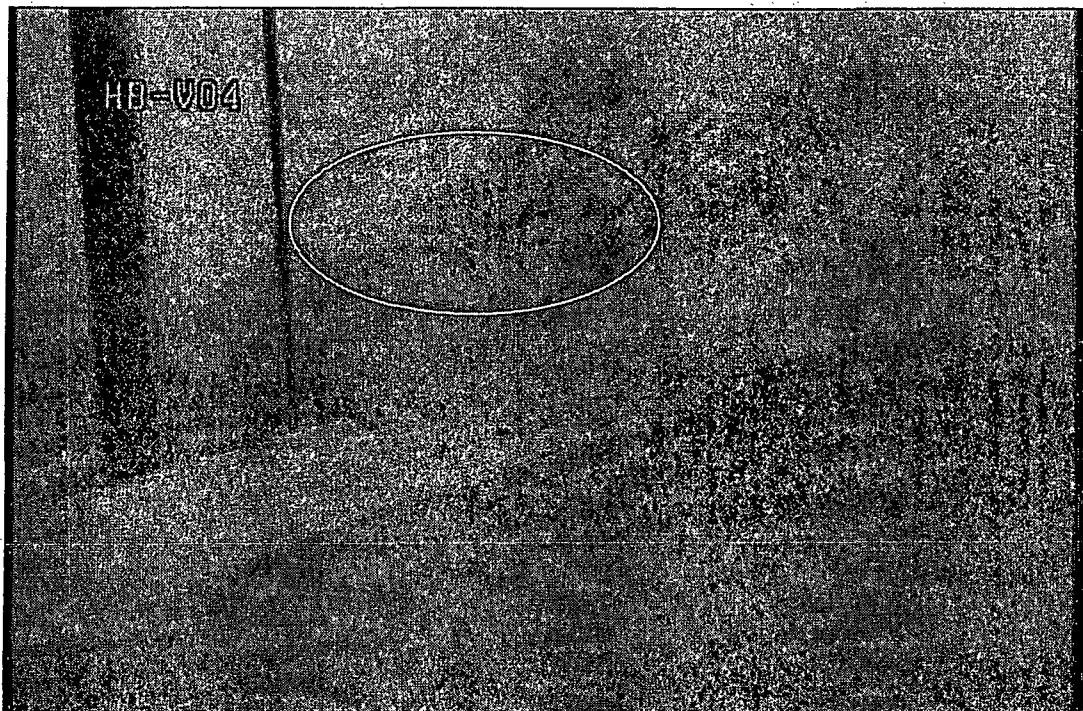
This is a 2007 photo of the bottom weld area and crud line.

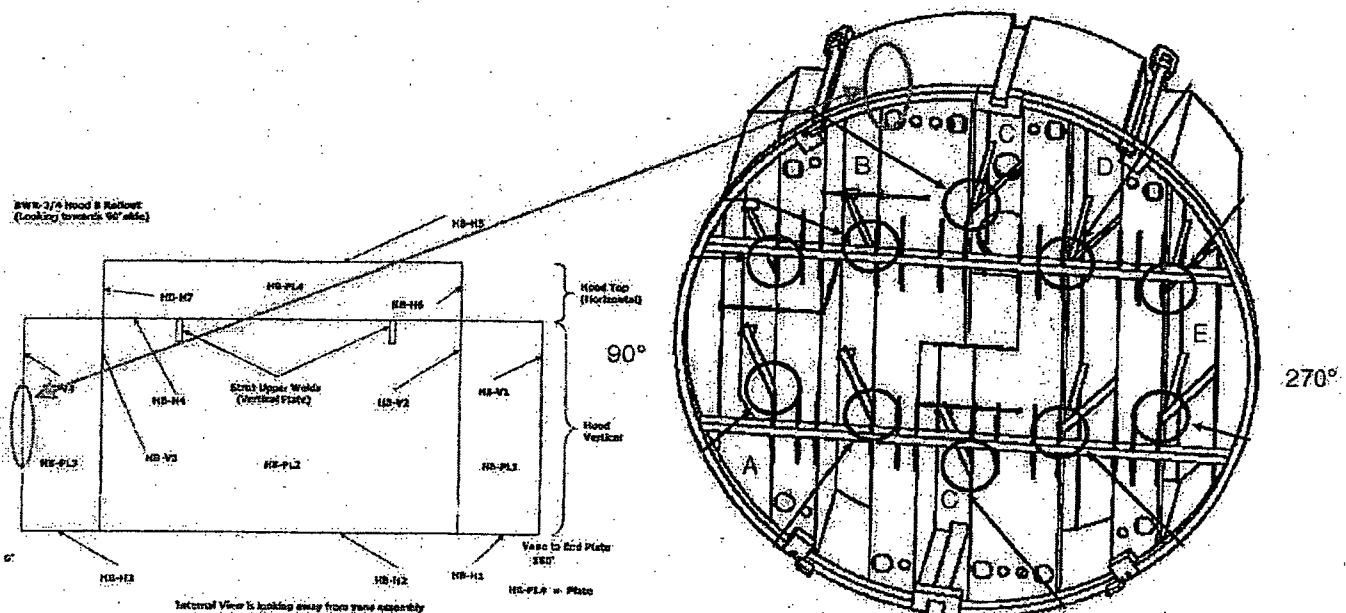
Sketch on the left shows the weld map rollout The sketch on the right shows a bottom view of the dryer.

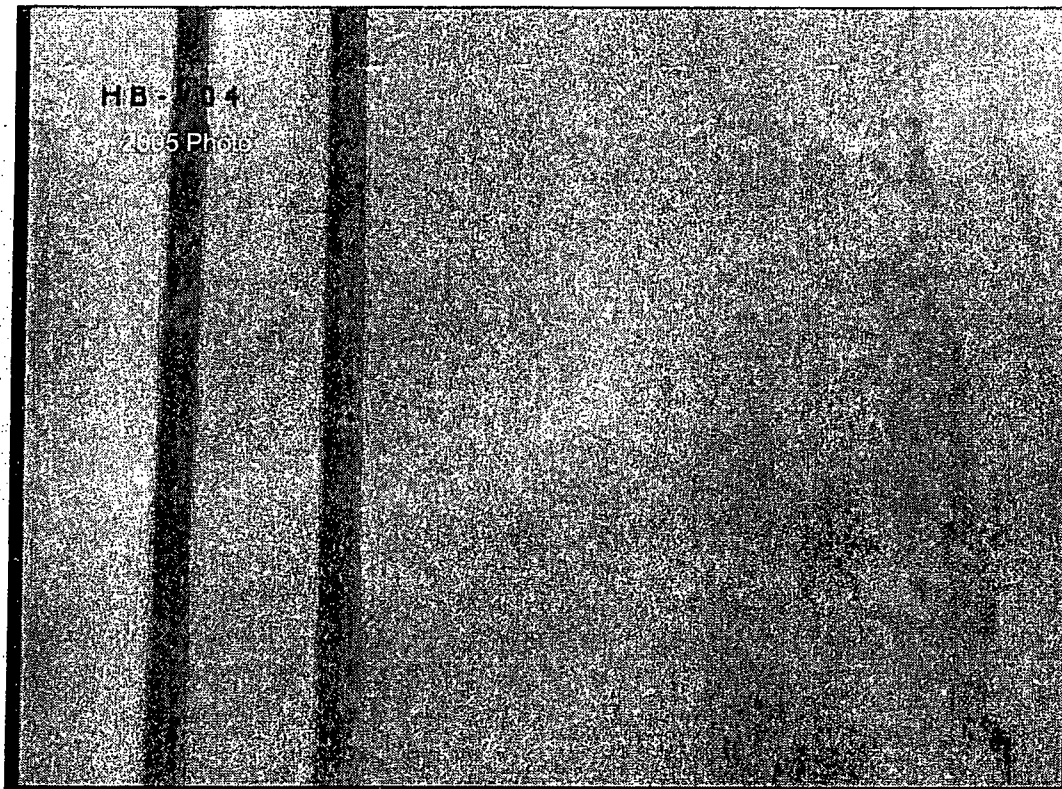
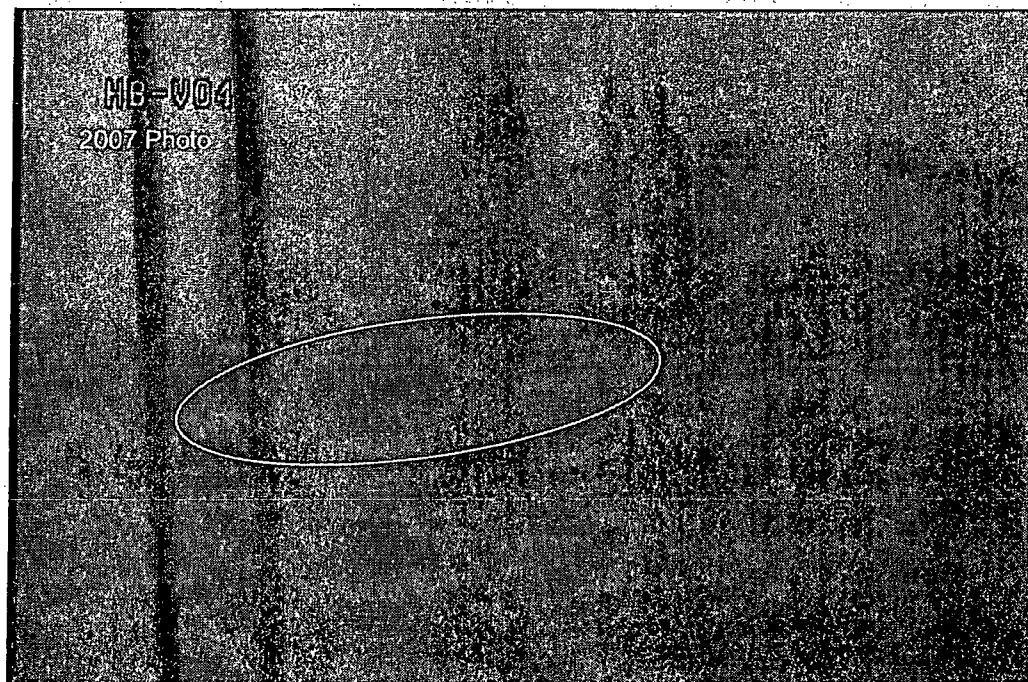
This 2007 photo is of the 1st indication from top down (Correlates to RFO25: 1st indication).

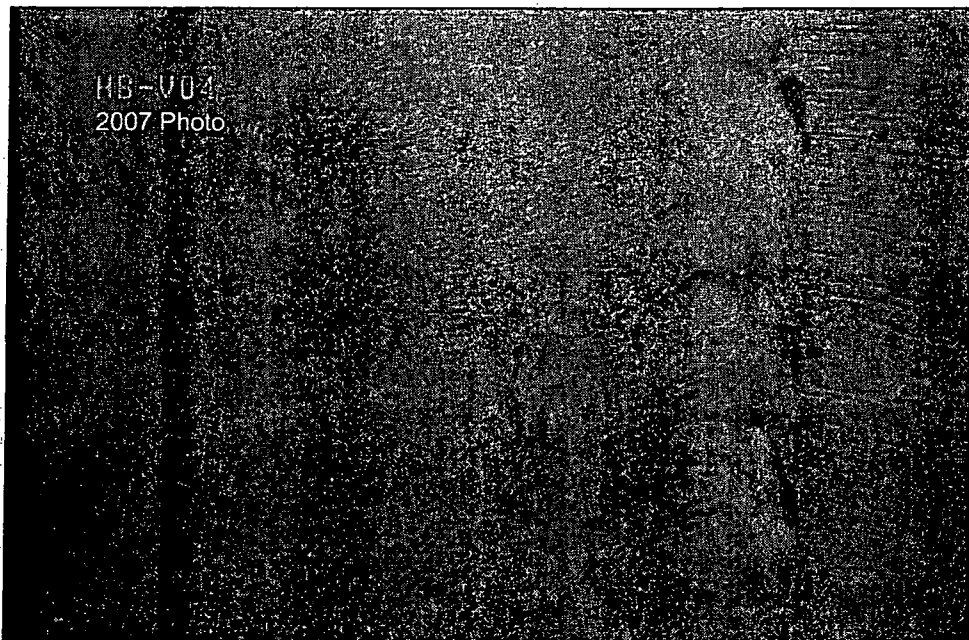
This 2007 photo is a close-up of the 1st indication (Correlates to RFO25: 1st indication).

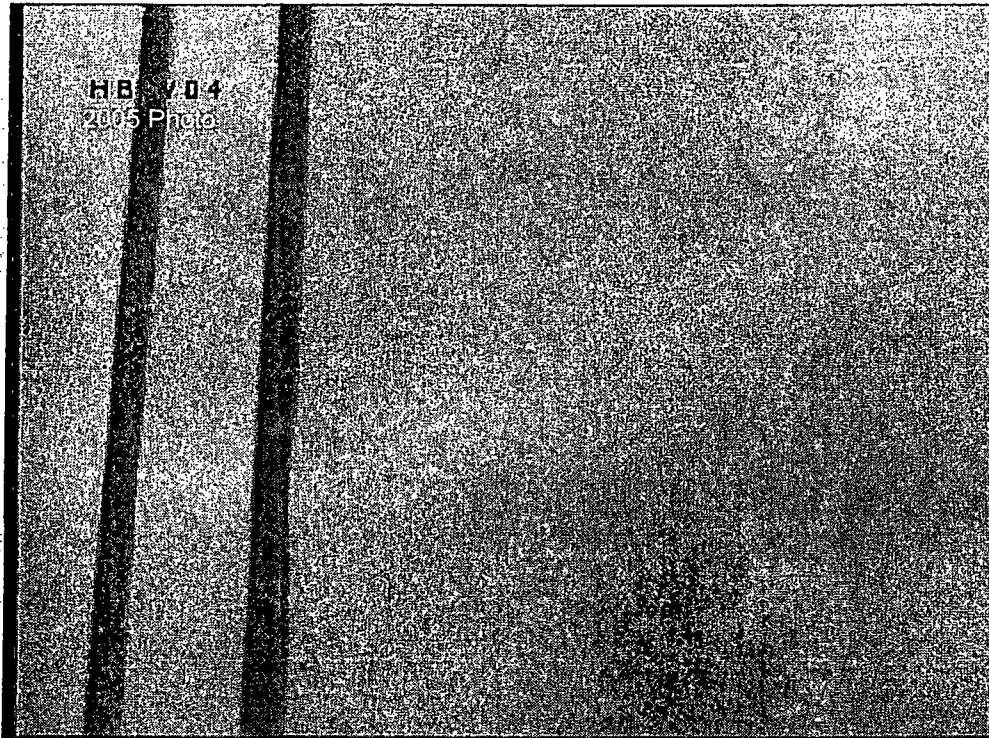
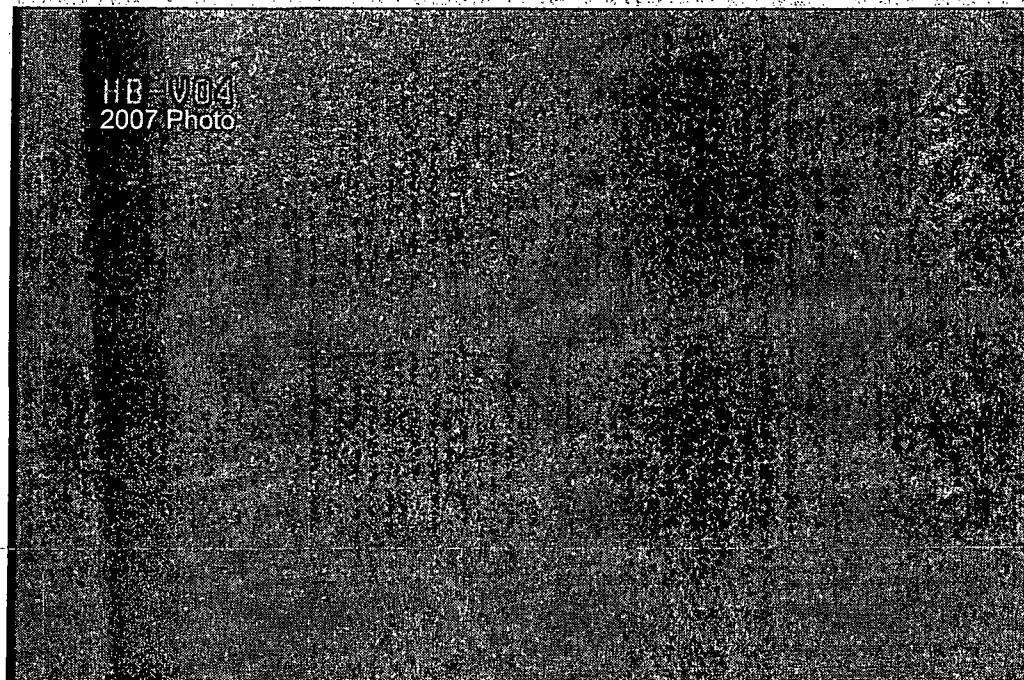
This 2007 photo is the 2nd indication (Correlates to RFO25: 2nd indication).

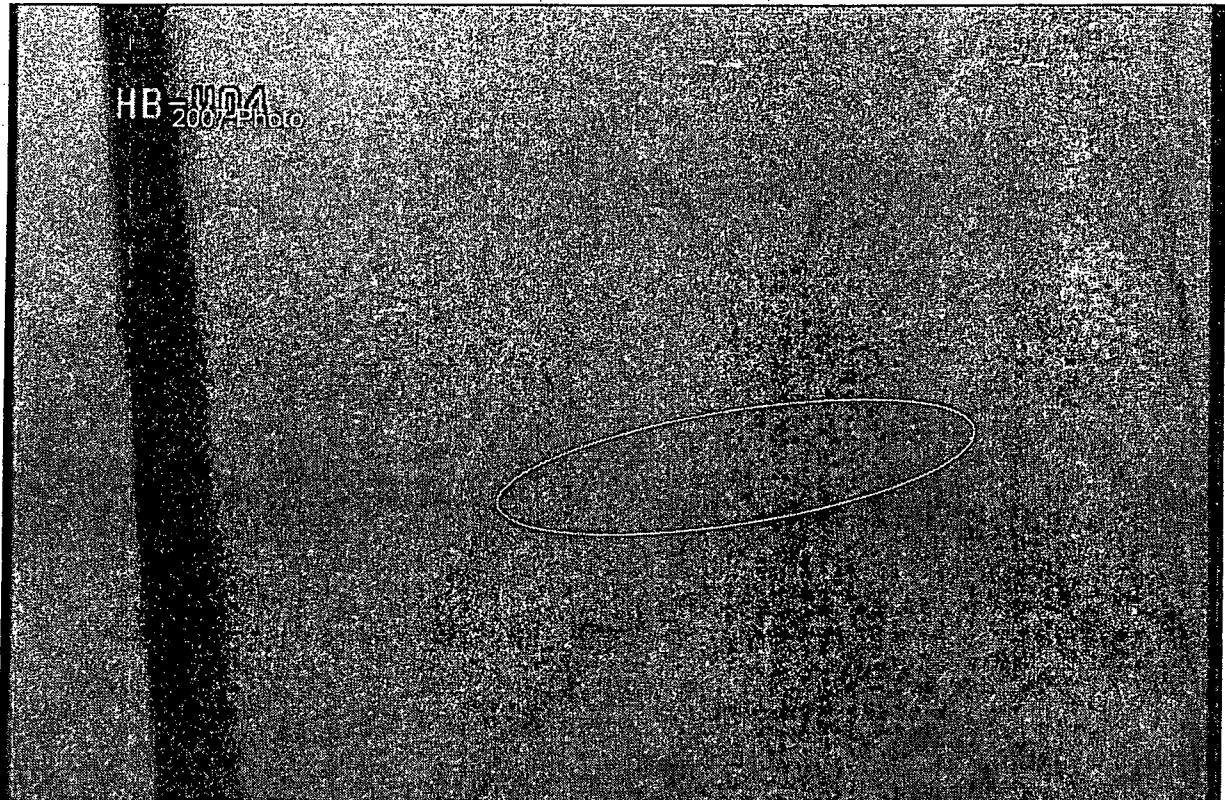
One new indication was found adjacent to weld HB-V04, located on bank B at the 0° end and is labeled as the 3rd indication on INR-IVVI-VYR26-07-10 Rev.1 (Reference 2). This indication is of similar appearance, orientation and size as those previously seen. Because of this it is being treated similar to those indications identified in RFO25. The remainder of indications on the steam dryer listed as References 1-10 were previously identified and show no signs of growth. These indications are acceptable to leave as is per GE evaluation GENE-0000-0047-2767 (Reference 11) performed in RFO25. Therefore, the one new indication described above is the only one requiring an evaluation.

GE's evaluation in RFO25 cites IGSCC as being the likely cause of most of the indications previously observed. This is based on the jagged appearance and location in the weld heat affected zone (HAZ). The unit end plates may have cold work resulting from cold forming. Cold working Type 304 material can promote initiation of stress corrosion cracks when exposed to the BWR environment. The dryer unit end plates are located in the dryer interior and are not subjected to any direct main steam line acoustic loading. However, continued growth by fatigue cannot be ruled out. Nevertheless, all of these indications appear to have stopped without propagating into the vertical weld; this is indicative of IGSCC behavior as opposed to fatigue, since weld material is more resistant to IGSCC. The flanges have experienced a near infinite number of fluctuating load cycles and if fatigue driven, more significant cracking is likely to have occurred after many years of operation. IGSCC in steam dryers has been typically limited in depth and length since in many cases it is caused by cold work or weld induced residual stress.

This is a 2007 photo of the 3rd indication and is a new RFO26 indication.

The dryer unit end plates flaw assessment is based on the following factors: (1) it is a highly redundant structure and there is no structural consequence of the cracking and (2) postulated significant flaw extension leading to the flaw reaching the full section of the channel geometry would not create the opportunity for loose parts. Field experience supports this as-is operation decision in the context that the indications will be re-inspected at the next outage. It is recommended that the new visual indication given in Reference 2 be accepted as is. Repair is not recommended.

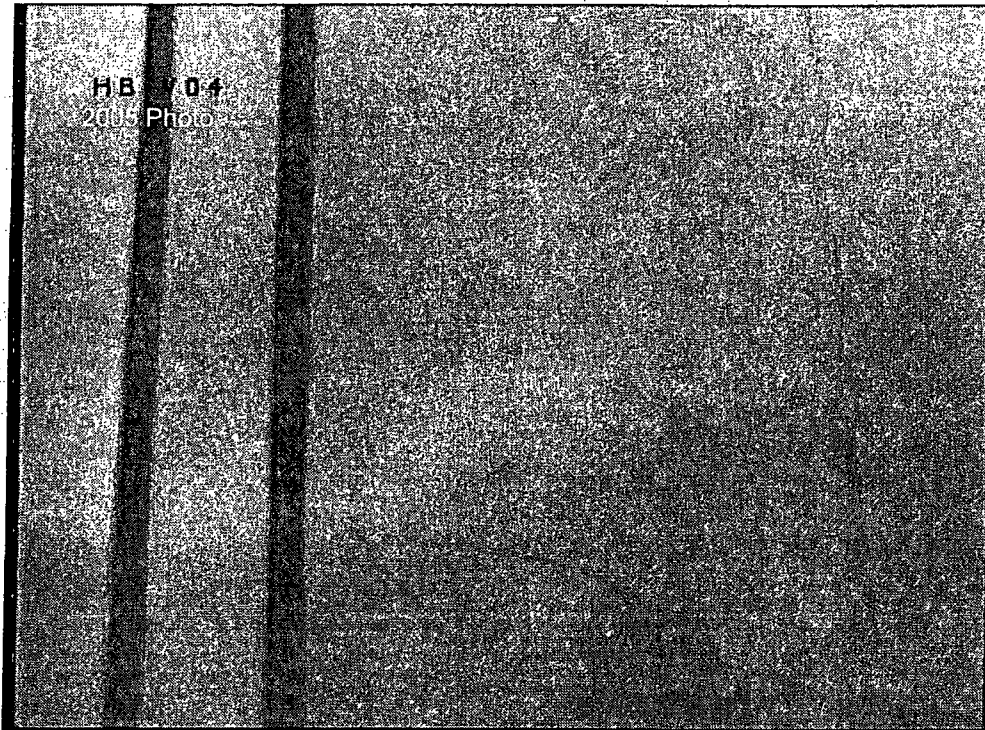
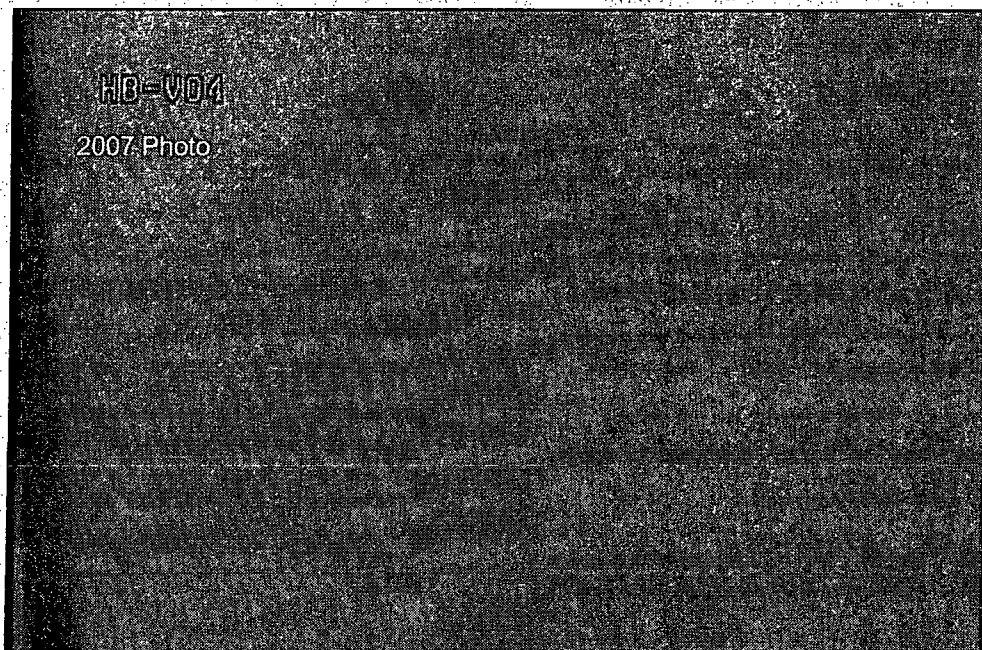
This is a 2007 photo of the 4th indication (Correlates to RFO25: 3rd indication)

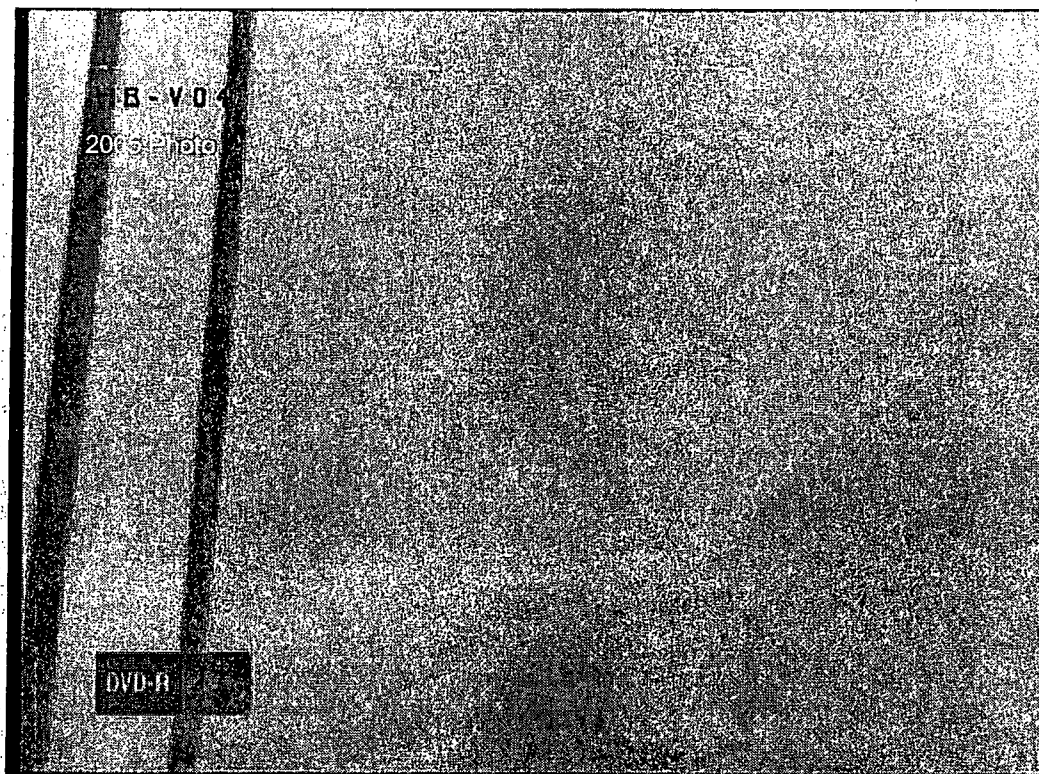
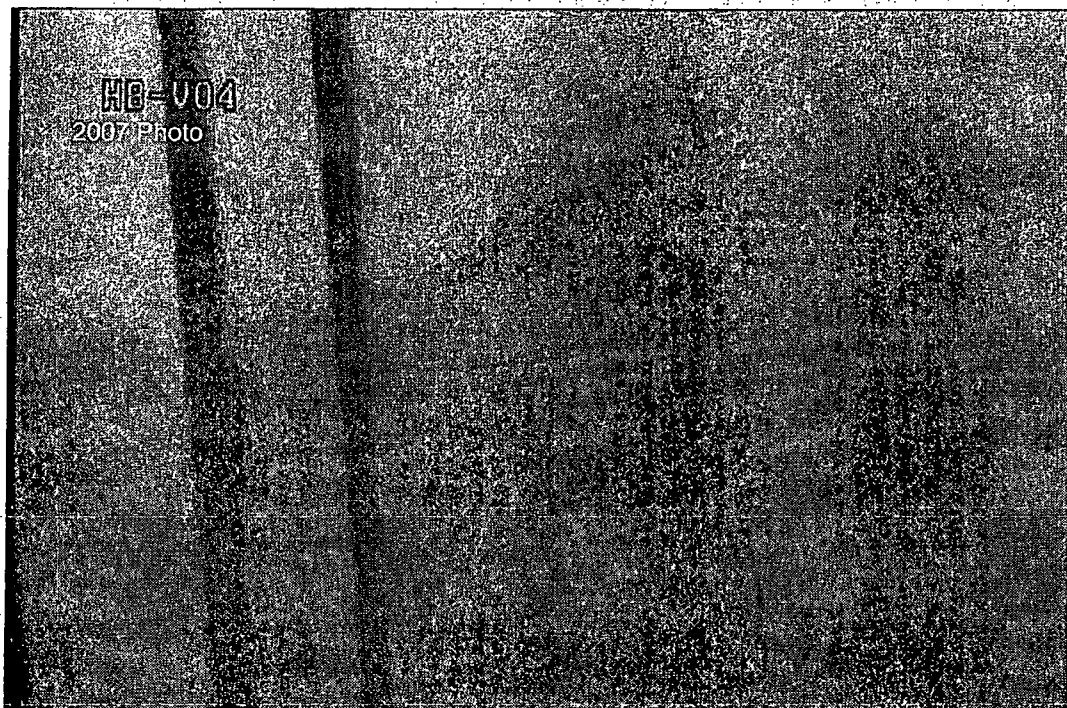
This is a 2007 photo of the 5th indication (Correlates to RFO25: 4th indication).

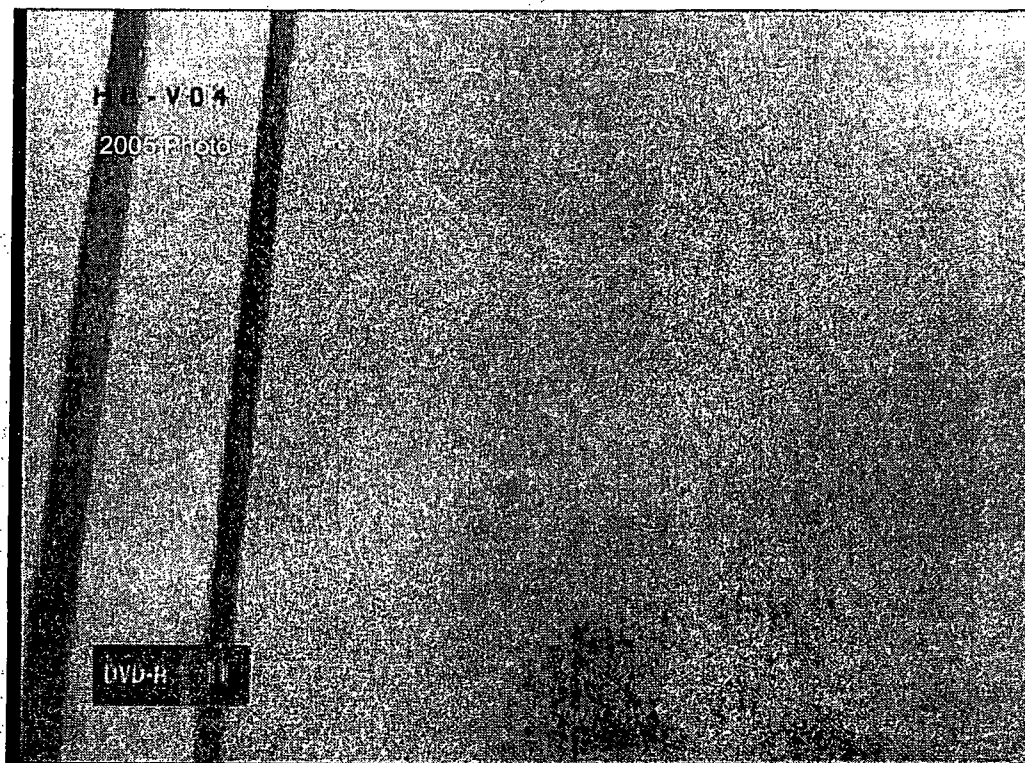
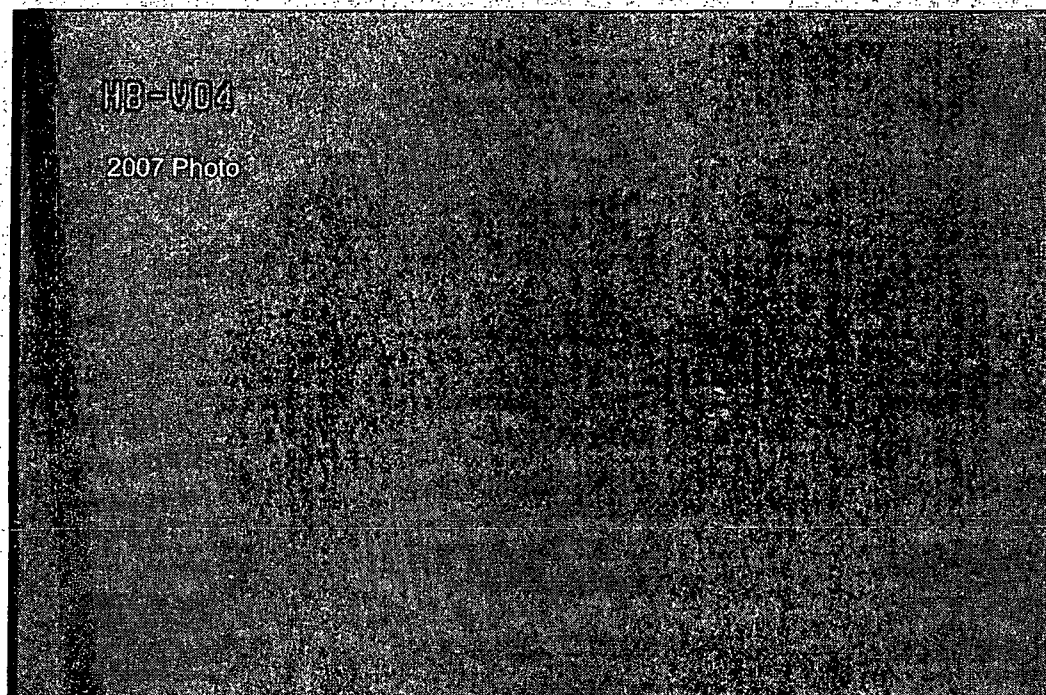
This is a 2007 photo of the 6th indication (Correlates to RFO25: 5th indication).

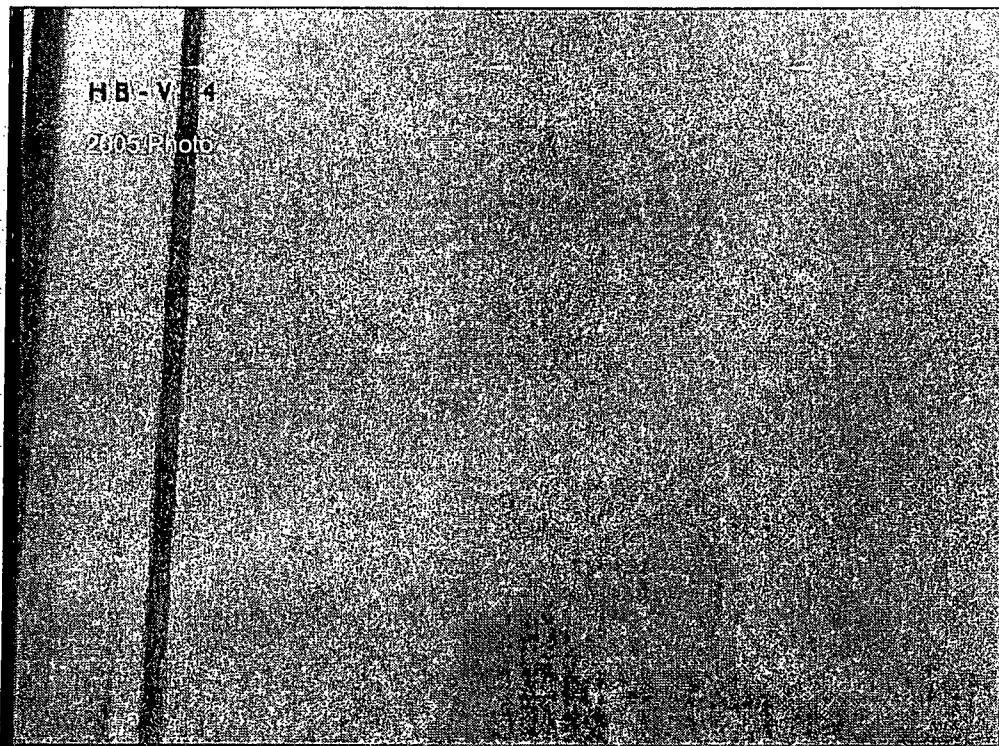
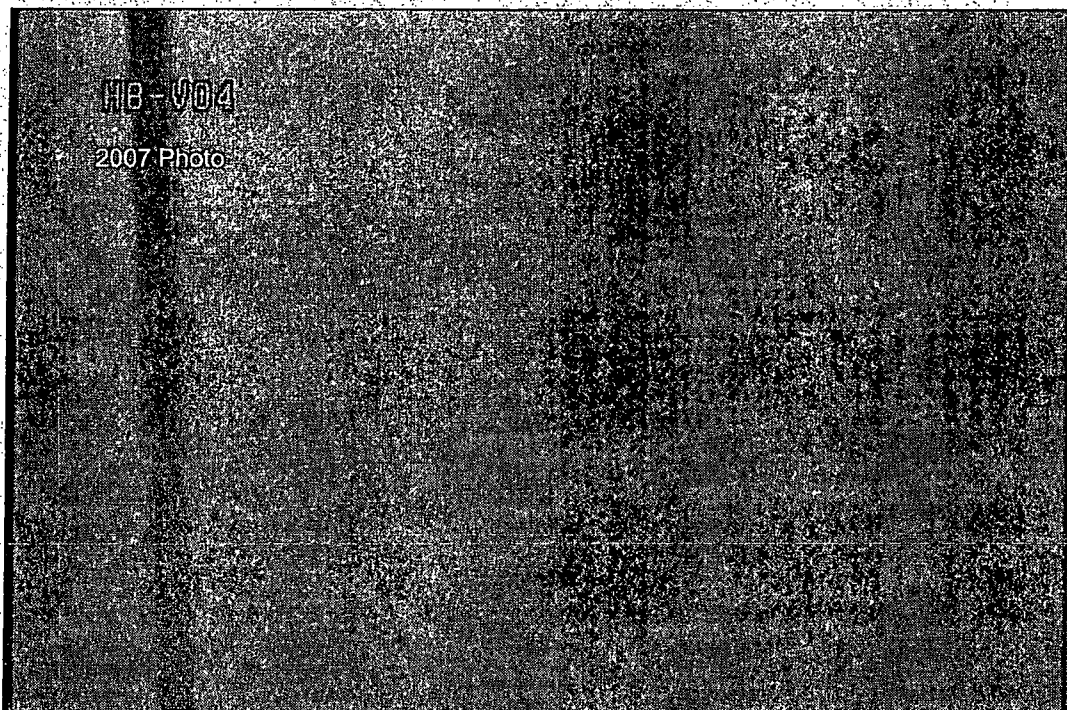
This is a 2007 photo of the 7th indication (Correlates to RFO25: 6th indication).
