**NEW ENGLAND COALITION, INC.'S (NEC) SUPPLEMENT TO OPPOSITION
TO ENTERGY'S MOTION FOR SUMMARY DISPOSITION OF NEW
ENGLAND COALITION CONTENTION 3 (STEAM DRYER)**

SECOND DECLARATION OF ULRICH WITTE

INR-IVVI-VYR26-07-10- Steam Dryer Interior HB-V04

Indication Notification Report

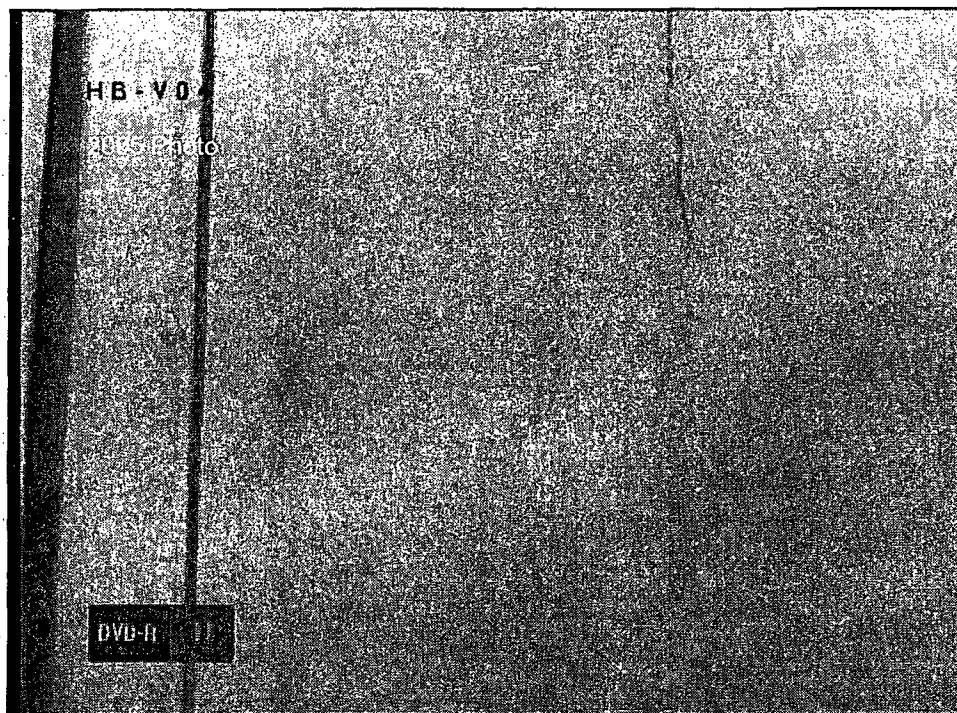
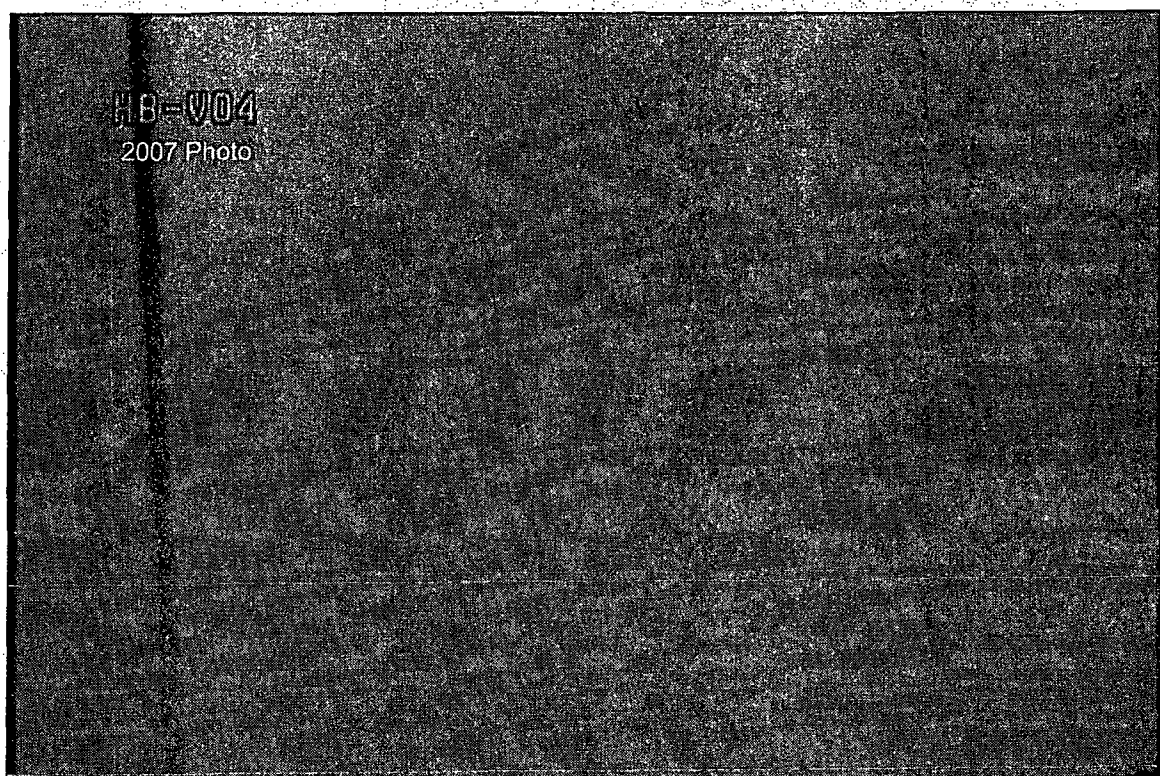
This is a 2007 photo of the 8th indication (Correlates to RFO25: 7th indication).

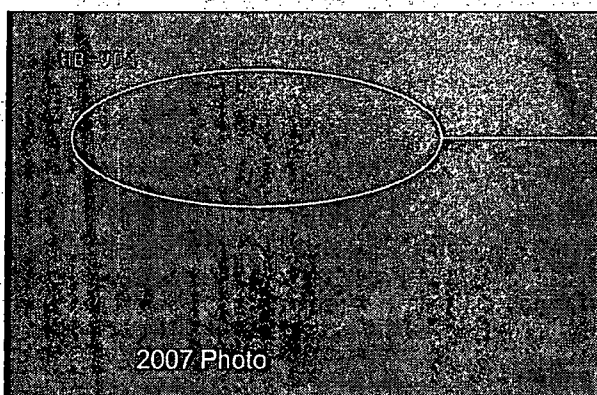
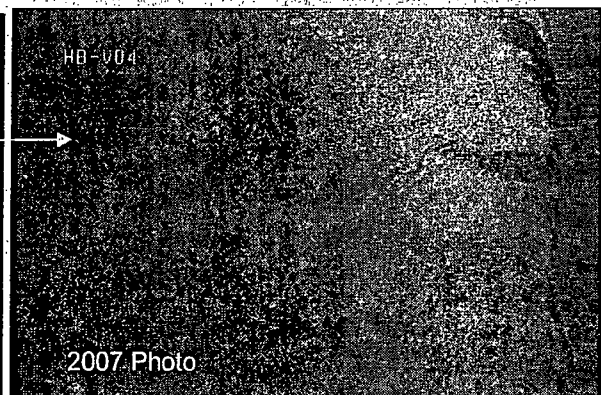
These 2007 photos show a linear indication and with a change of lighting there is no indication. This indication is considered non-relevant. (Correlates to RFO25: 9th indication).

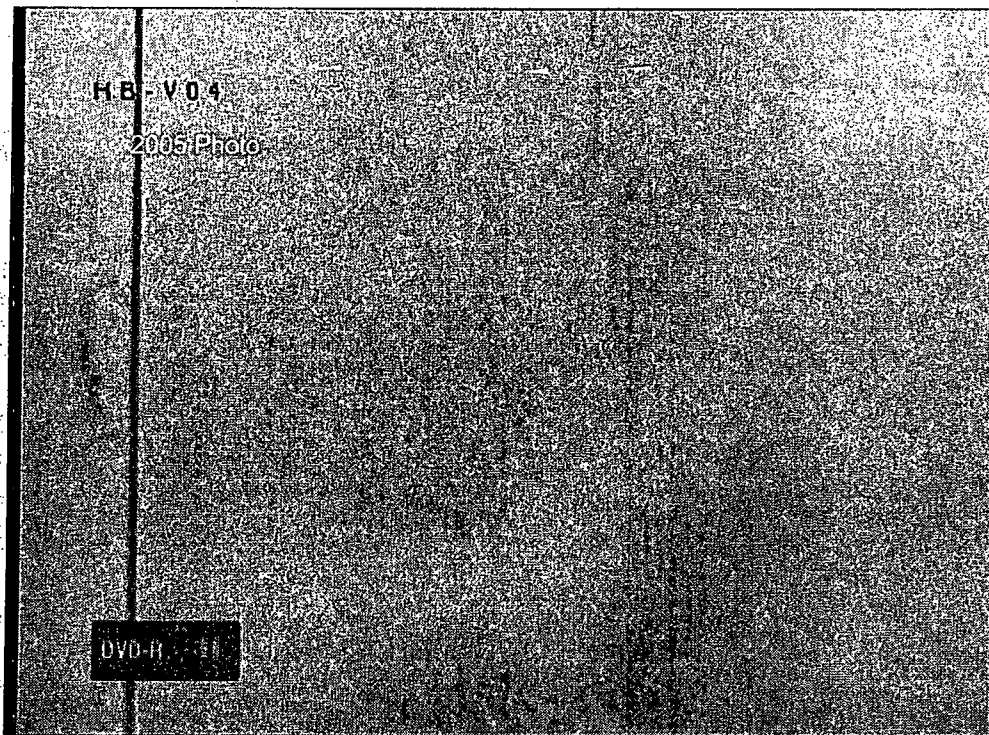
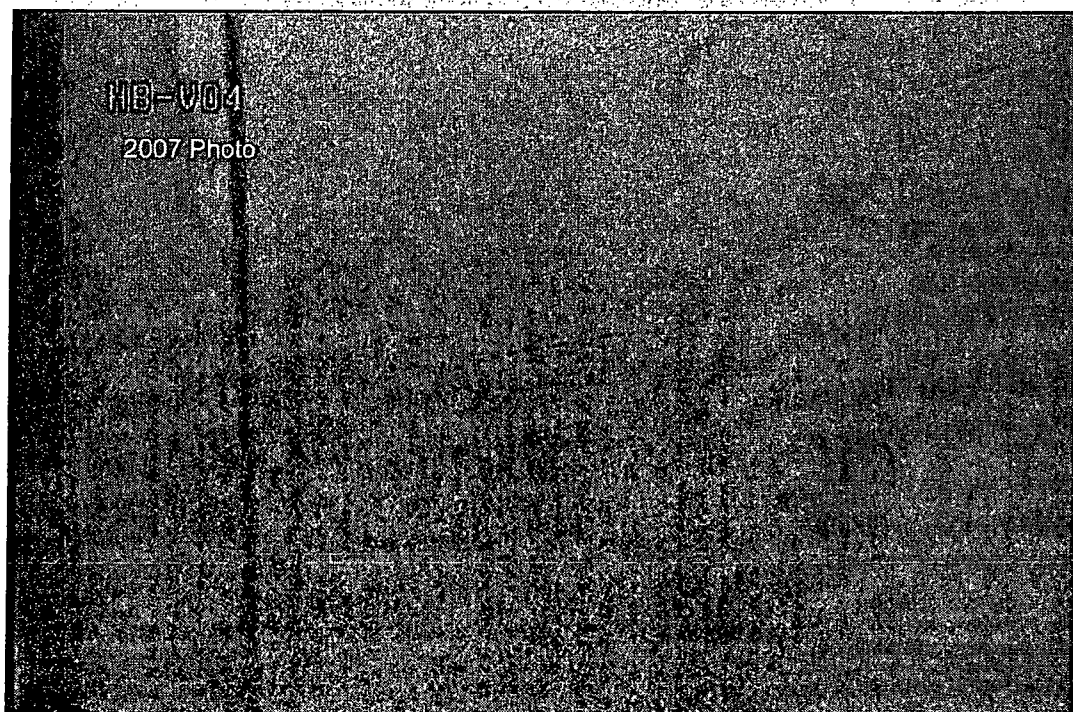
This is a 2007 photo of the 9th indication (Correlates to RFO25: 10th indication).

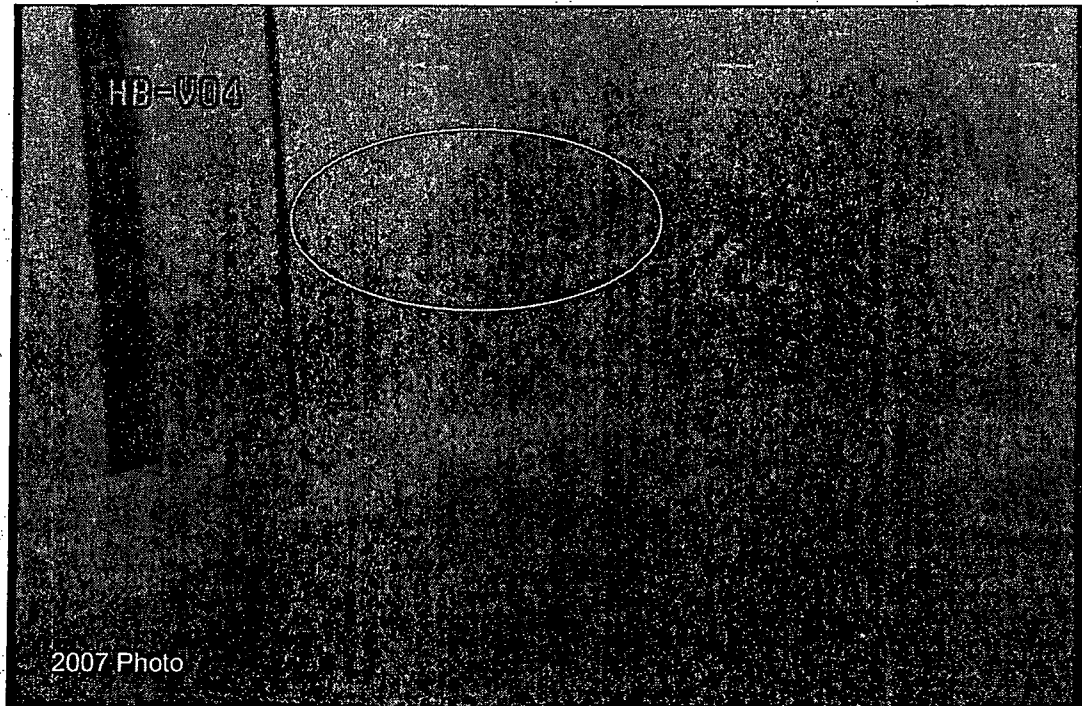
This is a 2007 photo of the bottom weld area and crud line.
