Annual Site Inspection and Monitoring Report for Uranium Mill Tailings Radiation Control Act Title I Disposal Sites

**Interim Annual Report for the Period
October 1, 1997 Through December 31, 1997**

April 1998

**Prepared by
MACTEC Environmental Restoration Services, LLC
Grand Junction, Colorado**

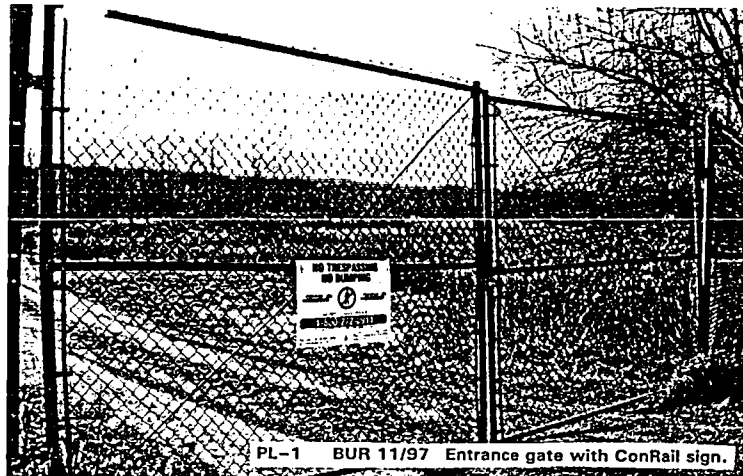
The site access gate at Strangford Road and chain-link fencing on both sides of the gate are in excellent condition (BUR PL-1). The gate is secured by chain and padlocks. Although this is a DOE gate on DOE property, there are both DOE and ConRail padlocks on the chain. Farther down Strangford Road, ConRail has placed a pole gate across an informal dirt road that parallels the railroad tracks. It appears that ConRail has taken steps to limit public access along the tracks and to stop illegal dumping along the railroad tracks to the west.

PL-1 BUR 11/97 Entrance gate with ConRail sign.

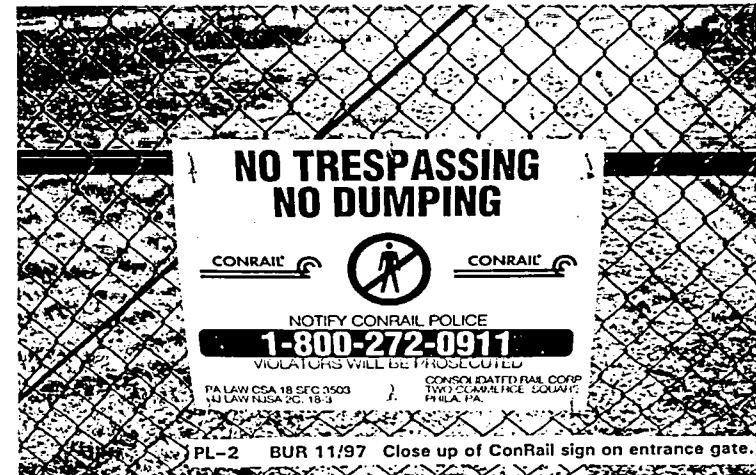
ConRail has attached a "no trespassing" sign to DOE's access gate (BUR PL-2). A DOE entrance (warning) sign will be posted on this gate on or before the next site inspection.

PL-2 BUR 11/97 Close up of ConRail sign on entrance gate.

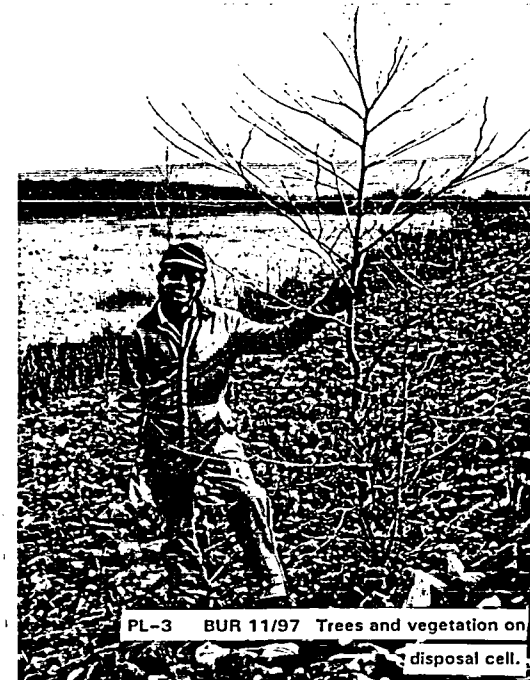
Riprap on the disposal cell is in good condition. However, trees and large shrubs continue to grow on the top and all side slopes of the disposal cell (BUR PL-3). Several attempts have been made to control this vegetation by cutting and spraying. The last such attempt, spraying, was in August 1997. These attempts have not been completely or permanently successful. The vegetation, given abundant rainfall, is aggressive and quickly grows back.

A biointrusion study, begun in 1996, concluded that abundant, deep-rooted Japanese knotweed has increased the hydraulic conductivity of the radon barrier in the root zone of these plants by 3-to-4 orders of magnitude. A screening-level risk assessment, part of the biointrusion study, is currently underway to determine if the increase in water infiltration and possible contaminant leaching will have a measurable effect on human health or the environment. The risk assessment will be completed in 1998. Efforts to control vegetation on the disposal cell will continue pending results of the risk assessment.

PL-3 BUR 11/97 Trees and vegetation on disposal cell.

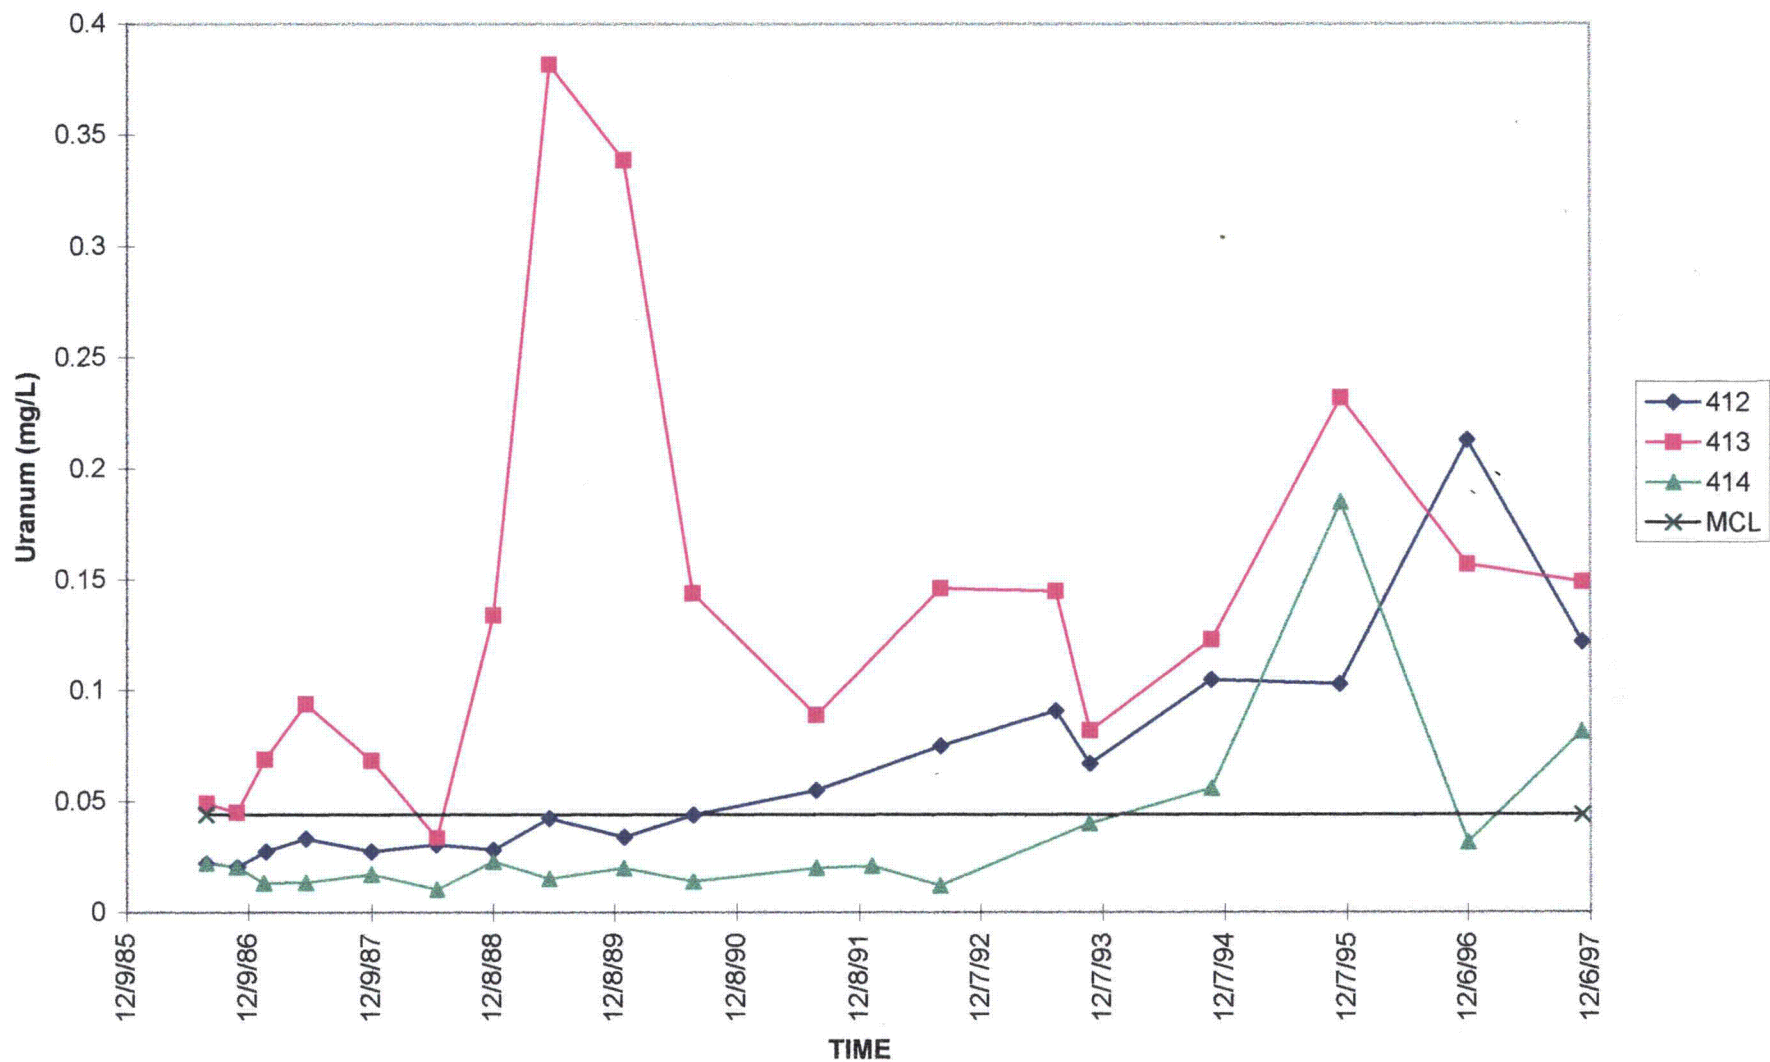
Figure 4-2.

MW-412. Uranium has been above the MCL in ground water at this well every year since 1991. The time vs. concentration plot for this wells shows a gradual increase in uranium since about 1988 (Figure 4-2). A large peak, 0.213 mg/l, well above the general trend, occurred in 1996. In 1997, the concentration dropped to 0.122 mg/l.

MW-413. Uranium at this well has exceeded the MCL, with one exception, every year since sampling began in 1986. The time vs. concentration plot is irregular with two peaks, the first during 1989-1990 and the second in 1995 (Figure 4-2). Because of these peaks and the scatter in the rest of the data, there is no apparent trend in the concentration of uranium over time in this well.

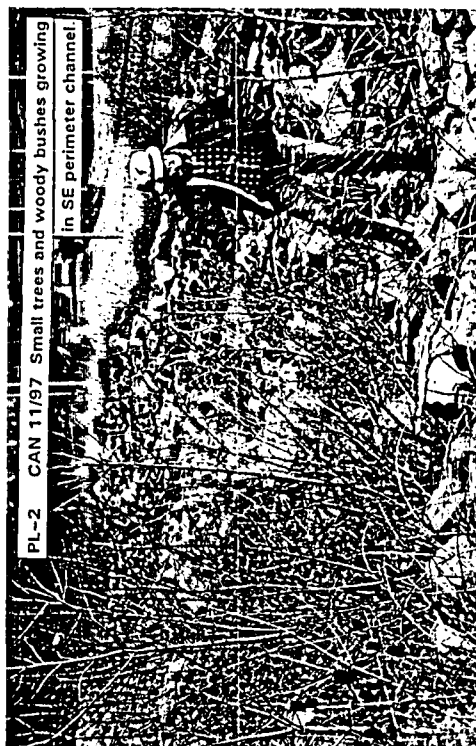
The rock in the diversion channels that surround the disposal cell is in excellent condition. Vegetation, however, continues to encroach in all of these channels (CAN PL-2). Encroachment includes shrubs, deciduous trees, and grasses.

PL-2 CAN 11/97 Small trees and woody bushes growing in SE perimeter channel.

Vegetation was cut and cleared from the channels and ditches in July 1994, and again in August 1996. If the channels are to be maintained in their as-built or vegetation-free condition, they need to be cleared again and perhaps every 2 to 3 years thereafter. The concern, or perception, is that encroaching vegetation may interfere with the ability of these channels to divert runoff during heavy storms. However, the cost and labor to keep vegetation out of these channels will, over time, be considerable and perhaps prohibitive. Intervention on an every 2-to-3-year-basis for the next 200 to 1,000 years is neither realistic nor practical. Options need to be considered. An engineering evaluation of the long-term effect of encroaching vegetation in these channels may be undertaken to see if the long-term effect of uncontrolled growth will unacceptably impair the performance of the diversion channels.

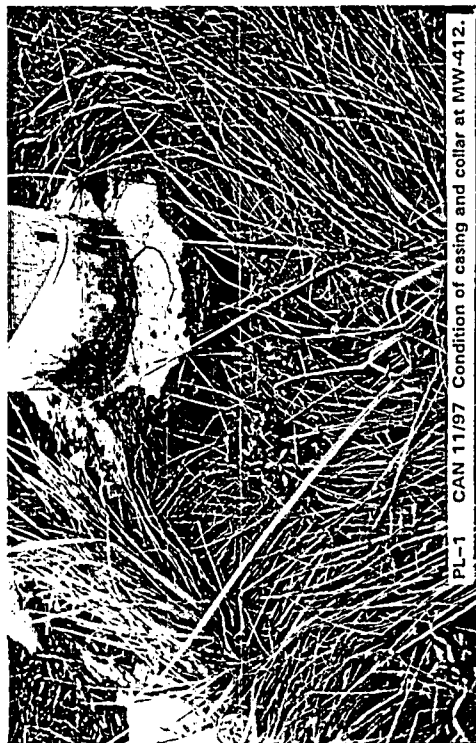
There are six monitor wells in the LTSM Program monitoring network and one additional well that is sampled for the UMTRA Ground-Water Project. Each monitor well is secured with a cap-and-pin locking system and a standard padlock. In general, the steel casings, concrete collars, caps, and pins, of all wells were in good condition. Padlocks are corroding and will have to be replaced from time to time. The concrete collar and surface casing for MW-412 are leaning in the down-slope direction (CAN PL-1). Ground-water monitoring personnel advise that slightly displaced collars are not a serious problem at this site because the casing farther down the borehole is securely grouted to provide a seal against contamination from surface runoff. Replacement of the collar at MW-412 is not required.

PL-1 CAN 11/97 Condition of casing and collar at MW-412.

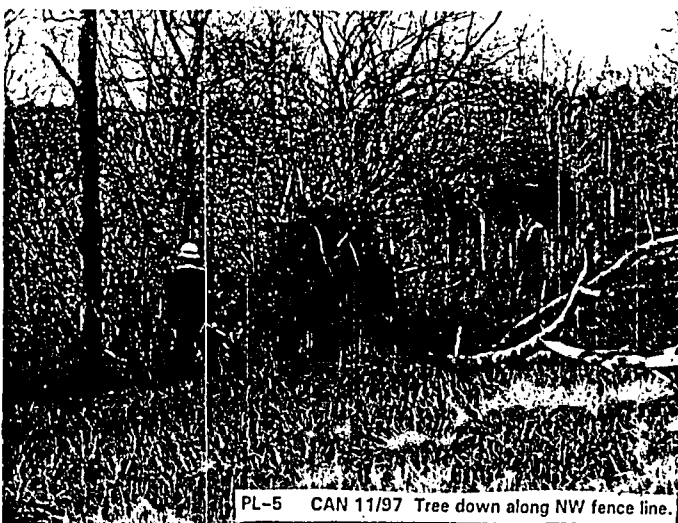
enough that dying trees and branches are commonplace. Deadfalls continually batter the fence. Truckloads of material were removed from along the fence line in 1996, and new deadfalls were discovered during this year's inspection (CAN PL-5 and CAN PL-6). These will be removed. If the fence beneath the deadfalls is damaged, so as to compromise security, the fence will be repaired. As stated above, relocation of the fence may be the most inexpensive and effective, long-term solution to the problem. (The security fence is 12 years old and is believed to have a 20-to-25 year lifetime.)

PL-5 CAN 11/97 Tree down along NW fence line.

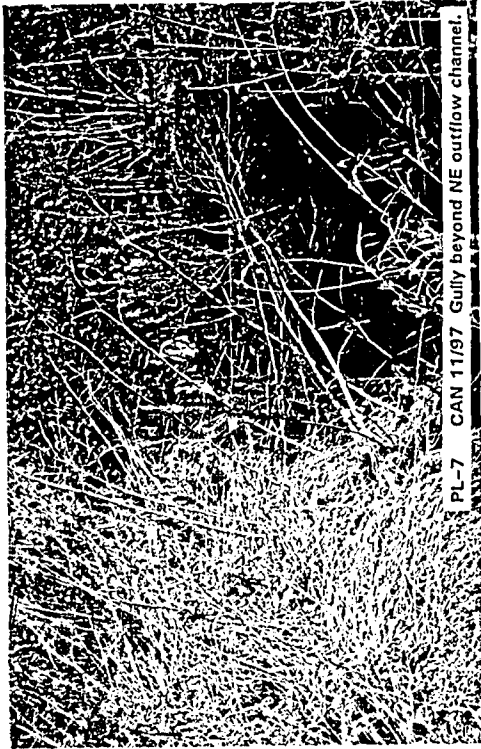
Bedrock of the Casselman Formation is exposed in part of the gully, but elsewhere the bottom of the gully is clayey and slippery when wet. The gully is not a threat to the disposal cell or to as-built structures on the site because there is a buried erosion control structure along the fence line that will stop headcutting should it advance that far. The gully is, however, outside the security fence and close to Strabane Avenue. DOE, therefore, considers the gully to be a safety hazard. DOE will address the problem in 1998.

PL-7 CAN 11/97 Gully beyond NE outflow channel.

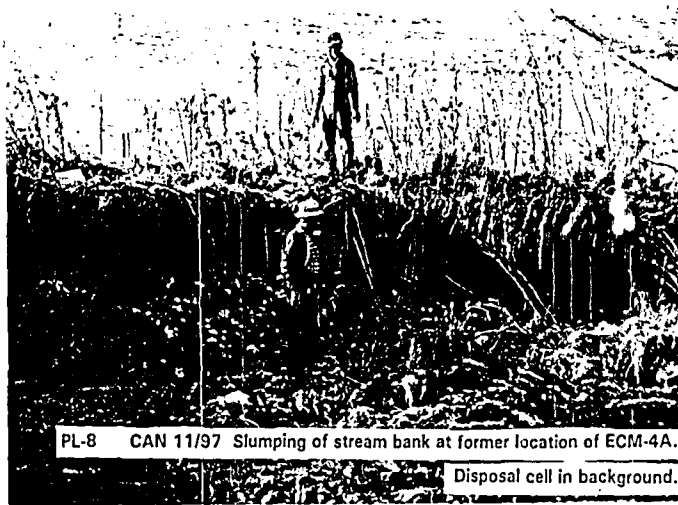
All four pairs of erosion control markers (ECMs) were undisturbed with one exception: ECM-4A, which was near the edge of the bank along Chartiers Creek at the time of the 1996 inspection, is now lost where the bank has slumped into the creek. (See section on "Bank Stabilization.") ECM-4A does not need to be replaced. The other marker in the pair, ECM-4, can be used for reference.

Downstream from ECM-2 and 2A, and to the east along Area C, the bank is grassed. Changes along this portion of the bank were noted. As stated above, ECM-4A is lost where the bank has slumped into the creek (CAN PL-8). Erosion and loss of bank are not a concern at this location because it is beyond a buried erosion control barrier situated between the disposal cell and the creek. Continued, small-scale slumping of the bank at Area C, where the bank is likewise grassed, was also noted. Erosion here is minor, and most likely only a natural response to an over-steeped bank condition resulting from final grading during the course of remedial action.

PL-8 CAN 11/97 Slumping of stream bank at former location of ECM-4A.

Disposal cell in background.
