Subject: Braidwood Station, Unit 1, 60-Day Response to First Revised NRC Order
EA-03-009, "Issuance of First Revised NRC Order (EA-03-009) Establishing Interim
Inspection Requirements for Reactor Pressure Vessel Heads at Pressurized Water
Reactors"

A1R12 Reactor Vessel Head Visual Inspection Results

**“Braidwood Unit 1 – A1R12
Reactor Vessel Head Penetration Examination
April 2006”**

WDI-PJF-1303195-FSR-001

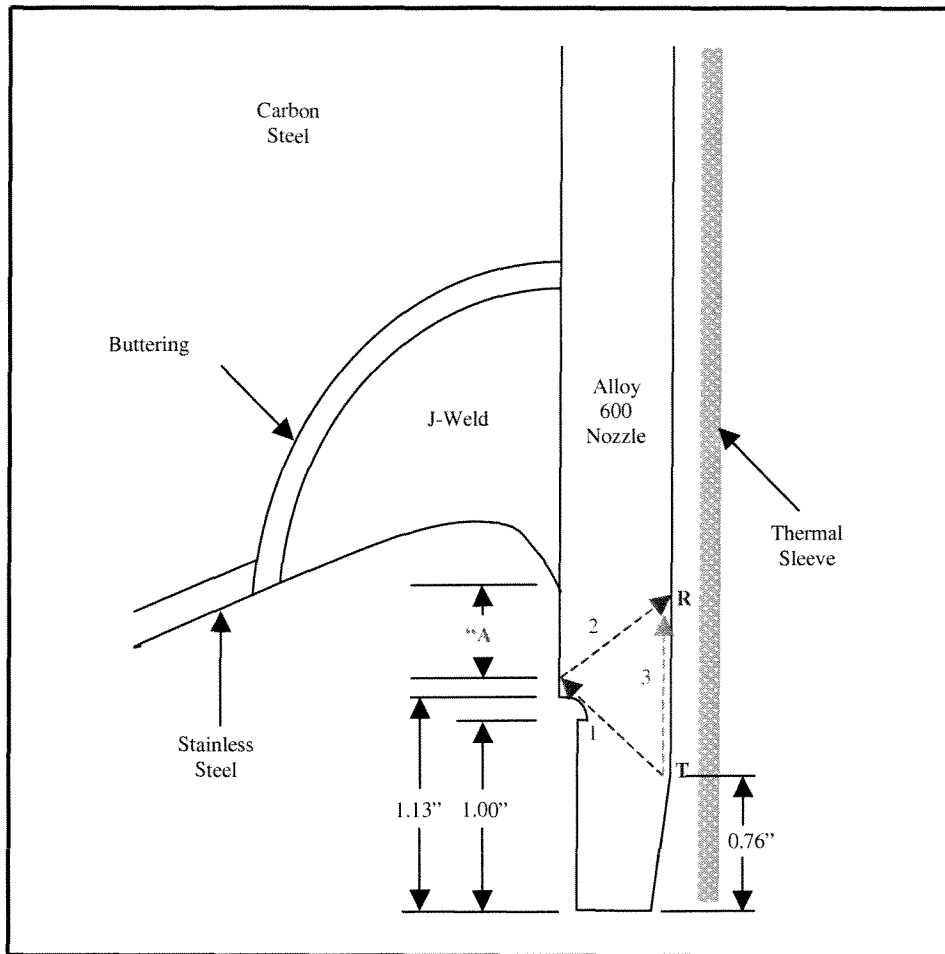
The configuration of a sleeved Braidwood CRDM penetration tube is illustrated in Figure 4-1. This figure represents the tube-to-head geometry at the penetration 0° azimuth, or “downhill” side of the tube. The bottom ends of all penetration tubes are threaded on the OD surface and have a chamfer on the ID surface. The threads extend from the bottom of the tube to an elevation of approximately 1.00” where a thread relief is machined. The top of the thread relief is 1.13” above the bottom of the tube. The distance from the top of the thread relief to the bottom of the fillet of the J-groove weld, identified as “A”, varies based on location of the penetration in the head. These distances are generally longer for penetrations at “inboard” locations and become progressively shorter for penetrations located further away from the center of the head. The ID surface chamfers are machined at a 20° angle from the bottom of the tube to an elevation of 0.76”.

Figure 4-1: Illustration of Axially Oriented TOFD Examination Coverage on Braidwood Unit 1 Penetration Geometry at 0° (Downhill Side)

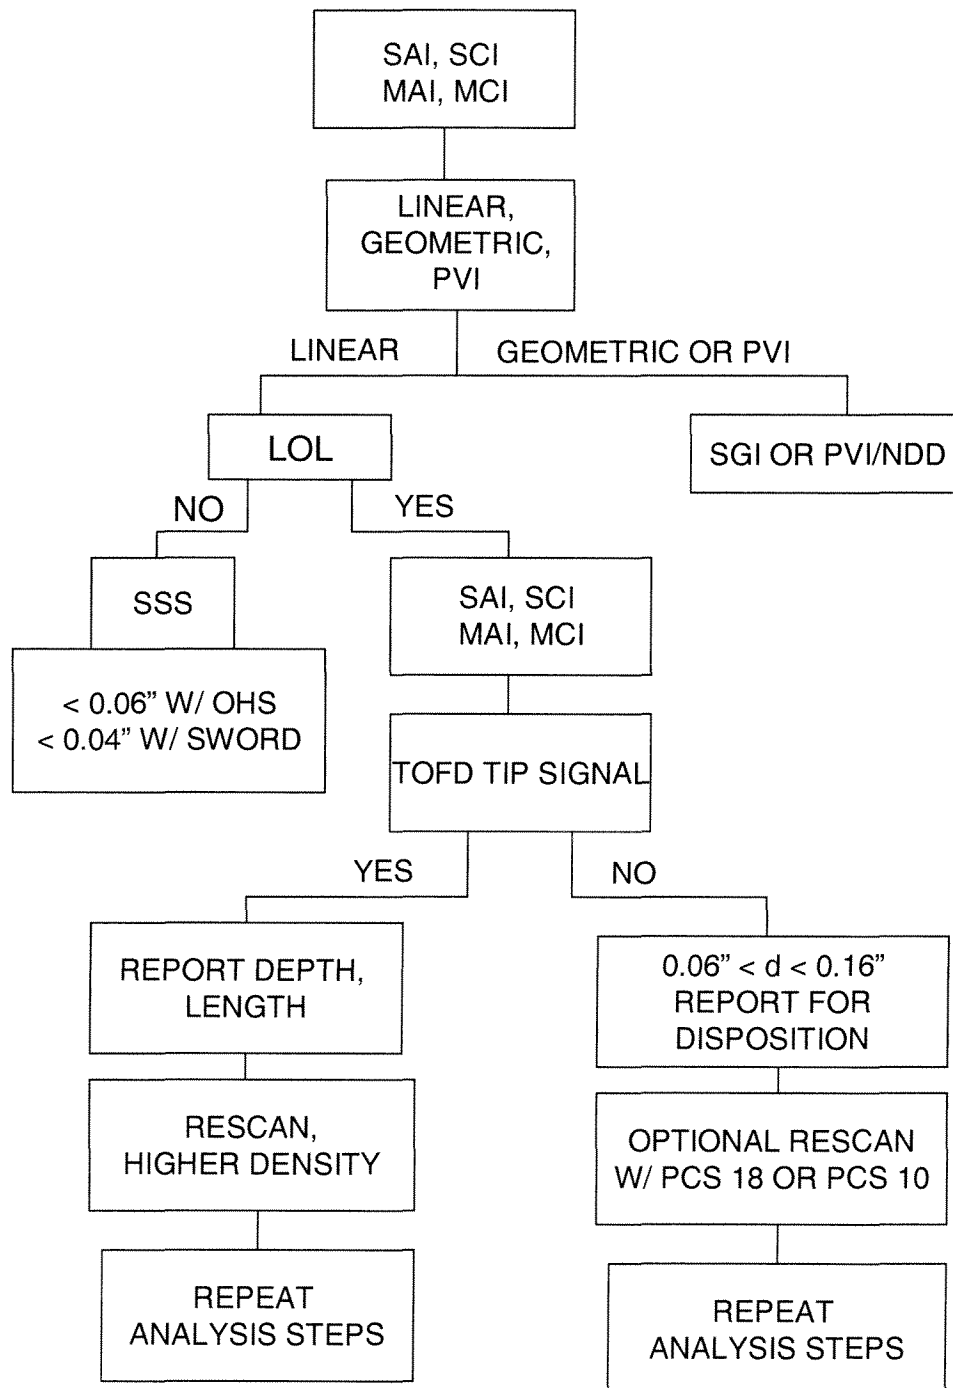
Figure 5-1 - Penetration Tube ID Indication Screening

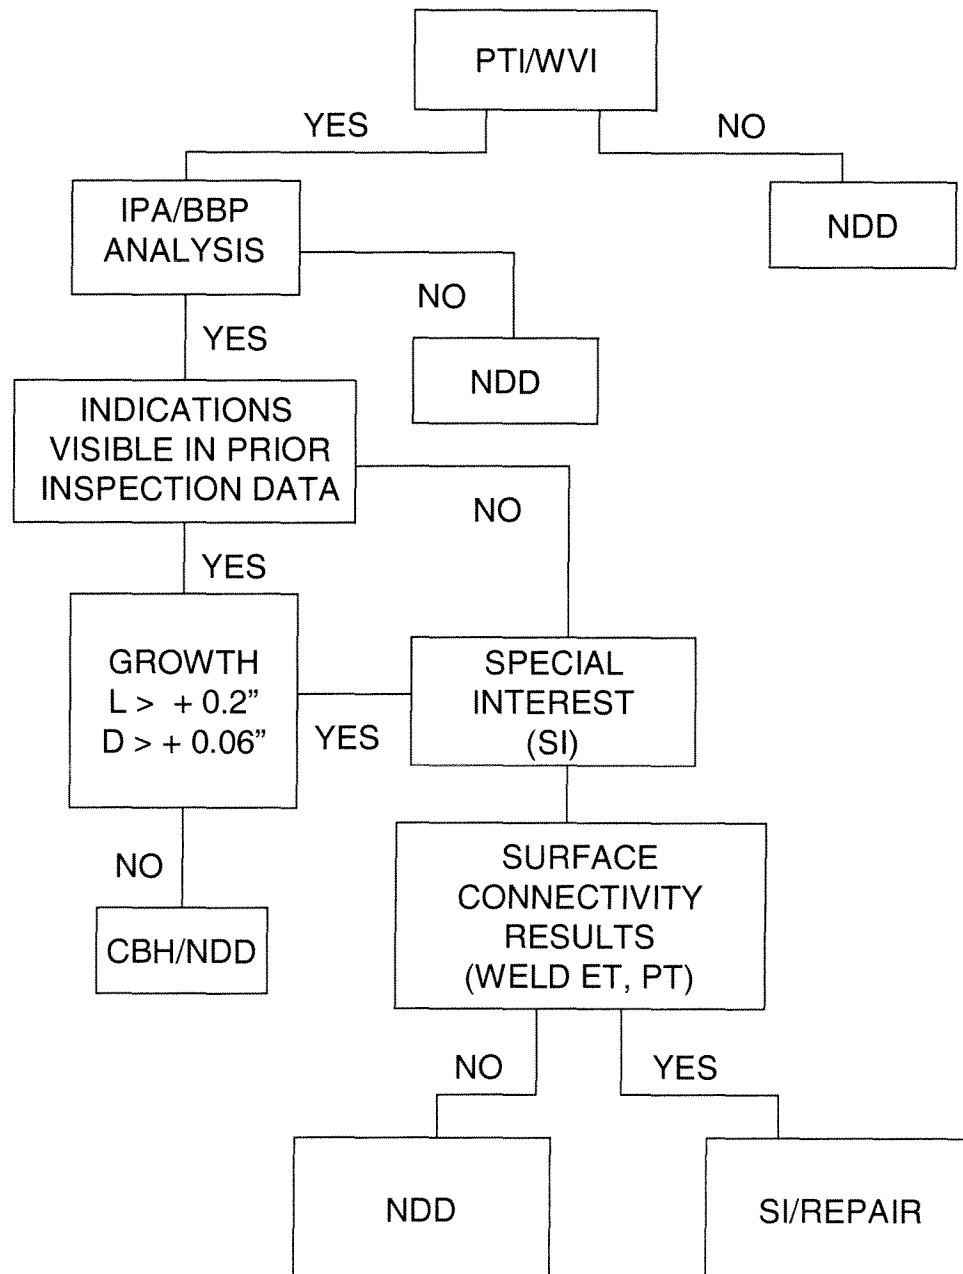
Figure 5-2 - Penetration Tube OD Indication Screening Within Weld Zone

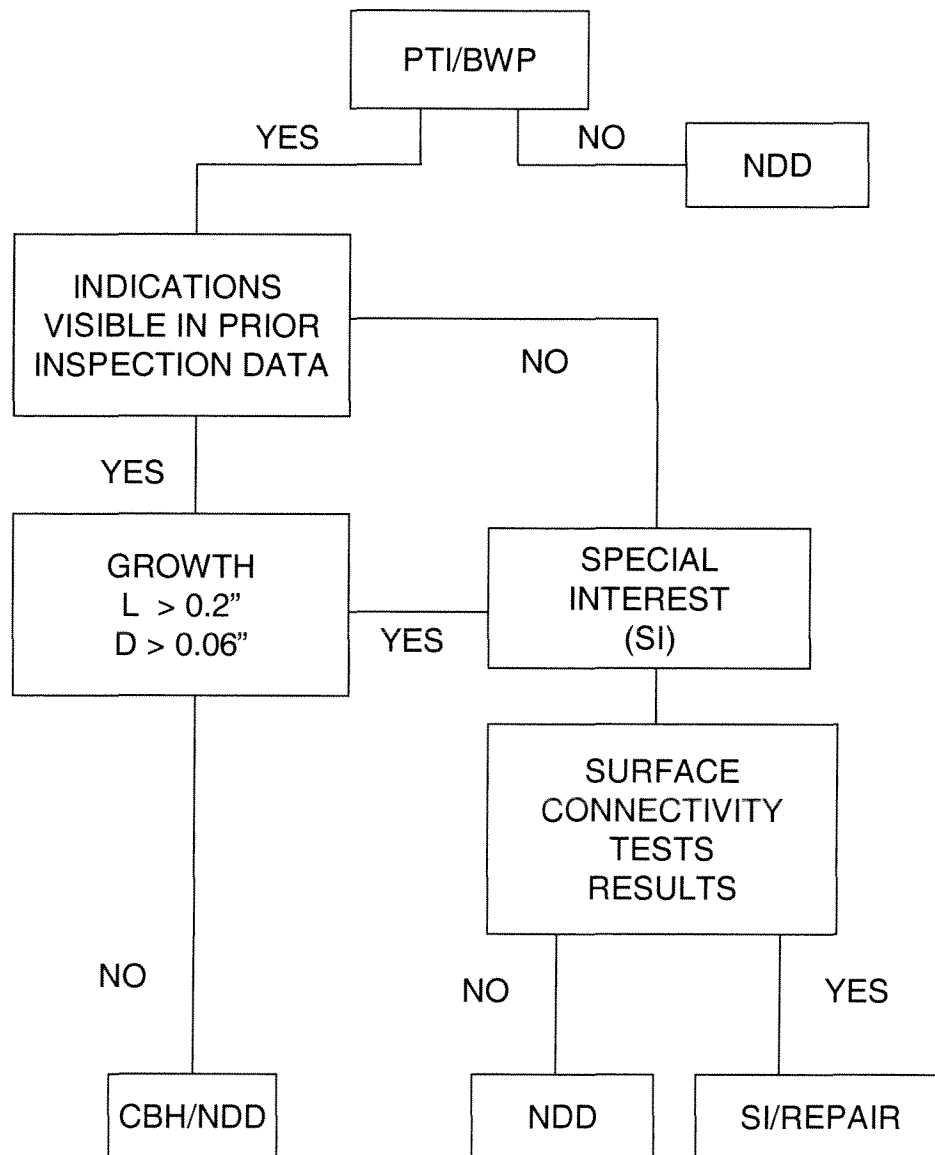
Figure 5-3 - Penetration Tube OD Indication Screening Above or Below Weld Zone
