VIRGINIA ELECTRIC AND POWER COMPANY  
RICHMOND, VIRGINIA 23261

August 10, 2007

**VIRGINIA ELECTRIC AND POWER COMPANY**  
**SURRY POWER STATION UNITS 1 AND 2**  
**RESPONSE TO REQUEST FOR ADDITIONAL INFORMATION**  
**2006 STEAM GENERATOR INSERVICE INSPECTION REPORTS**

**Response to NRC Request for Additional Information Regarding  
2006 Steam Generator Inservice Inspection Reports**

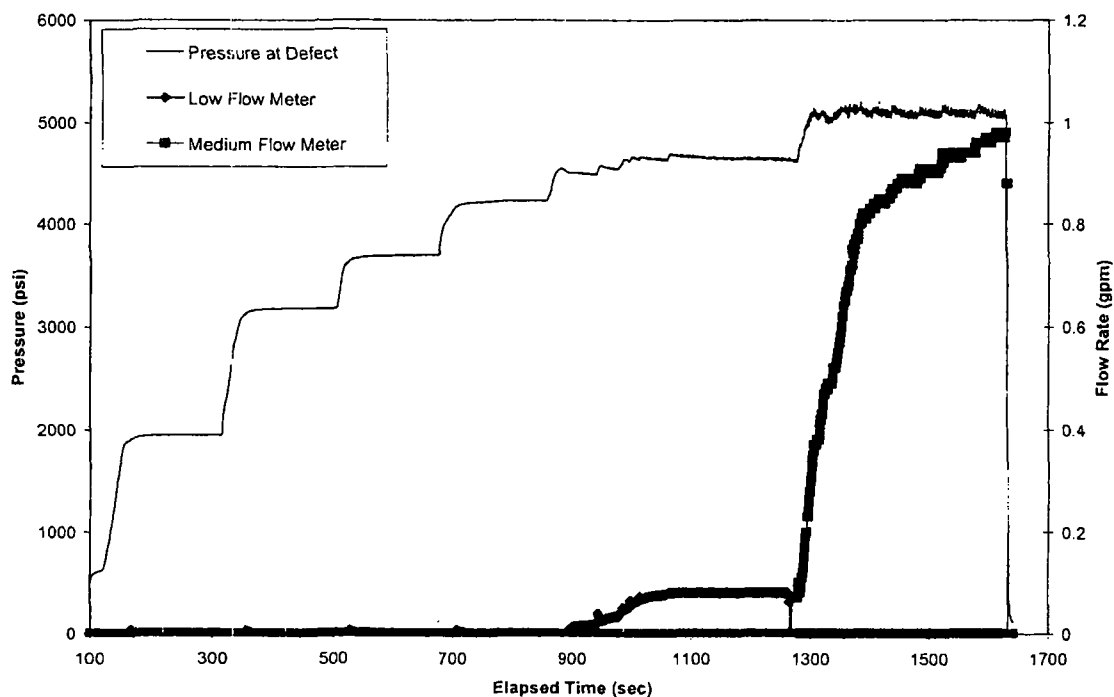
**SURRY UNIT 1, SG A 35/68 TSH  
Second Test Attempt**

A copy of the leak rate and pressure versus time plot for the in-situ pressure test performed on Tube Row 35 Column 68 in Surry Unit 1 SG A is provided in the attachment to this enclosure. As noted on the plot, the information provided is for the second in-situ test that was performed on the subject tube. The first in-situ test attempt was aborted due to a faulty medium flow meter that required replacement prior to completing the test.
