NL-07-1547

Joseph M. Farley Nuclear Plant – Unit 2  
Proposed Alternative for Continued Operation With Pinhole Leaks  
in Class 2 Valve Q2N11V003B

FNP-ISI-ALT-07-02, Version 1.0  
Proposed Alternative for Continued Operation With Pinhole Leaks in Class 2 Valve  
Q2N11V003B

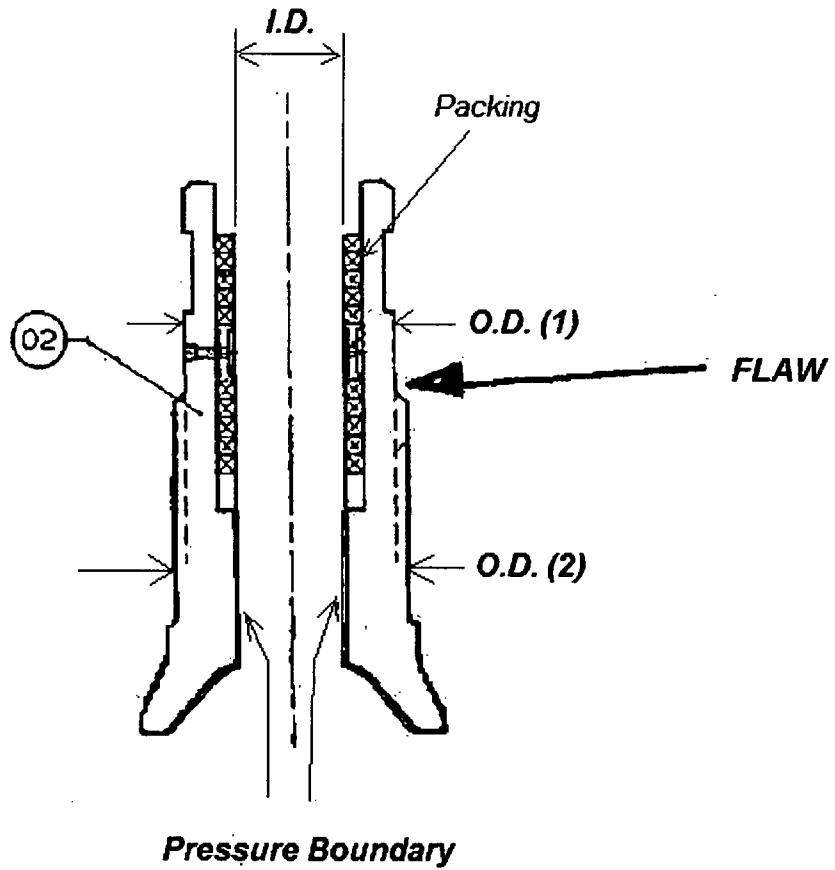
A small pinhole leak was discovered in Class 2 valve Q2N11V003B as shown in Figures 1-1, 1-2, and 1-3. Upon visual examination, the steam leakage was determined to be originating from the valve bonnet at a location just above the threaded area of this valve part. This leakage was conservatively considered to be the result of a through-wall defect in a pressure retaining part and was therefore an unacceptable condition.

***Bonnet Showing Location of Flaw***

**Figure 1-1. Approximate Location of Flaw in Valve Q2N11V003B**

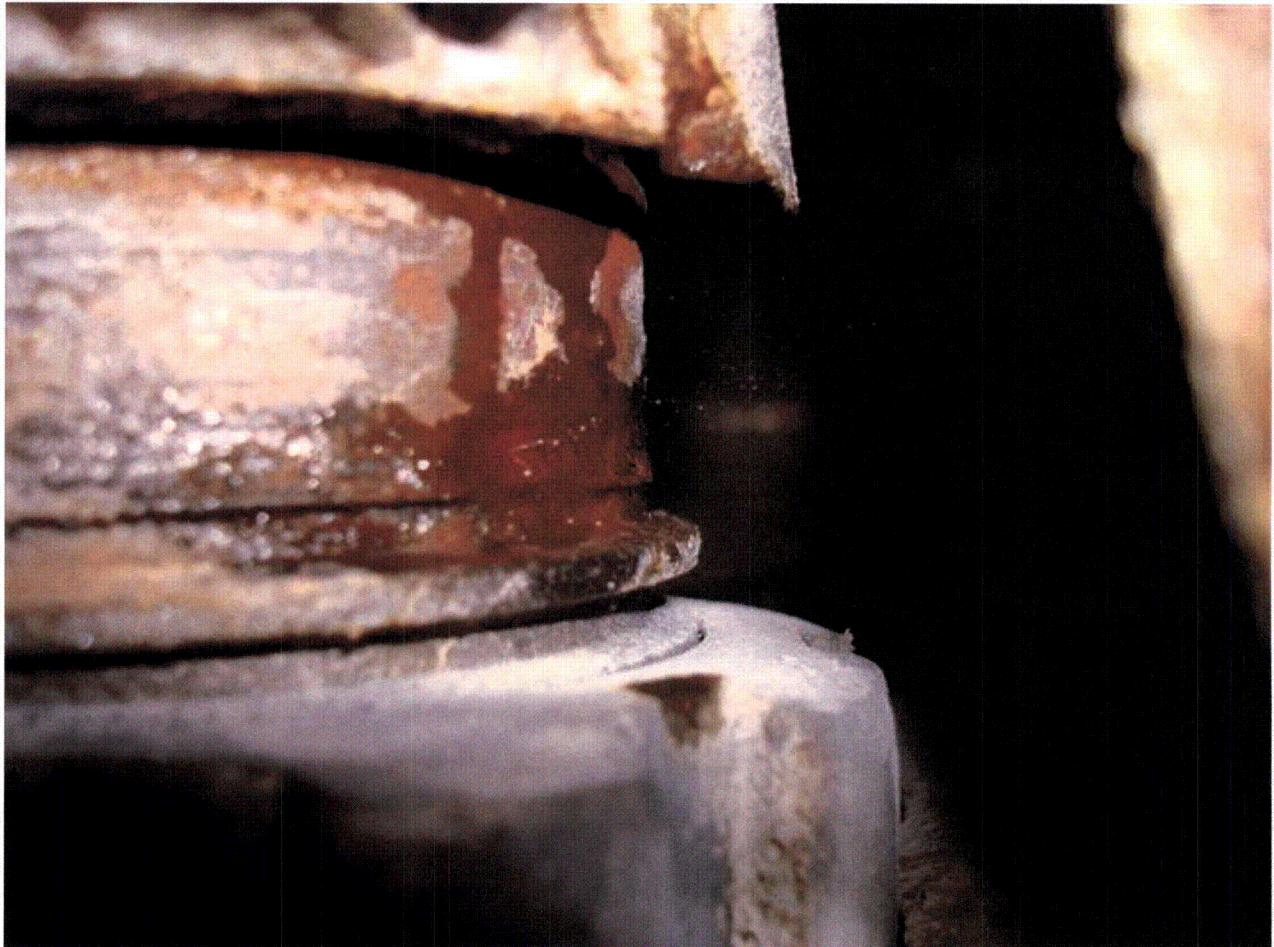
The leaking flaw was initially visually characterized as a single rounded flaw. After surface preparation for UT, the initial leaking flaw was measured to be approximately 0.1 inch long and two other leaks surfaced nearby.

**Figure 1-2. Picture of Leak in Valve Bonnet**

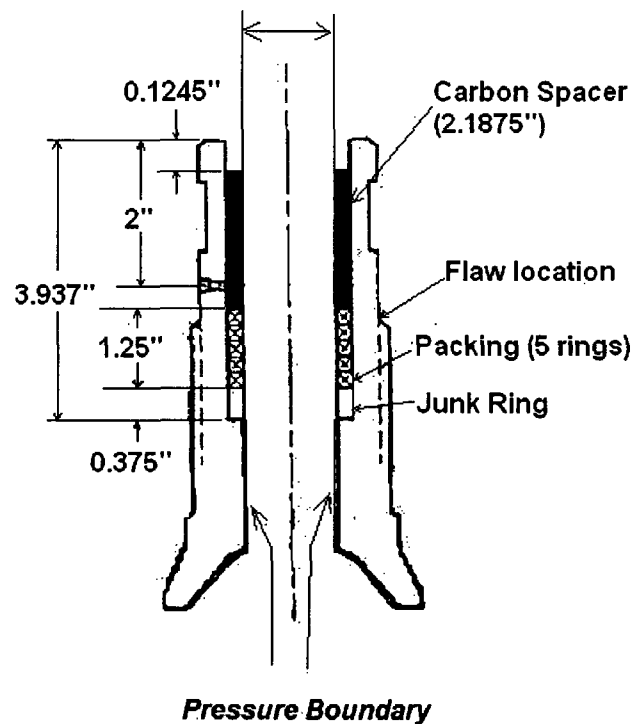
The hypothesis is that a subsurface flaw existed in the forging that escaped detection during original valve manufacture. Due to the packing configuration shown in Figure 2-1, this flaw was not exposed to significant thermal or pressure loads for the majority of its operating history. During 2R17 (Fall 2005), the packing configuration was changed to that shown in Figure 2-2 and packing stud torque was increased. These changes resulted in a higher radial load in the area of the flaw, where there was a stress concentration due to the different diameter. These stresses, in combination with a pre-existing fabrication defect, may have resulted in a small crack on the inside surface. After the leak was detected, it was determined that the packing loading was less than the target value. This reduction was attributed to vibration causing the packing loading to relax. Subsequently, this allowed the system pressure to place additional stress at the flaw location, and the additional stress eventually drove the flaw to the surface.

**Figure 2-1: Packing Configuration Prior to November 2005**

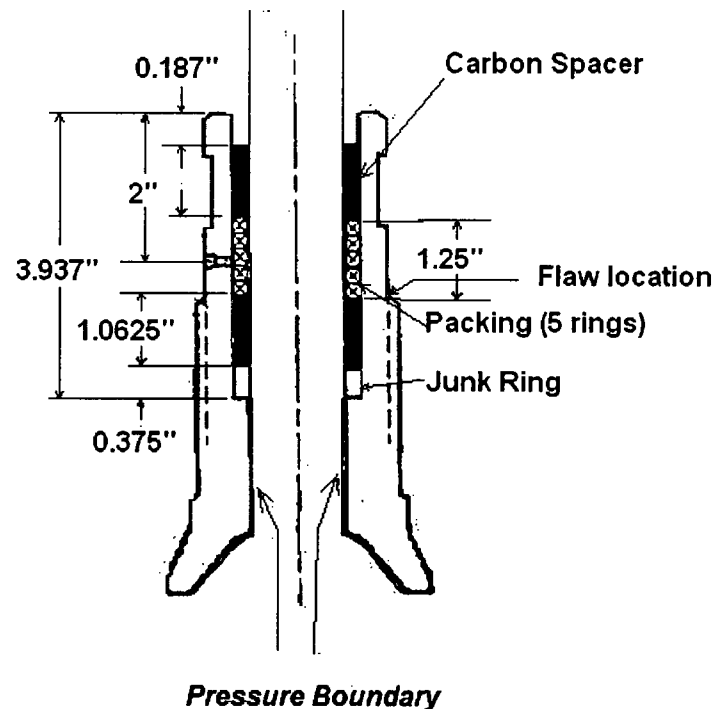
The most likely cause of the leakage was determined to be a latent manufacturing defect that, over time, resulted in leakage due to a combination of mechanical and pressure stresses from radial packing load and system pressure. This is supported by the lack of observed leakage on other valves of the same design, application, environment and manufacture as Q2N11V003B. The timing of the observed leakage can be explained by the changes to the valve packing configuration and applied loads at the flaw location.

**Figure 2-2: Packing Configuration After November 2005**
