Report No.: SIR-07-221-NPS  
Revision No.: 0  
Project No.: FNP-08Q  
File No.: FNP-08Q-401  
August 2007

**DEGRADATION MECHANISMS AND  
FLAW EVALUATION ASSOCIATED  
WITH A LEAK IDENTIFIED IN MAIN  
STEAM SYSTEM BYPASS VALVE  
Q2N11V0003B AT FARLEY UNIT 2**

Southern Company  
Contract No.: P.O. B9246, Release Order 2007-08

Structural Integrity Associates, Inc.  
San Jose, California

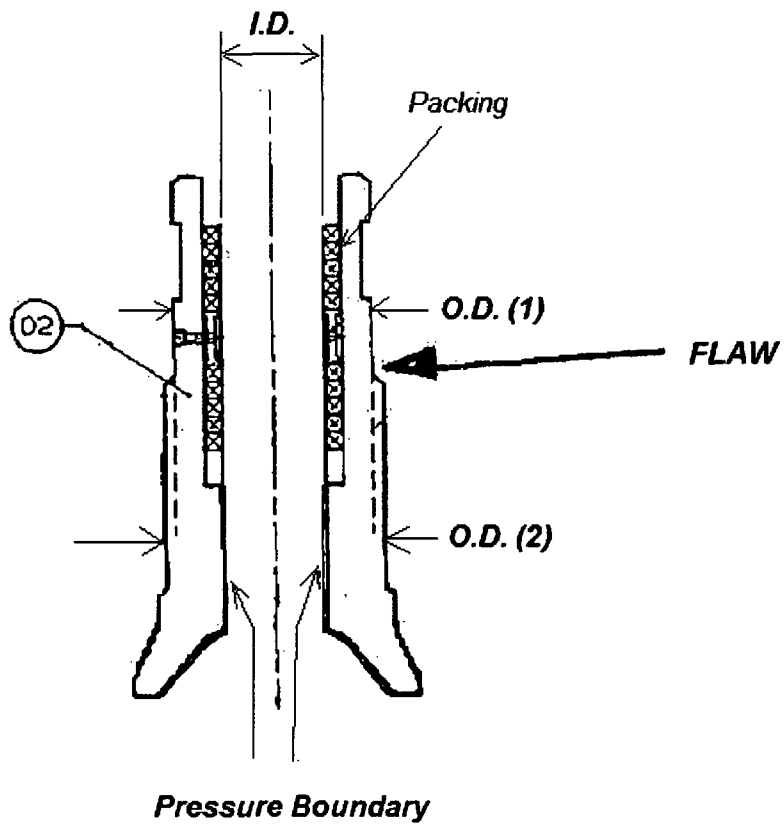
Figure 1-1. Approximate Location of Flaw in Valve Q2N11V0003B [1.2]

The leak is located above the threaded section of the bonnet as shown in Figure 1-1 [1.2]. The valve is located on a horizontal line with the valve bonnet pointing upwards. Pictures of the affected valve are shown in Figures 1-2 and 1-3 [1.3].

The nature of the leaking flaw in Valve Q2N11V0003B is most consistent with a minor fabrication defect or imperfection associated with fabrication or installation of the valve. Although fabrication defects are not common in forged components, the geometry associated with the valve, including stress concentrations, may have given rise to a fabrication related defect. Installation loadings, in combination with a pre-existing fabrication defect and local stress concentration, could have been a contributor to producing a surface crack or extending a crack associated with the defect.

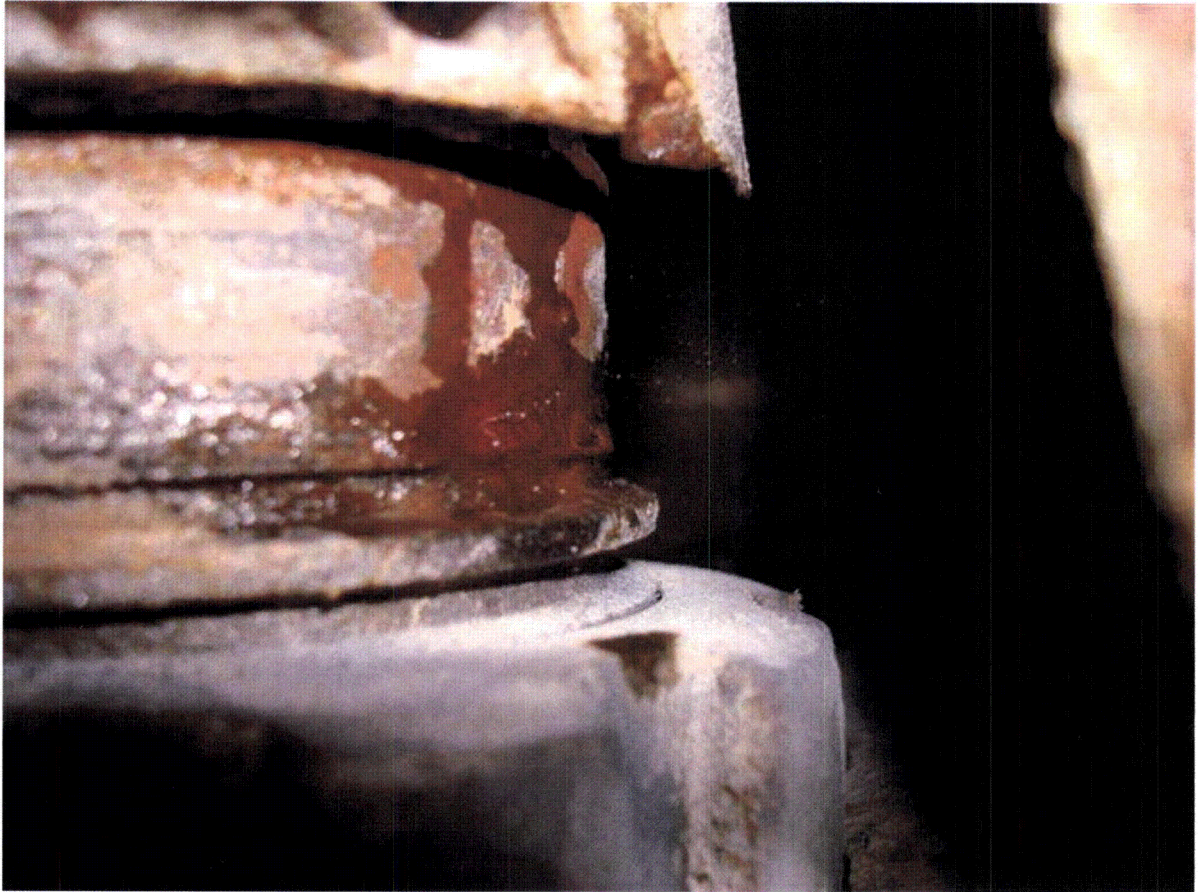
Figure 1-2. Picture of Leak in Valve Bonnet [1.3]

A small pinhole leak was discovered in the bonnet of a small bore main steam system isolation valve (Q2N11V0003B) at Farley Nuclear Plant (FNP), Unit 2. This valve is the upstream Main Steam Isolation Valve (MSIV) bypass line isolation valve for the “B” main steam line. Valve Q2N11V0003B is a 3-inch, Class 600 lb, pressure seal, flexible wedge, gate valve with pneumatic actuator. This safety-related, ASME Section III, Class 2 valve, was manufactured by Velan Valve Company for FNP. The valve body and bonnet material are SA-105 Gr. II carbon steel [1.1].

Further support for a pre-existing flaw is supported by the NDE report that notes a loss of signal 1/3 of the way through the bonnet wall and that light sanding opened up two additional leaks (reported as “pinhole leaks” by station personnel [2.17]) in the vicinity of the original location.

It is recommended that the following actions be taken to monitor the leakage from the pinhole in Valve Q2N11V0003B:

- Walk down the line on a regular basis (possibly daily) to monitor leakage
- Perform periodic UT examination of the flaw region to verify no significant changes in the flaw characterization at intervals of no more than 90 days.
- Confirm there is rigid body motion between the valve and actuator as discussed in Section 2.2.6.1.

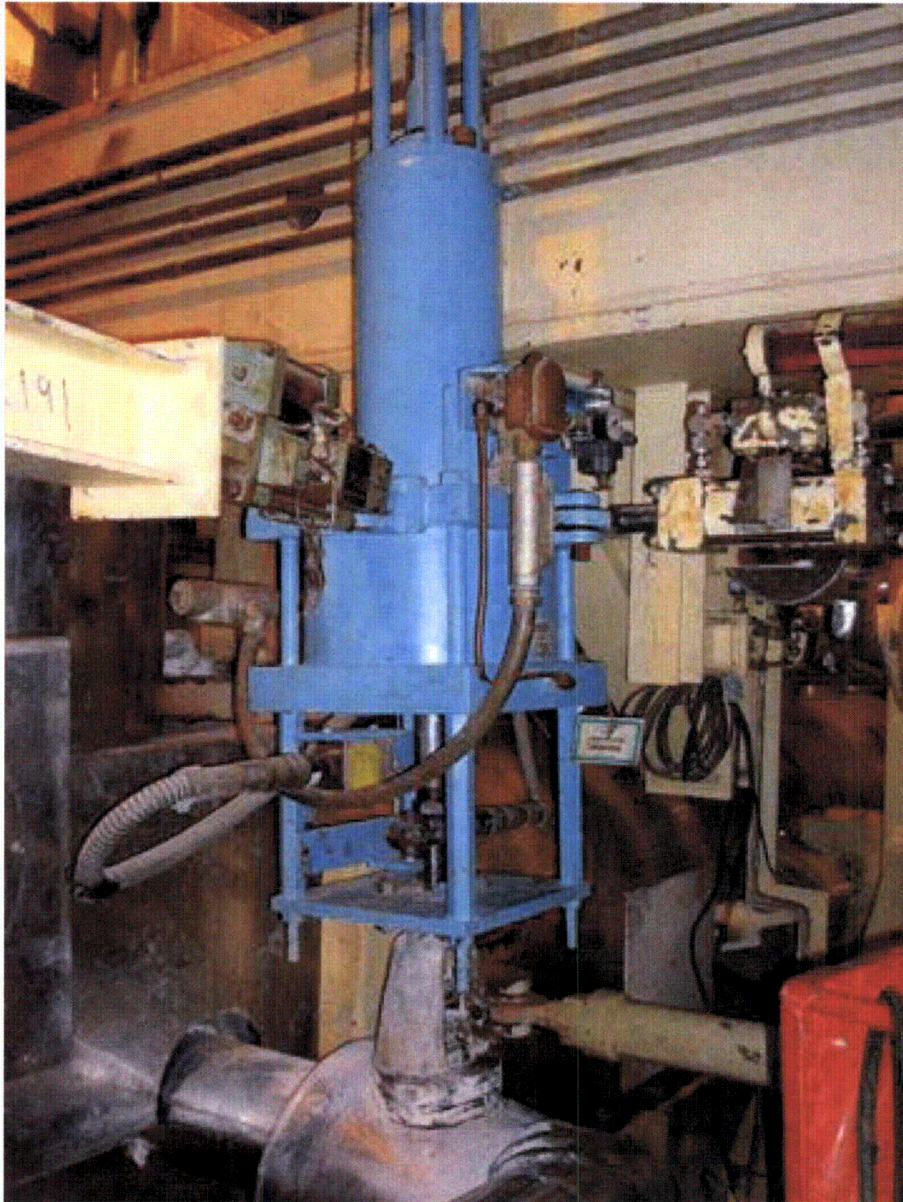
Figure 1-3. Picture of Entire Valve Body and Actuator [1.3]

Since there is minimal relative movement between valve yoke (near the leak location) and the actuator, vibration levels are not large enough to cause flaw initiation. However, if the bonnet was loose, the vibration amplitude levels would probably have increased and could have contributed to crack growth; however, there is no evidence that this occurred.

To confirm that the vibration is essentially rigid body motion, it is recommended to evaluate simultaneously collected steady state vibration data from at least two points (e.g., valve yoke and bottom of the actuator plate), in the axial direction, on MSIV bypass valve Q2N11V0003B and confirm that the motion is in phase.

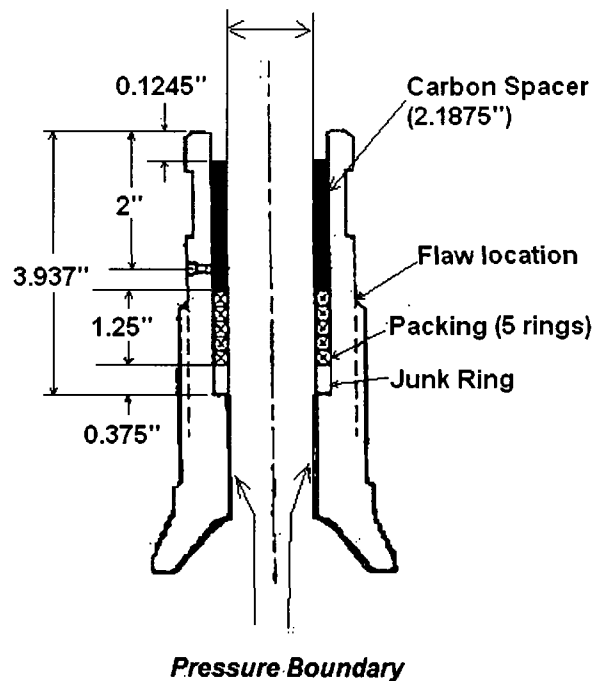
Figure 2-1: Packing Configuration Prior to 2R17

Q2N11V0003B has a history of steam leaks going back at least 3 operating cycles [2.8 through 2.10, 2.12, and 2.13]. Prior to 2R17, the packing arrangement (shown in Figure 2-1) isolated the flaw location from the system pressure [2.8]. Leakage identified in October 2002 was due to loose bonnet bolts. Immediately following startup from 2R16 in April 2004, the valve was observed to be leaking in the body to bonnet area and no leakage was observed in the area of the packing [2.9]. The bonnet clamp was confirmed to be tight. The leakage gradually worsened during the operating cycle. In addition, damage was observed in the area where the actuator and valve stem are connected and the condition report notes that this is a recurring issue [2.9]. The combination of loose bolting prior to 2R16 and the actuator to valve stem damage [2.11] suggests vibration as a possible contributor to the observed problems to this point. However, there is no evidence to suggest that vibration could have been the cause of crack initiation or crack growth at the location of the observed flaw.

The hypothesis is that there was a subsurface flaw in the forging that escaped detection during original valve manufacture. Due to the packing configuration shown in Figure 2-1, this flaw was not exposed to significant thermal or pressure loads for the majority of its operating history. Following 2R17, the change in packing configuration to that shown in Figure 2-2 and increase in packing stud torque resulted in a higher radial load in the area of the flaw, where there is a stress concentration. This, in combination with a pre-existing fabrication defect, may have resulted in a small crack on the inside surface. The load on the bonnet that would result from a flaw connected to the inside surface would produce additional stress at the location of the flaw and eventually drive the flaw to the outer surface.

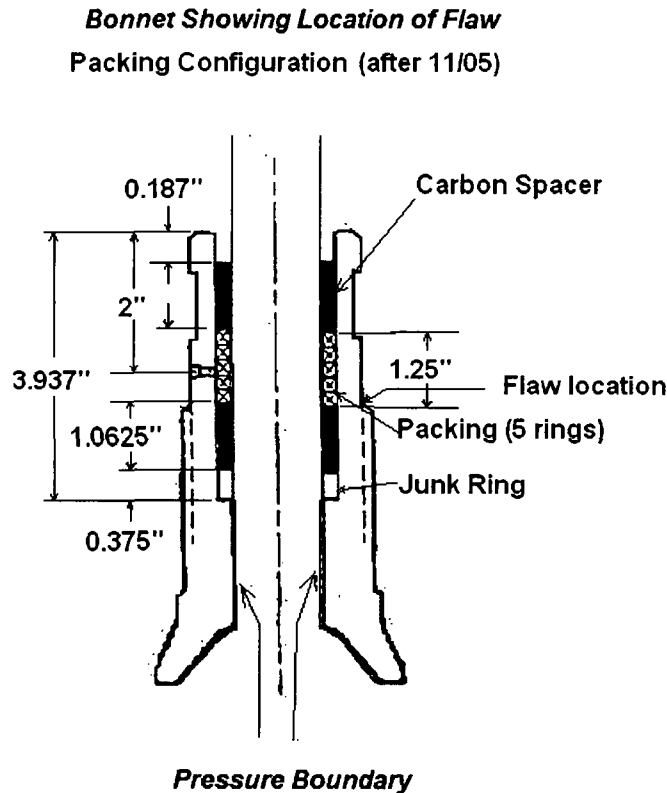
Figure 2-2: Packing Configuration Following 2R17

During 2R17, the maintenance work order [2.9] notes that there is evidence of leakage outside of the seal, but is not specific as to what the evidence was or how detailed an inspection was performed of other areas of the valve. During this maintenance, the packing configuration was changed to that shown in Figure 2-2. In addition, the packing torque was raised significantly, resulting in an increase in packing friction and a corresponding increase in the radial load on the bonnet in the stuffing box area. The lower packing rings are in the vicinity of the location where the flaw was later discovered.

The loads produced by packing or internal pressure are accounted for in the design of the component and could not have initiated a crack alone. Since increasing the torque from 9 ft-lbs to 12.5 ft-lbs significantly reduced the leakage at the flaw location on 7/5/2007, it is likely that the packing extends below the location of the flaw. Following 2R18, the leak was not immediately observed, as occurred following 2R16 and 2R17. This suggests the packing was originally performing its intended function until it loosened up, most likely due to system vibration given the previous history, and allowed the system pressure to place additional stress at the flaw location.

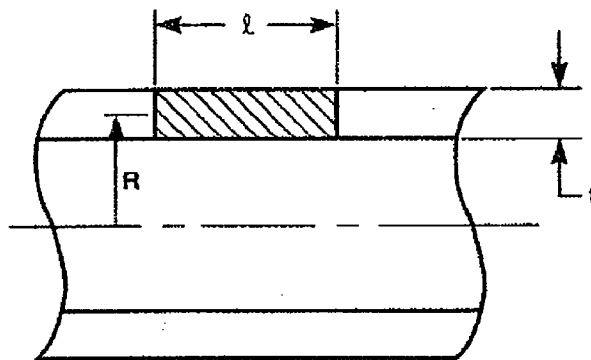
Figure 3-1. Assumed Axial Flaw Geometry in a Pipe

For comparison, a conservative linear elastic fracture mechanics (LEFM) analysis for the axial flaw was also performed using the **pc-CRACK** program [4.1]. The results showed an allowable flaw size of 5.6 inches would be required to exceed the criterion for initiation ( $K_I > K_{IC}$ ), including the code defined safety factor of  $\sqrt{10}$  [3.6]. The results using LEFM are more conservative even though the Code Case N-513-1 method allows the use of limit load. Both the limit load and LEFM produce an allowable flaw size that is larger than the maximum height of the observed indications from the NDE report of 0.625 inches [2.15].

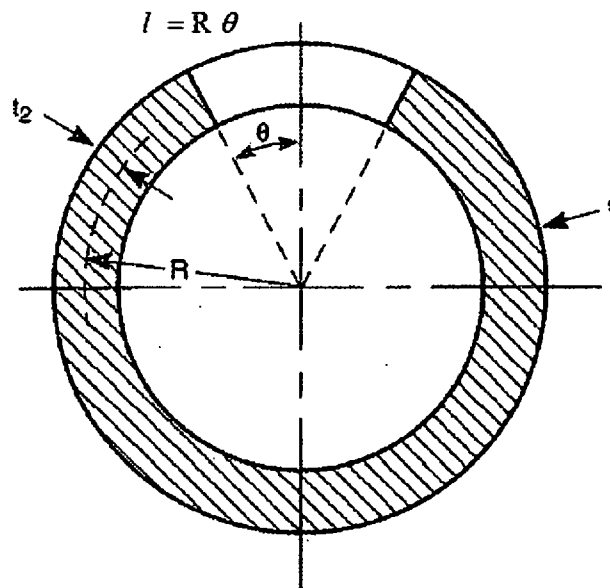
Figure 3-2. Assumed Circumferential Flaw Geometry in a Pipe

The **pc-CRACK** program [4.1] was used to solve for the maximum allowable circumferential flaw length based on linear elastic fracture mechanics (LEFM). The results show that a maximum flaw length of 3.8 inches would be required to exceed the criterion for initiation ( $K_I > K_{IC}$ ), including the Code defined safety factor of  $\sqrt{10}$  [3.6]. This is compared to the maximum width of indications from the NDE report of 0.25 inches [2.15].
