UNITED STATES OF AMERICA
NUCLEAR REGULATORY COMMISSION
ATOMIC SAFETY AND LICENSING BOARD

(License Renewal for Oyster Creek Nuclear
Generating Station)

**AMERGEN ENERGY COMPANY, LLC
REBUTTAL STATEMENT OF POSITION**

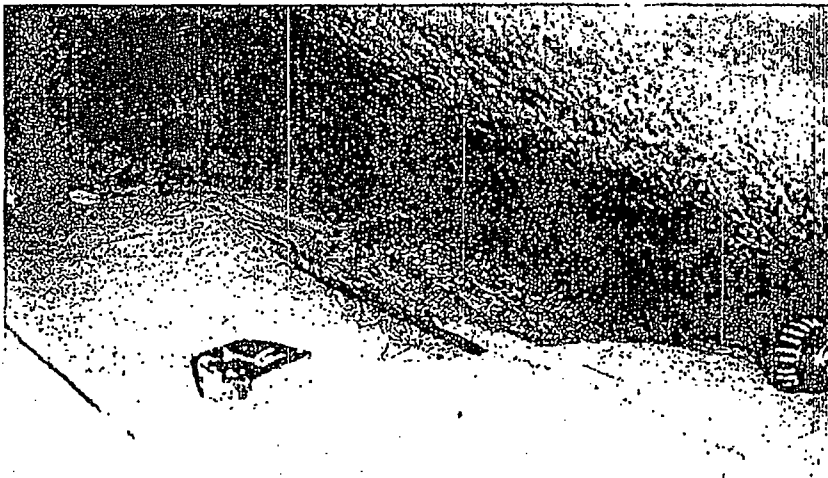
Figure 5

A more serious finding was the condition of the floor in the sand bed. The concrete was not finished, there were holes and craters along side the vessel, there was no evidence of a drainage ditch as shown on the drawings and in most cases the drain pipes were higher than the floor. (See Figs. 4 and 5). This was a general condition in all bays, however some were worse than others. Apparently the finish pour of concrete was not installed. This condition had a significant effect on the project's schedule and cost. To make the drain system effective the holes and craters needed to be filled, and the floor leveled using a suitable material compatible with both concrete and the steel shell. (See Figs. 6 and 7). The Devco epoxy product 184 was used to refurbish the floor. This was done after evaluation of the suitability of the material in the sand bed environment. This condition was documented using a MNCR (see reference 2.17). As a part of the floor refurbishment, a wedge of Devco 140S caulking material was placed at the intersection of the vessel shell and the floor. The caulking material will keep water away from the vessel in the event a volume of water greater than the drains capacity is introduced into the area. (See Figs. 8 and 9).

Deep depression in floor adjacent to drywell vessel.

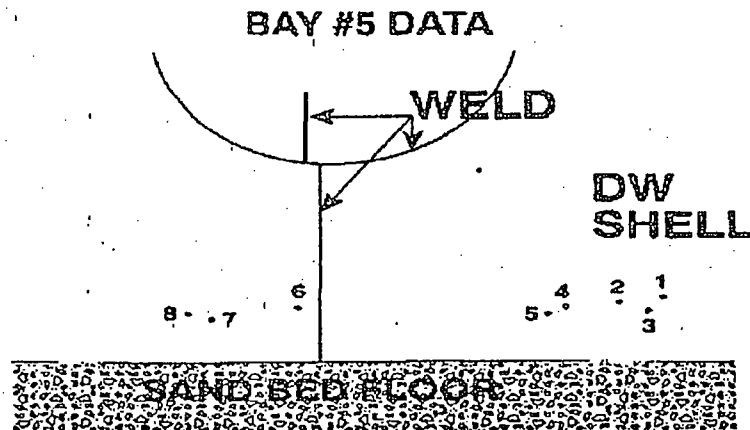
Figure 12

NOTE: In this bay the drywell shell (butt) weld is about 8 inches to the right of center line of the vent pipe. Therefore, all measurements were taken from a line drawn on shell which approx. coincide with the vent pipe center line.

Given the UT measurements, a conservative mean evaluation thickness of 0.950 inches is estimated for this bay and therefore, it is concluded that the bay is acceptable.

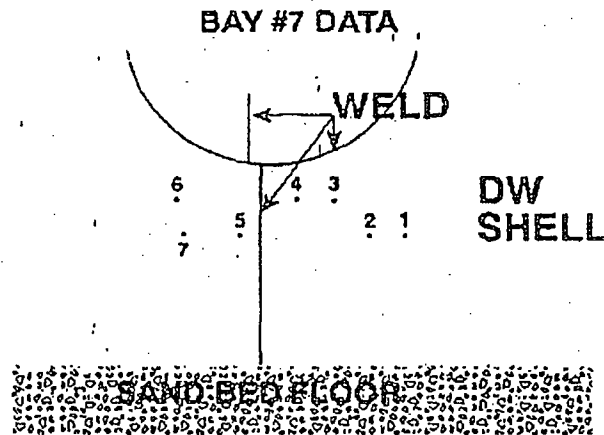
Figure 13

Given the UT measurements, a conservative mean evaluation thickness of 1 inch is estimated for this bay and therefore, it is concluded that the bay is acceptable.

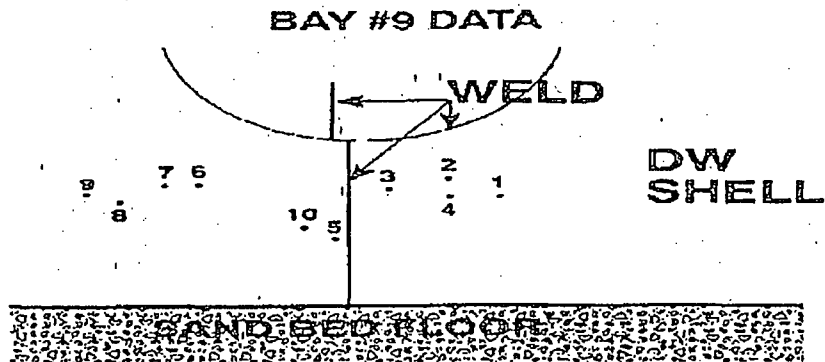
Figure 14

Given the UT measurements, a conservative mean evaluation thickness of 0.900 inches is estimated for this bay and therefore, it is concluded that the bay is acceptable.
