NDE and DE of PWSCC found in the J-Groove Weld of a Removed-From-Service Control Rod Drive Mechanism

**6th International Conference on NDE in Relation to
Structural Integrity for Nuclear and Pressurised
Components**

**October 8-10, 2007
Budapest, Hungary**

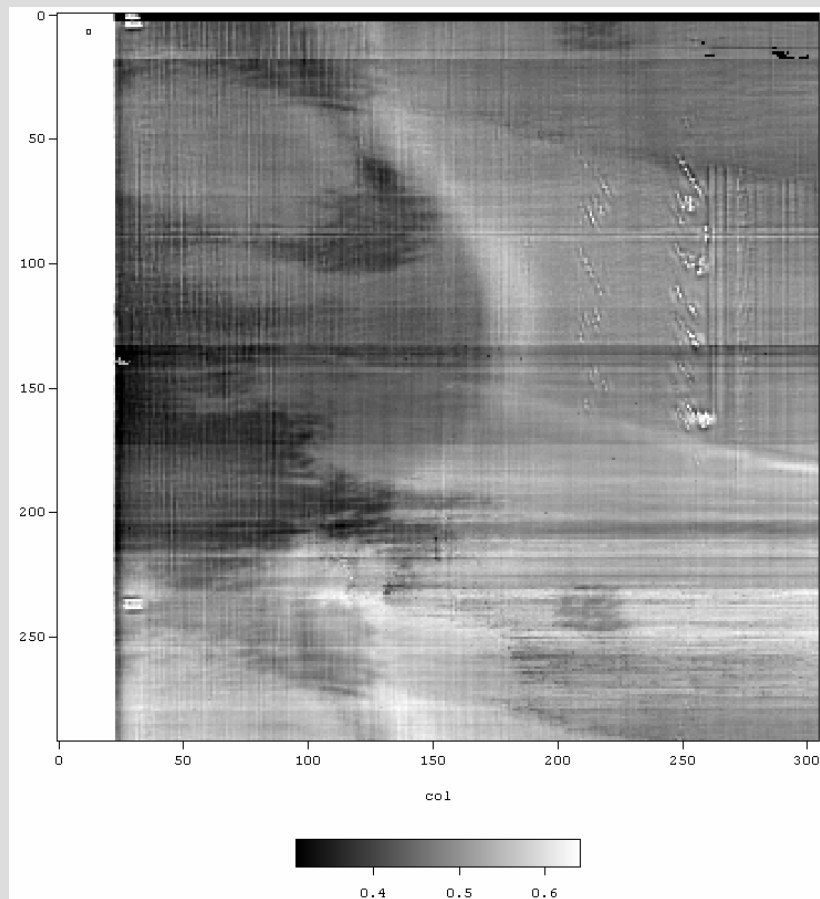
Nozzle #31- Penetration Tube ID ET exam

- ▶ No crack-like indications found.
- ▶ Indications consistent with shallow scratches discovered.
- ▶ J-groove weld clearly visible in data.

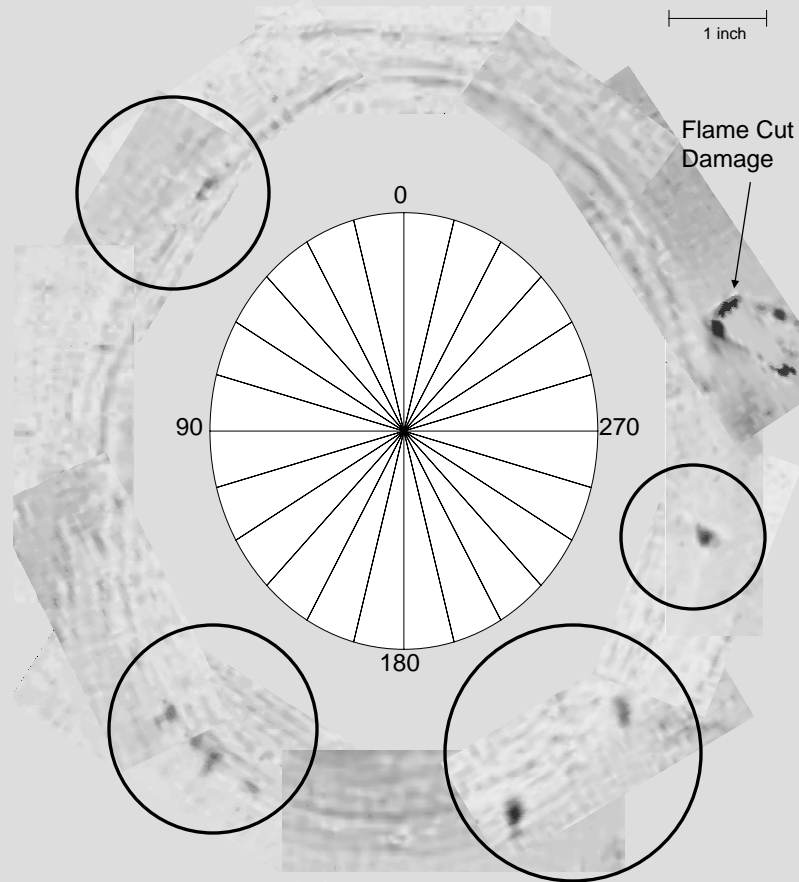
Zero Degree Probe Rotation

Eddy Current Results on Crown of J-Groove Weld and Buttering

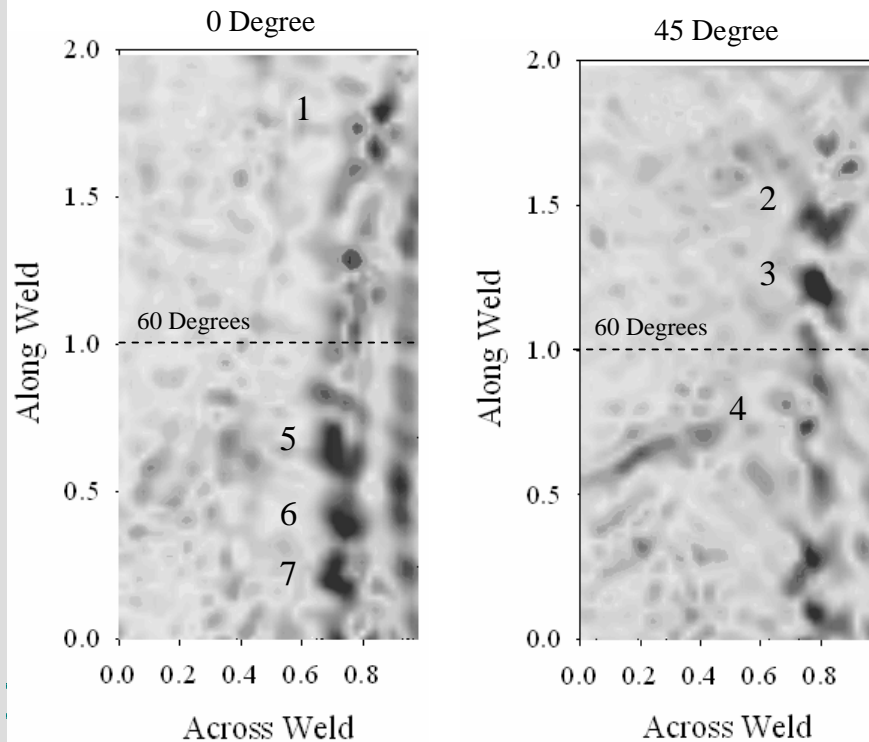
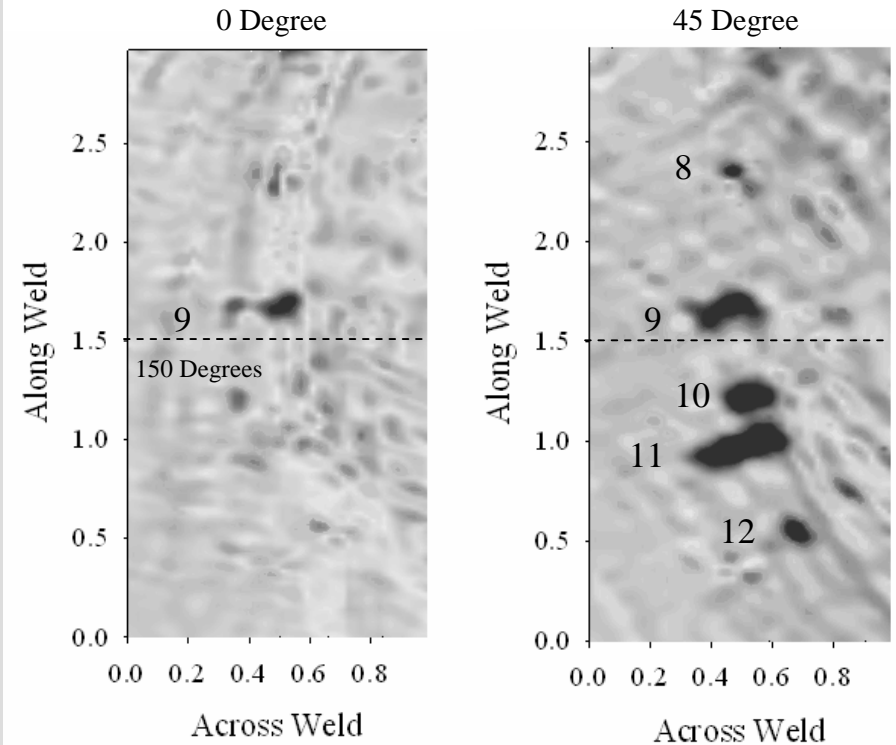
Centered on 60°

Indication	Length	Max Voltage
1	5 mm	2.1
2	3 mm	1.9
3	4 mm	3.3
4	2 mm	1.8
5	5 mm	2.2
6	3 mm	2.5
7	4 mm	2.3

Indication	Length	Max Voltage
8	3	2.3
9	8	3.2
10	6	3.3
11	10	4.1
12	4	2.6

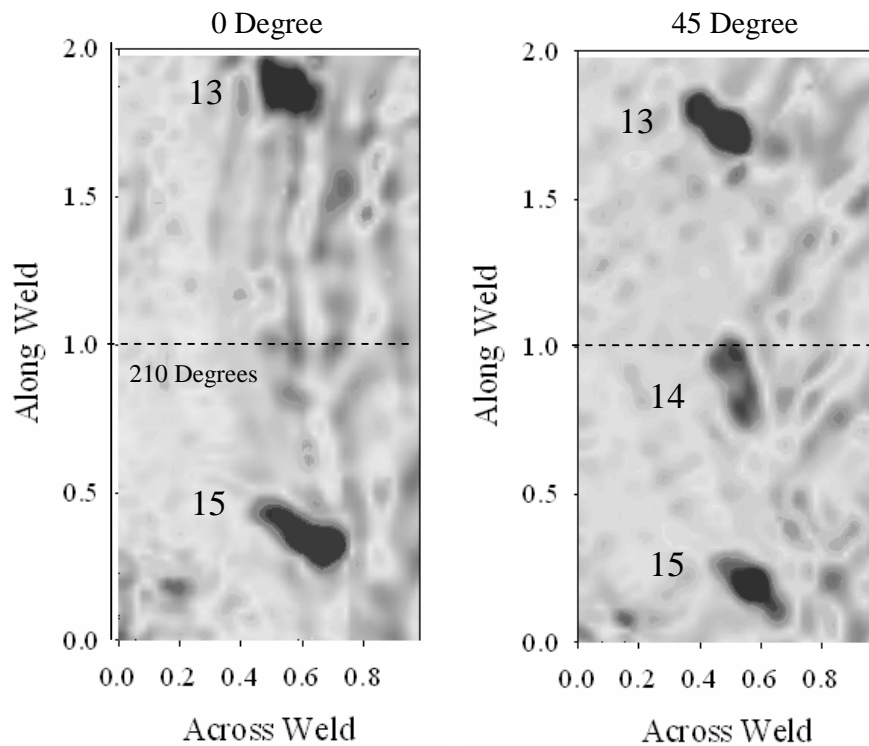
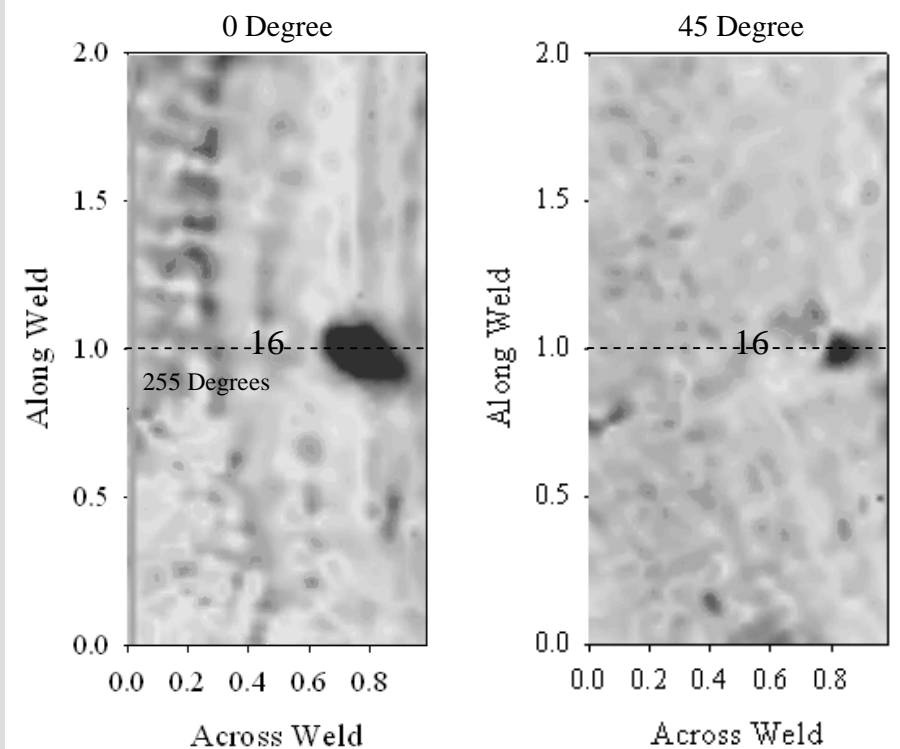
Centered on 210°

Indication	Length	Max Voltage
13	7	4.6
14	7	1.8
15	8	4.6

Indication	Length	Max Voltage
16	8	4.2

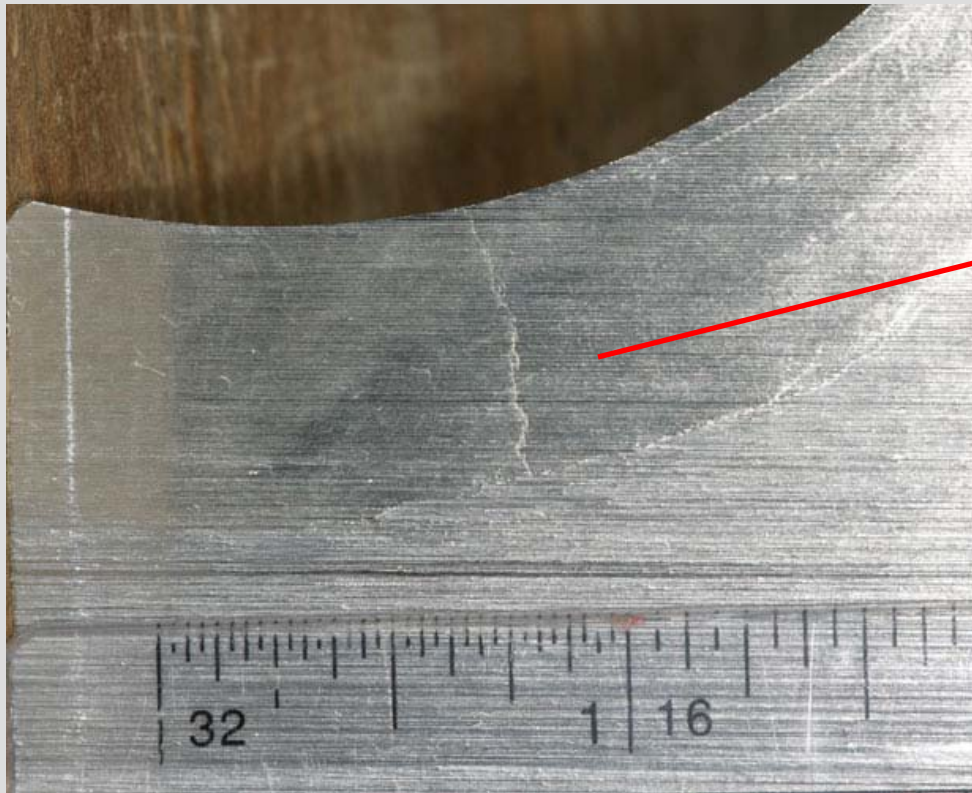
Located at 135 degrees

Crack Confirmed Through NDE

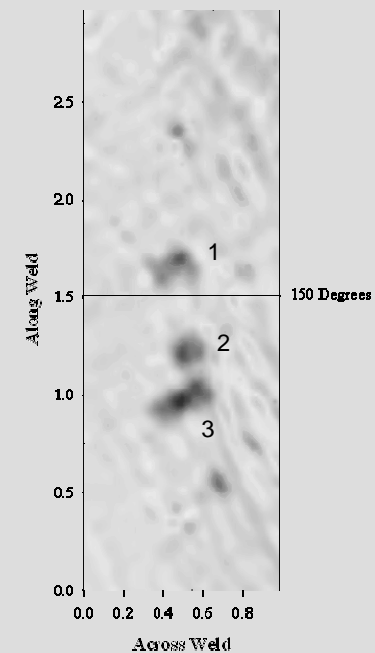
Indications near 150 degrees

No PT indications

#1: 146 degrees Max 3.1 V, 5 mm

#2: 153 degrees Max 3.3 V, 4 mm

#3: 157 degrees Max 4.1 V, 8 mm

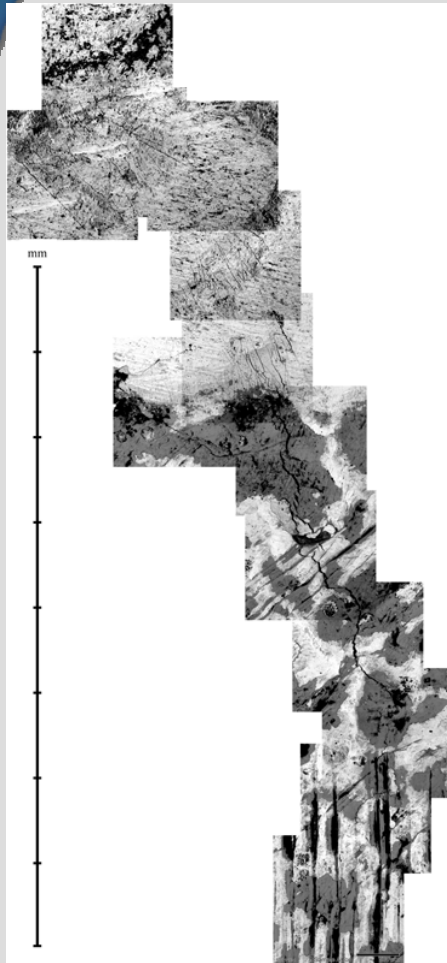
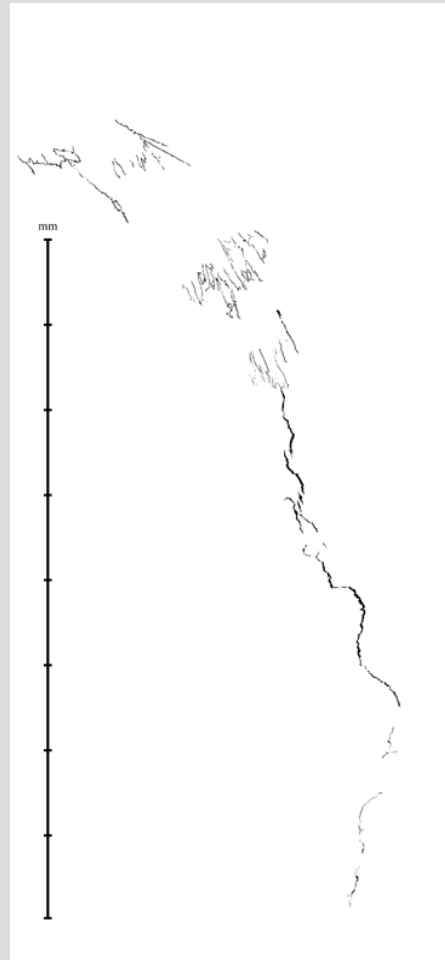
SEM of Surface

Microscopy of Crack #2

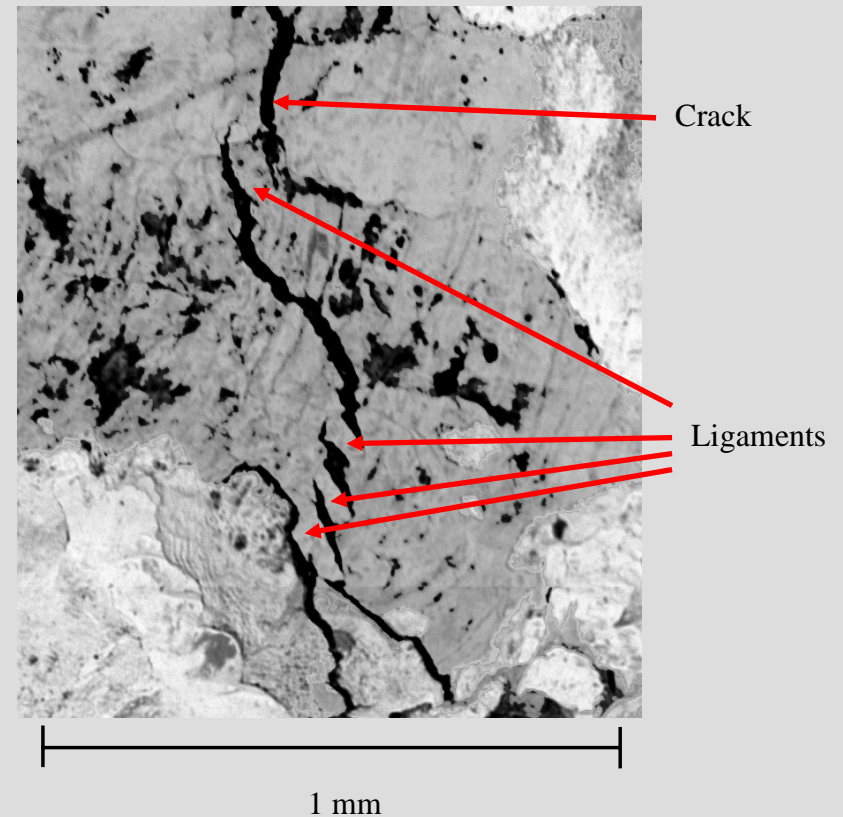
Expanded View of Through-Weld Crack

The through-weld crack has ligaments of metal crossing the crack in several places

The meandering nature of the crack below the surface also allows for electrical contact between the crack faces.

This electrical contact between the crack faces is likely responsible for the reduced ET response.

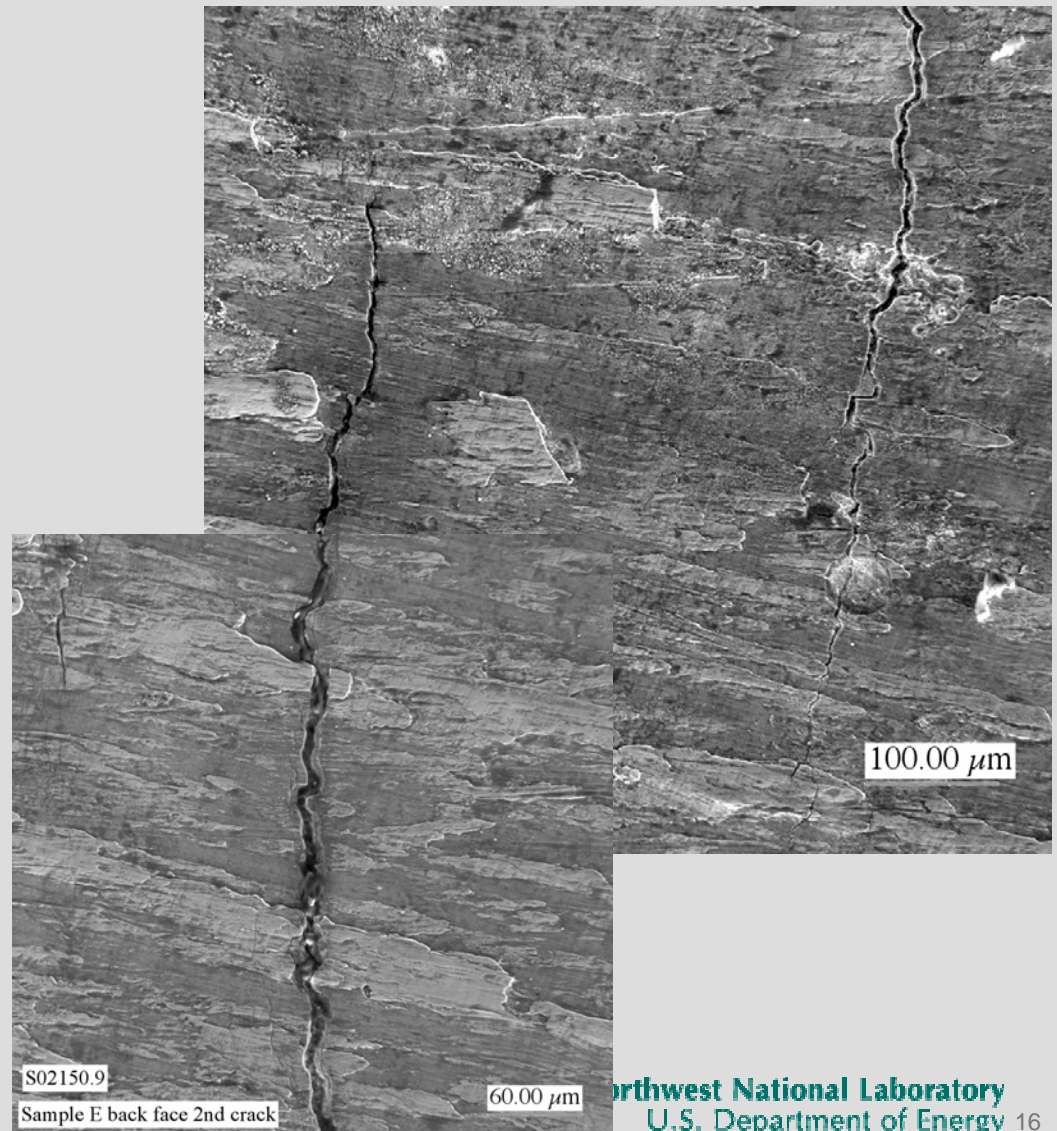
Exit Point into Annulus

The crack was tracked from the wetted surface to the annulus.
