UNITED STATES
NUCLEAR REGULATORY COMMISSION

SUBJECT: NRC INSPECTION REPORT NO. 70-143/2006-006

SUBJECT: SPECIAL INSPECTION TEAM CHARTER FOR NUCLEAR FUEL
SERVICES (NFS) - DOCKET NO. 70-143 (INSPECTION REPORT
NUMBER 70-143/2006-006)

Nuclear Fuel Services, Inc.
NRC Inspection Report 70-143/2006-006

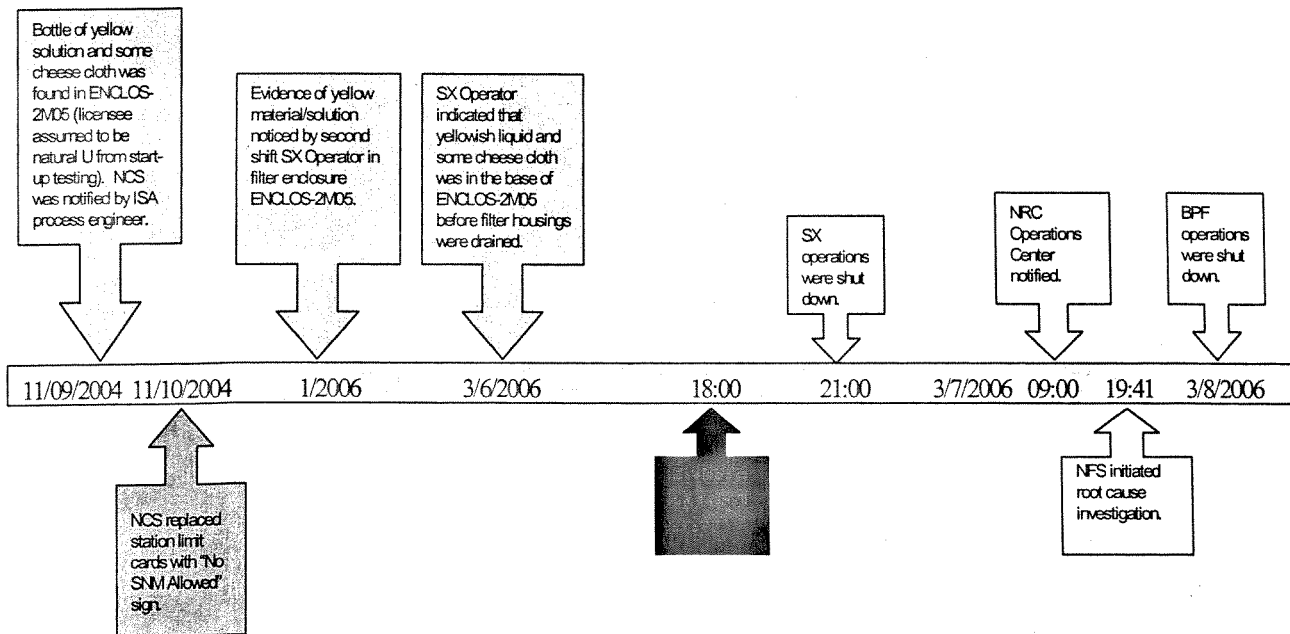
The inspectors noted that there were three previous occasions where either a small amount of yellow solution or evidence of yellow solution was found in the enclosure (see Figure 1). The operators involved reported their observations to their supervisor. The personnel involved thought the material was depleted uranium solution from start-up testing. None of the observed events were reported in the licensee's problem identification, resolution, and correction system (PIRCS).

Figure 1: Event time line showing three previous occasions where either a small amount yellow solution or evidence of yellow solution was found in the bag filter enclosure (ENCLOS-2M05).

The inspectors identified three examples, prior to the event, where yellow solution was found in the 2M05 enclosure. Since the enclosure was not approved for use, the presence of yellow solution, possibly uranyl nitrate, was not authorized. In two cases, area supervision was notified, but the issue was not entered into the PIRCS system for formal safety review and was not reported to the Nuclear Criticality Safety function as required by NFS-HS-CL-26. As such, the inspectors concluded that the less-than-rigorous followup to the discovery of yellow solution in three different instances represented lost opportunities to possibly identify and correct the problem before the March 6 spill. The failure to report the events concerning the yellow solution in the 2M05 enclosure in accordance with the requirements of Section 5.1 of NFS-GH-65 is identified as an apparent violation (APV 70-143/2006-006-08).

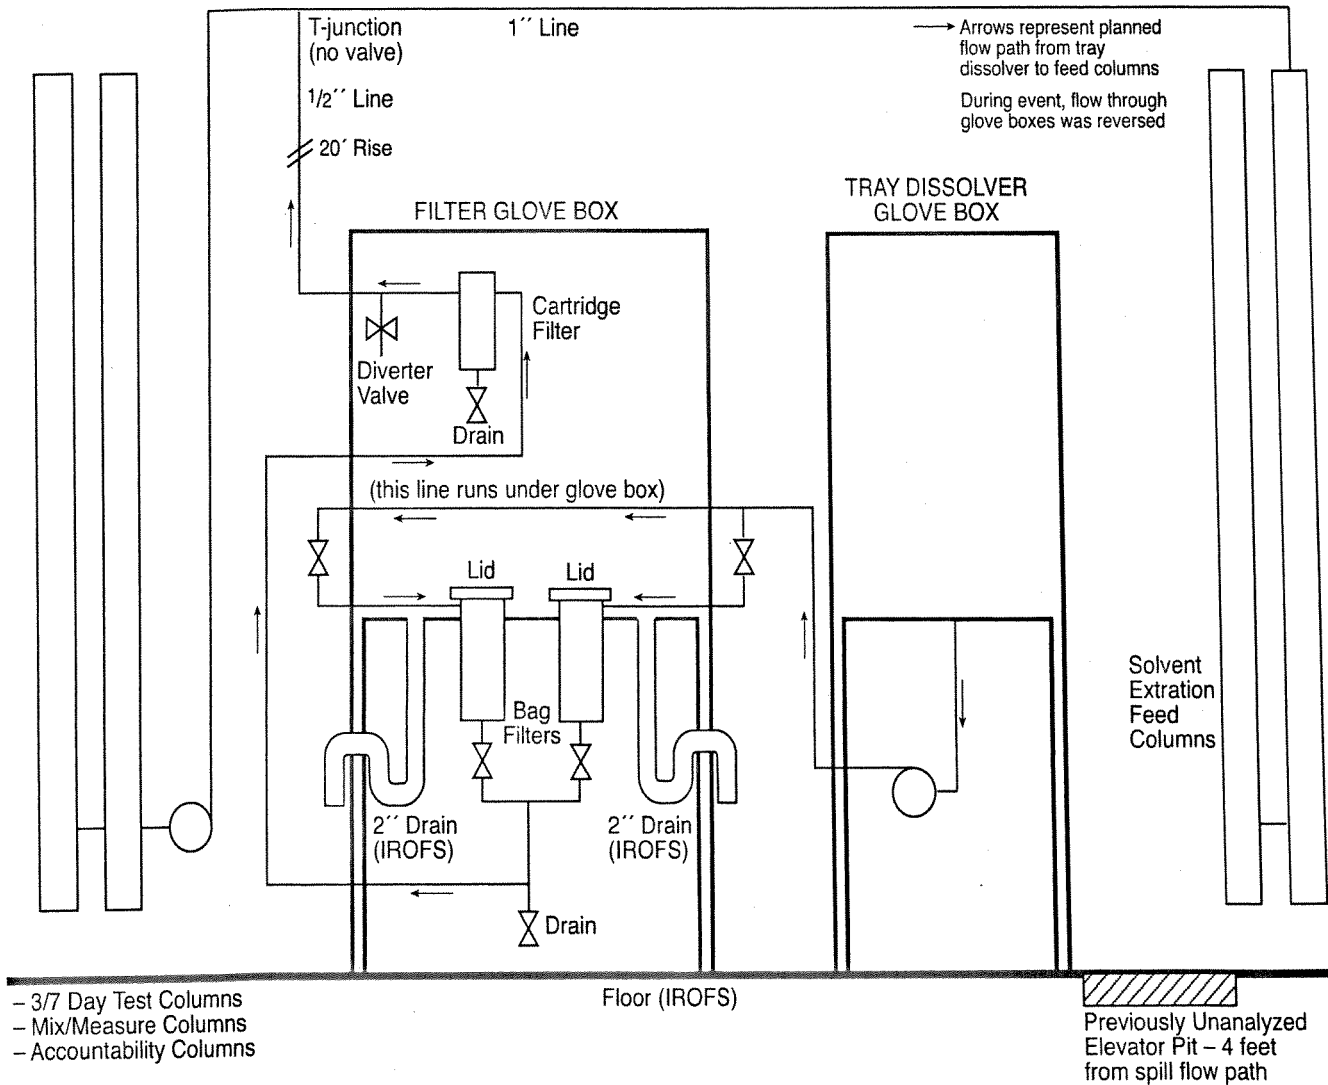
Figure 3: Tray Dissolver and Filter Enclosure Equipment Layout

The inspectors noted that the tray dissolver filter enclosure was installed without isolation valves and was connected to fissile process lines, utilities, and ventilation as if the tray dissolver system was in service and would therefore be required to meet the performance requirement of 10 CFR 70.61(d) for accident sequences leading to criticality due to handling fissile material with the tray dissolver equipment. The inspectors determined that because management measures were not implemented for the enclosure drain system, the enclosure did not meet performance requirements for criticality safety relative to accumulation of fissile material in the enclosure or on the floor of the solvent extraction room. Failure to meet the performance requirements of 10 CFR 70.61(d) for accident sequences related to handling fissile material in the tray dissolver system is identified as an apparent violation **(APV 70-143/2006-006-03)**. The inspectors reviewed similar filter enclosures in the plant and observed that they had isolation valves on both sides and an uninterrupted transfer line to the discharge point. No generic issue was identified relative to similar enclosures and equipment in the facility.

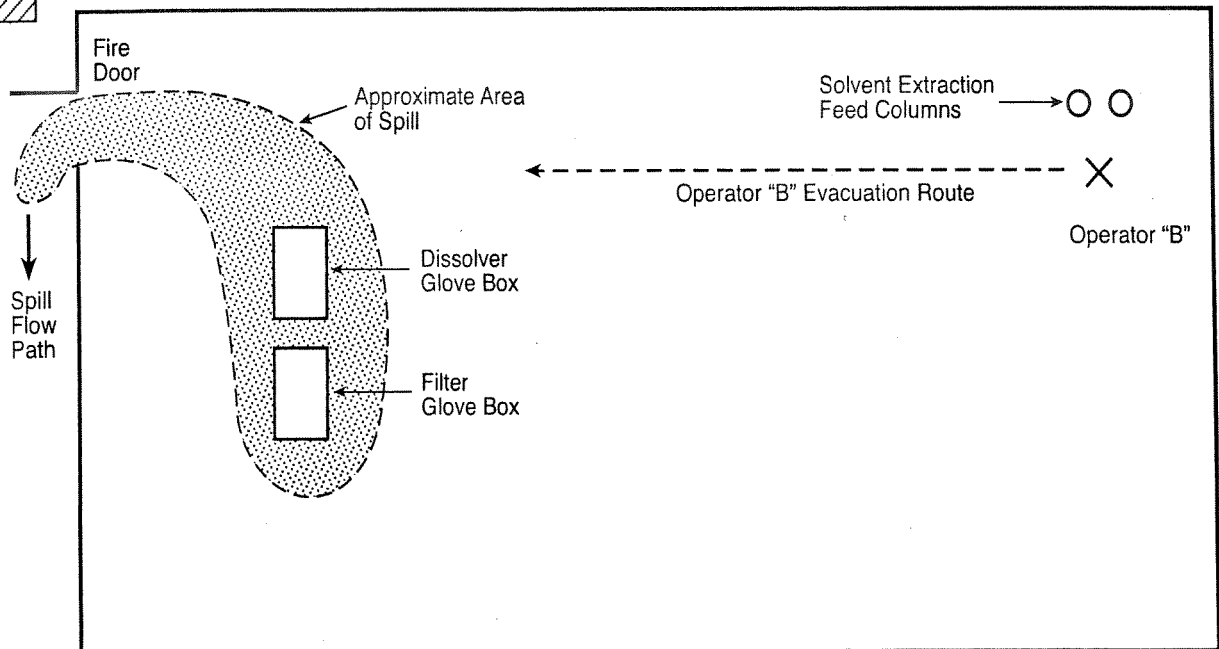
BPF Solvent Extraction Layout

The licensee identified that the floor of the solvent extraction room was compromised by an elevator pit that was not considered in previous analysis of the facility floor. The inspectors analyzed the elevator pit to determine how much solution would be required for a critical system. The inspectors performed the analysis using KENO IVa and used a model involving a nominal reflection condition on top of the fissile slab. The inspectors determined that a slab of the spilled solution in the shape of the elevator pit with full reflection on the sides and bottom and nominal reflection on the top will become critical at 8 centimeters (3.15 inches) with a volume of 100 liters (26.4 gallons).
