# James A. FitzPatrick Nuclear Power Plant

**ACRS License Renewal Subcommittee Presentation  
September 5, 2007**

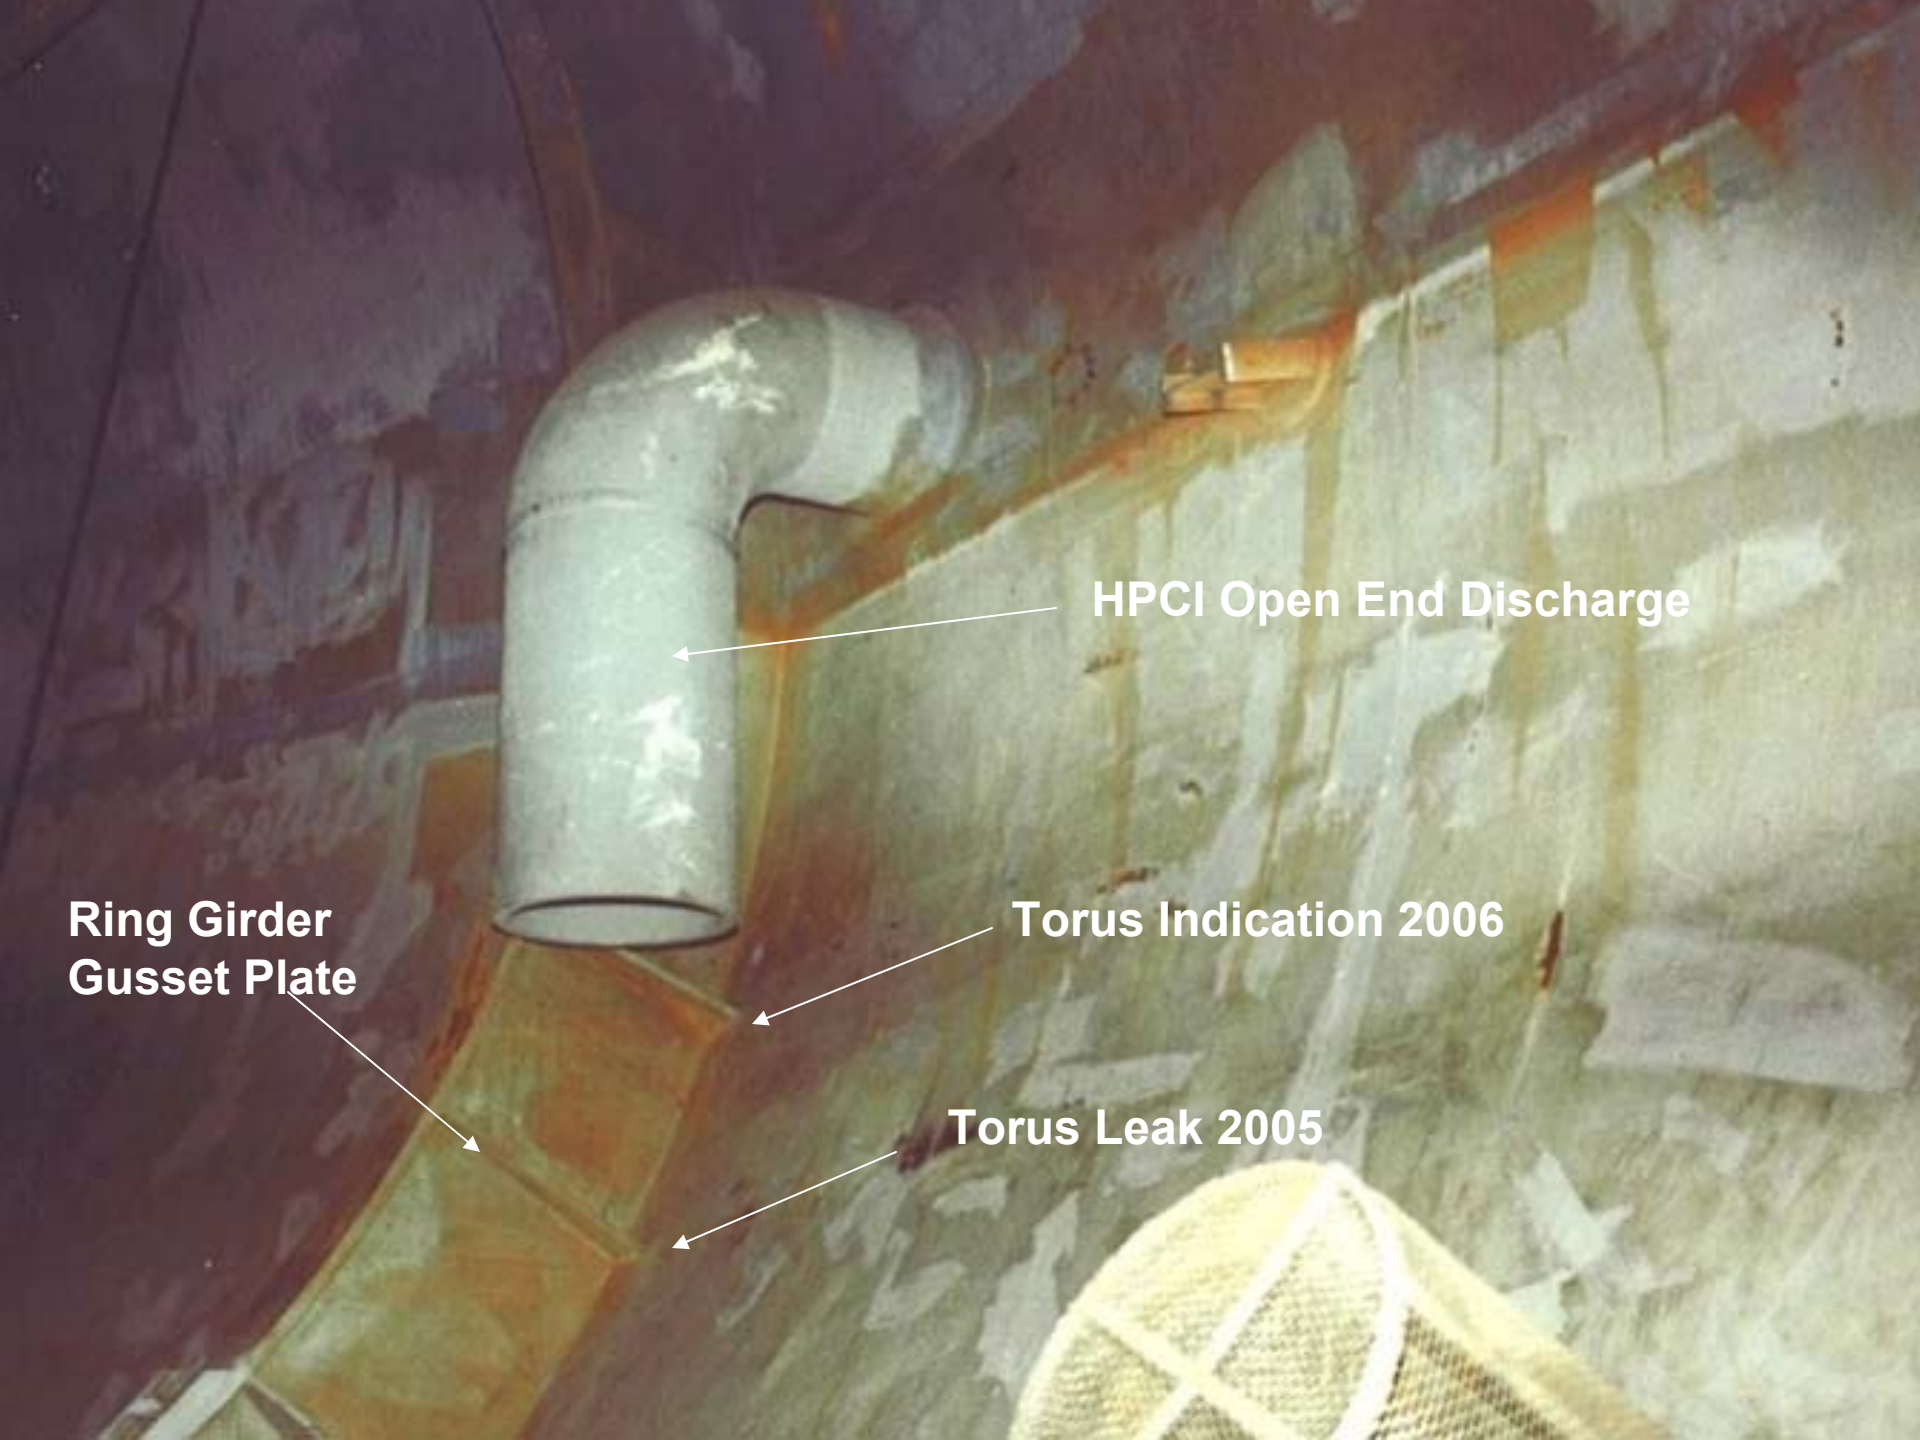
- Torus shell through-wall leak reported in June 2005
- Leak was located in same bay as HPCI Steam Discharge pipe near ring girder gusset plate weld
- ASME Section XI code repair performed in July 2005 by removing the flaw and adding a circular repair plate
- Root cause of flaw was vibration fatigue from HPCI steam condensation oscillation loading

HPCI Open End Discharge

Ring Girder  
Gusset Plate

Torus Indication 2006

Torus Leak 2005

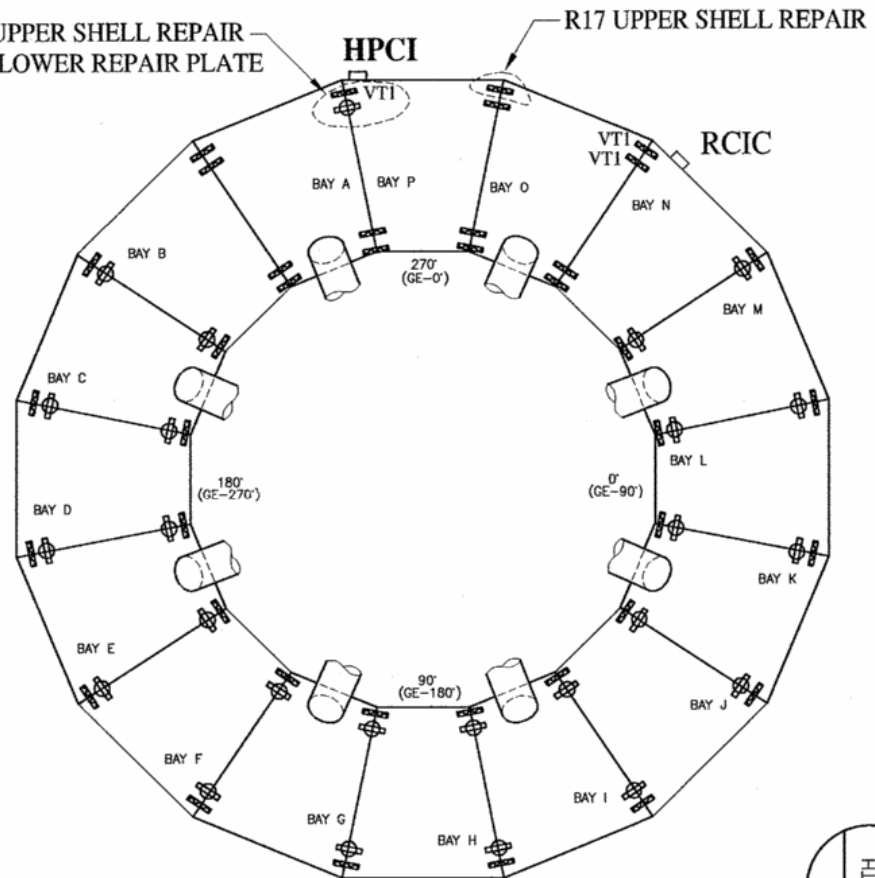
**TORUS PLAN VIEW**

- Extent of condition actions from Root Cause required additional shell exams during refueling outage October 2006
- ASME visual exams of similar ring girder gusset welds performed at HPCI and RCIC steam discharge locations
- General visual exams of similar ring girder gusset welds performed at several locations throughout the Torus
- Exam results reported shell base metal flaws at two additional locations in the HPCI discharge bay

R17 UPPER SHELL REPAIR  
2005 LOWER REPAIR PLATE

- ASME Section XI code repairs were performed by grinding to remove the flaws and welding to restore configuration
- Review was performed to confirm the HPCI steam discharge loading also caused these flaws
