UNITED STATES
NUCLEAR REGULATORY COMMISSION
OFFICE OF INSPECTION AND ENFORCEMENT
WASHINGTON, D.C. 20555

June 25, 1979

IE Bulletin No. 79-13

CRACKING IN FEEDWATER SYSTEM PIPING

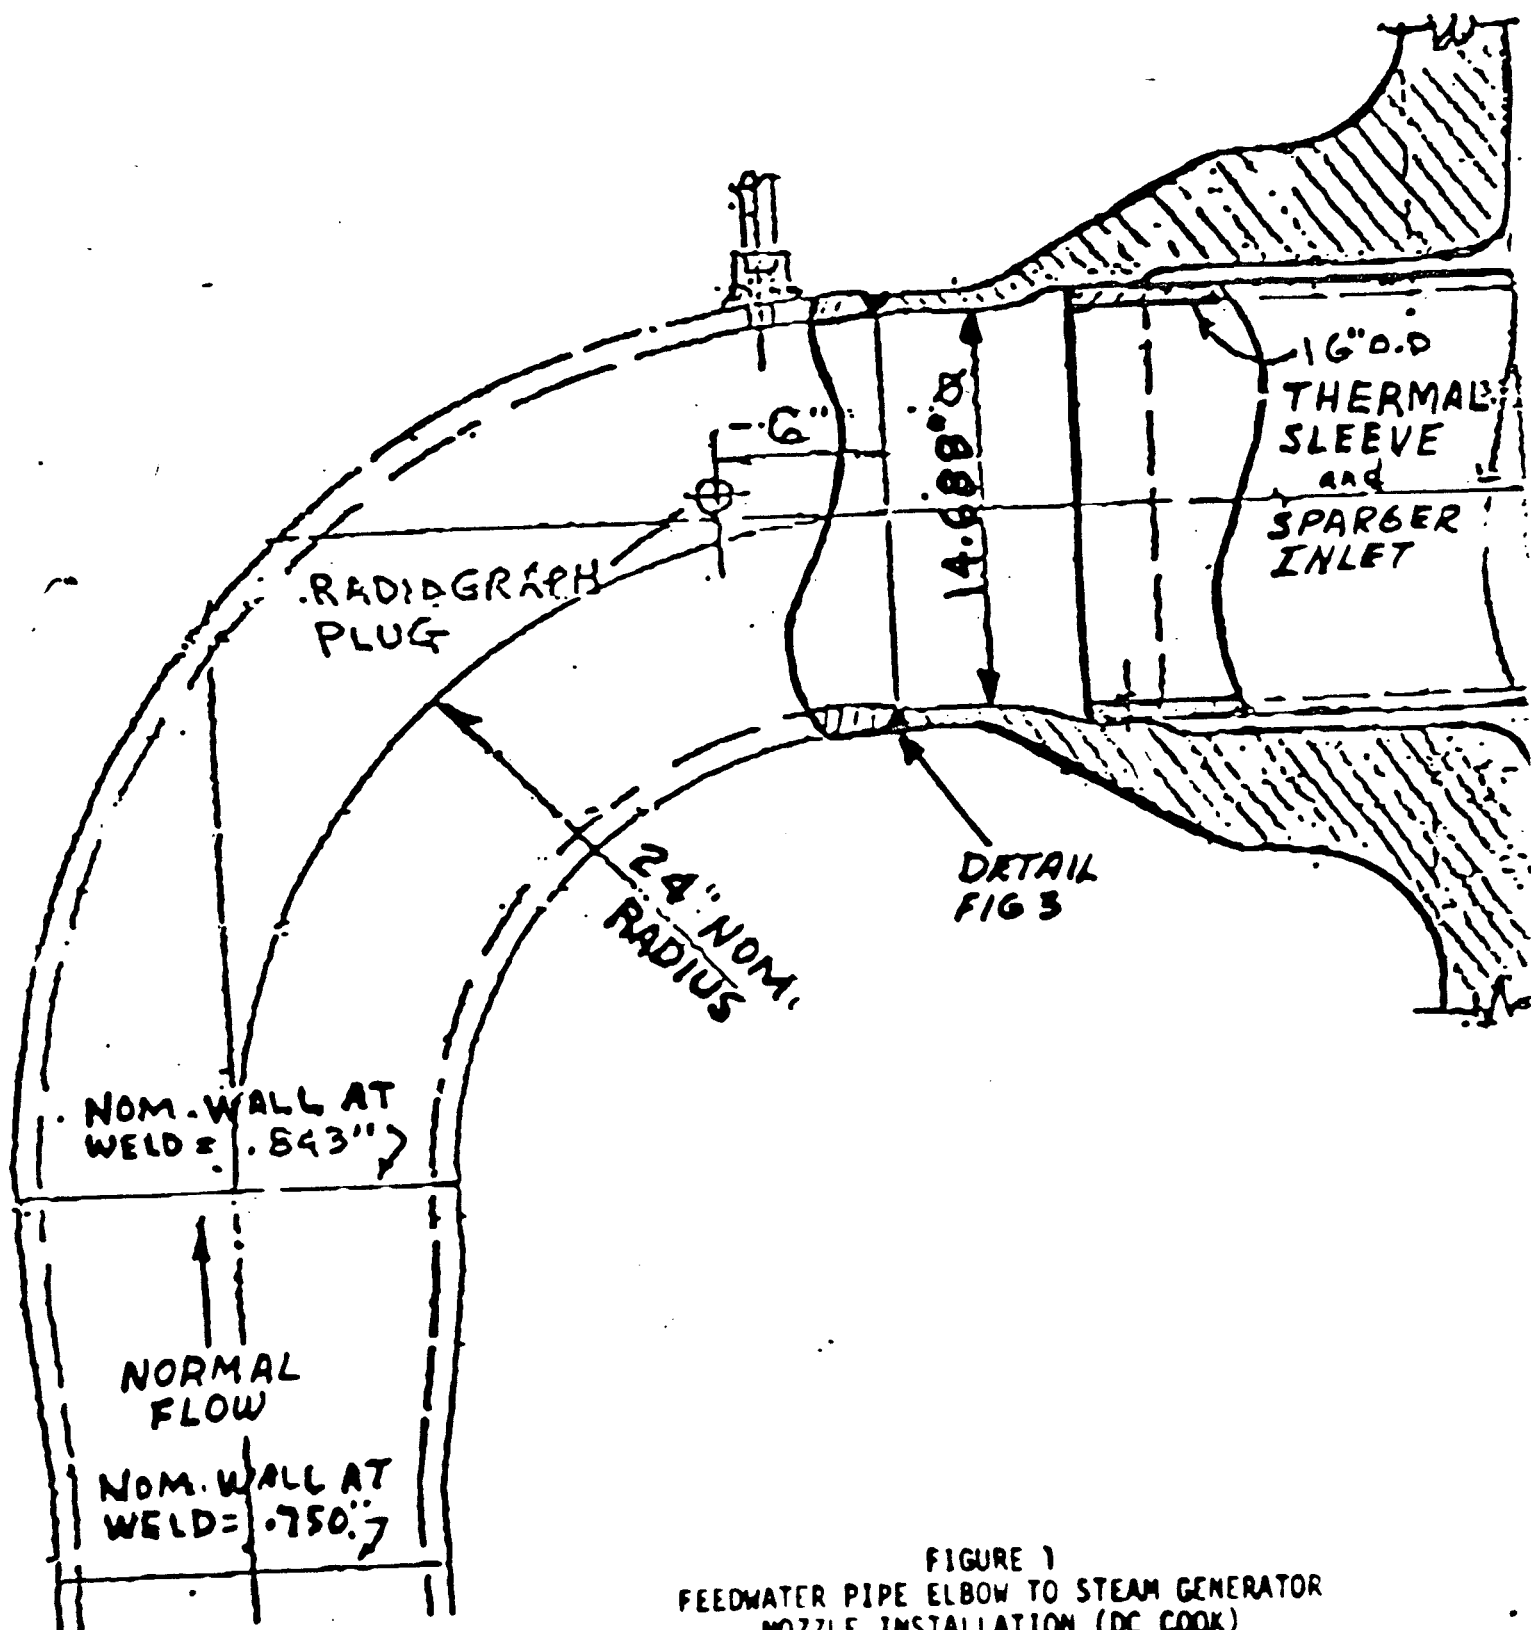
FIGURE 1
FEEDWATER PIPE ELBOW TO STEAM GENERATOR
NOZZLE INSTALLATION (DC COOK)

On May 20, 1979, Indiana and Michigan Power Company notified the NRC of cracking in two feedwater lines at their D. C. Cook Unit 2 facility. The cracking was discovered following a shutdown on May 19 to investigate leakage inside containment. Leaking circumferential cracks were identified in the 16-inch feedwater elbows adjacent to two steam generator nozzle elbow welds. Subsequent radiographic examination revealed crack indications in all eight steam generator feedwater lines at this location on both Units 1 and 2.

Cracked weldments have been removed from the D. C. Cook Units 1 and 2 and San Onofre Unit 1 feedwater systems for extensive metallurgical investigation by Westinghouse. Based on preliminary analysis, Westinghouse stated the D. C. Cook failure may be "fatigue assisted by corrosion." The San Onofre cracking was stated to be characteristic of "stress assisted corrosion."

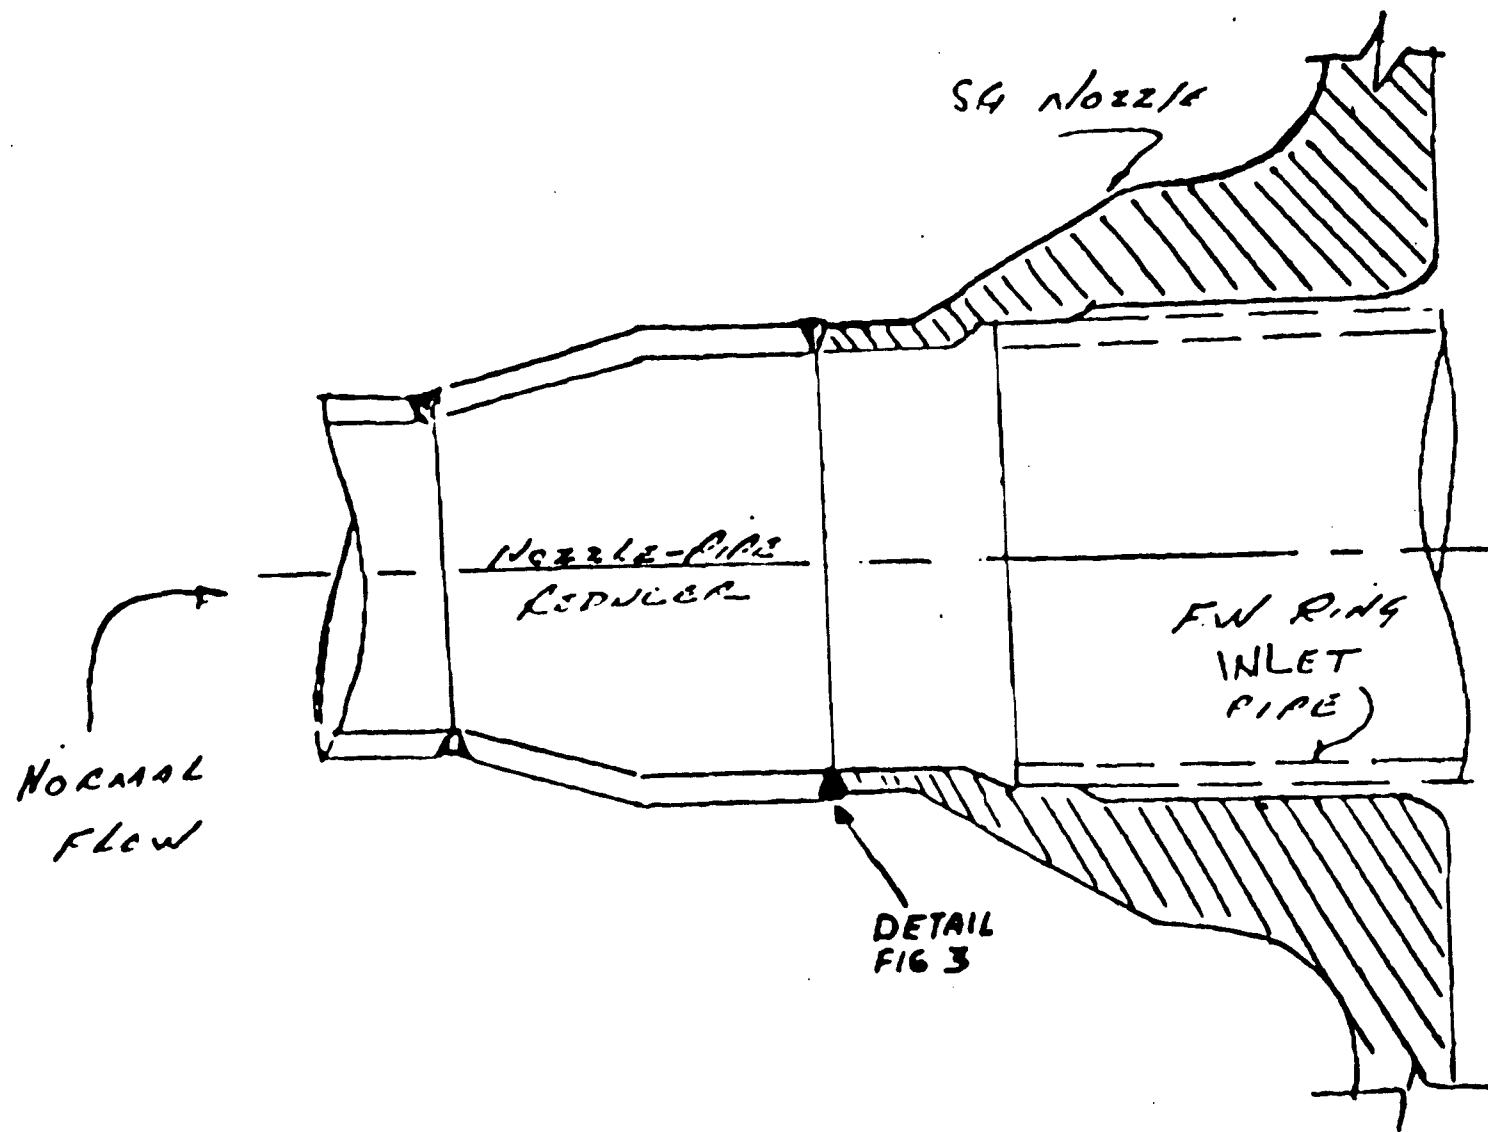
FIGURE 2
FEEDWATER PIPE REDUCER TO STEAM GENERATOR
NOZZLE INSTALLATION (SAN ONOFRE)

As a result of these actions, several other licensees with Westinghouse steam generators reported crack indications. Southern California Edison reported on June 5, 1979, that radiographic examination revealed indications of cracking in feedwater nozzle-to-piping welds on two of three steam generators of San Onofre Unit 1. On June 15, 1979, Carolina Power and Light reported that radiography showed crack indications in similar locations at their H. B. Robinson Unit 2. Duquesne Power and Light confirmed on June 18, 1979, that radiography has shown cracking in their Beaver Valley Unit 1 feedwater piping to vessel nozzle weld. Public Service Electric and Gas Company reported on June 20, 1979 that Salem Unit 1 also has crack indications. Wisconsin Public Service company decided on June 20, 1979 to cut out a feedwater nozzle-to-pipe weld which contained questionable indication, for metallurgical examination. As of June 22, 1979 and since May 25, 1979 seven other PWR facilities have inspected the feedwater nozzle-to-pipe welds without finding cracking indications.

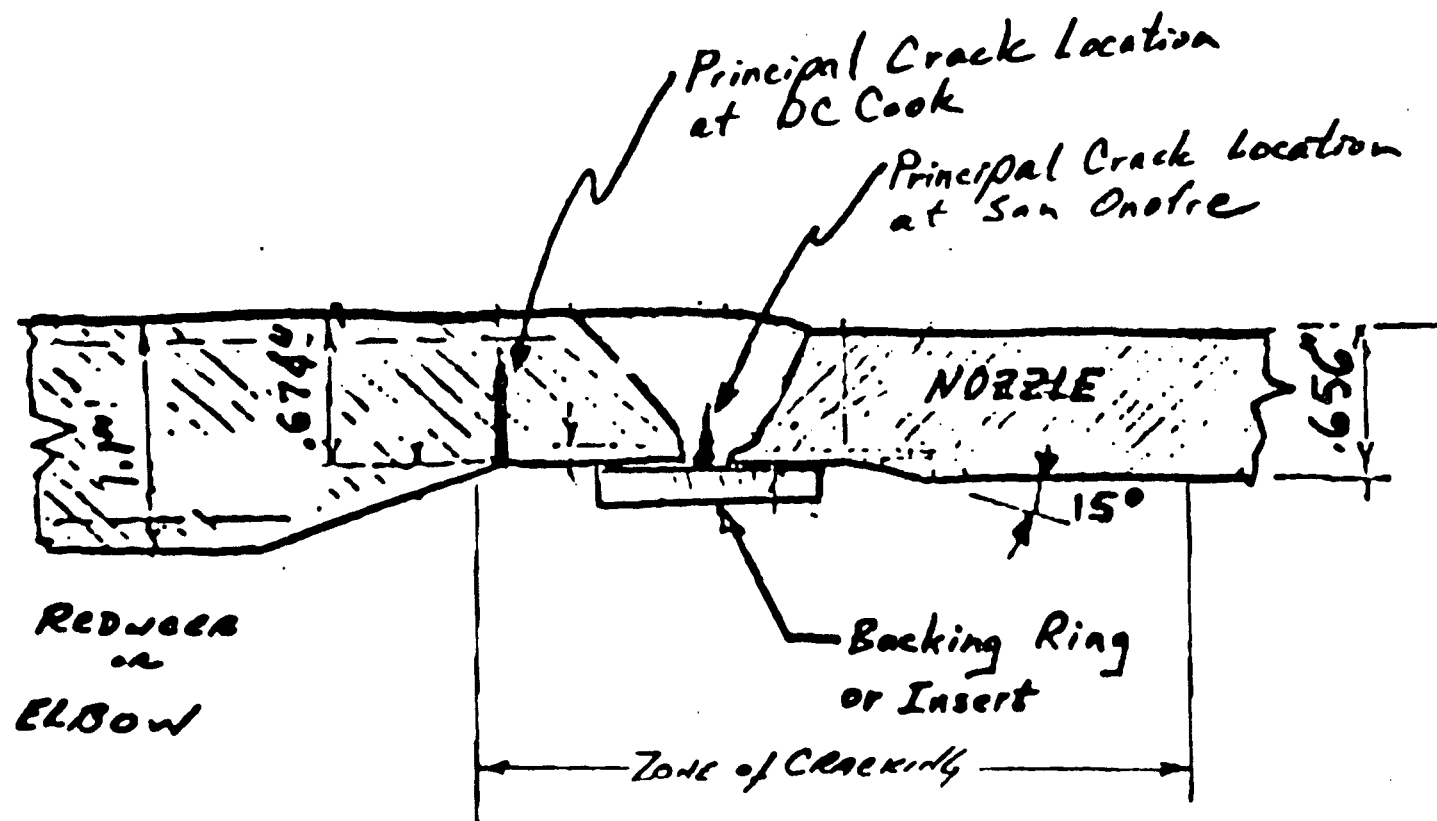
FIGURE 3
TYPICAL FEEDWATER PIPE TO NOZZLE
WELD JOINT DETAIL
(W , CE)

The feedwater nozzle-to-pipe configurations for D.C. Cook and for San Onofre are shown on the attached figures 1 and 2. A typical feedwater pipe-to-nozzle weld joint detail showing the principal crack locations for D.C. Cook and San Onofre are shown on the attached figure 3.

1. Facilities which have steam generators fabricated by Westinghouse or Combustion Engineering that have not conducted volumetric examination of feedwater nozzles since May 1979 shall complete the inspection program described below at the earliest practical time but no later than 90 days after the date of this Bulletin.
 - a. Perform radiographic examination, supplemented by ultrasonic examination as necessary to evaluate indications, of all feedwater nozzle-to-piping welds and of adjacent pipe and nozzle areas (a distance equal to at least two wall thicknesses). Evaluation shall be in accordance with ASME Section III, Subsection NC, Article NC-5000. Radiography shall be performed to the 2T penetrometer sensitivity level, in lieu of Table NC-5111-1, with systems void of water.
