NRC Activities Regarding Recent Japanese Earthquake

Mary Jane Ross-Lee, Nuclear Engineer
Office of Nuclear Reactor Regulation

September 6, 2007

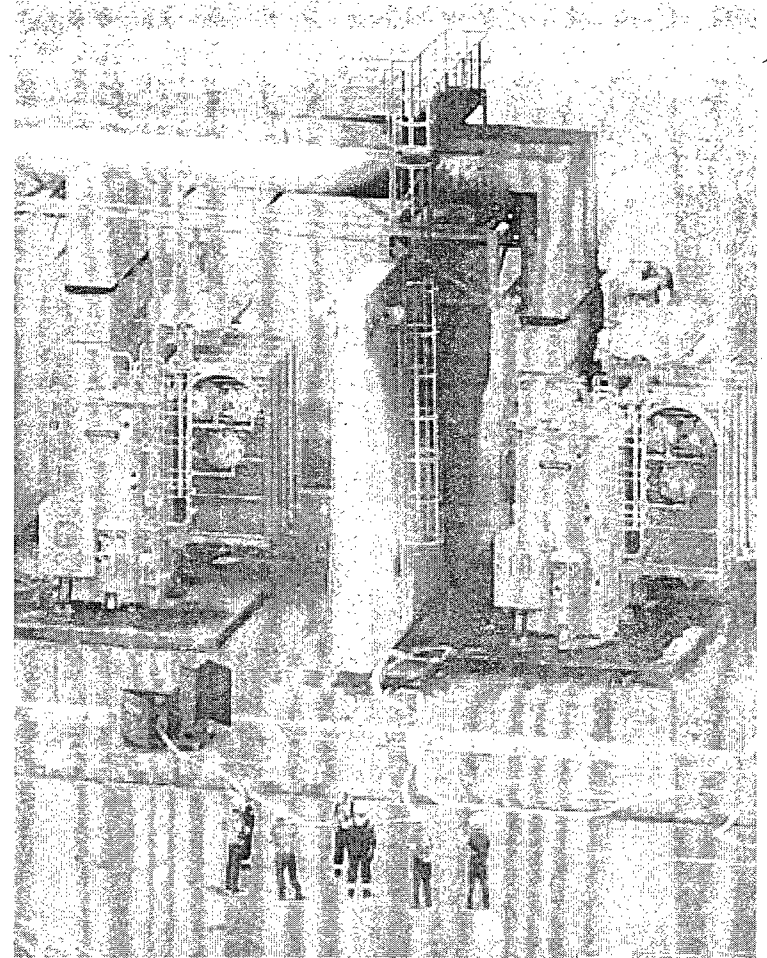
Auxiliary Transformer Fire

- Fire in Unit 3 auxiliary transformer.
- Fire extinguished in ~2 hours after quake
- Fire had no impact on radiological safety and no impact to the public.

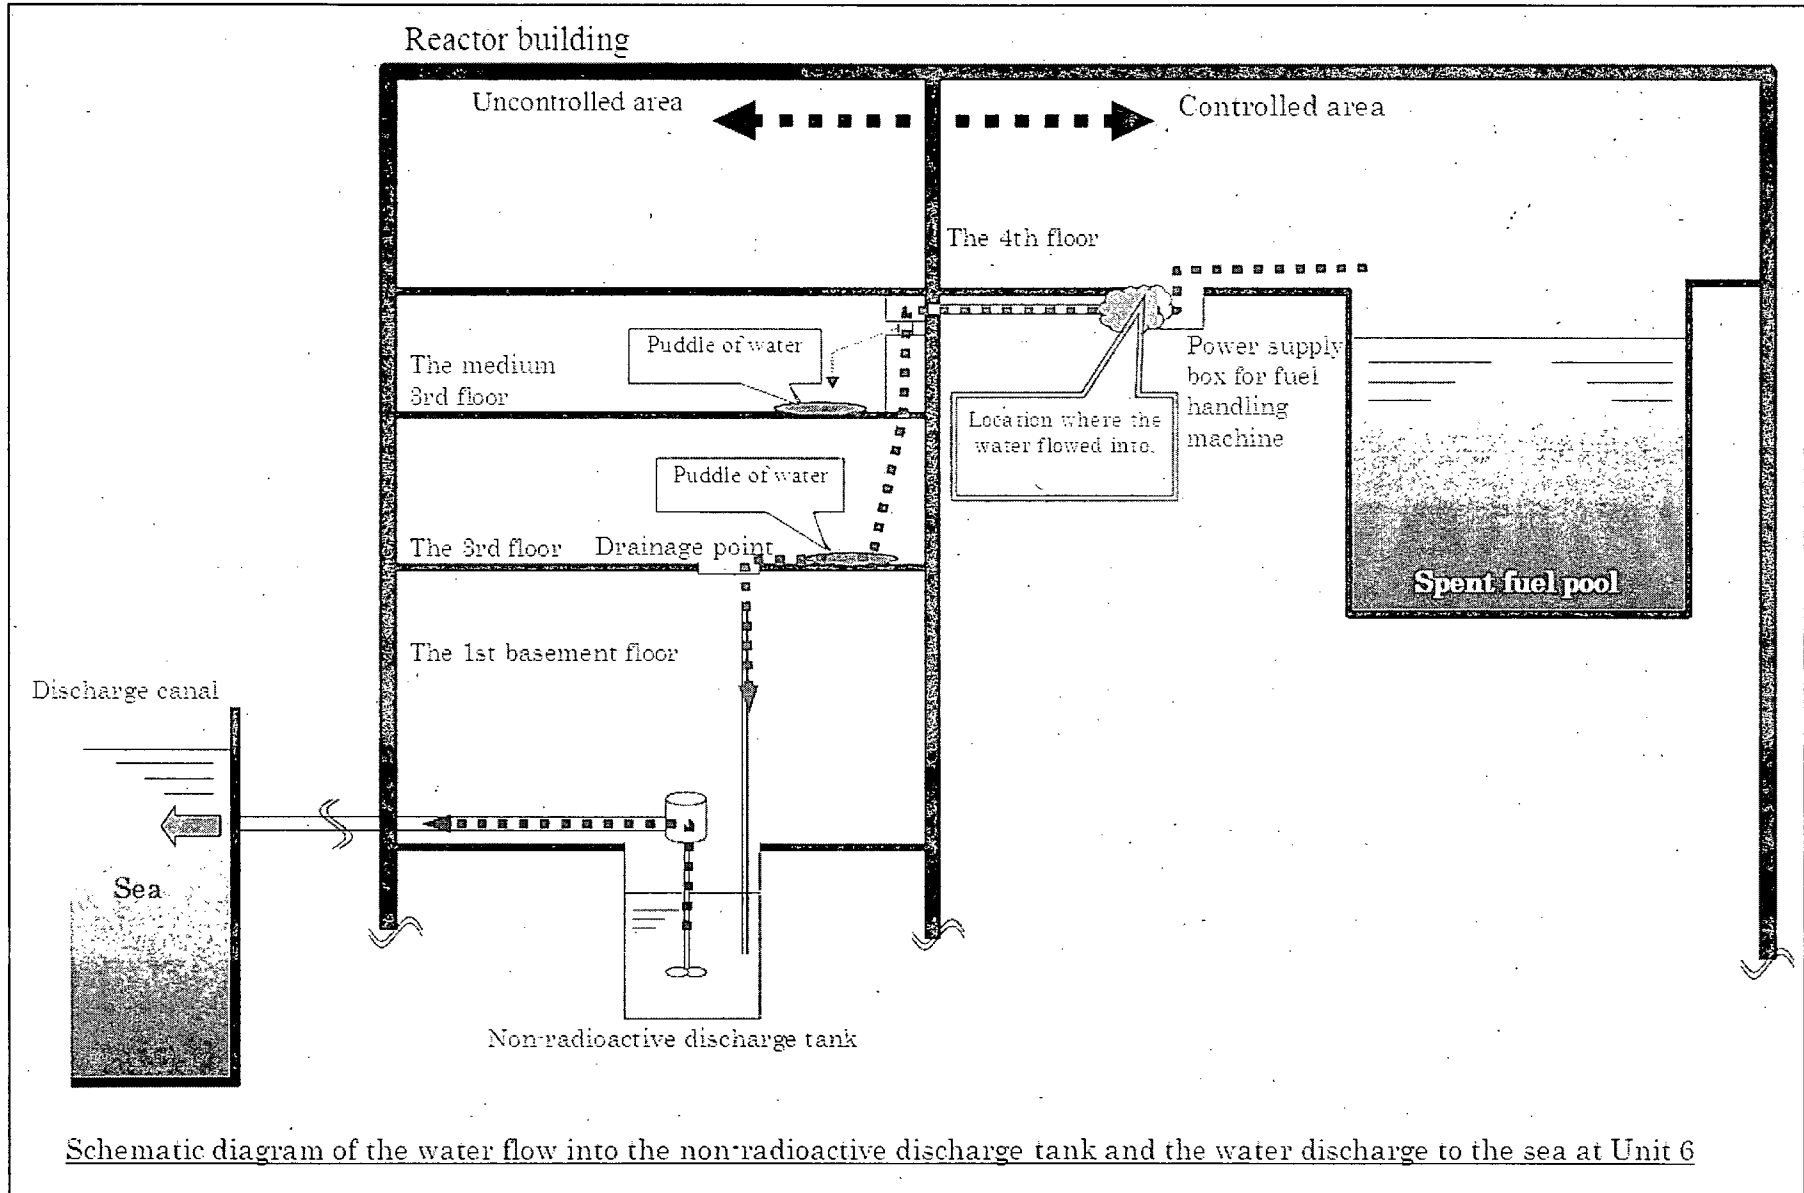
Liquid Radiological Release Flowpath

- Approximately 317 gallons of water discharged into Sea of Japan after leaking through floor
- Radioactive iodine and other radioactive particulate matter found only at the Unit 7 ventilation stack.
- Total amount of radioactivity released very low (estimated dose to public less than 1 millionth of annual limit).
- No impact on public health and safety.

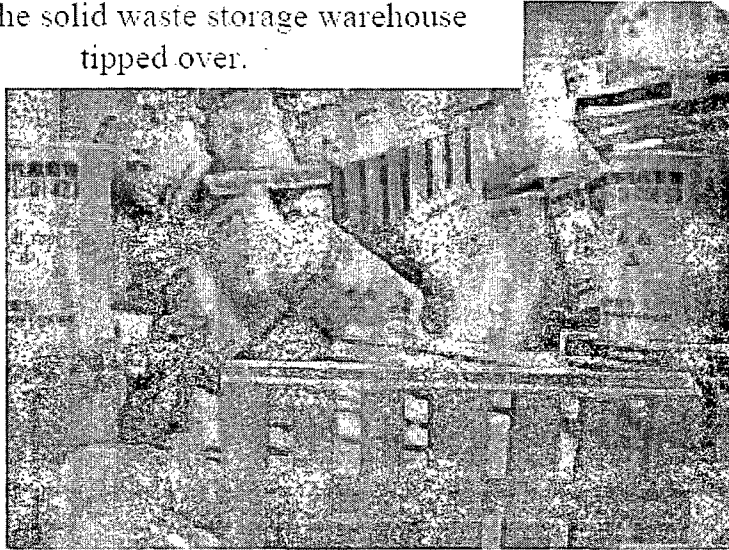
Several hundred drums containing low-level waste in the solid waste storage warehouse tipped over.

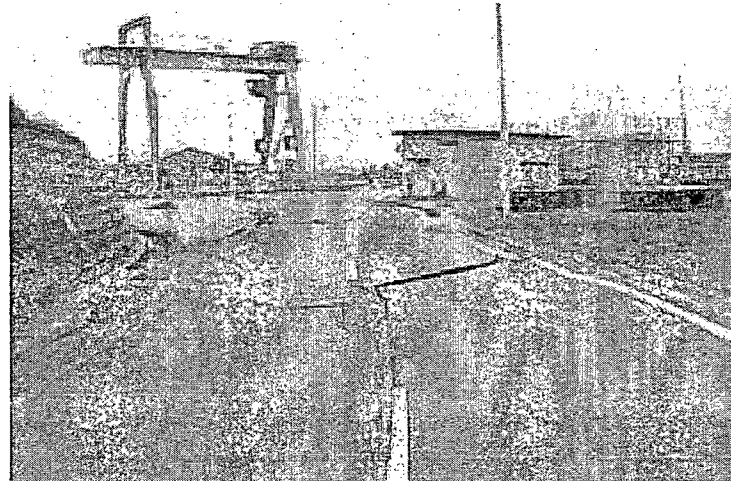
Access road in the site. (Close to the Unit 5 water discharge outlet.)

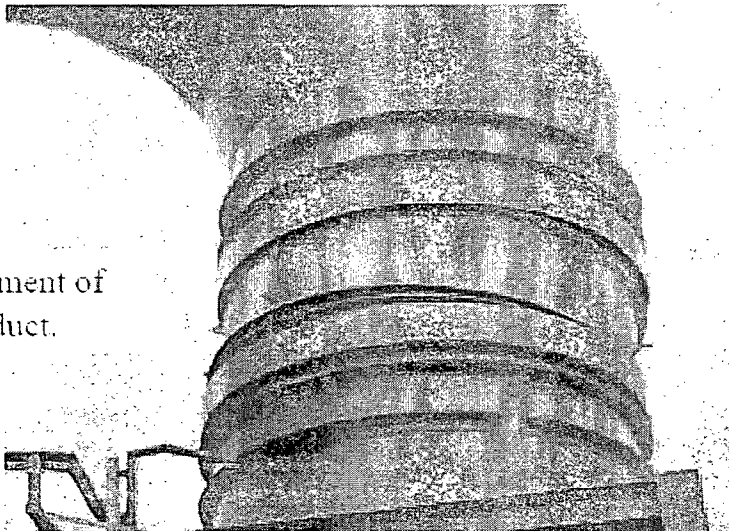
Displacement of exhaust duct.

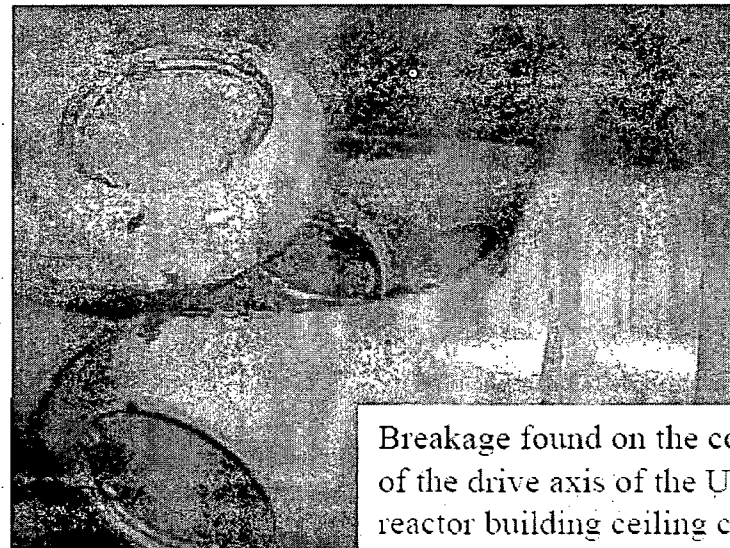
Breakage found on the coupling of the drive axis of the Unit 6 reactor building ceiling crane.
