EA-08-046

SUBJECT: BYRON STATION, UNITS 1 AND 2 SPECIAL INSPECTION - DEGRADATION OF THE ESSENTIAL SERVICE WATER RISER PIPING TO THE COOLING TOWER BASIN 05000454/2007009(DRS) AND 05000455/2007009(DRS) AND PRELIMINARY WHITE FINDING

IR 05000454/2007009(DRS) and 05000455/2007009(DRS); 10/23/2007 - 02/14/2008; Byron Station, Units 1 and 2; Special Inspection to evaluate the facts and circumstances surrounding the degradation of the essential service water riser piping to the cooling tower basin.

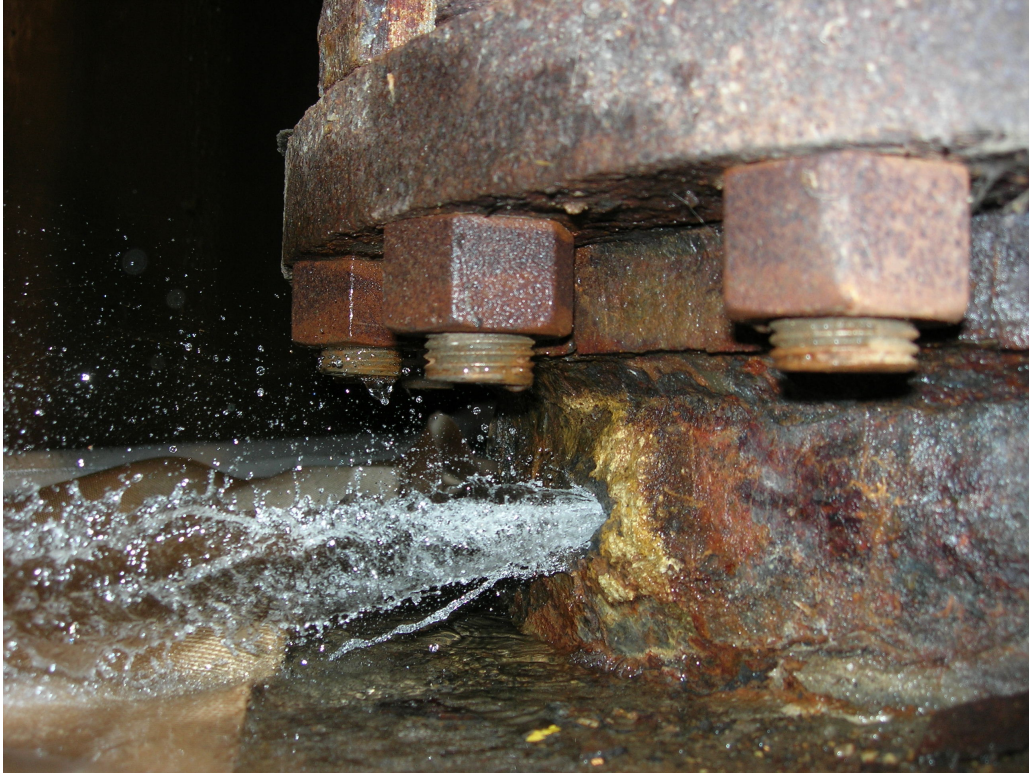
Picture No. 3 – 0C SX Riser Pipe- October 19, 2007

On October 19, 2007, during rust removal from the 0C essential service water riser pipe near valve 0SX163C, in preparation for pipe wall thickness measurements, a ½ inch diameter 10 gallon-per-minute leak occurred (Attachment 3, Picture No. 3). Because this section of pipe could not be isolated from other cells on the 0A essential service water cooling tower basin, the licensee declared the 0A tower of the ultimate heat sink inoperable, and shut down both Units due to entry into Technical Specification 3.7.9 (reference LER 2007-002-00). The riser pipe leak was caused by a loss of pipe wall thickness due to external corrosion induced by the wet environment surrounding the unprotected carbon steel pipe. The corrosion processes that caused this leak affected all eight similar locations on the essential service water riser pipes within vault enclosures and had occurred over many years. The NRC initiated a Special Inspection Team which consisted of Region III inspectors and a Region III Senior Reactor Analyst, with technical support from the Office of Nuclear Reactor Regulation staff. This team was chartered to evaluate the facts, circumstances, and licensee actions surrounding the degradation of the riser piping.

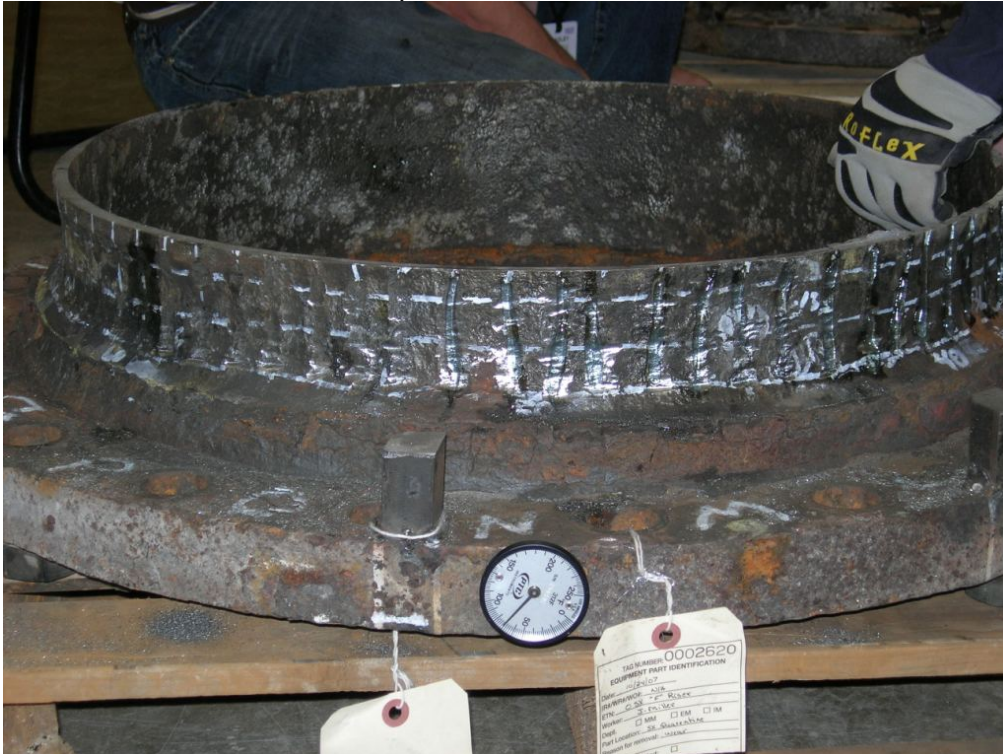
Picture No. 6 – 0F SX Riser Pipe Removed, Cleaned, with Grid- October 25, 2007

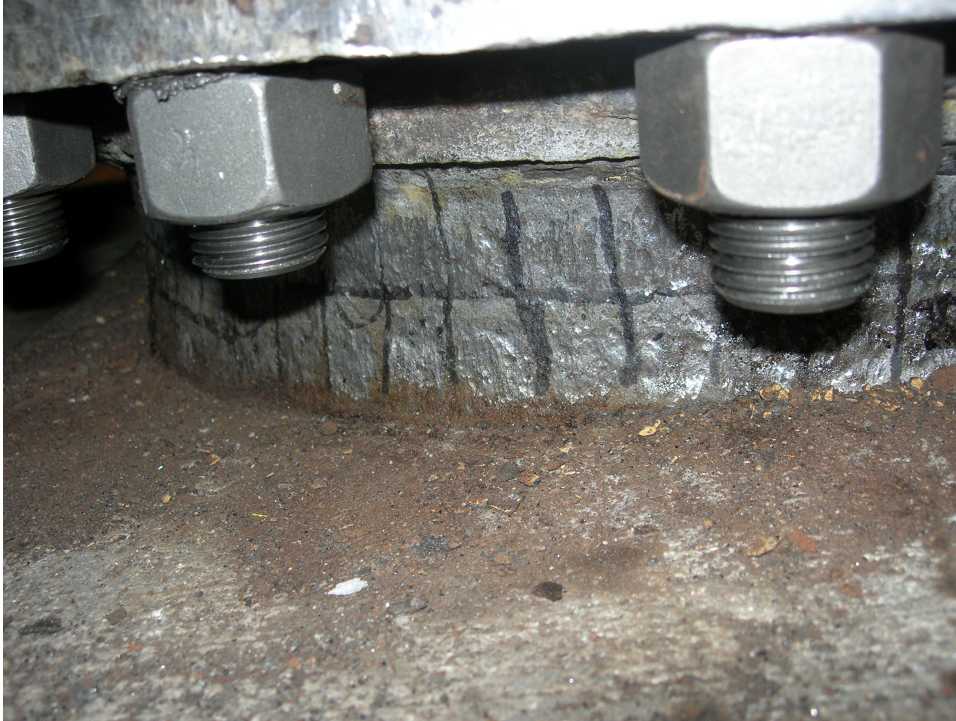
Picture No. 7 – 0D SX Riser Pipe- Cleaned with Grid - October 2007

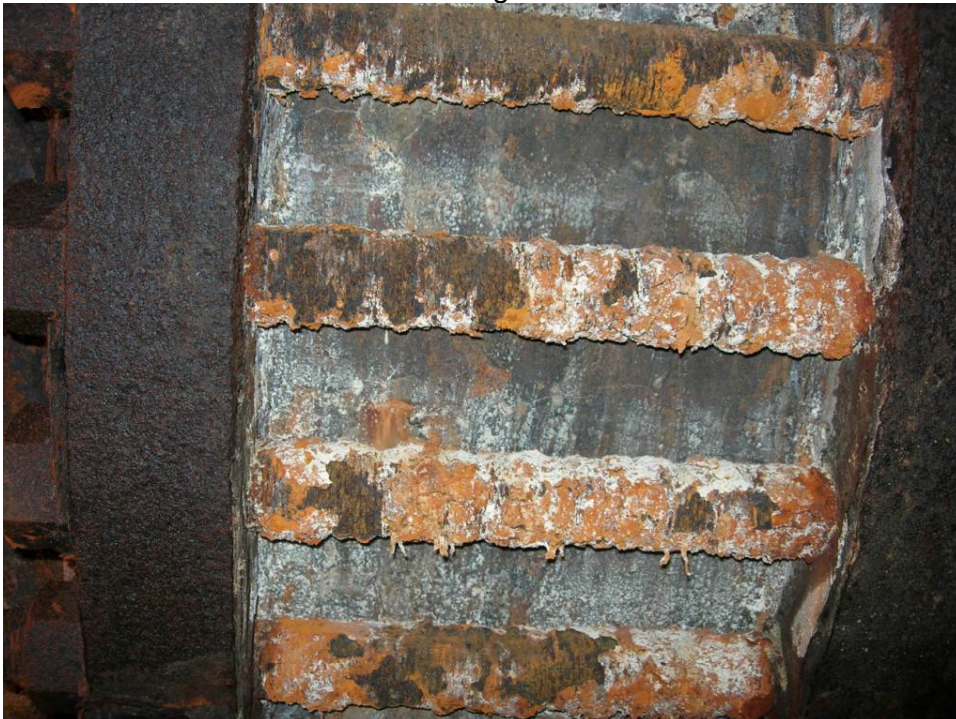
Picture No. 8– 0SX 138B Valve Bolting - October 2007

- **Green.** The team identified a finding of very low safety significance and a Non-Cited Violation of 10 CFR Part 50, Appendix B, Criterion XVI, "Corrective Action," for the licensee's failure to identify severely corroded bolts (condition adverse to quality) on the 0B SX basin suction supply isolation valve 0SX138B. The cause of this finding was related to the Corrective Action Program Component (Item P.1(a) of IMC 305) for the cross-cutting area of Problem Identification and Resolution, because the licensee staff failed to adopt an appropriate threshold for identifying issues. Specifically, the failure of the licensee VT-2 examiner to identify these degraded bolts was related to an excessively high threshold for problem identification. The licensee entered this issue into the corrective action program and replaced the bolts on the lower half of this valve which were subjected to the most severe corrosion.
