UNITED STATES
NUCLEAR REGULATORY COMMISSION
OFFICE OF NUCLEAR REACTOR REGULATION
WASHINGTON, D.C. 20555

December 22, 1992

NRC BULLETIN NO. 90-01, SUPPLEMENT 1: LOSS OF FILL-OIL IN TRANSMITTERS
MANUFACTURED BY ROSEMOUNT

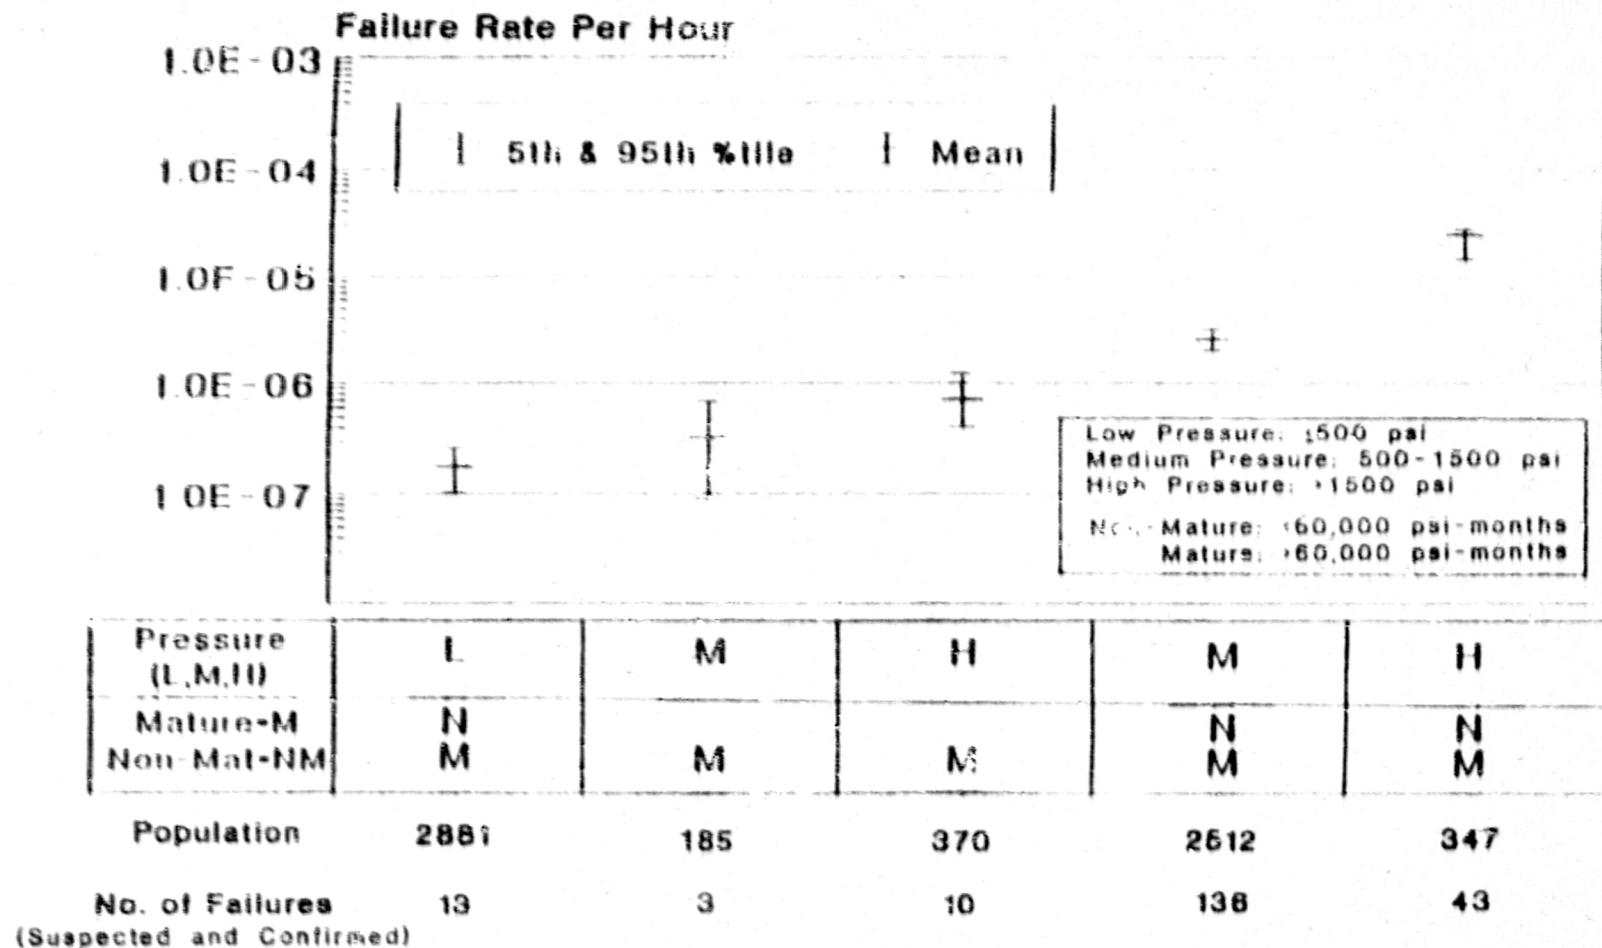
Figure 1. Rosemount Transmitter Failure Rates
(90% chi-squared confidence interval)

In evaluating this issue, the staff confirmed a relationship, as had been previously found by Rosemount and NUMARC, between operating pressure, time-in-service, and the suspect and nonsuspect lot classifications in identifying where the transmitters would most likely fail. A high operating pressure was the most dominant factor leading to a loss of fill-oil.

Second among these factors was time-in-service, with those transmitters having been in service for less than 60,000 psi months exhibiting higher failure rates than transmitters that had been in service for more than 60,000 psi months. Attachment 1 represents the staff estimates of Rosemount transmitter failure rates based on pressure application and the time in service derived from the NUMARC survey data.

Third among these factors was the classification of the lot as suspect or nonsuspect. All suspect lots as defined by Rosemount contained at least one confirmed failure and possibly more, depending on the size of the lot. However, many confirmed or suspected failures caused by a loss of fill-oil were identified in nonsuspect lots. If all other factors were assumed equal, suspect lots had higher failure rates than nonsuspect lots. When pressure application or time-in-service was considered, classification by suspect or nonsuspect lot was of lesser importance.
