Subject: **Docket No. 50-361**
Licensee Event Report No. 2008-006
San Onofre Nuclear Generating Station, Unit 2

1. FACILITY NAME				2. DOCKET NUMBER		3. PAGE	
San Onofre Nuclear Generating Station Unit 2				05000-361		1 OF 5	
4. TITLE							
Loose connection bolting results in Inoperable Battery and TS violation

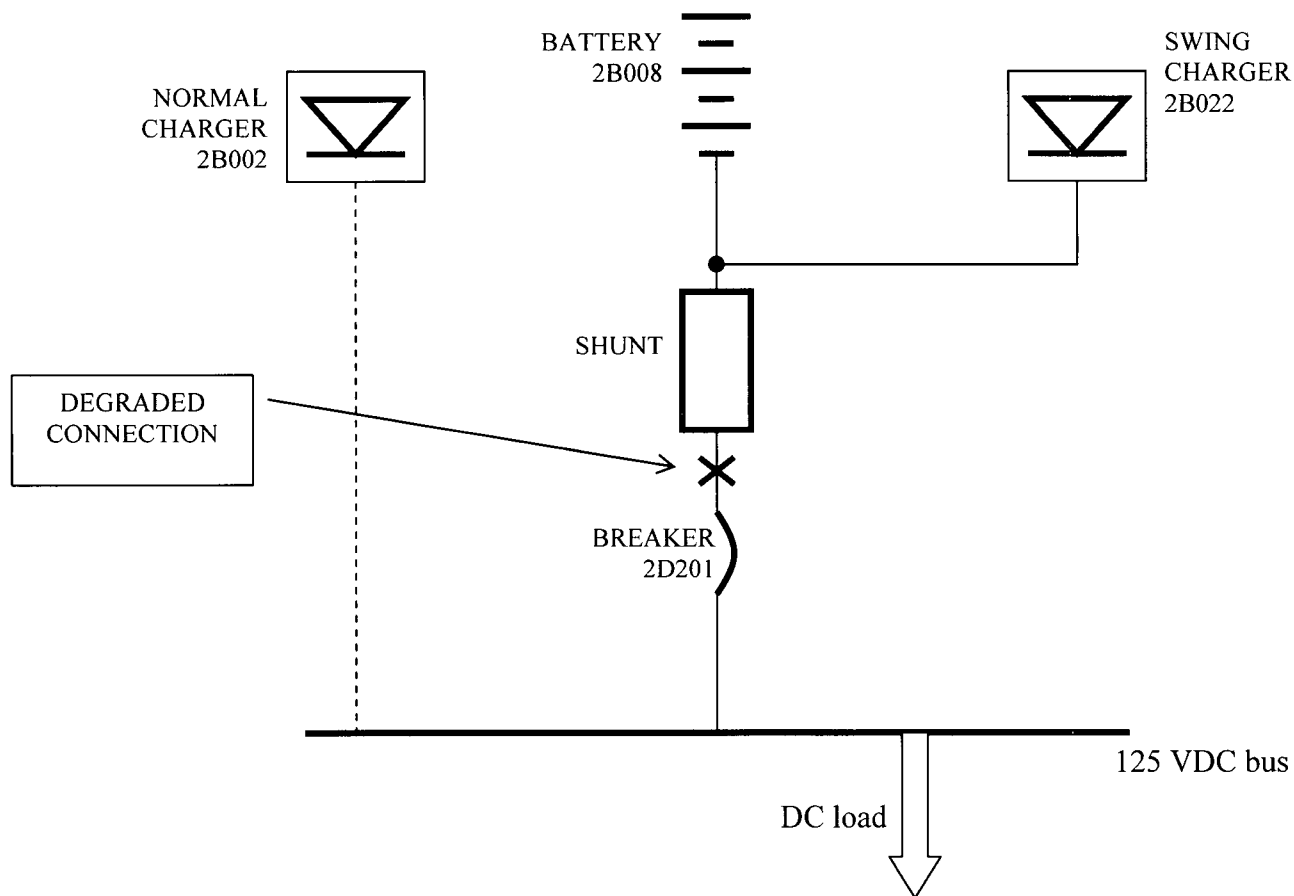
Figure: DC System Configuration

Technical Specification 3.8.4 requires Trains A, B, C and D electrical power subsystems to be operable in Modes 1 through 4. If one electrical subsystem is inoperable, Action A.1 requires restoration of the DC electrical power subsystem to operable status within 2 hours. If not completed within 2 hours, Action B requires Operators to place the plant in Mode 3 within 6 hours and Mode 5 within 36 hours. TS Surveillance Requirement 3.8.4.1 requires SCE to verify battery voltage is greater than or equal to 129 VDC once every 7 days. Technical Specification (TS) Surveillance Requirement (SR) 3.8.4.6 requires verification of each battery charger capability every 24 months. During this surveillance a swing charger is connected at the battery and supplies the DC bus through the same DC breaker. This allows isolation of the normal charger for testing (See attached figure).

On March 25, 2008 (Discovery Date), with Unit 2 at approximately 100 percent power, plant personnel began performance of the weekly surveillance (SR 3.8.4.1) of the Train B battery (2B008). The SR requires battery voltage to be greater than or equal to 129 VDC at the battery terminals. At about 0415 PDT, plant personnel discovered the battery voltage below the required value. Subsequently, while attempting to verify the low battery voltage reading, indications of a loose connection were observed on the bolt on the battery side of the breaker (2D201) that connects the battery to its DC bus (2D2) (See attached figure).
