Subject: Byron Station, Unit 2, 60-Day Response to First Revised NRC Order EA-03-009, "Issuance of First Revised NRC Order (EA-03-009) Establishing Interim Inspection Requirements for Reactor Pressure Vessel Heads at Pressurized Water Reactors"

**“Byron Generating Station Outage – B2R14  
Reactor Vessel Head Penetration Examination”**

# **Byron Generating Station Outage – B2R14 Reactor Vessel Head Penetration Examination**

**WDI-PJF-1303982-FSR-001**

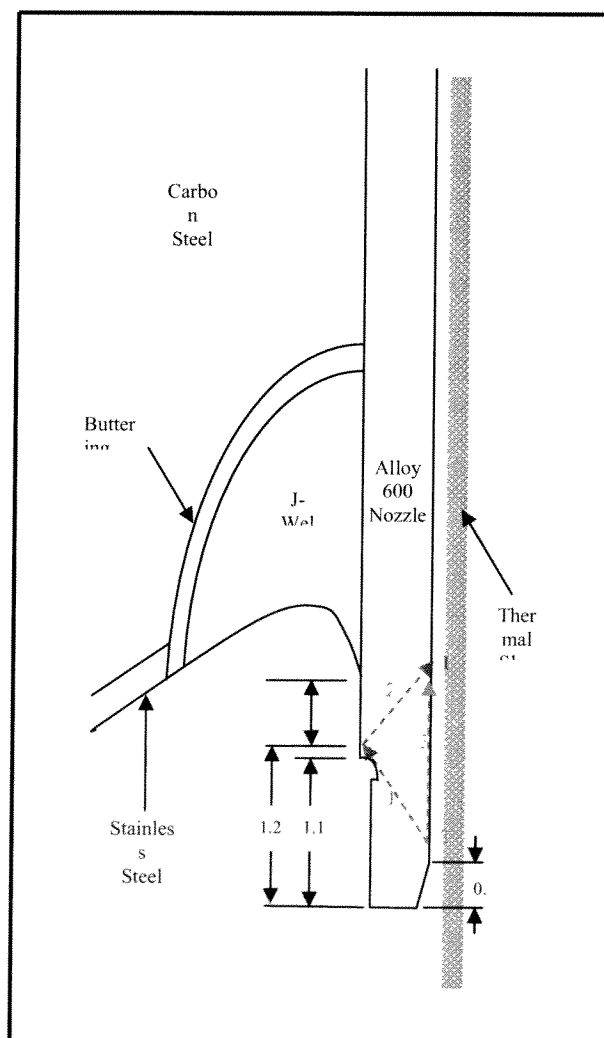
**Figure 4.1**  
**Byron Unit 2 Tube End Geometry**

The configuration of the Byron Unit 2 CRDM penetration tubes is shown in the figure 4.1 below. This figure represents the tube-to-head geometry on the “downhill” side of the tube ( $0^\circ$  location of the penetration). The bottom ends of all seventy-eight penetration tubes are threaded on the OD surface and have a  $20^\circ$  chamfer on the ID surface. The threads on the tube OD surfaces and chamfer on the ID surfaces represent geometric conditions which limit examination coverage near the bottoms of the tubes.

The coverage below the weld that was obtained during the B2R13 outage was measured and documented in WesDyne report PJF-1303451-FSR-001. The coverage below the weld obtained for each tube during the B2R14 outage was the same as the coverage below the weld obtained during the B2R13 outage.
