Event # 44896

## PART 21 NOTIFICATION - DEFECTIVE HK AND K-LINE CIRCUIT BREAKER TENSION SPRINGS

Subject: Amended Report -- 10 C.F.R. Part 21 Notification of Deviation re. P/N 716539A00 Tension Springs

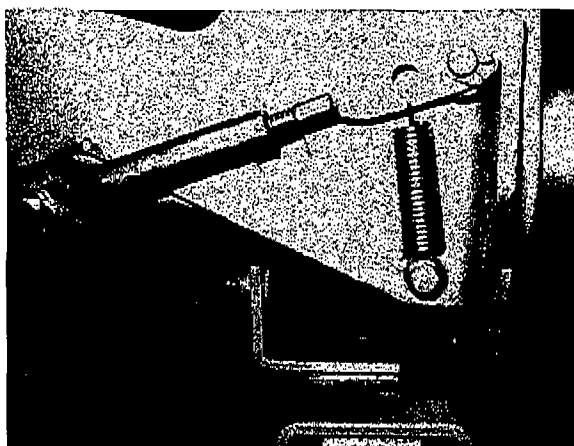
The identification of the Subject component is as follows: ABB P/N 716359A00 Tension Spring. These springs are used in both HK (Medium Voltage) and K-Line (Low Voltage) circuit breakers. In the HK breaker, the spring is used on the racking mechanism to position the racking mechanism interlock latch. In the K-Line circuit breaker, the spring resets the prop latch mechanism following a circuit breaker trip. See photos below:

HK Racking Mechanism Latch

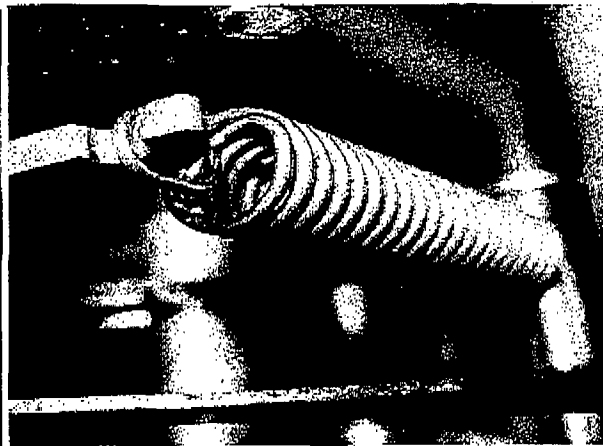
K-Line Prop Latch Reset Arm

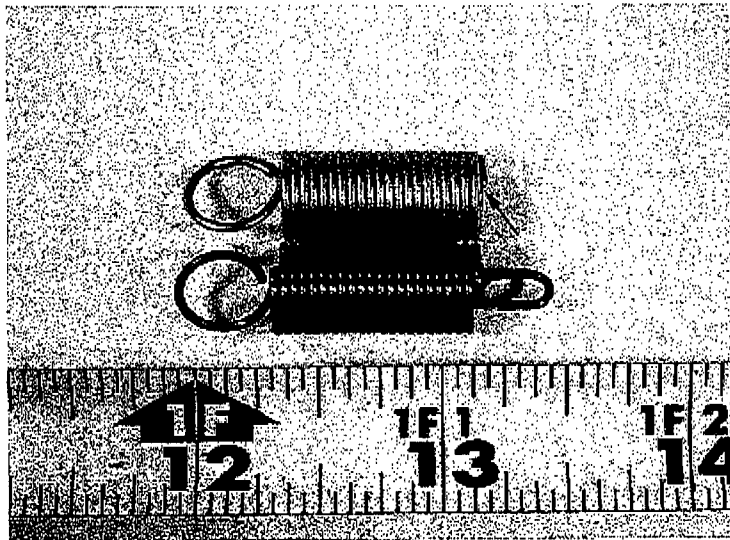
An additional issue was identified during the investigation in that the opposite end rectangular hook had tool marks from the forming operation that could result in premature spring failure. One spring failed after 6000 cycles in the concave bend area at this end. See photo below:

- c. Worked with our vendor, Ace Wire, to determine how future incidents can be prevented and developed quality assurance means to minimize the possibility of a recurrence. As of March 9, 2009, tooling has been polished to minimize tooling marks, and the fully formed hook will be made using the automatic forming machine on future orders.
