June 25, 2009

SUBJECT: NRC SITE VISIT TO THE OCONEE NUCLEAR STATION ON
JUNE 15, 2009

SUMMARY OF NRC SITE VISIT TO THE OCONEE NUCLEAR STATION JUNE 15, 2009

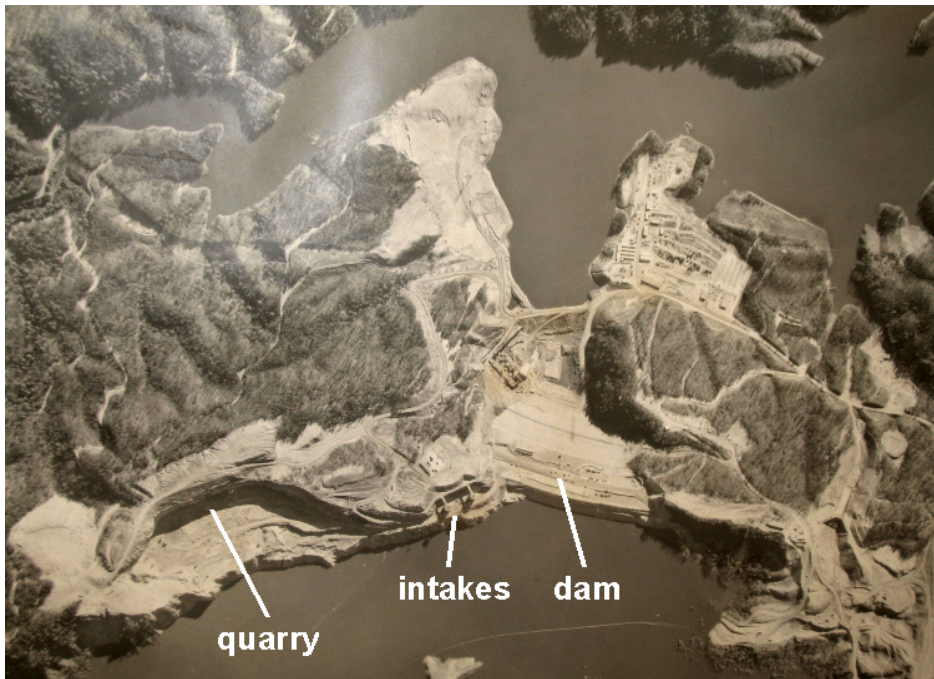
Historic photograph of Jocassee Dam during construction.

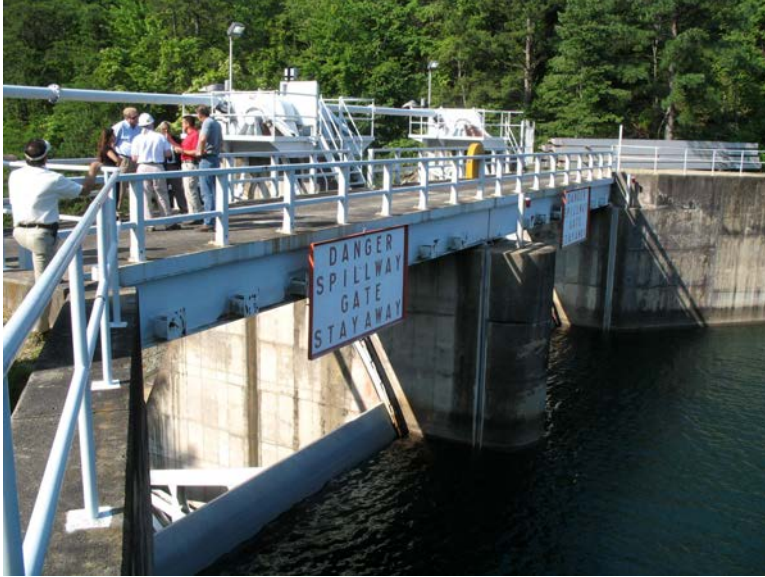
The NRC staff also visited the spillway for Jocassee Lake. It is located west of the dam and east of the Saddle Dikes. The spillway is controlled by two large radial gates. The report by FEI (2004) discusses potential failure modes (PFM) of Jocassee Dam. One scenario examined was overtopping of the dam caused by failure to operate the radial gates during a flood. Overtopping was classified as Category IV (ruled out) given the current programs of inspection, testing, maintenance, surveillance, and backup power. FEI (2004) reports there are two backup portable compressors that could be used to open the gates, and that the gates could also be opened with a hand crank or with a crane. Our observations at the spillway found that a support frame for an air-operated motor is bolted to the platform where the hand crank would be used. A hand crank could not be used unless a ratchet device is provided or unless the support frame is removed. Also, it was not obvious where a lifting device for a crane could be attached to the radial gates. If water overtopped the gates, they would be under water and the downstream force would be very large, making it challenging to hook onto the gates for lifting.

Spillway structure for Jocassee Reservoir.

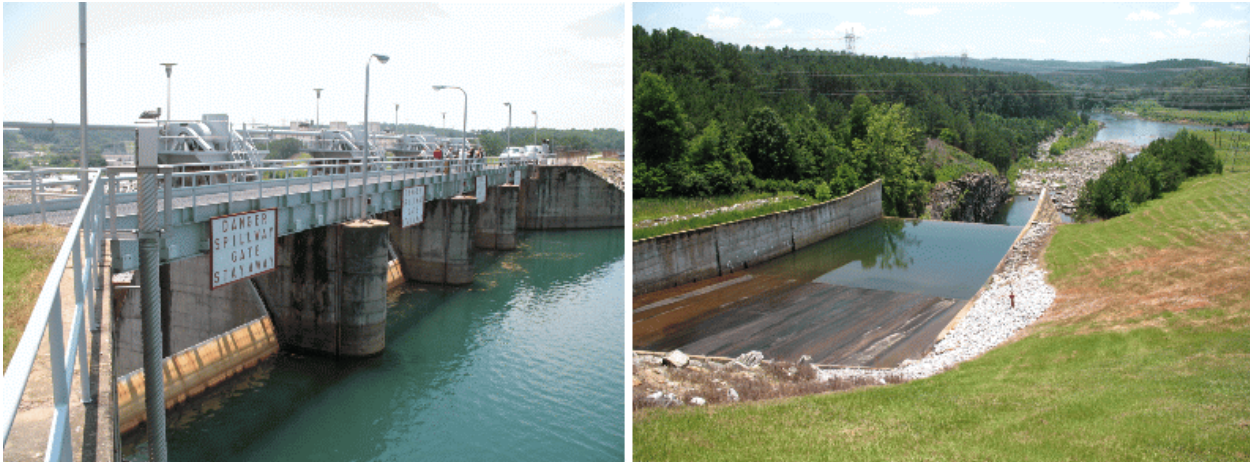
In the afternoon of June 15, 2009, the NRC review team visited the Keowee dam and its appurtenant structures, and found them to be in good condition.

Keowee Dam spillway with four radial gates (left), and view of outflow channel (right).
