BVPS Unit No. 1

Containment Liner Corrosion Report

CR 06-01122, Dated February 20, 2006

Report Date: March 14, 2006

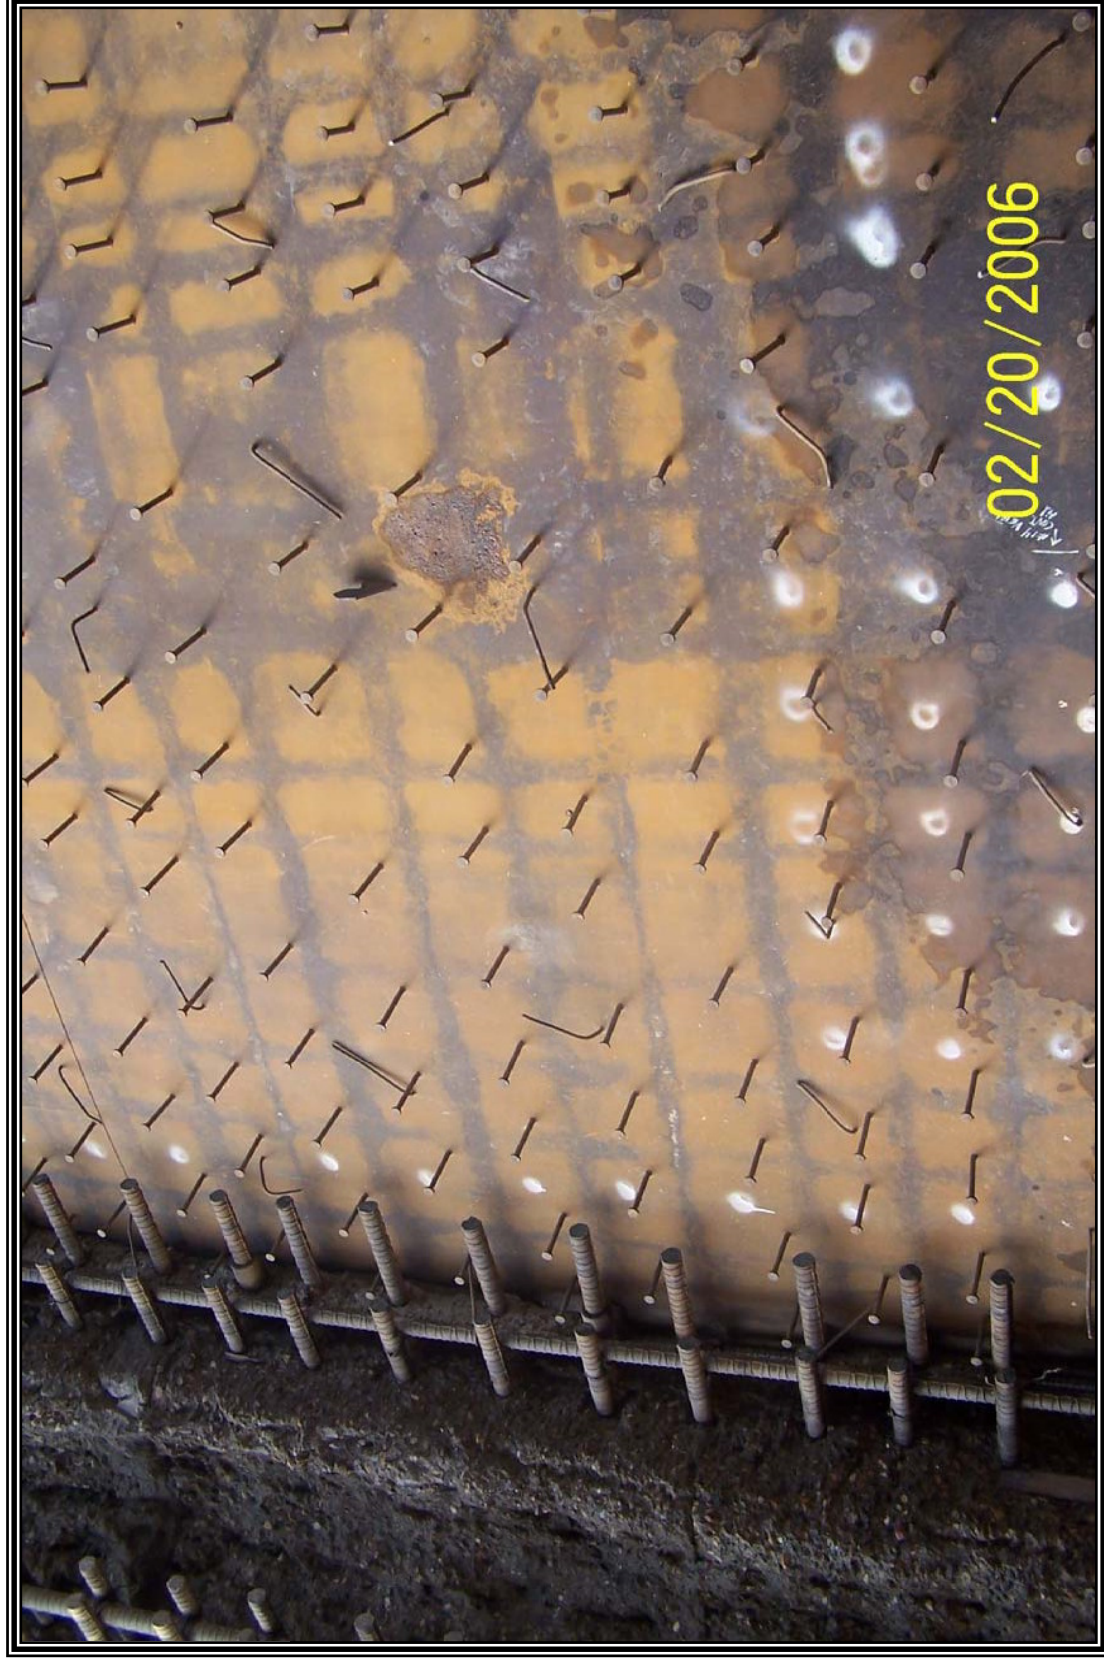
Location Area 1

Area 1 exhibited general thinning that resulted in a liner thickness range of 0.283" to 0.300". Isolated pitting was evident in Area 1 with a minimum liner thickness of 0.225 inch at a small isolated pit. Minimum UT thickness measurement in Area 2 was 0.151 inch at a visible deep pit. The long area visible in Attachment 2 photos was determined as having a 0.194 inch minimum thickness. The thickness of the Area 2 general area was measured as 0.30 inch. Corrosion Area 3 as described has a liner thickness of 0.375" or greater. Six pits were identified in Area 3, the liner thickness at the deepest being 0.330 inch. The deepest pit therefore was 45 mils less than the nominal plate thickness of 0.375 inch.

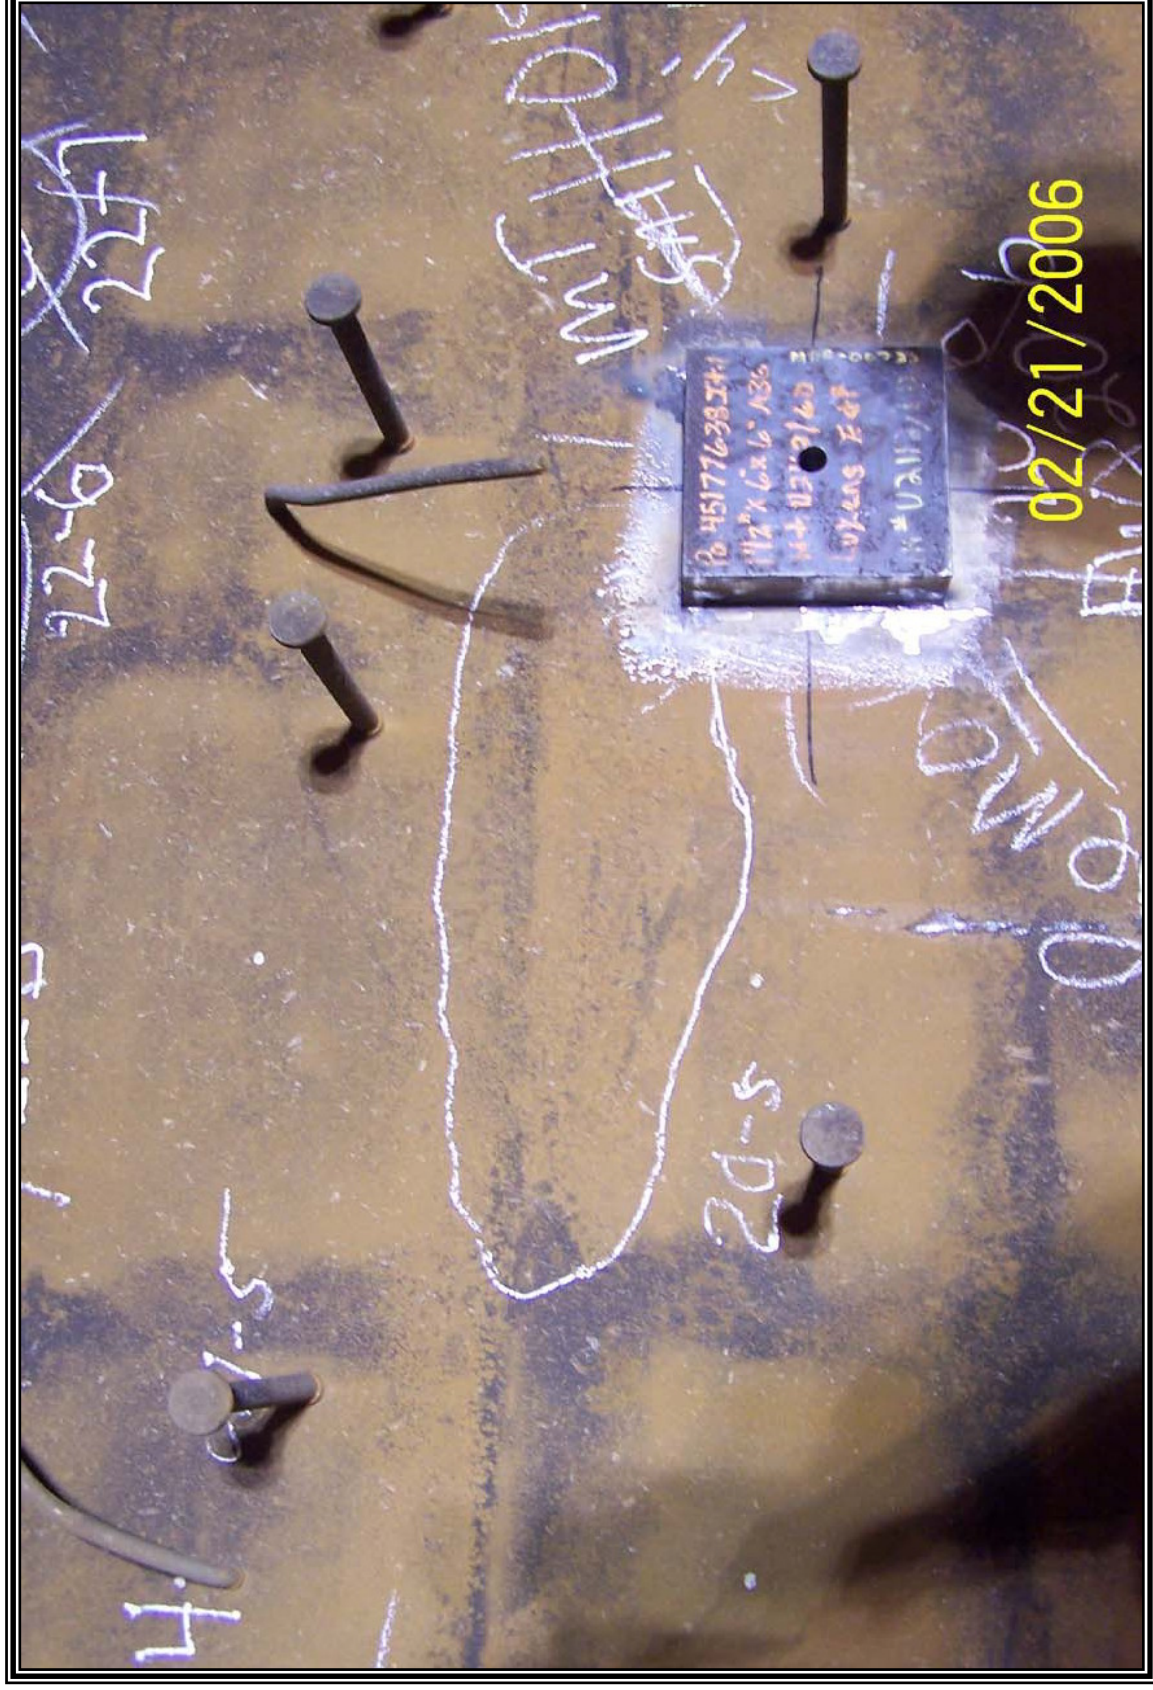
Area 3 and Lift Lug Attachment

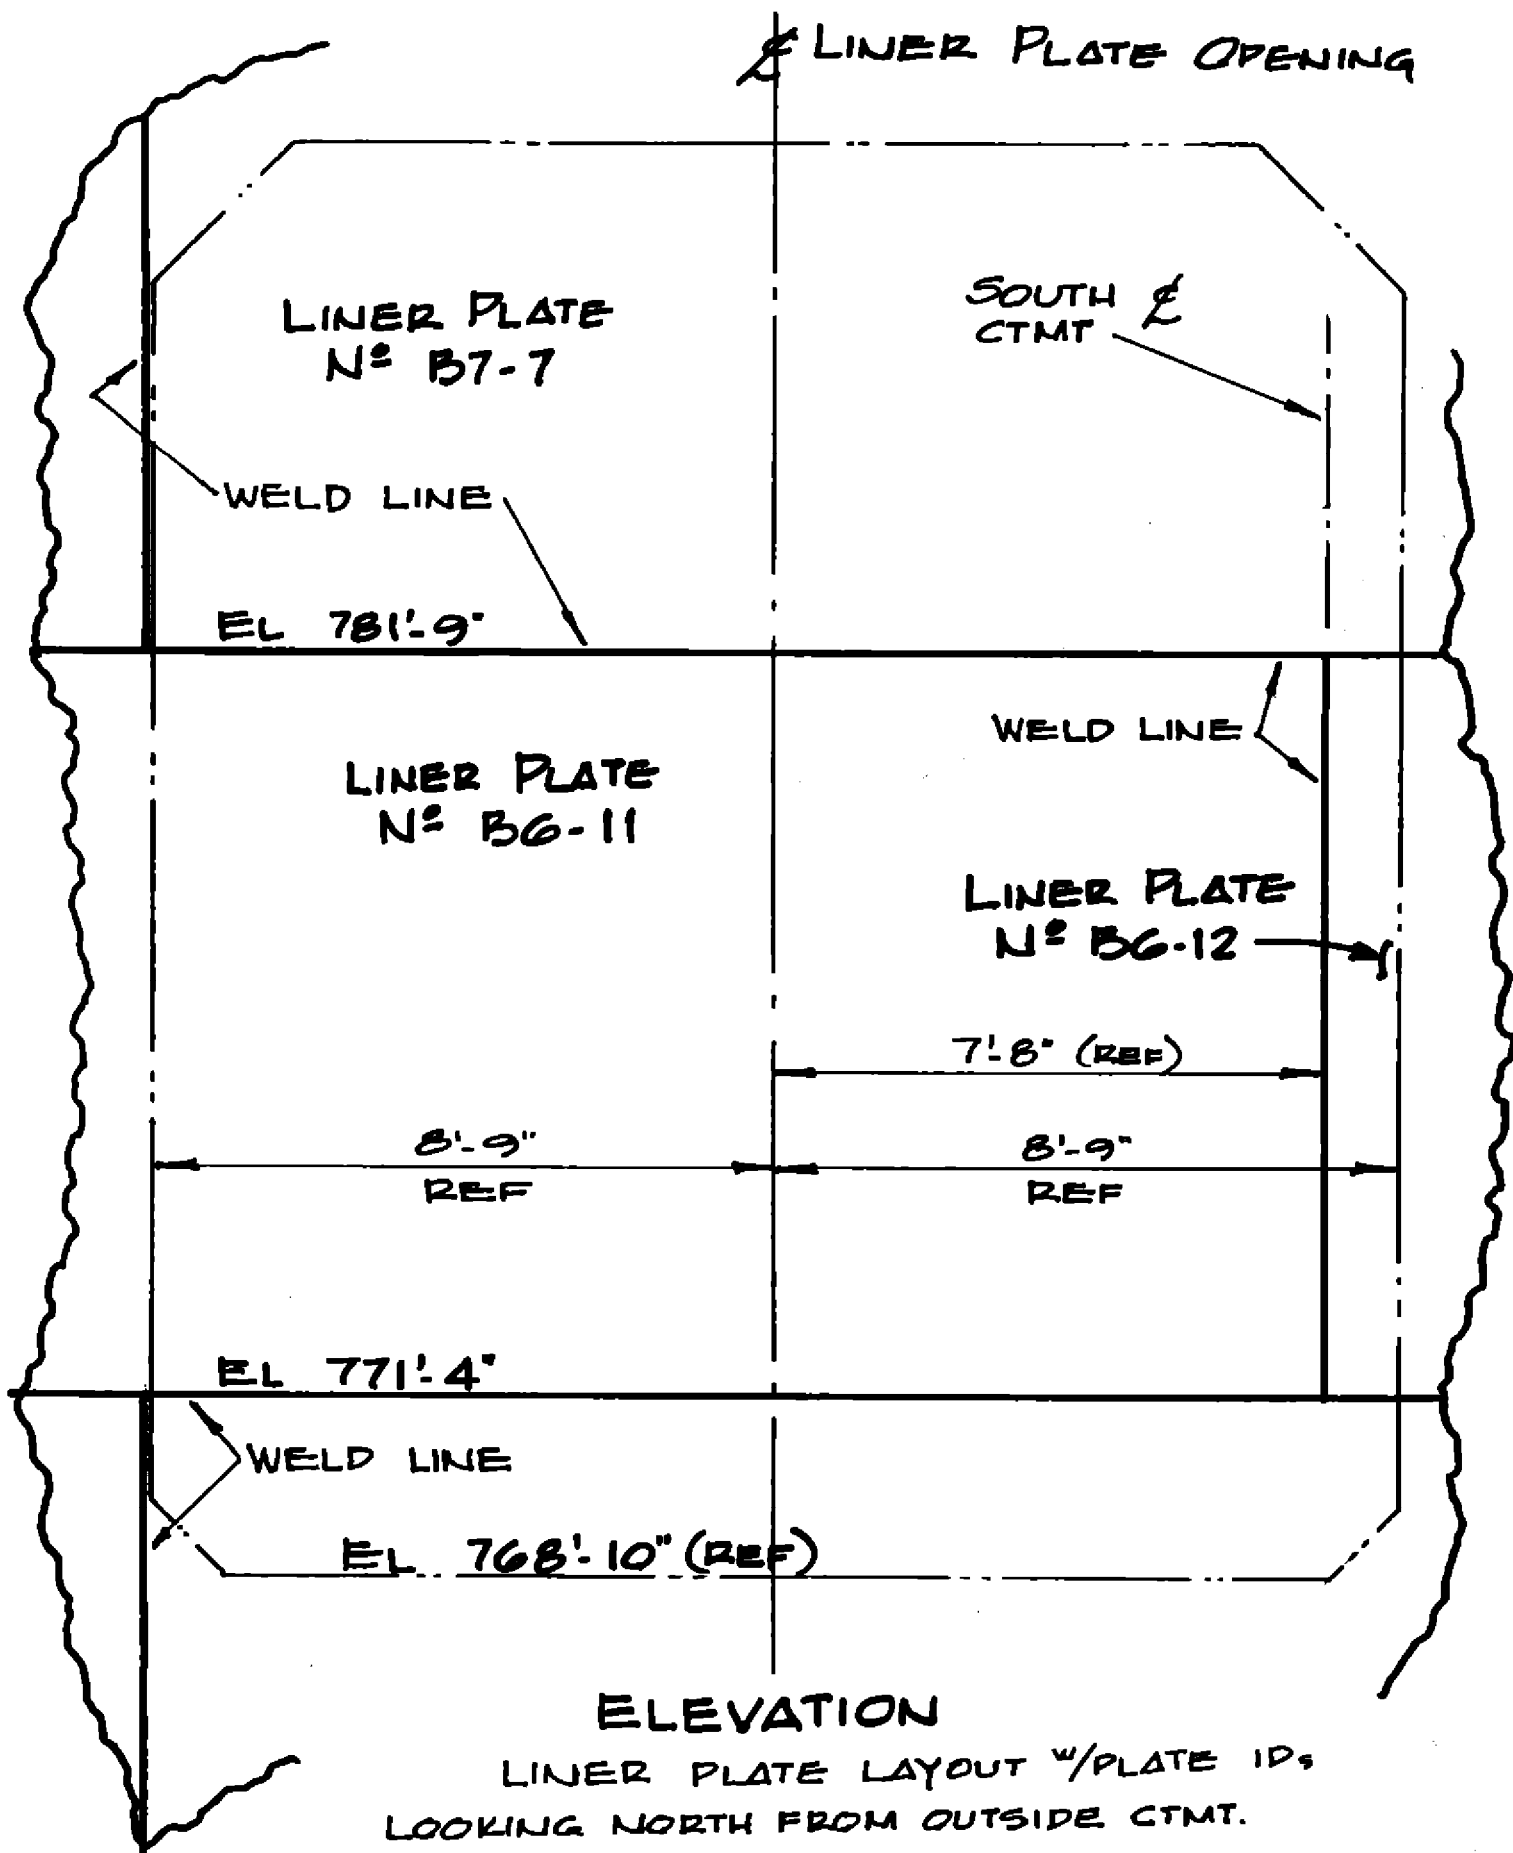
ELEVATION
 LOOKING NORTH FROM OUTSIDE CTMT.
 $\frac{3}{8}" \times 1'-0"$
 LOCATIONS OF CORROSION AREAS
