LAB NO.: M06074	WORK TRACKING NO.: 14878	PAGE 58 OF 78
PLANT & UNIT: BEAVER VALLEY #1	PART: CONTAINMENT MATERIALS	DATE: 3/9/2006

MATERIAL ANALYSIS REPORT

Beaver Valley Unit 1
Engineering Assessment Report
1 R 17 Exterior Containment Liner Corrosion

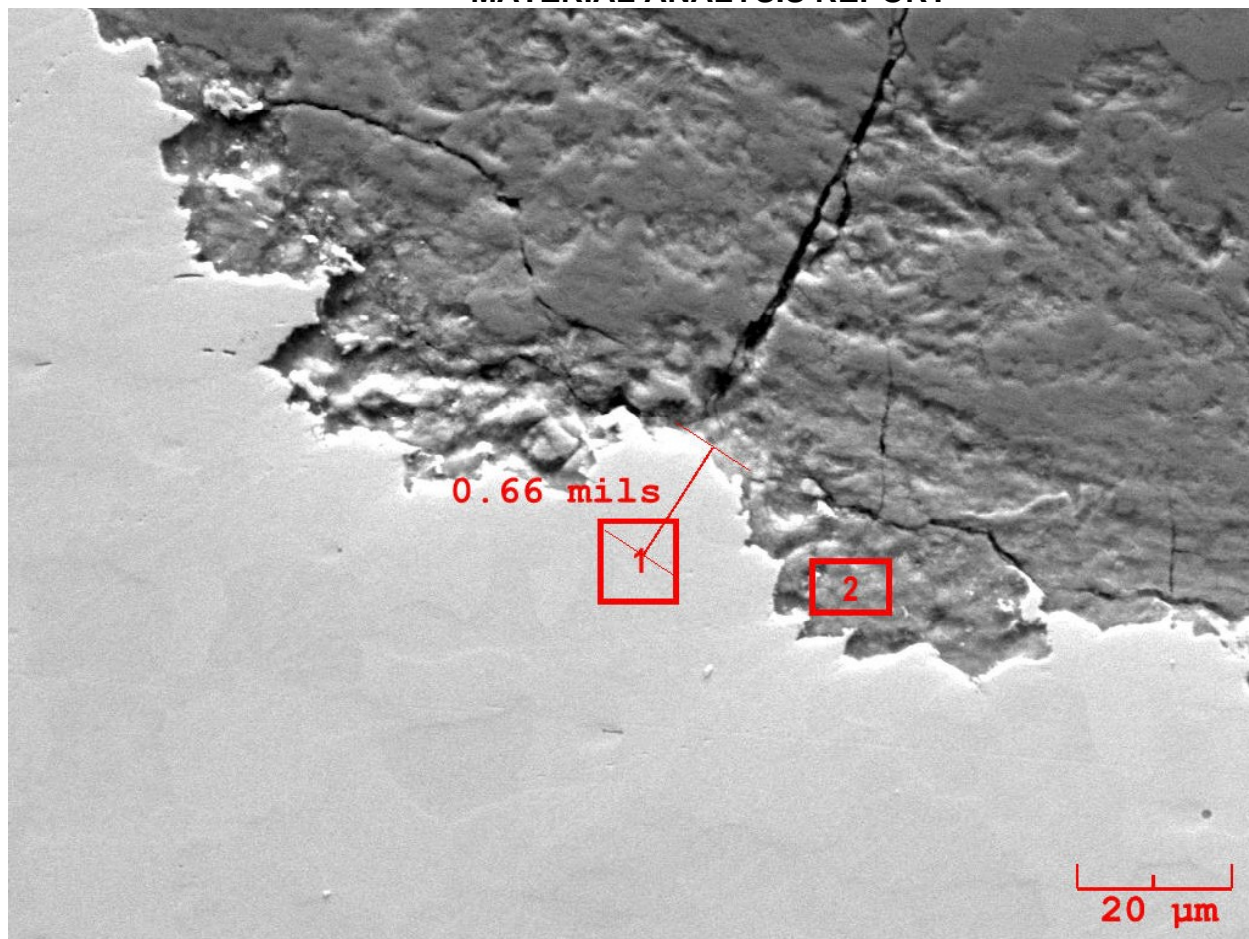
FIGURE 32, LINER SAMPLE "B", QUADRANT #10, SECTION #3, OD PIT, DETAIL IN THE SEM.

TEST SAMPLE [^]	CHEMICAL COMPOSITION, WT. %												
	O	NA	Mg	AL	SI	S	K	CL	CA	TI	CR	MN	FE
"B", Q10-#3, PIT-1	ND	ND	ND	ND	0.4	ND	ND	ND	ND	ND	ND	0.6	99.0
"B", Q10-#3, PIT-2	18.3	ND	ND	0.9	0.6	ND	0.3	ND	0.2	ND	ND	0.4	79.2

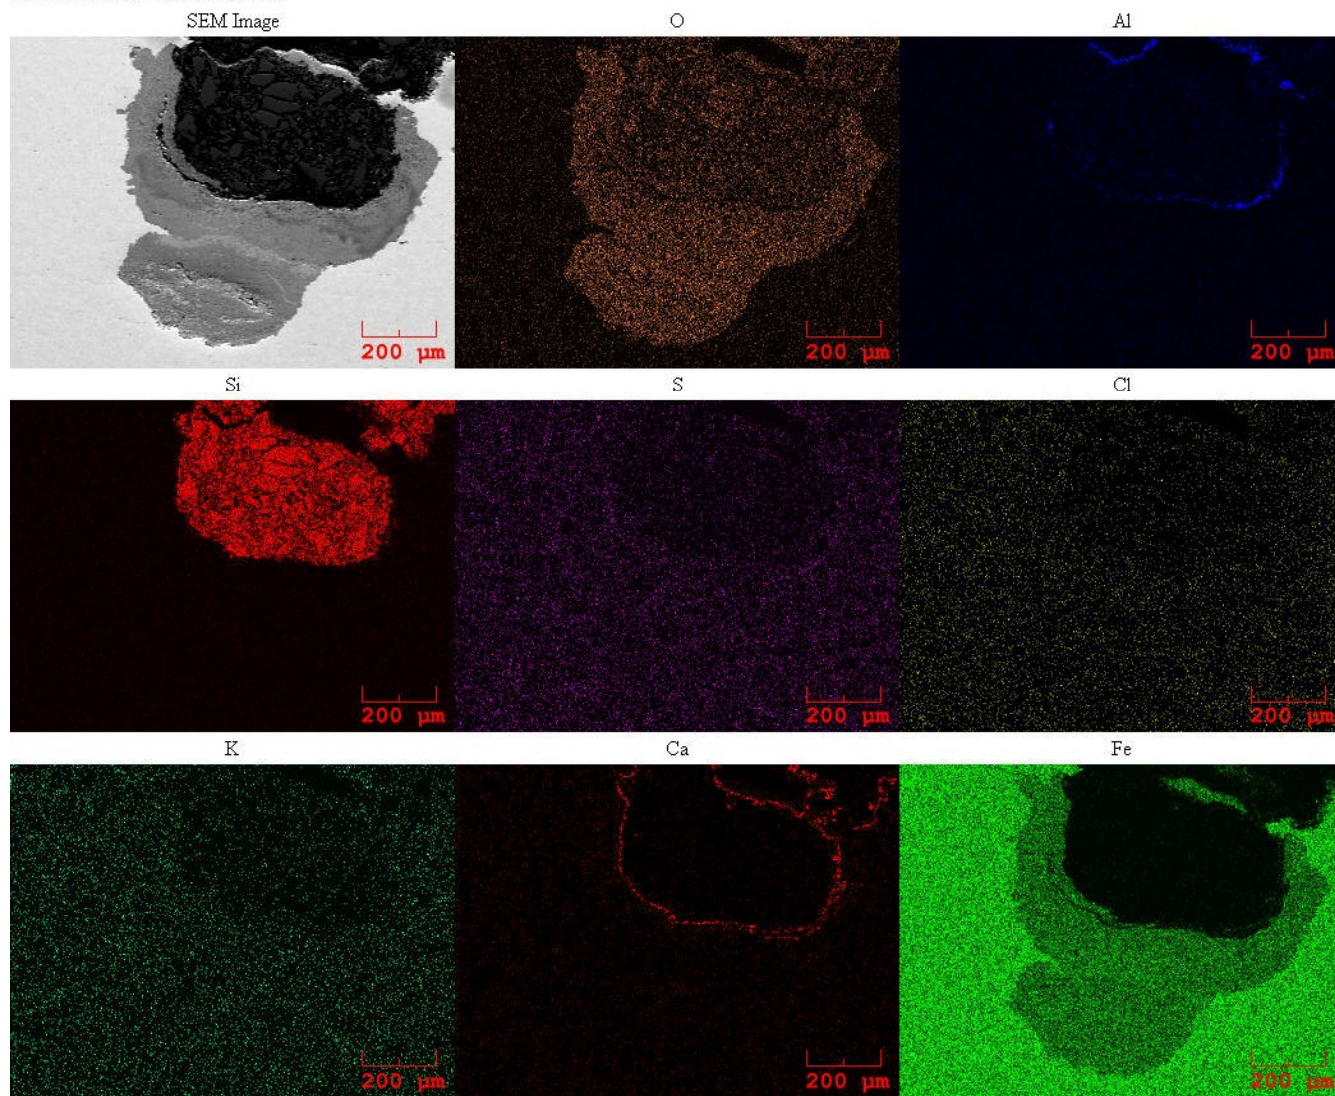
Sample B, Q10, #3, Maps at 200x

**FIGURE 33, LINER SAMPLE "B", QUADRANT #10, SECTION #3, OD PIT;
SEM-EDS ELEMENTAL DOT-MAPPING.**

THE MATERIAL FILLING THE BOTTOM OF THIS PIT APPEARS TO BE MAINLY FE AND O.

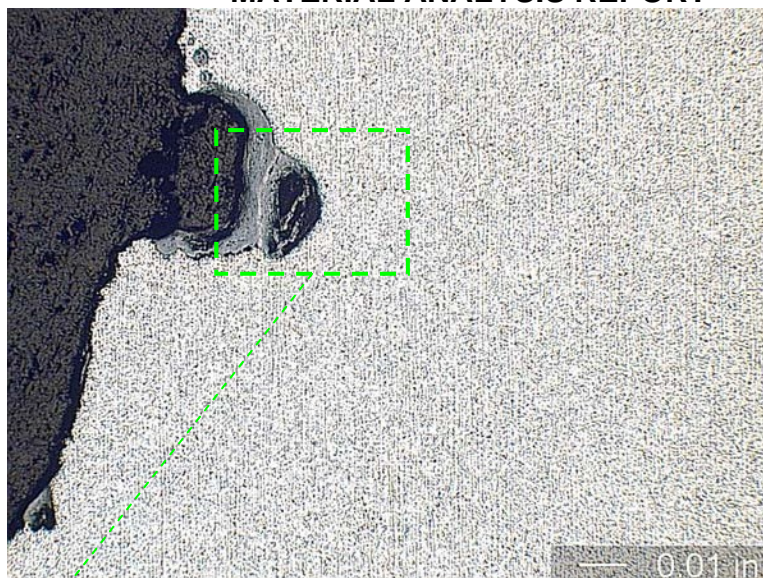
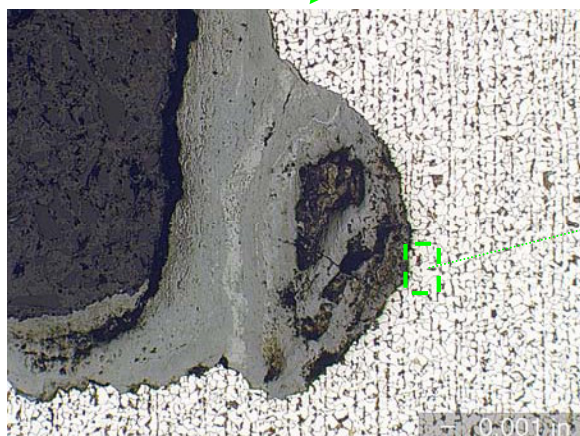
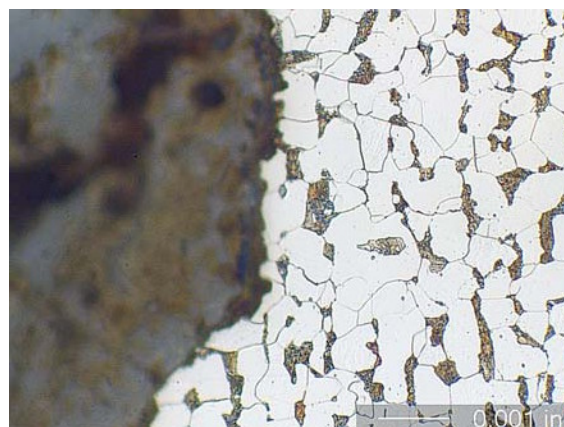
FIGURE 34, LINER SAMPLE "B", QUADRANT #10, SECTION #3, OD PIT MICROSTRUCTURES.

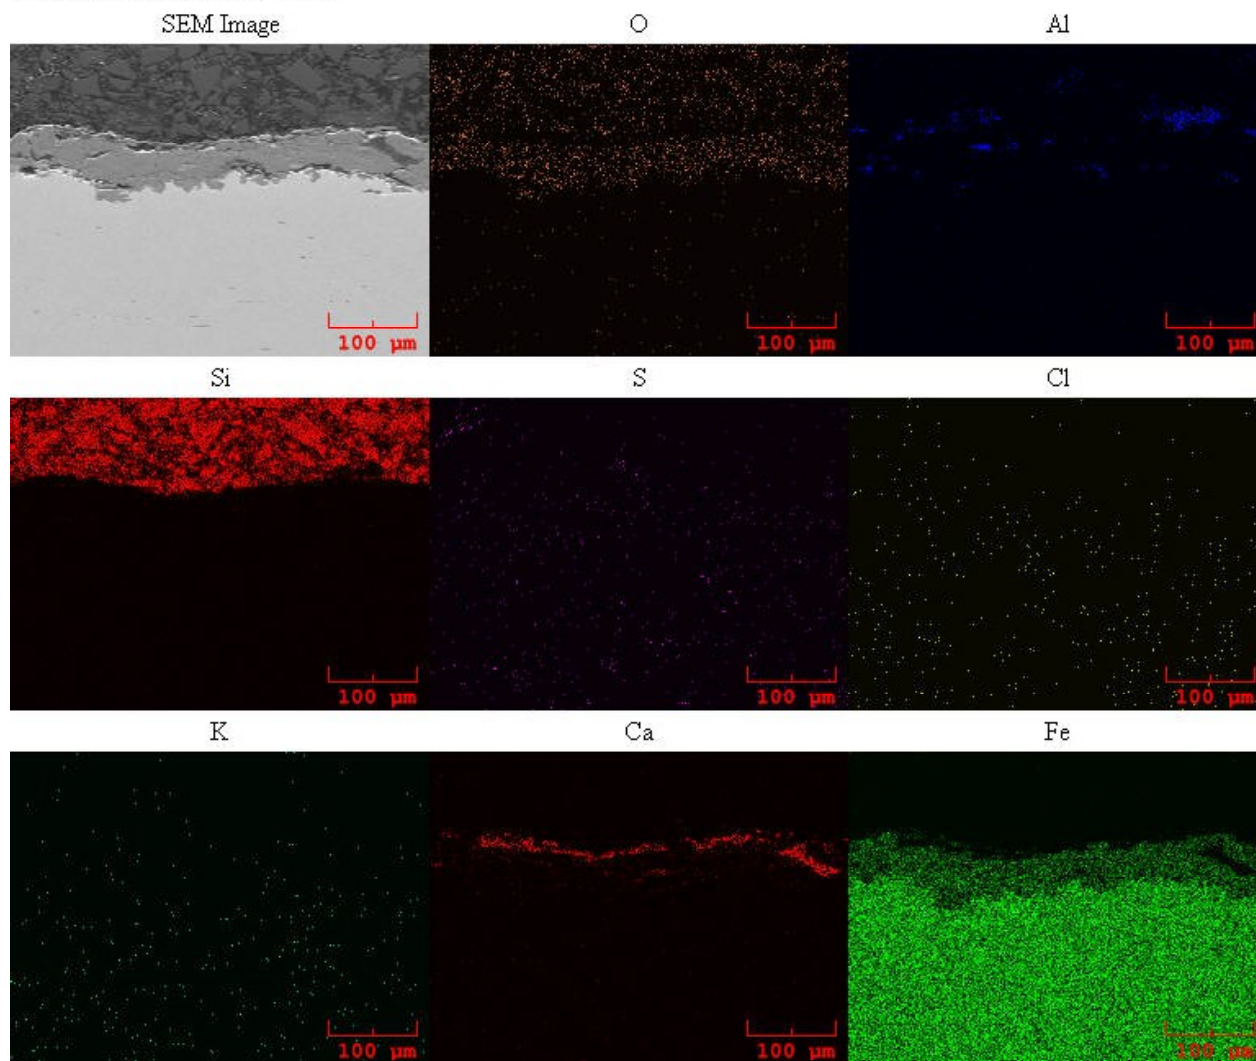
Mount, AQ11-5, Maps at 500x

**FIGURE 35, LINER SAMPLE "A", QUADRANT #11, SECTION #5;
OD SURFACES IN SECTION, DETAIL IN THE SEM.**

TEST SAMPLE^	CHEMICAL COMPOSITION, WT. %												
	O	NA	Mg	AL	SI	S	K	CL	CA	TI	CR	MN	FE
OD "SCALE"	23.4	ND	ND	0.3	0.7	0.7	ND	ND	2.3	ND	ND	0.4	72.1

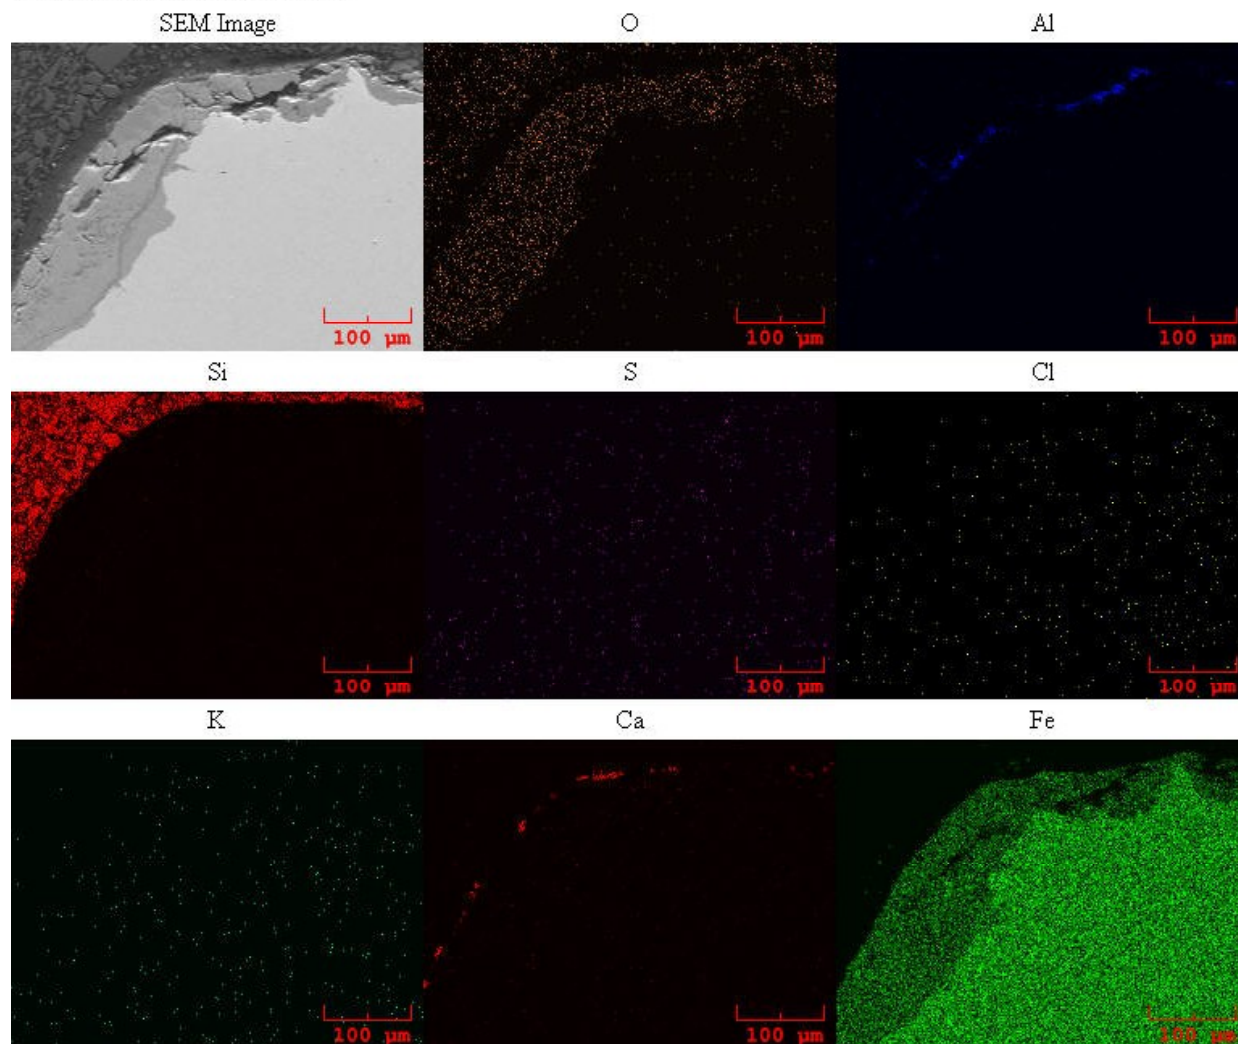
Mount, AQ11-6, Maps 1 at 500x

**FIGURE 36, LINER SAMPLE "A", QUADRANT #11, SECTION #6;
OD SURFACES IN SECTION, DETAIL IN THE SEM**

TEST SAMPLE [^]	CHEMICAL COMPOSITION, WT. %												
	O	NA	Mg	AL	SI	S	K	CL	CA	TI	CR	MN	FE
OD "SCALE"	15.9	ND	ND	ND	1.6	ND	ND	ND	0.4	ND	ND	0.5	81.7

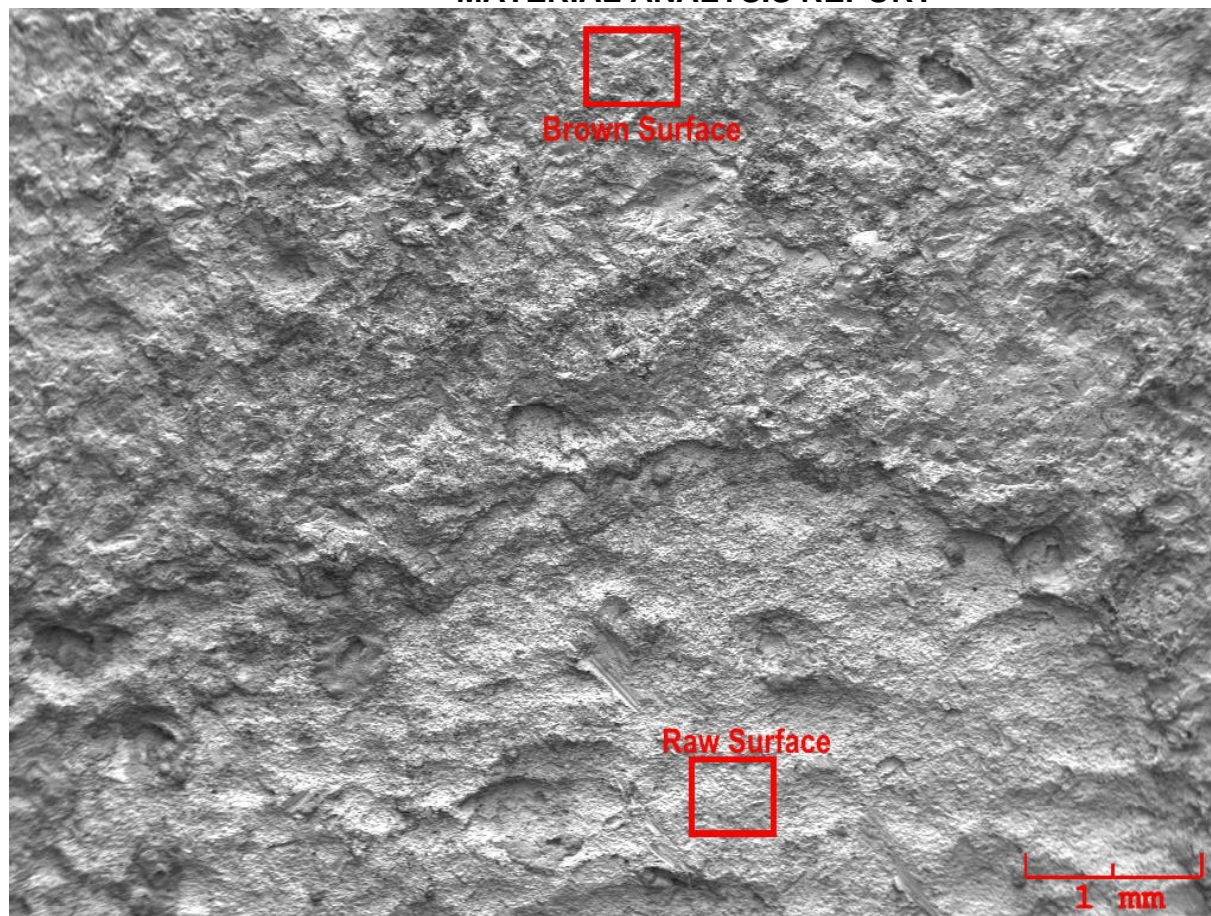
**FIGURE 37, LINER SAMPLE "A", QUADRANT #11, PIECE IN THE SEM;
IN-SITU OD SURFACES AFTER CLEANING[^].
BOX DETAILS ARE SHOWN BELOW.**

SAMPLE	CHEMICAL COMPOSITION (WT. %) VIA EDS*													
	O	NA	Mg	AL	SI	S	K	CL	CA	TI	CR	MN	FE	ZN
BROWN SURFACE	26.6	ND	ND	0.5	1.4	0.2	ND	ND	5.9	ND	ND	0.6	64.4	0.4
RAW (WHITE) SURFACE	4.2	ND	ND	0.2	0.7	ND	ND	ND	0.2	ND	ND	0.5	94.2	ND

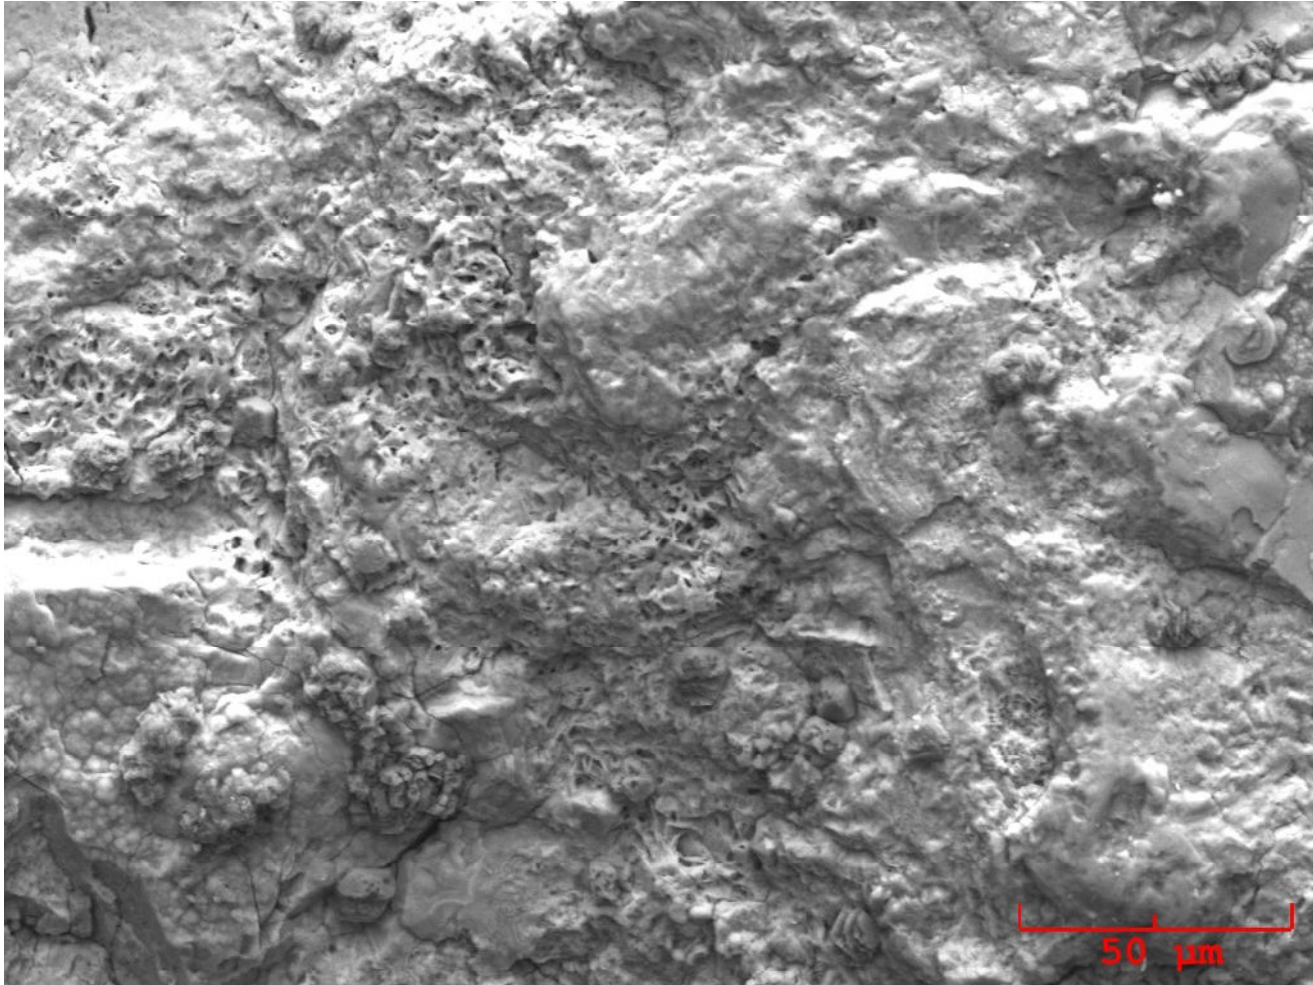
**FIGURE 38, LINER SAMPLE "A", QUADRANT #11, CLEANED PIECE;
BROWN SURFACE DETAIL IN THE SEM.**

THIS SURFACE IS MOSTLY Fe (64.4%), O (26.6%), AND CA (5.9%).

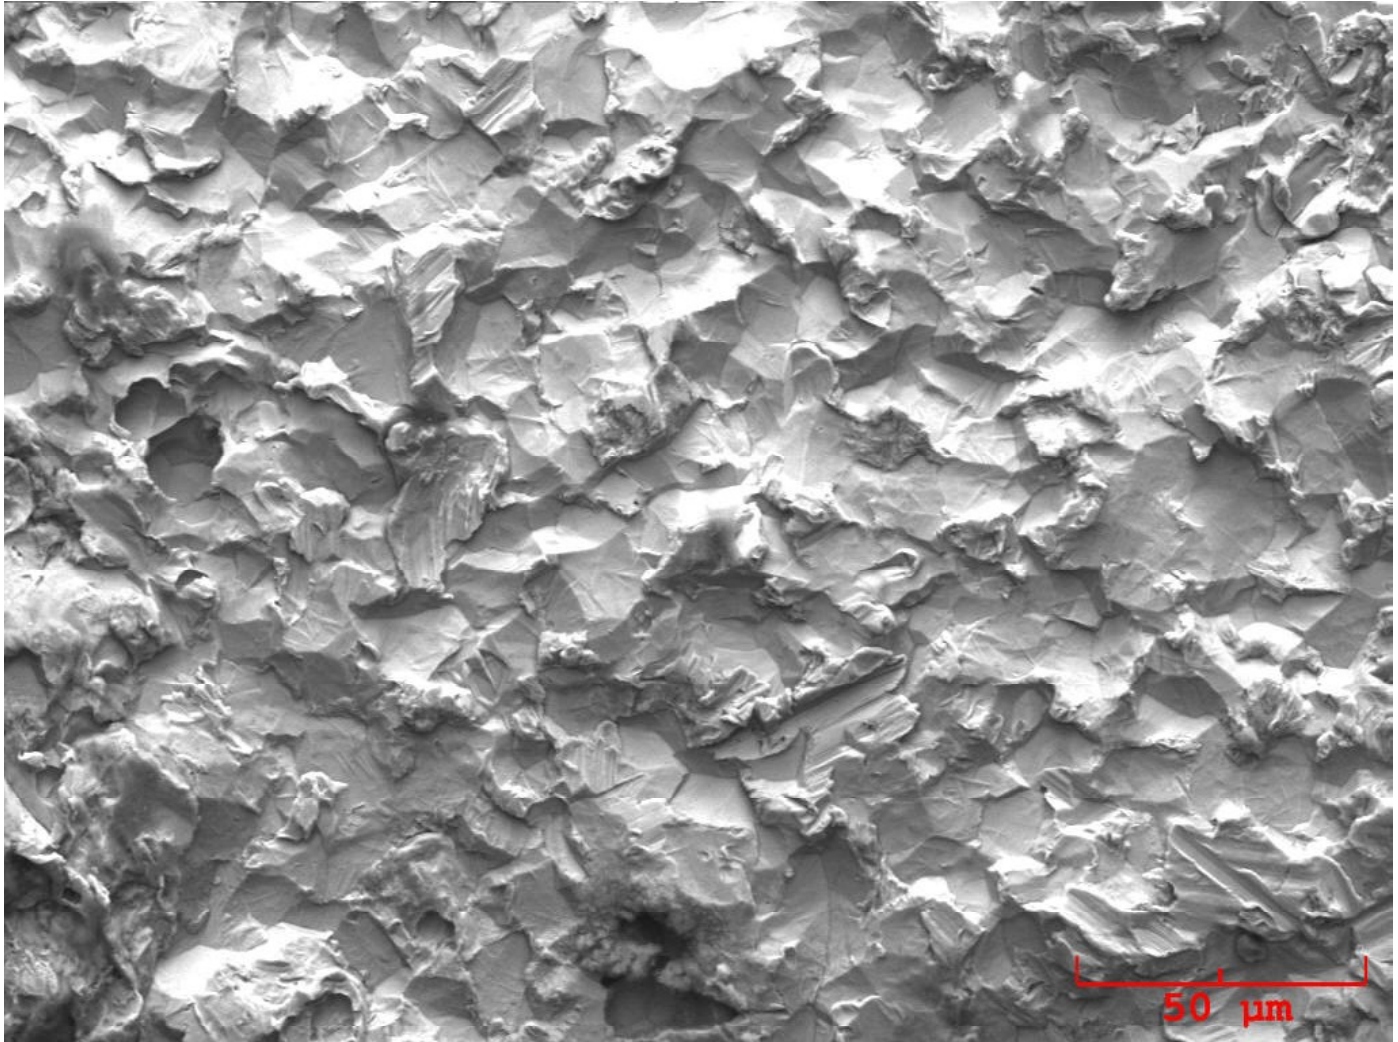
**FIGURE 39, LINER SAMPLE “A”, QUADRANT #11, CLEANED PIECE;
WHITE SURFACE DETAIL IN THE SEM.**

THIS SURFACE IS MOSTLY Fe (94.2%) AND O (4.2%).

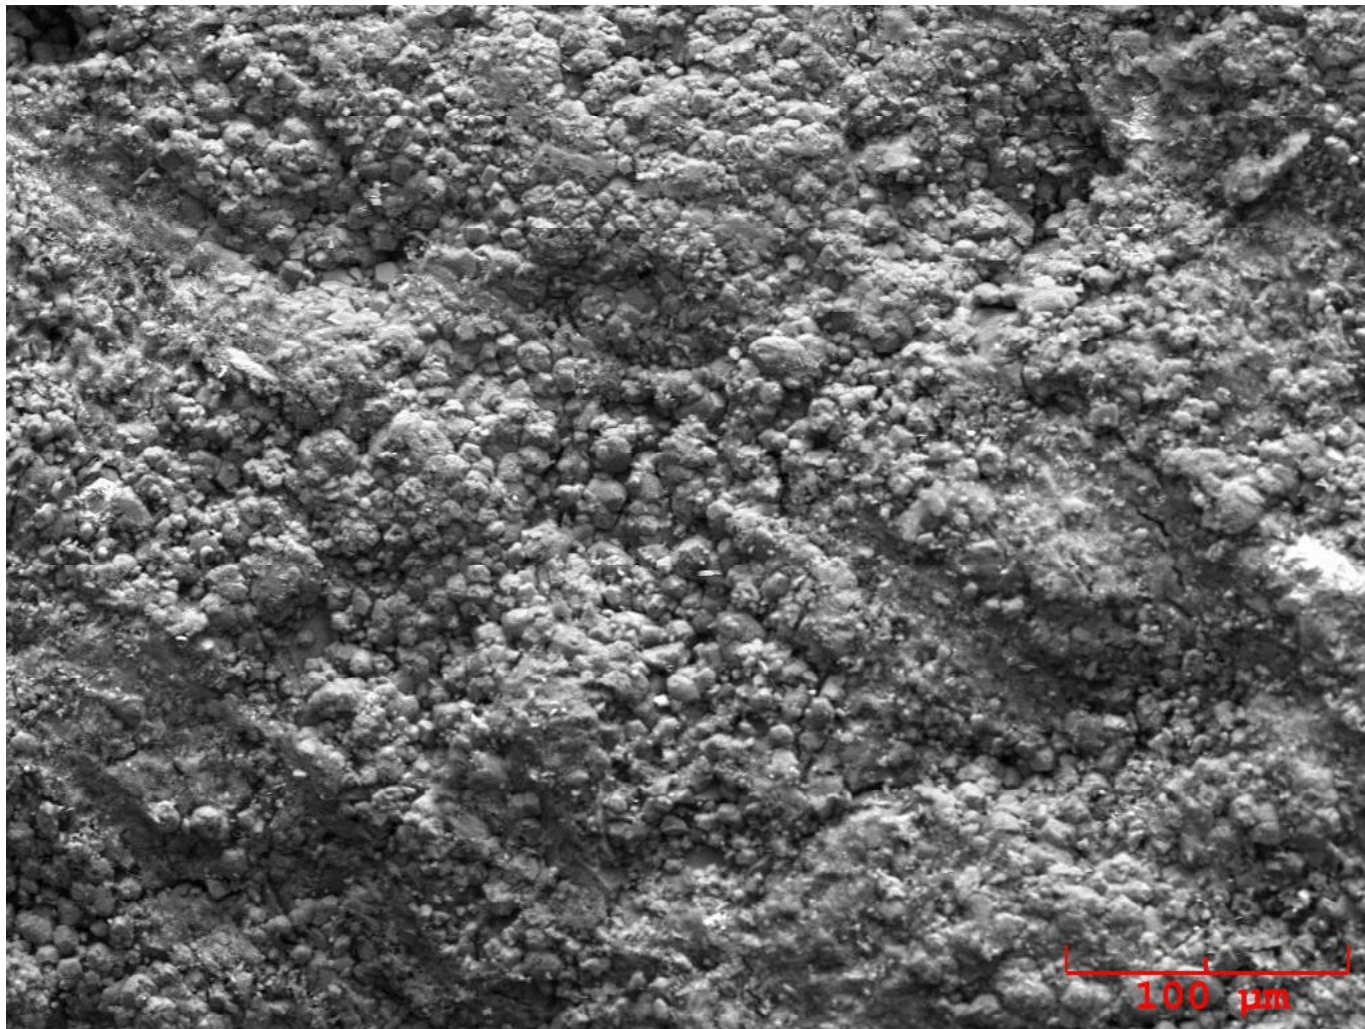
FIGURE 49, LARGE CONCRETE SAMPLE (FROM #1), “FLAT” SURFACE, “SPECIAL”, AS-IS IN THE SEM.

CHEMICAL COMPOSITION (WT. %) VIA EDS*												
O	NA	Mg	AL	SI	S	K	CL	CA	TI	CR	MN	FE
41.0	ND	1.0	2.2	13.6	0.4	0.2	0.1	38.5	ND	ND	ND	2.9

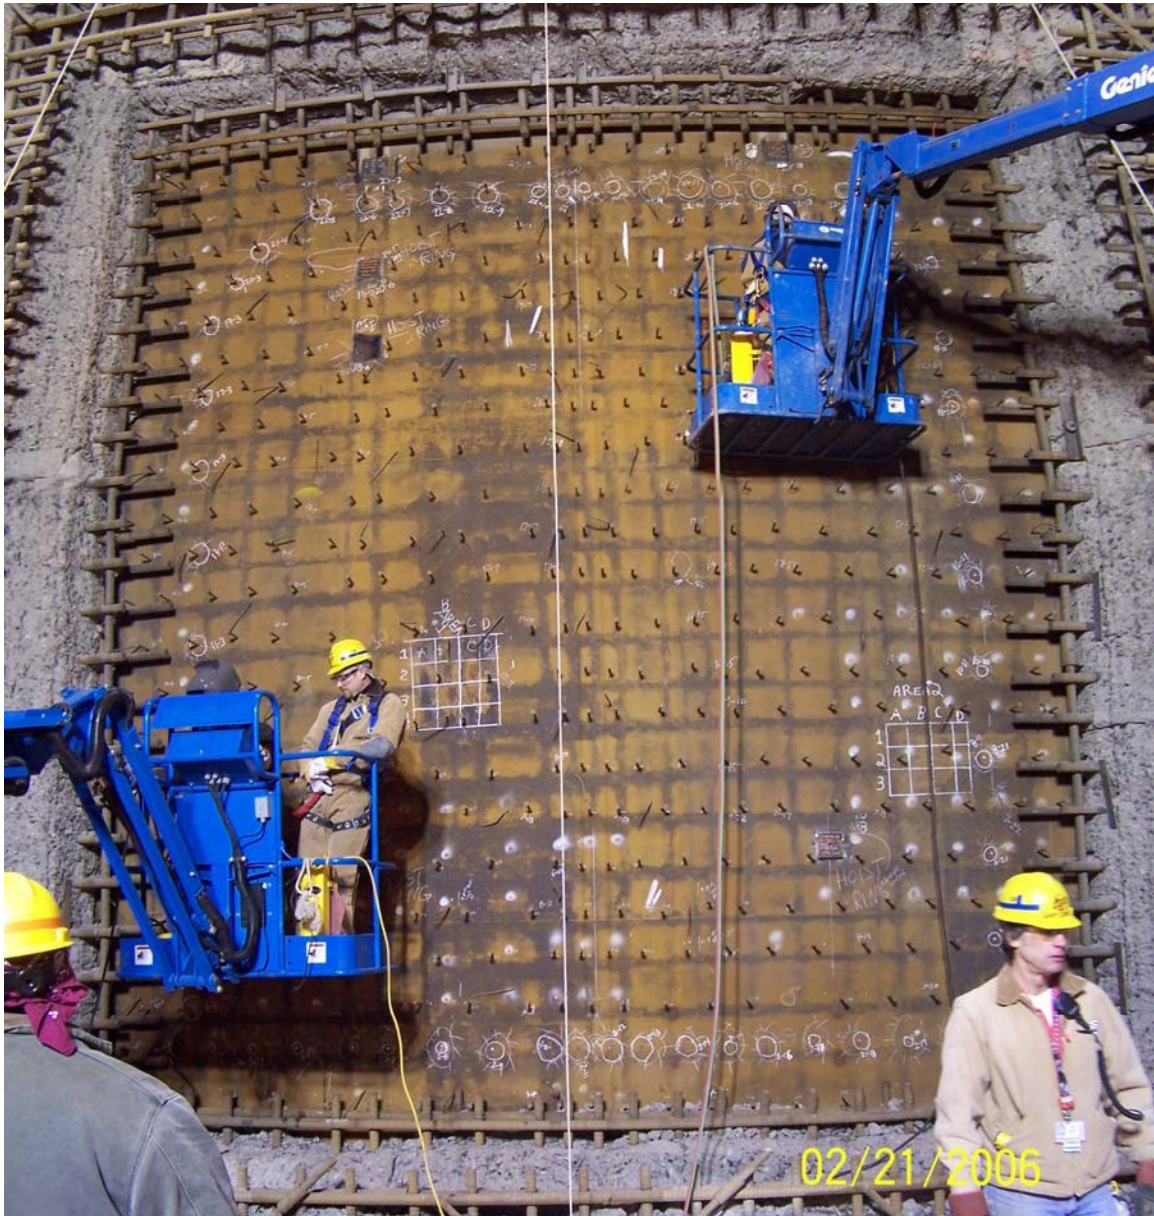
Photograph 1. An overall photograph showing the liner before it was removed from the containment. Laboratory Sample 1 is located just left of the center of the plate, just below the middle of the plate and is identified as "AREA 1." Laboratory Sample 2 is located near the right edge of the plate, approximately $\frac{1}{3}$ rd of the distance up the plate and is identified as "AREA 2". Area 3 is located at the upper left-hand corner of the plate and is within the oblong area outlined in white. Area 3 was not removed from the plate because the degree of pitting is much less than on the samples from Area 1 and Area 2, and a lifting lug had been welded in the vicinity of the corrosion.

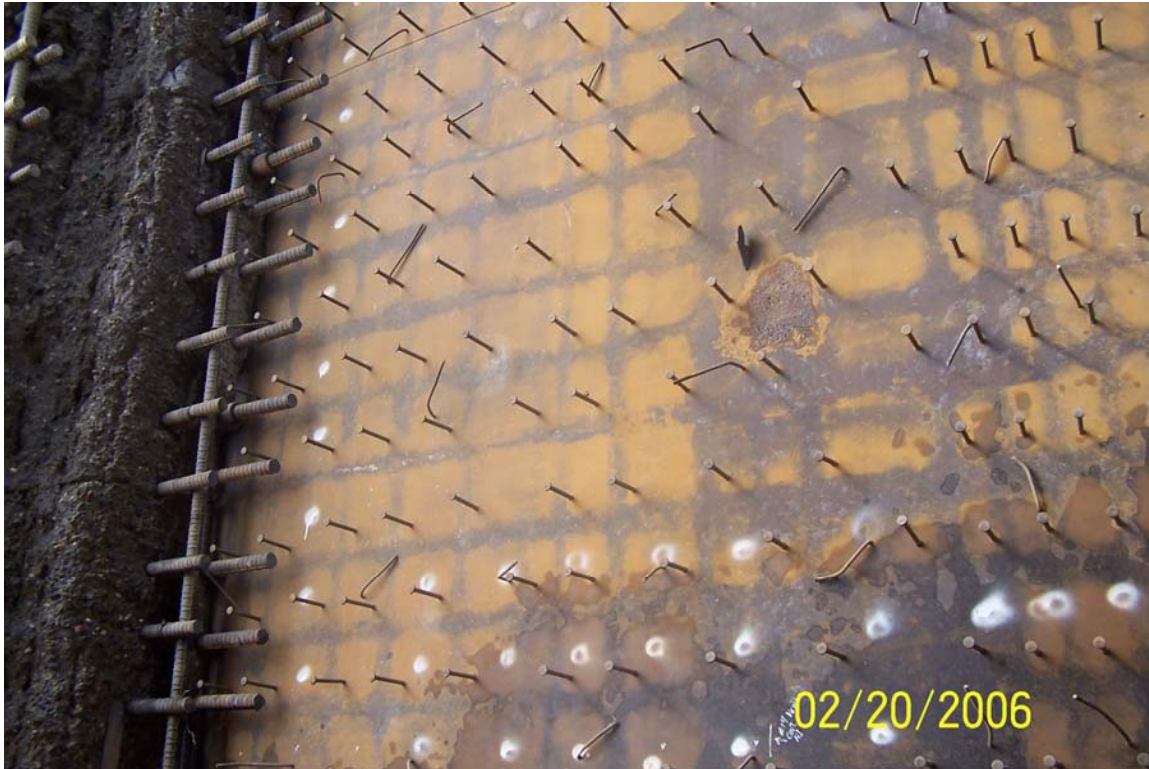
Photograph 2. This is a wide angle view showing the location of AREA 1. Note the pattern of undisturbed mill scale in the photograph. It appears as if the original mill scale was removed by water blasting during the process of removing the concrete from the containment liner.

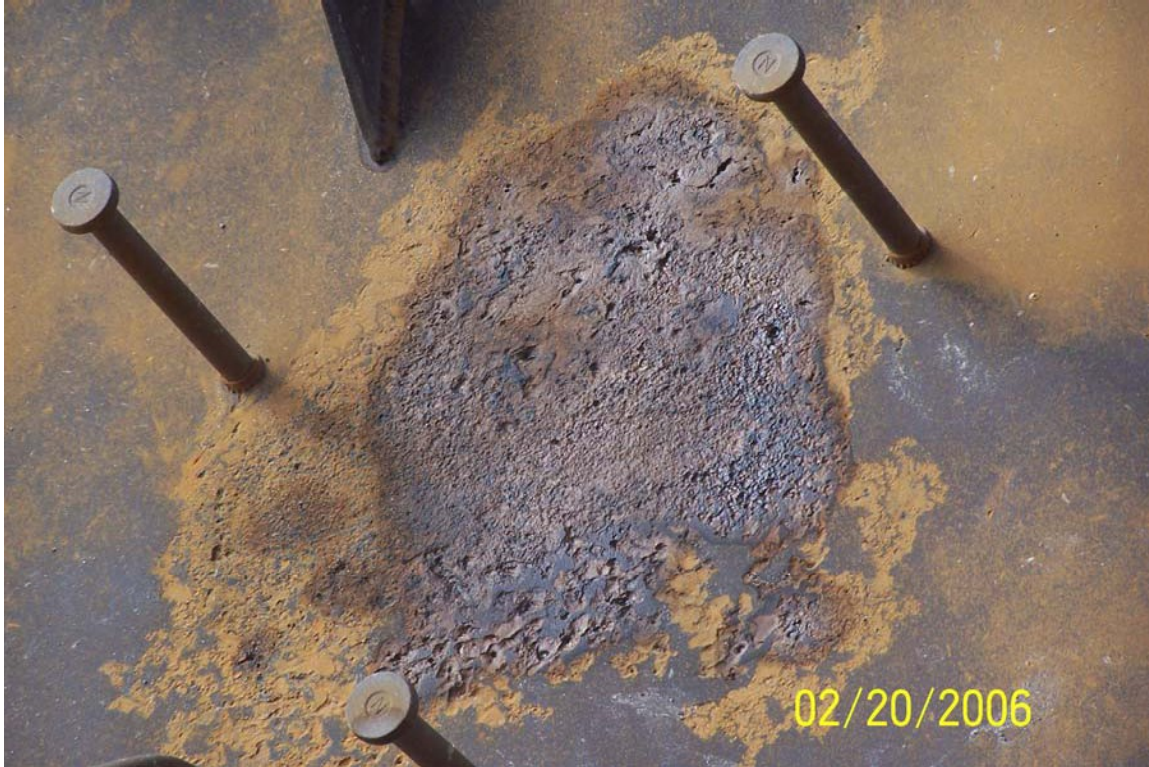
Photograph 3. This is a close-up view of AREA 1 that includes the entire corroded area. Note the original mill scale shown in the left and right portions of the photograph. Note the original scale throughout the pitted area.

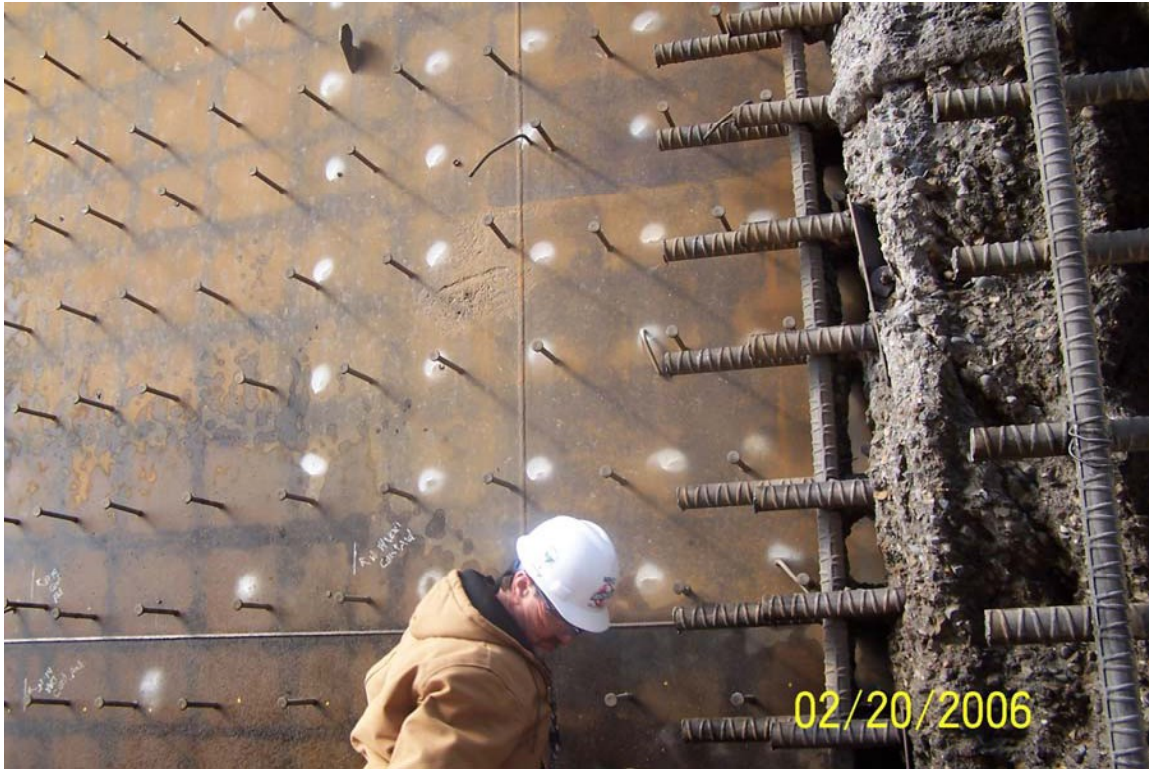
Photograph 4. This is a wide angle view showing the location of AREA 2. Note the reinforcing bars in the right portion of the photograph that show no visible evidence of rusting.

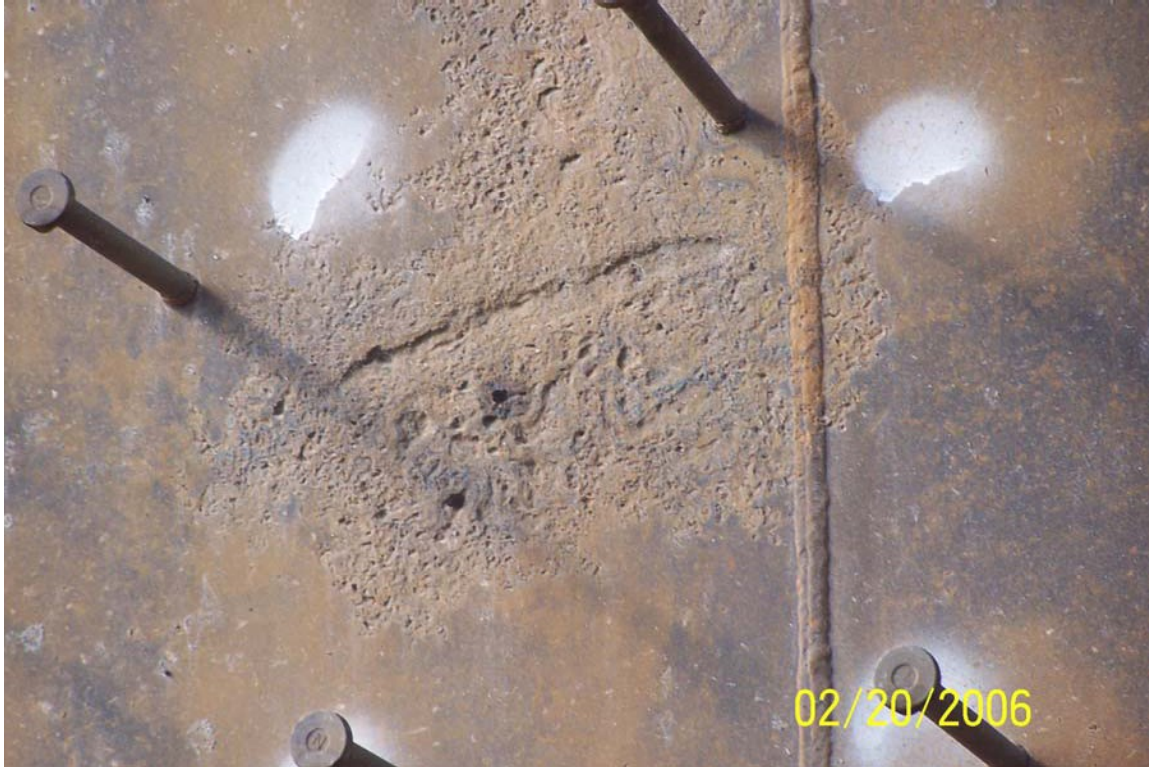
Photograph 5. This is a close-up view of AREA 2 that includes the entire corroded area. Note the corroded area includes a portion of a vertical weld. No preferential corrosion has occurred in the heat affected zone of the weld and/or on the weld.

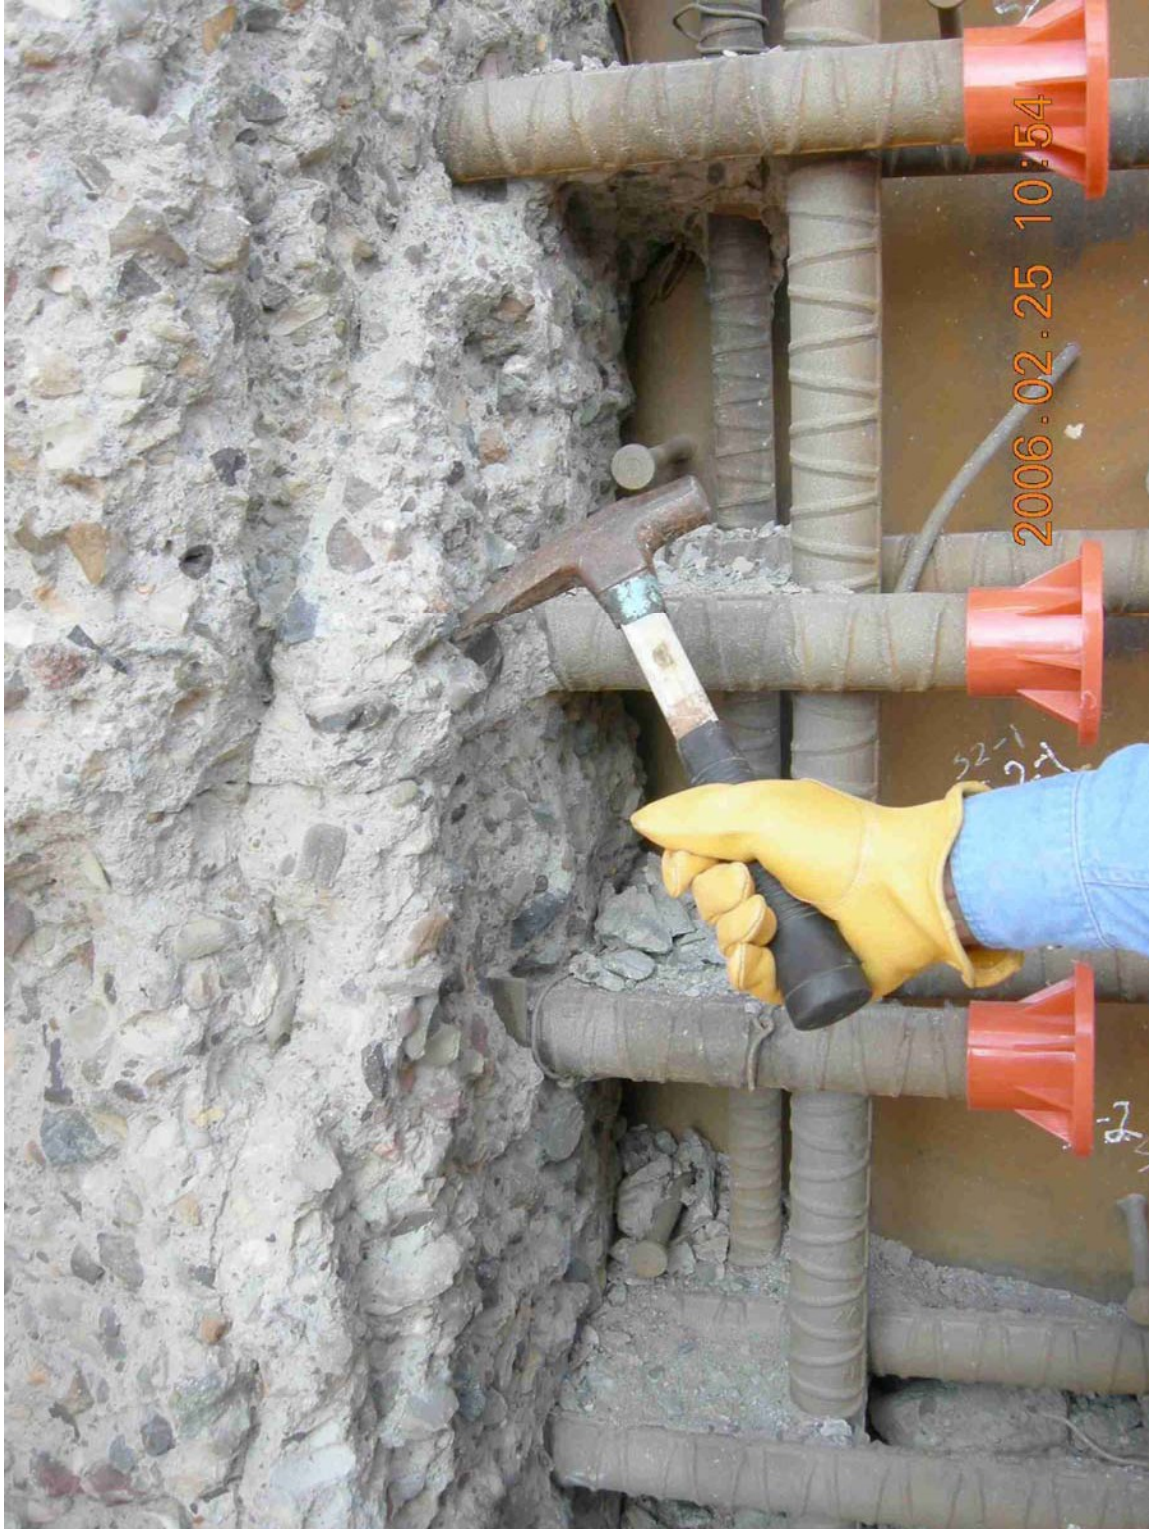
Photograph 6. Note the sound concrete that is on the left side of the access area. Note the lack of rusting on the reinforcing bars shown in the photograph.

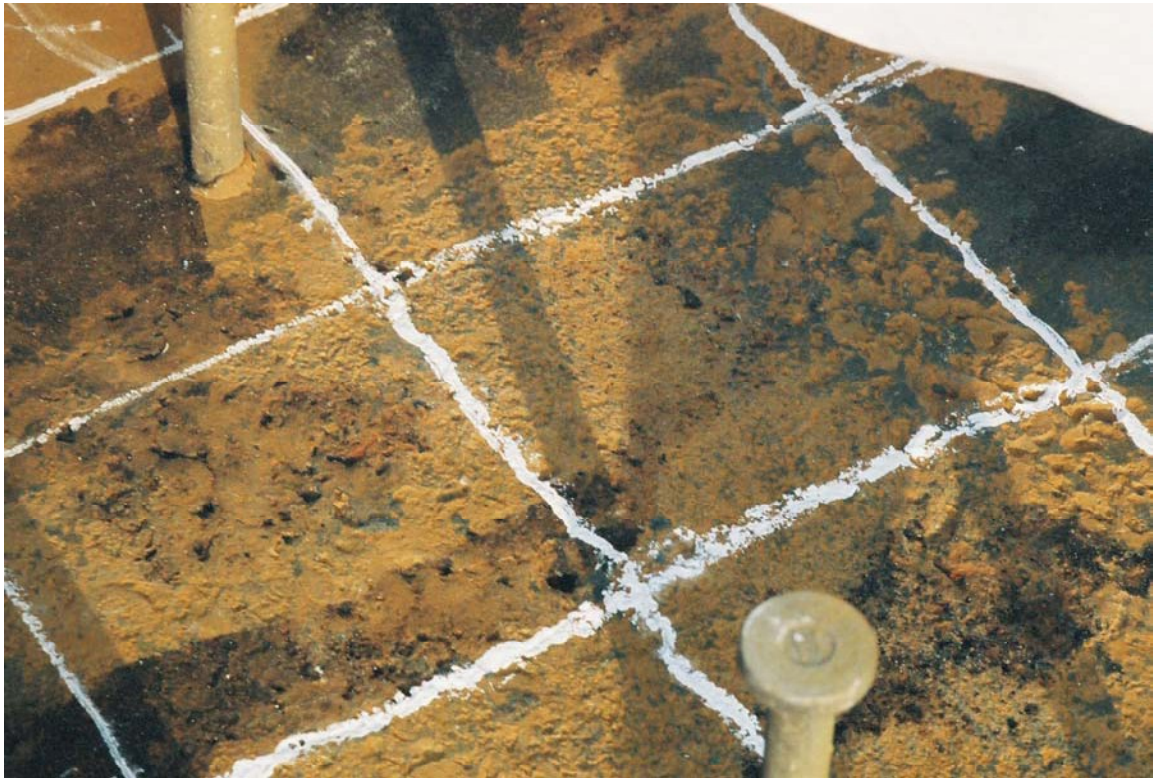
Photograph 7. Oxygen Concentration Cell Corrosion. Note the attached studs are free of corrosion other than a flash rusting. Note mill scale is present on the steel panel in the upper right portion of the photograph.

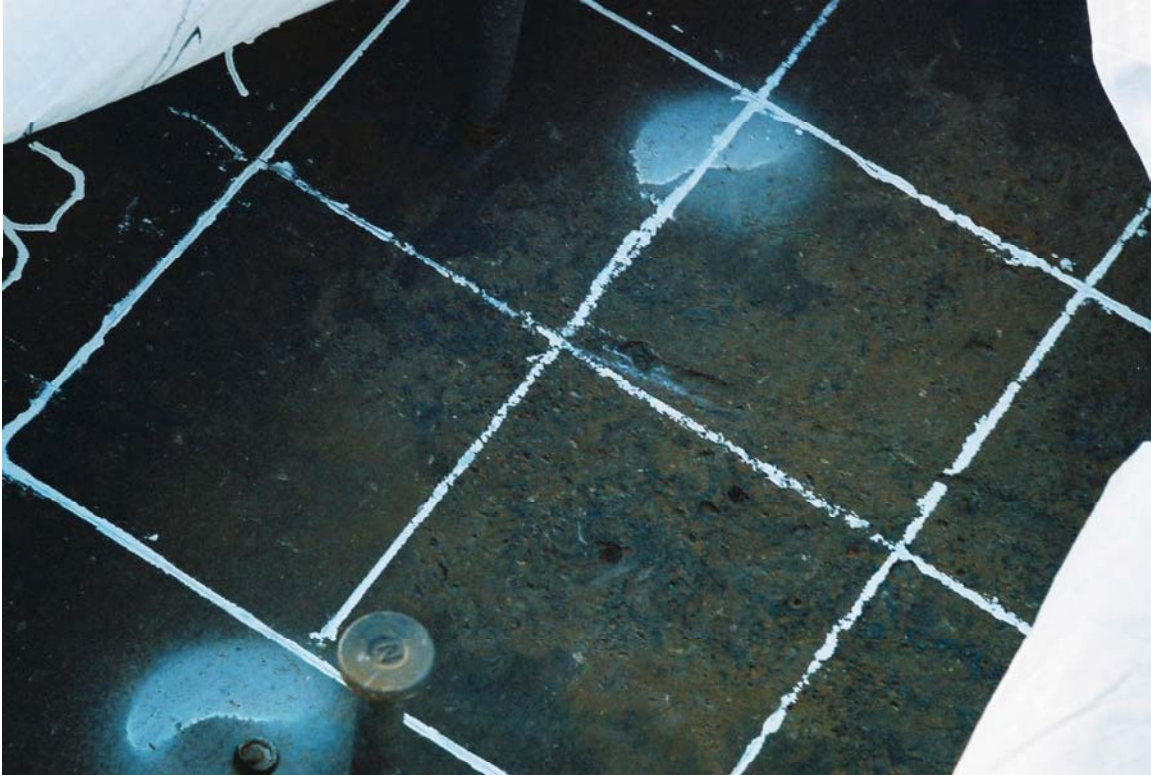
Photograph 8. Note Groove in Center of Photograph. Original mill scale is evident in this photograph in the upper portion of the photograph. There may be some black corrosion products in two of the pits near the center of this photograph.

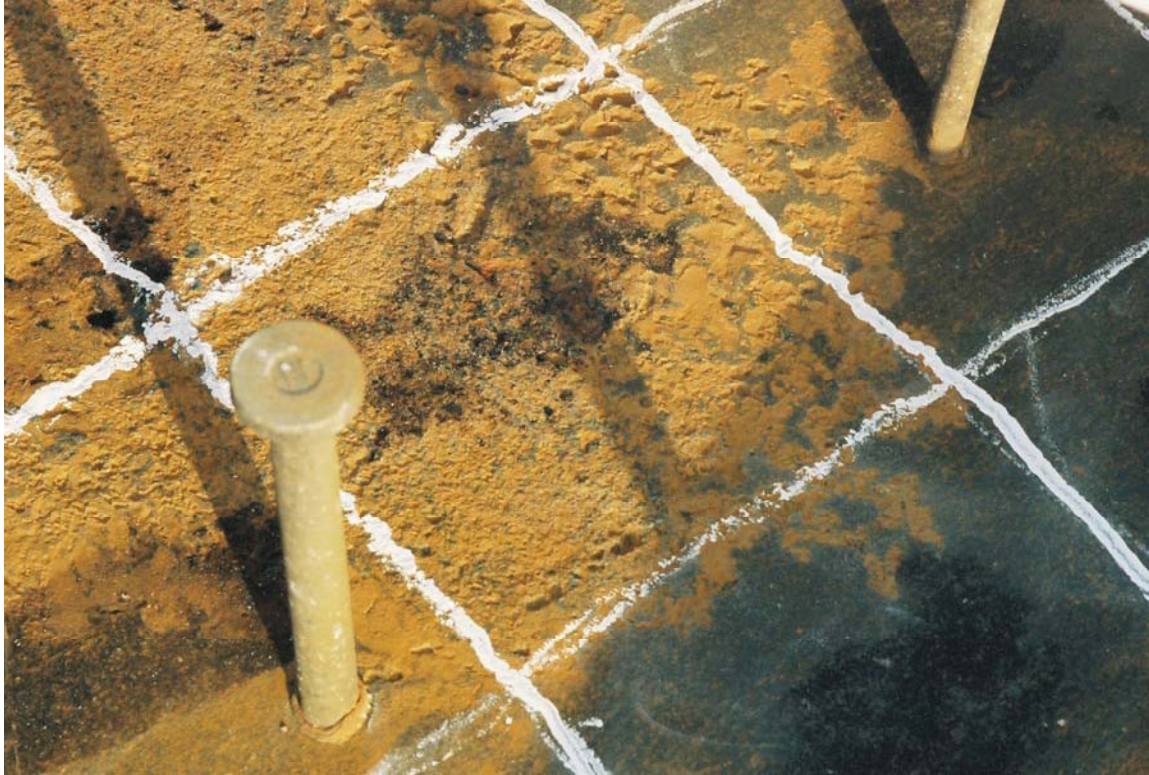
Photograph 9. Note Original Mill Scale in Lower Right of Photograph. There is a darkening of the corroded steel in the center of the photograph. (This darkening may have been water coming from pits in the steel as the discoloration was not apparent when the samples were observed in the laboratory). Note no apparent rusting on the steel studs (other than a flash rusting) attached to the corroded plate.

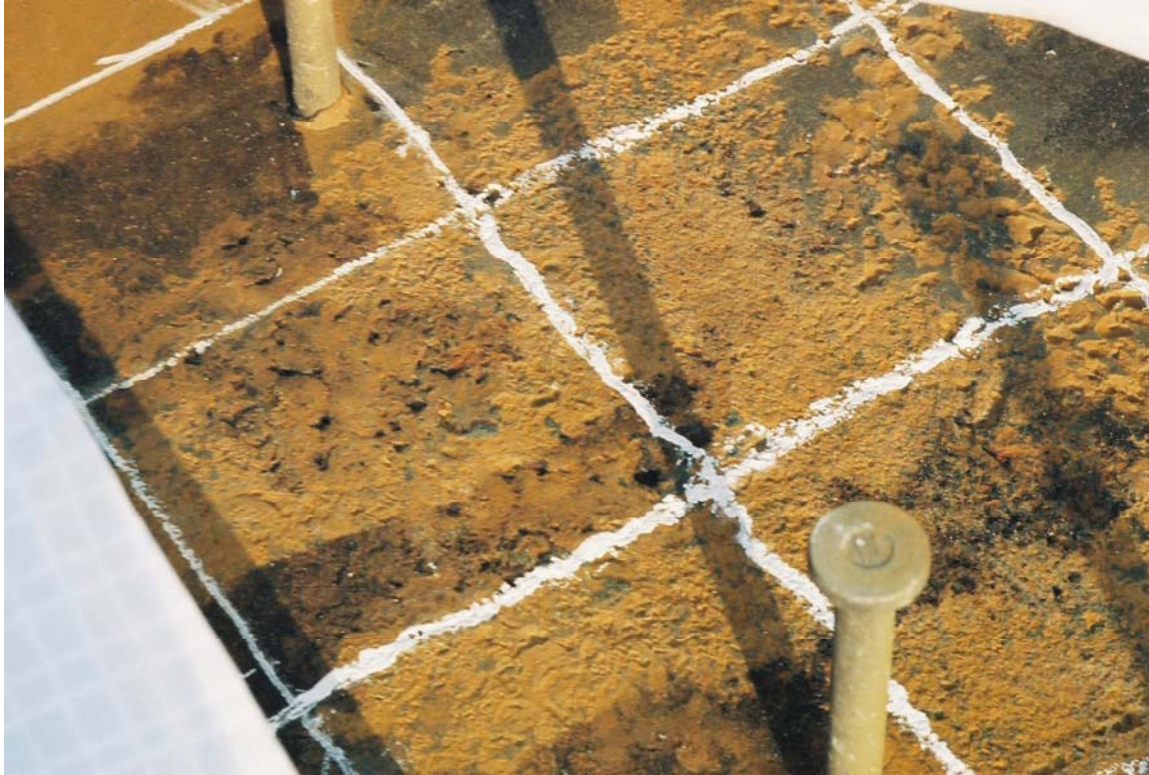
Photograph 10. Typical of Oxygen Cell Corrosion of Carbon Steel. Note the discoloration surrounding some of the pitted areas. Some original mill scale remains near the corroded areas.
