LAB NO.: M06074	WORK TRACKING NO.: 14878	PAGE 58 OF 78
PLANT & UNIT: BEAVER VALLEY #1	PART: CONTAINMENT MATERIALS	DATE: 3/9/2006

MATERIAL ANALYSIS REPORT

Beaver Valley Unit 1
Engineering Assessment Report
1 R 17 Exterior Containment Liner Corrosion

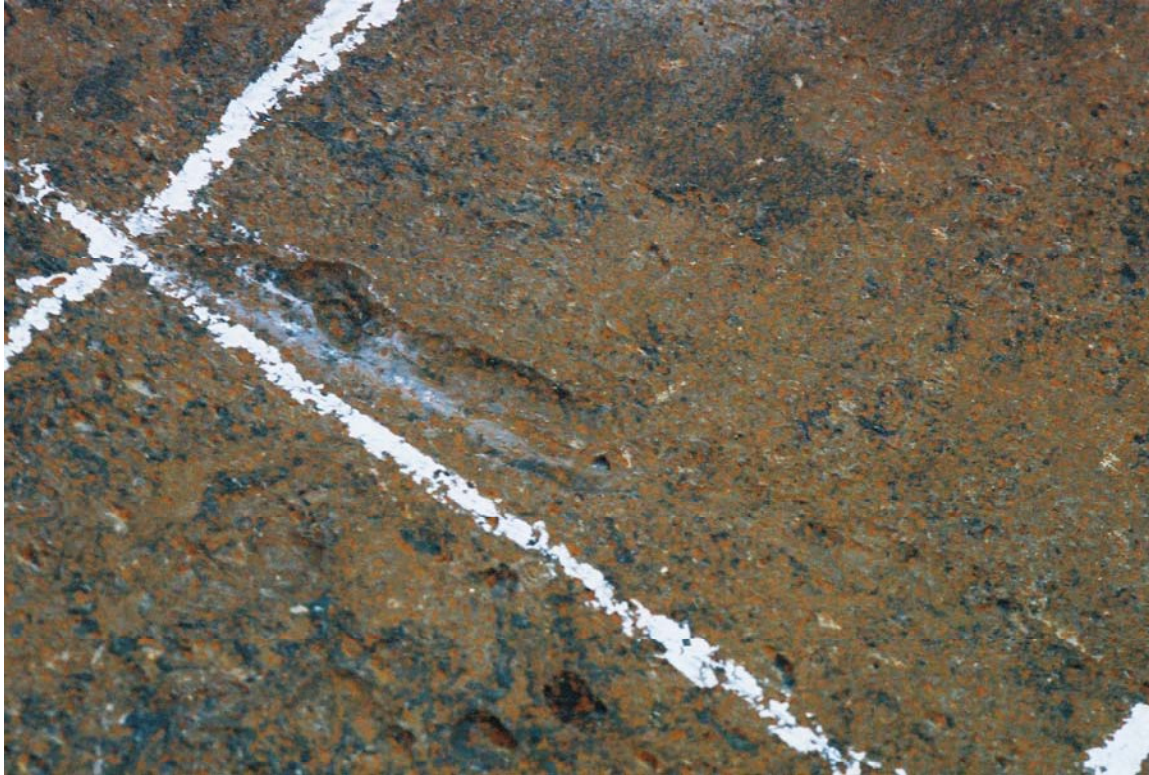
Photograph 11. Deep Depression in Corroded Carbon Steel. Oxygen cell corrosion on the steel panel in addition to the presence of original mill scale. There is a pit within the deep depression.

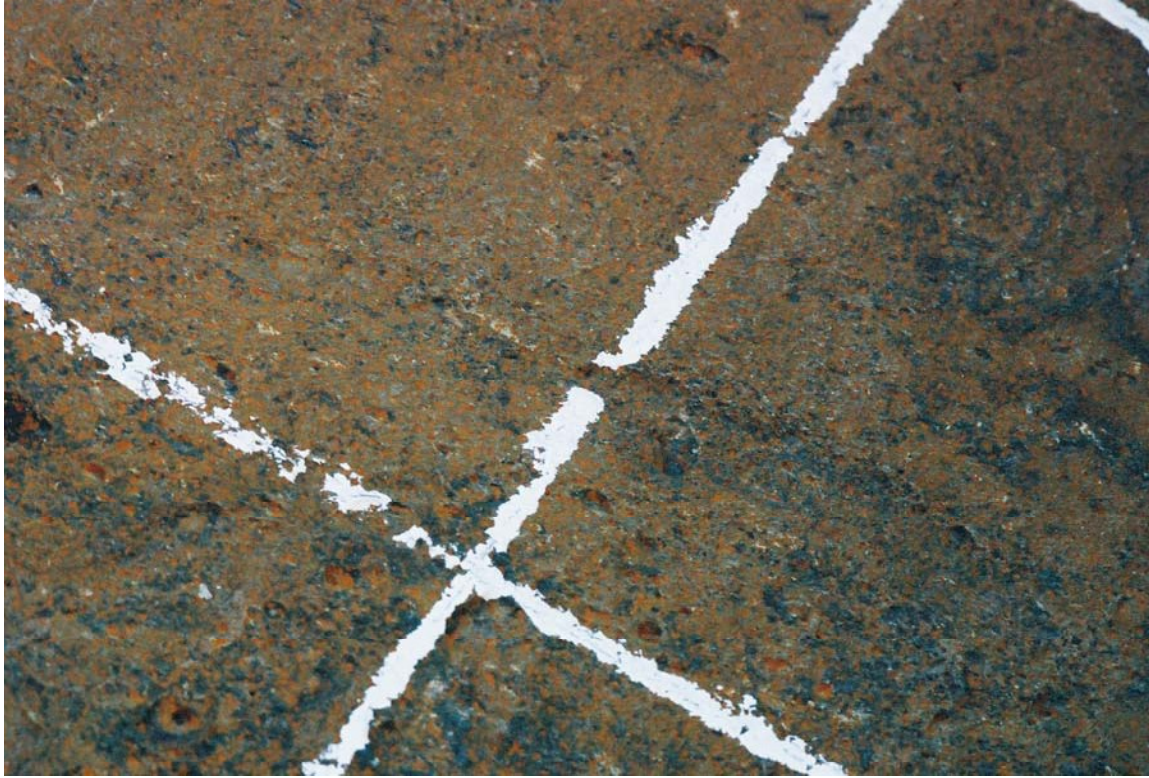
Photograph 12. Oxygen Concentration Cell Corrosion. Some mill scale appears throughout the photograph.

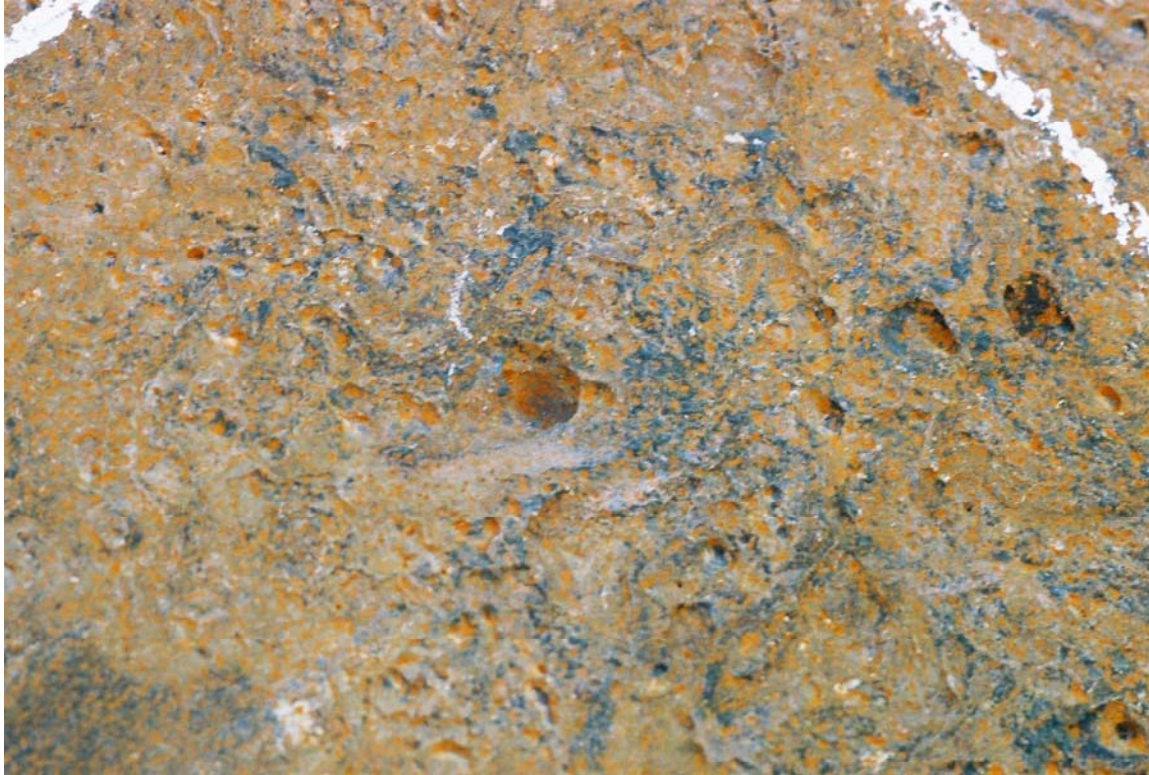
Photograph 13. Localized Pitting Corrosion. Typical of oxygen concentration cell Corrosion. The corrosion pattern has the appearance of having started at several breaks in the original mill scale and then have proceeded over the remainder of the surface in the photograph.

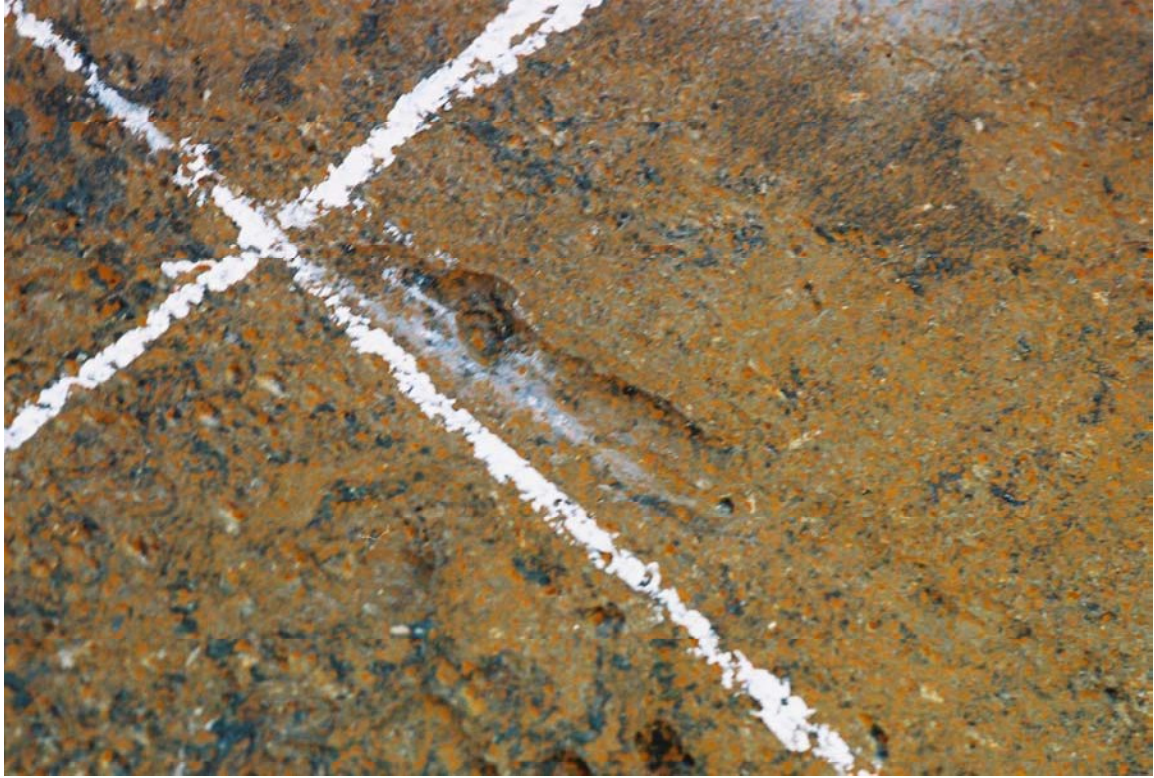
Photograph 14. Deep Corrosion Channel in Carbon Steel.

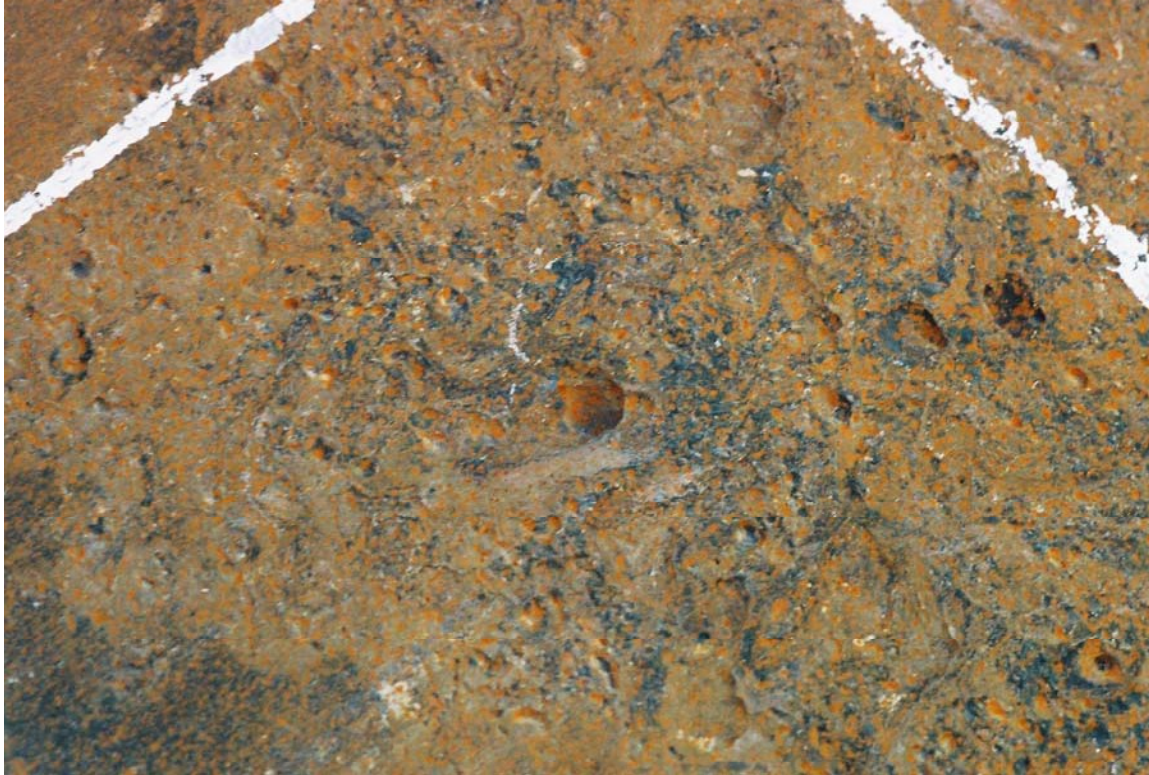
Photograph 15. Details of Corrosion Pit in Carbon Steel.
