II. Second Investigation

1. Purpose

The purpose of this report is to provide results of additional investigation of I type mockups and boat samples collected from the U3B and U3A RSGs.

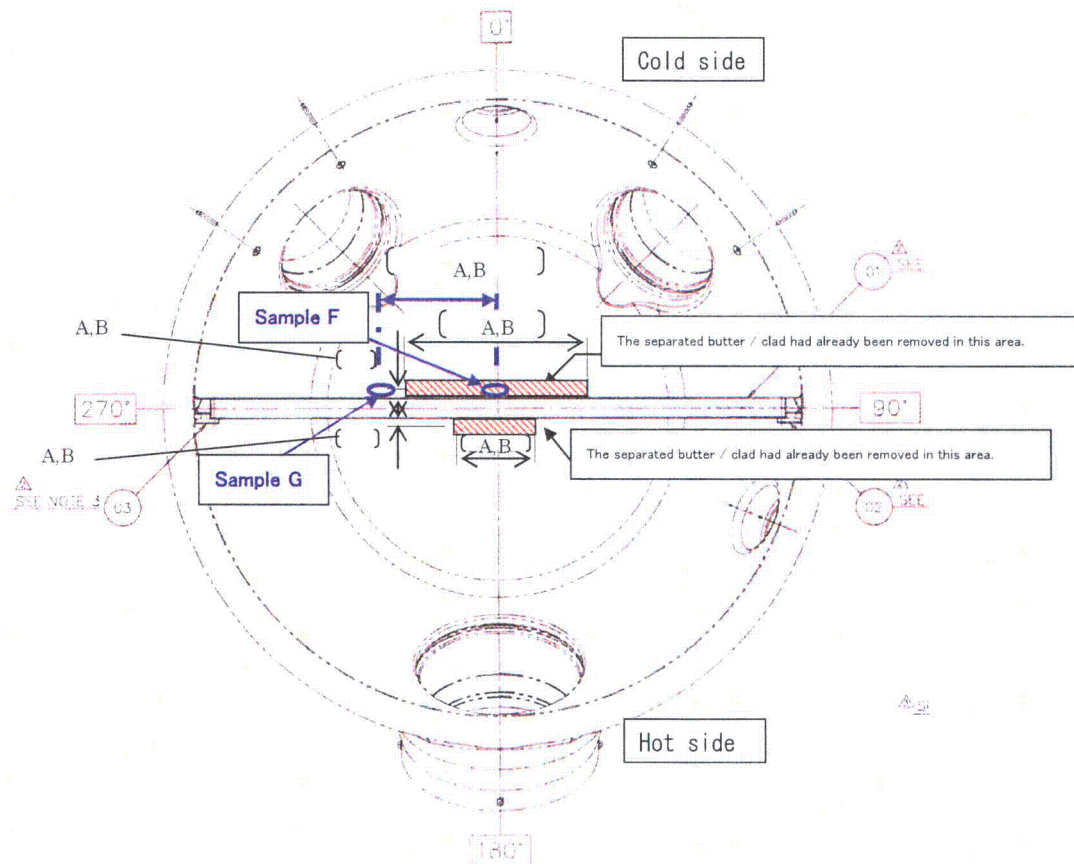
Figure A.44(1) The collecting location and schematic illustration of boat samples.
(collecting location of boat samples)

2 boat samples were additionally collected from Unit 3A RSG at the location as shown in Figure A.44. The detail of the each sample was shown in Table A.5.

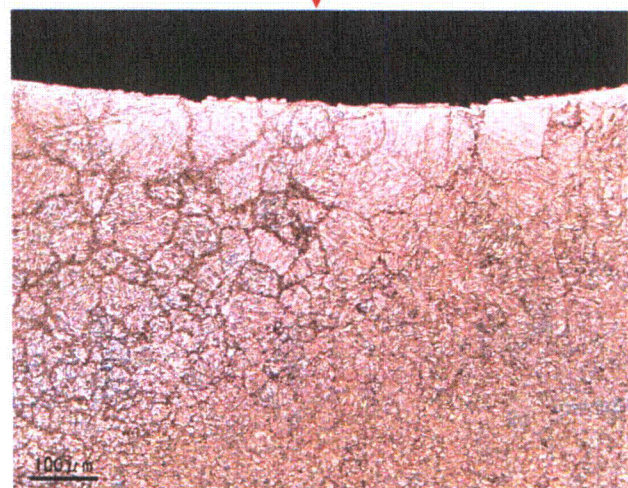
Figure A.45(1) Microstructure of the cross section of LAS channel head in boat samples A and B(152 buttering)

Table A.7 shows the result of the grain size measurement in HAZ. The photographs used for grain size measurement were shown in Figures A.45.

The HAZ of 152 buttering tends to reveal larger grains (mean grain size was about 0.1mm) compared with HAZ of stainless steel clad (mean grain size was 0.02mm to 0.01mm). It was considered that the HAZ of stainless steel clad was refined by heat input of 2nd layer welding.

Sample B, HAZ by 152 buttering (SMAW)
Grain size number: 5, Grain size: 0.063mm

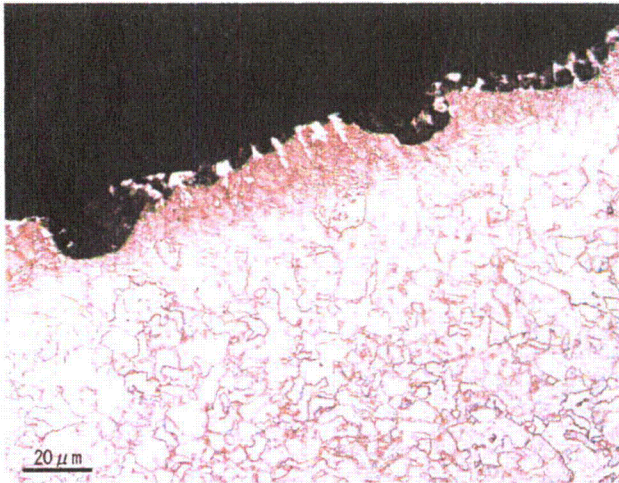
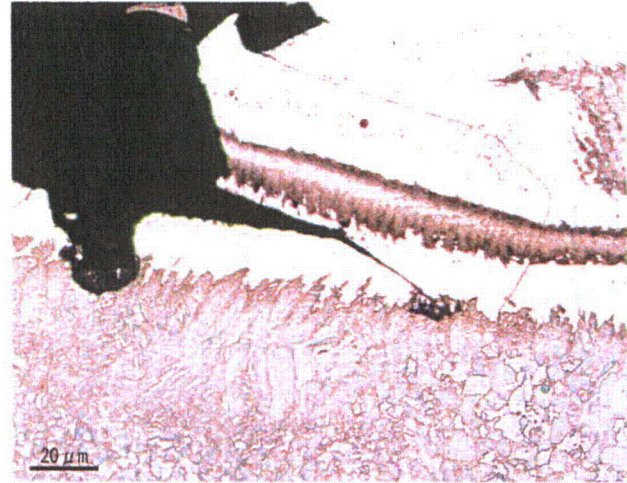
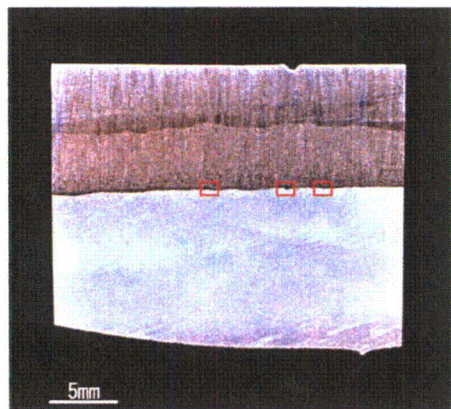
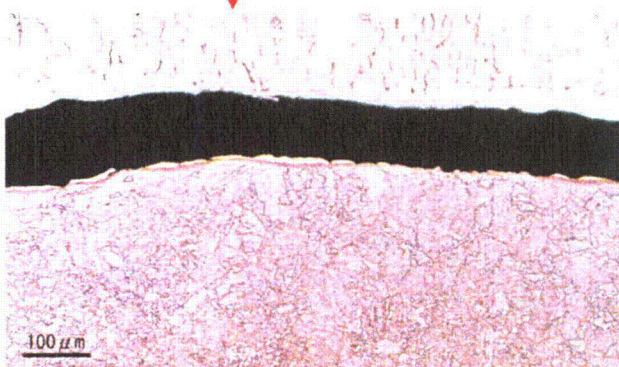
Figure A.45(2) Microstructure of the cross section of LAS channel head in boat samples A and C

Sample A, HAZ by Stainless steel (SMAW)
Grain size number: 10.5, Grain size: 0.009mm

Sample C, HAZ by Stainless steel (ESW)
Grain size number: 9.5, Grain size: 0.013mm

Sample C, HAZ by Stainless steel (ESW)
Grain size number: 6, Grain size: 0.044mm

Sample C, HAZ by Stainless steel (ESW)
Grain size number: 9, Grain size: 0.0193mm

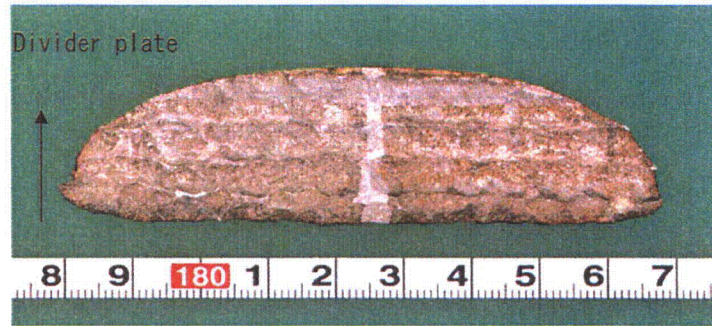
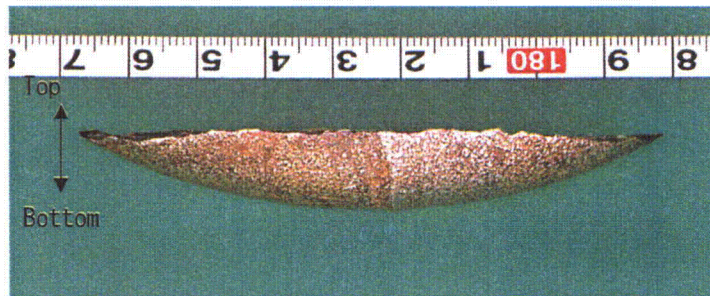
Figure A.46 Appearance of sample F collected from U3A

Fracture surface (direction A)

Electron discharge machined surface (direction B)

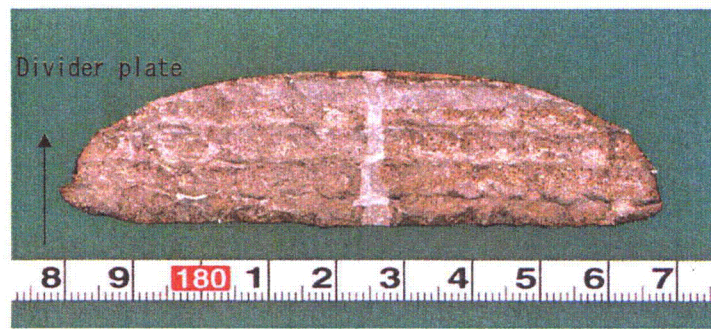
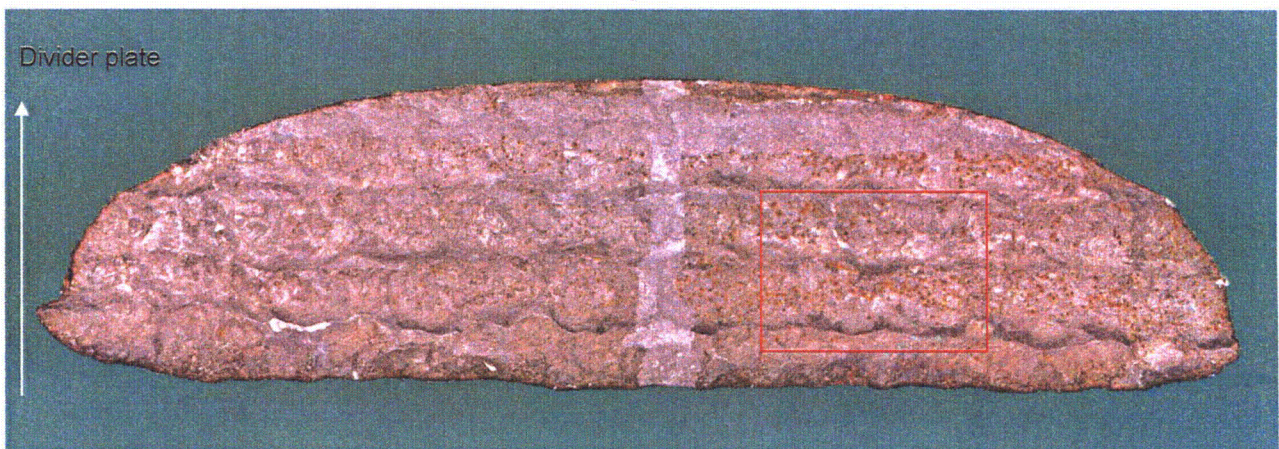
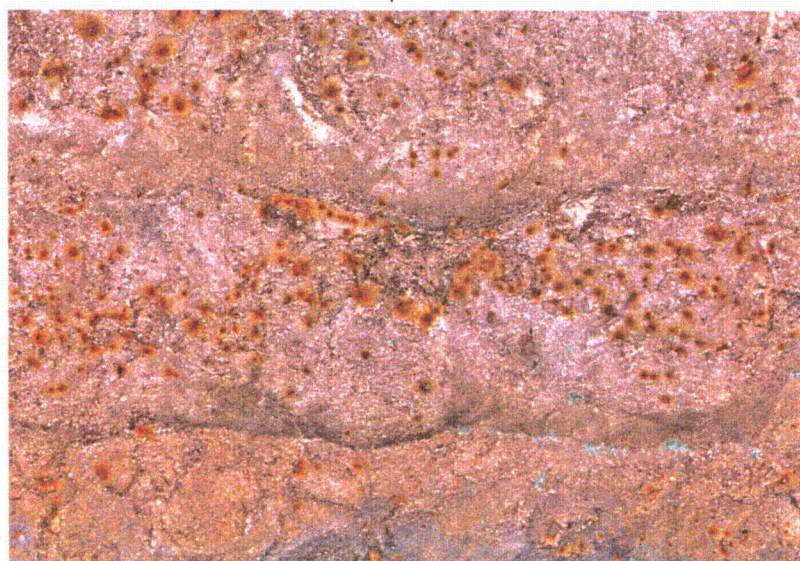
Figure A.47 Appearance of fracture surface of sample F

Figure A.47 shows appearance of fracture surface of the sample. A rough surface was observed on the fracture surface as observed in sample F. It is supposed that the rough surface corresponds to welding bead shape of 152 buttering.

Fracture surface of sample F

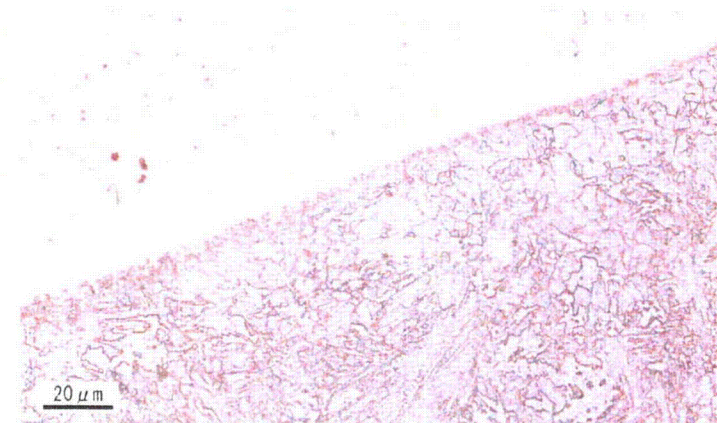
Figure A. 53(1) Microstructure of the cross section of LAS in I type model (after 152 buttering)

Any difference in grain size was not observed between machining and grinding after 152 buttering in I type mockups as shown in Figure A. 53(1). The effect of gouging on grain size was observed before 152 buttering as shown in Figure A. 53(2).

TP.2-2, ESW + Gouging + grinding + 152 buttering (SMAW)
Grain size number: 10.5, Grain size: 0.009mm

TP.3-1, ESW + Machining + 152 buttering (SMAW)
Grain size number: 10.5, Grain size: 0.009mm

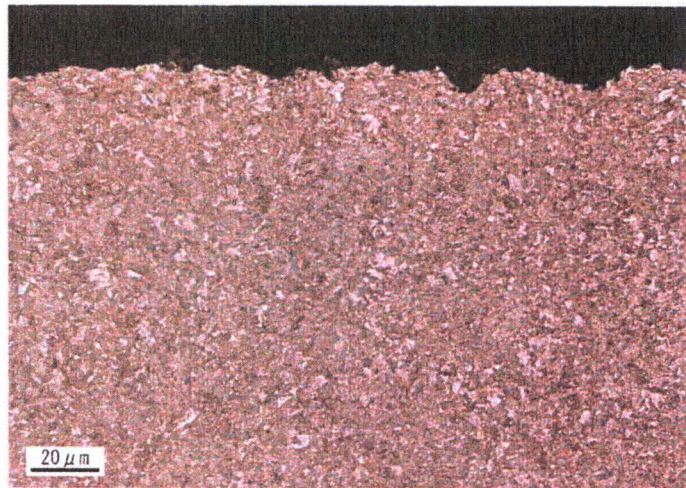
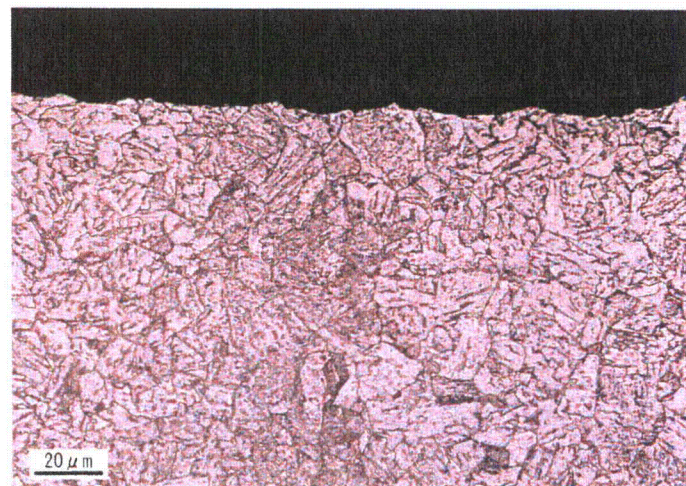
Figure A. 53(2) Microstructure of the cross section of LAS in I type model (before 152 buttering)

TP.2-1, ESW + Gouging + grinding
Grain size number: 13, Grain size: 0.004mm

TP.4-2, As gouging
Grain size number: 14, Grain size: 0.003mm

TP.3-1, As machining
Grain size number: 10, Grain size: 0.011mm

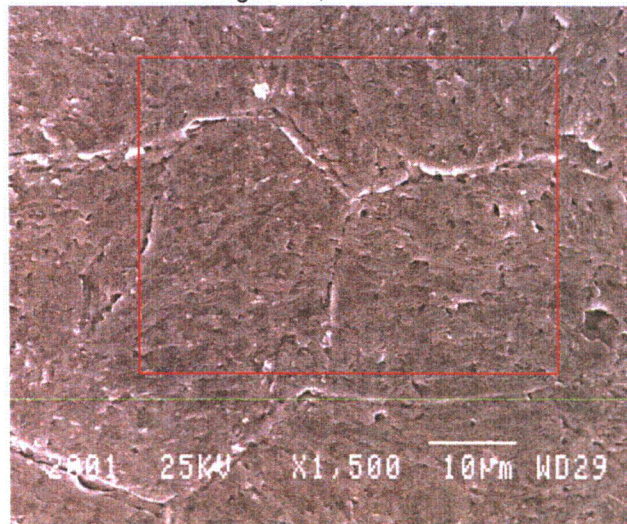
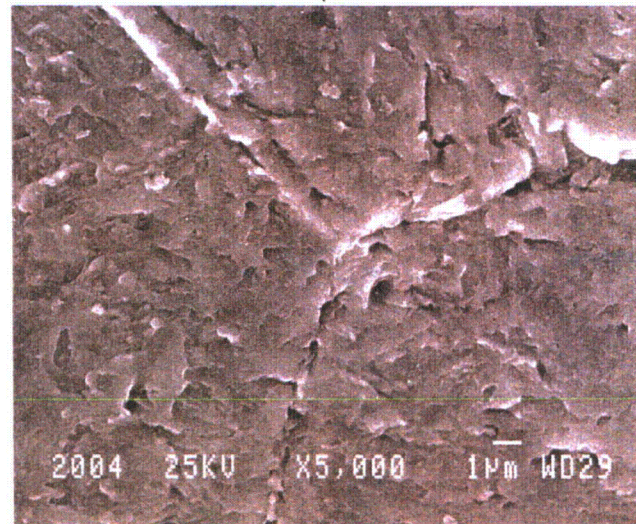
Figure S.2(1) SEM pictures of the fracture surface of the boat sample
(Sample A, TP A-1, location C)

- 1) At high magnification, the fracture surface of separation between low alloy steel and 152 buttering appeared to be like martensitic lath structure.
- 2) At high magnification, the fracture surface of separation between low alloy steel and stainless steel clad reveals relatively smooth surface.
- 3) Component variations were observed in 152 buttering adjacent to the separation.
- 4) It was observed that there was a certain level of compositional distribution of Fe, Cr and C at the fracture surface.
