U.S. NUCLEAR REGULATORY COMMISSION
REGION IV

Inspection Report: 70-925/94-01

Inspection At: Cimarron Facility, Crescent, Oklahoma

Inspection Conducted: November 17-18, 1994

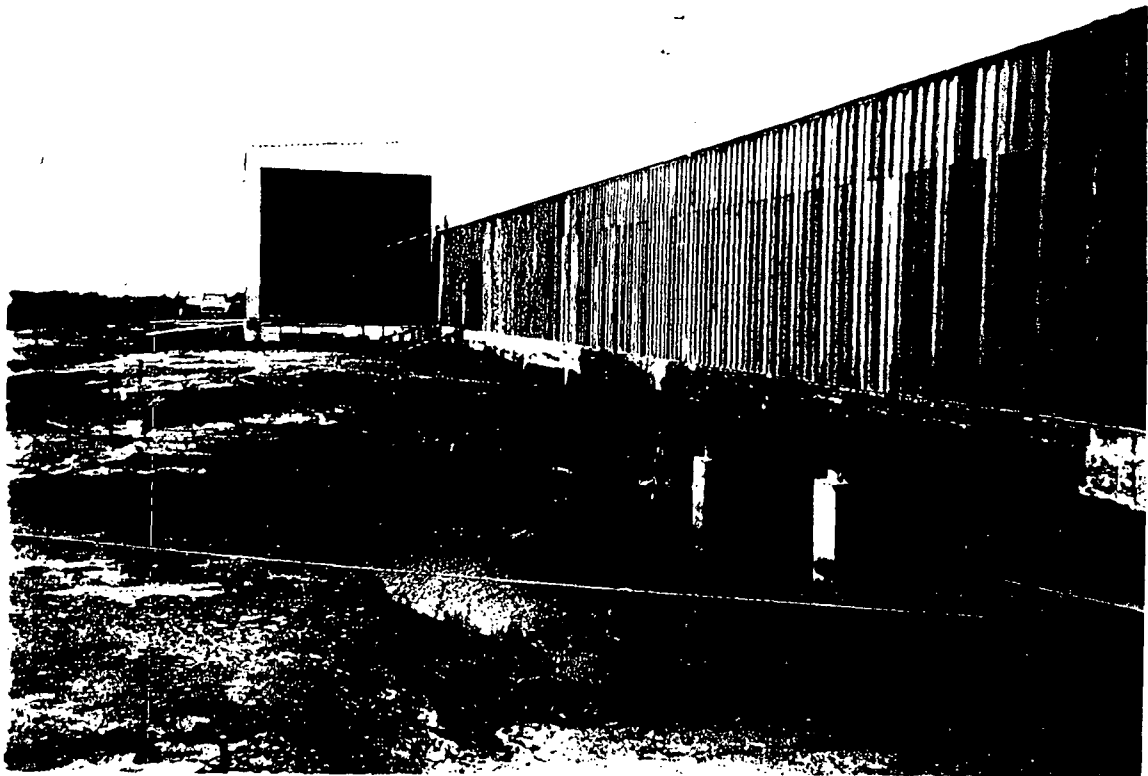
The areas of the facility that were toured included the uranium building, the yard, and the onsite soil disposal cell (also referred to by the licensee as Burial Ground No. 4). Large amounts of building material and soil had been excavated from within and around the uranium building during the remediation process. The licensee stated that the lack of soil in and around the uranium building was creating a foundation support hazard. The inspector noted that some concrete blocks had been fabricated to assist in the support of the building foundation. The licensee was waiting on NRC approval of the final survey results of the remediated area prior to moving foundation support material back into the area.

Photograph 3: Uranium Building (south end). Note excavation of soil around foundation.
