SUMMARY REPORT OF  
REINSPECTION AND APPRAISAL OF THE INDIAN POINT NO. 3  
REACTOR PRESSURE VESSEL SUBSEQUENT TO HOIST  
FAILURE ON JANUARY 12, 1971

D. A. Canonico      R. W. McClung  
J. G. Merkle

Summary Report of ORNL Consulting Services to  
Consolidated Edison Company of New York, Inc.  
per  
Consultant Contract OIC-C-45

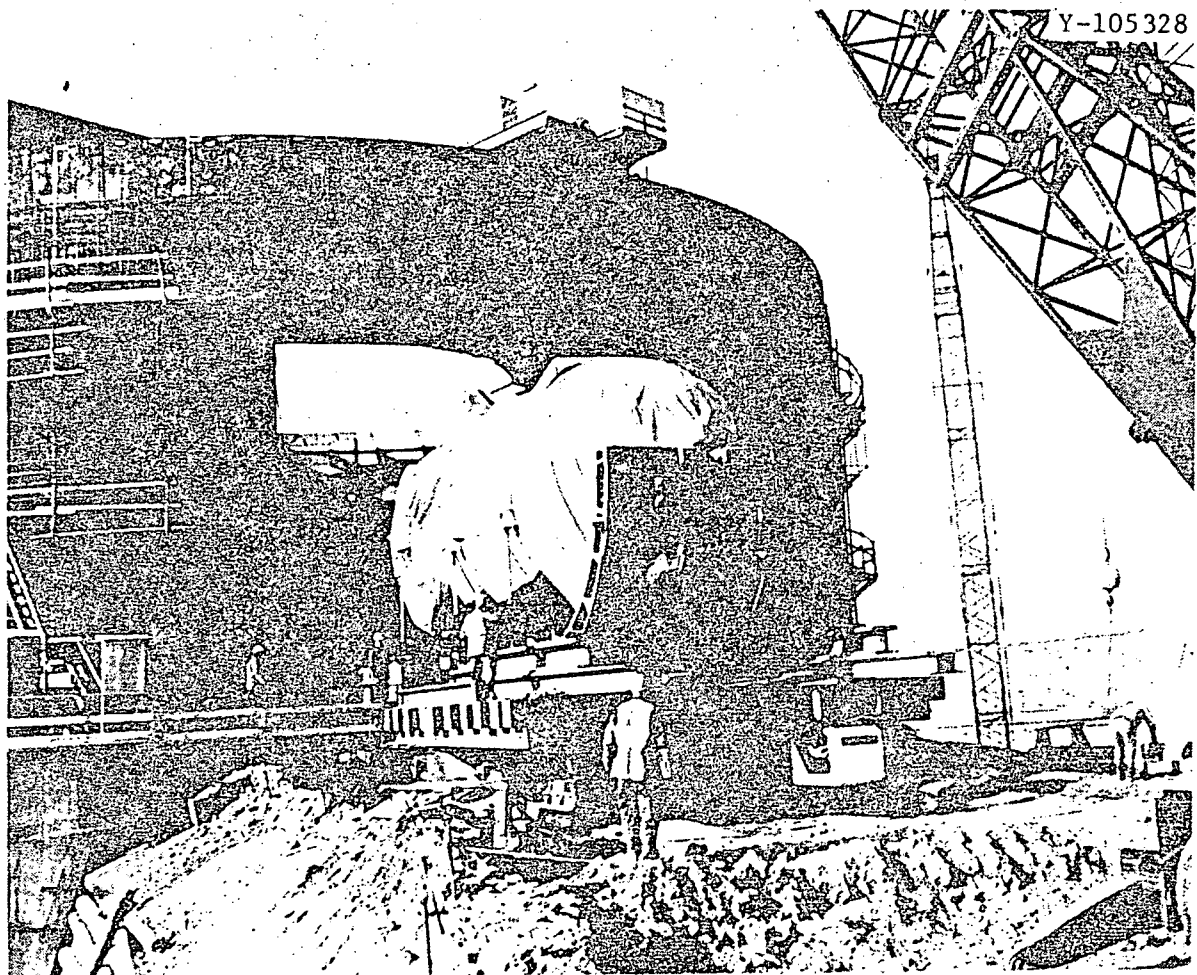
Fig. 1. Vessel Being Moved Onto Site. Note shipping ring and U-shaped hold-down bolts.
