**UNITED STATES  
NUCLEAR REGULATORY COMMISSION**  
REGION II  
SAM NUNN ATLANTA FEDERAL CENTER  
61 FORSYTH STREET, SW, SUITE 23T85  
ATLANTA, GEORGIA 30303-8931

March 19, 2010

**SUBJECT: NRC AUGMENTED INSPECTION TEAM REPORT NO. 70-143/2009-011**

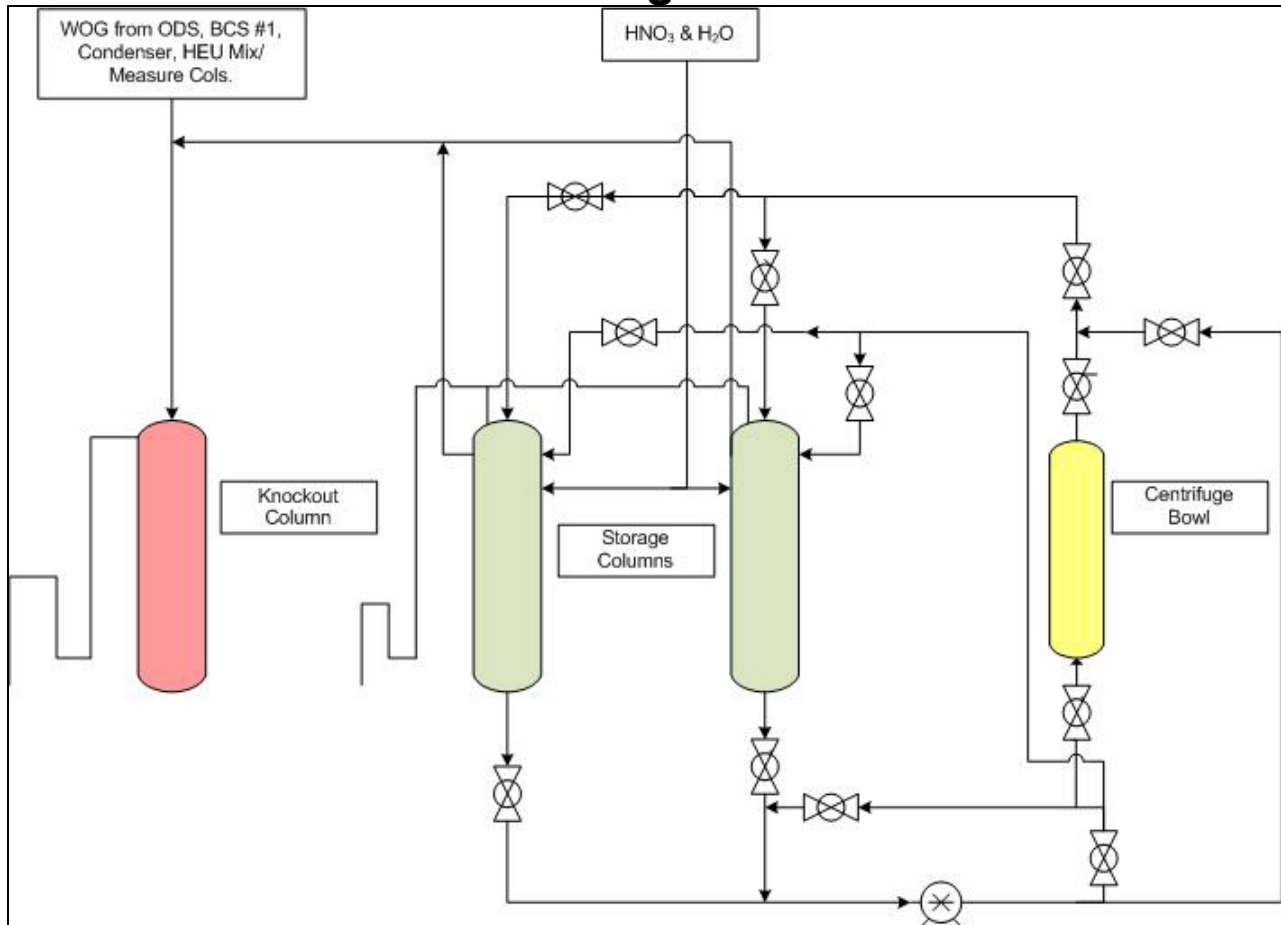
### **Bowl Cleaning Station #2**

This chemical process is exothermic and has historically produced nitrogen oxide compounds (NOx) which are normally captured and processed by the wet off-gas (WOG) system. Safety Controls designated as IROFS include a NOx detection system with sensors at the employee working level and at the ceiling close to the knock out column's siphon break which is a potential release point for these gases.

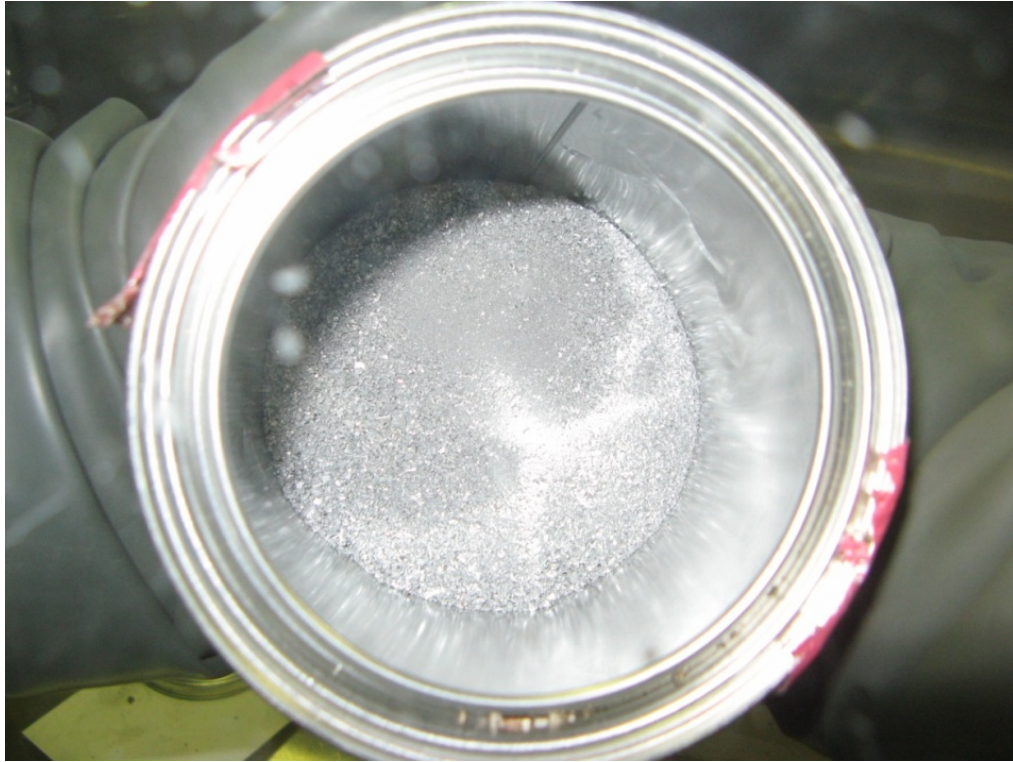
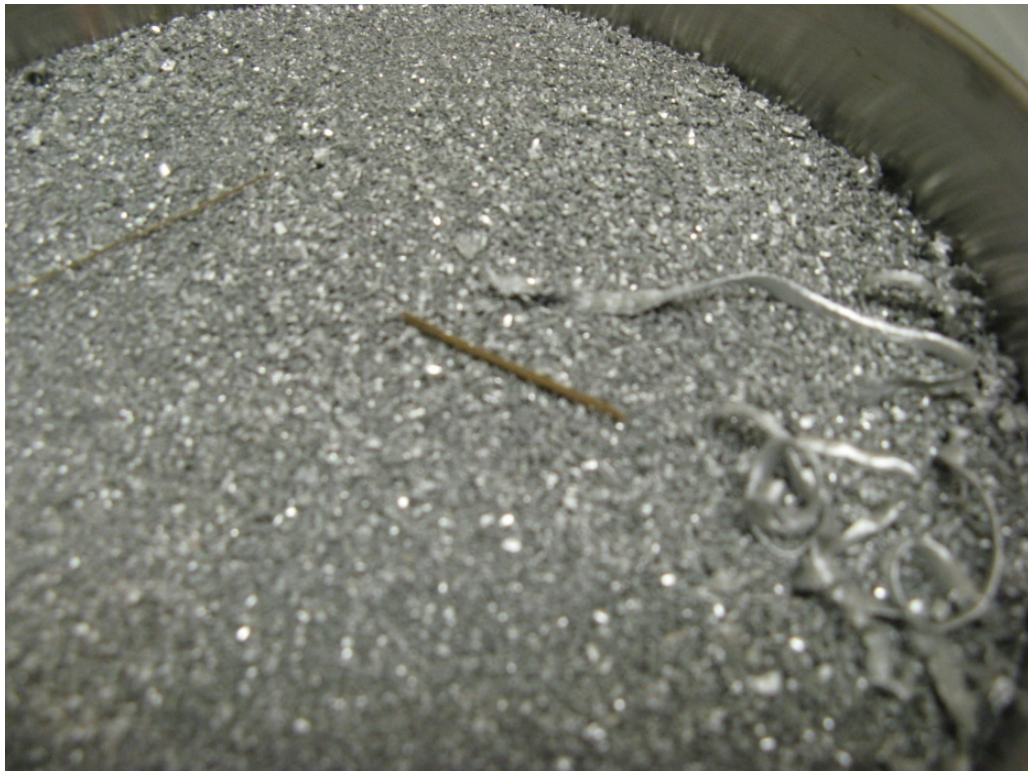
## Representative Picture of UAL Alloy Fines

On October 12, 2009, NFS finalized its procedures for chemical processing of UAI fines scrap material in the centrifuge BCS. A representative picture of this material is included as Attachment 3. The NFS laboratory had analyzed a sample of fines to determine the procedure modifications that were necessary to process this material. The decision was made to process the fines in the BCS using nitric acid because laboratory testing indicated that dissolving the fines with caustic in the normal dissolver column was not recommended due to the potential for a vigorous reaction. The nitric acid dissolution of the first batch of material (performed in BCS 2) did not proceed according to expectations.

The information collected by the team indicated that the safety reviews of the ECRs were processed without consideration given as to how the high surface area of the fines could affect the rate of dissolution (and thus NO<sub>x</sub> generation) at the BCS. In addition, the team noted that safety approvals for ECR 20092008, which was initiated to address a procedural inconsistency that ECR 20091919 failed to catch, were conducted after hours over the phone to expedite the processing of this change request to continue production with little to no questioning attitude. The team determined that the decisions from the safety reviews were also based on incorrect assumptions regarding the changes proposed and resulted in the decisions to proceed with the operations that resulted in the event.

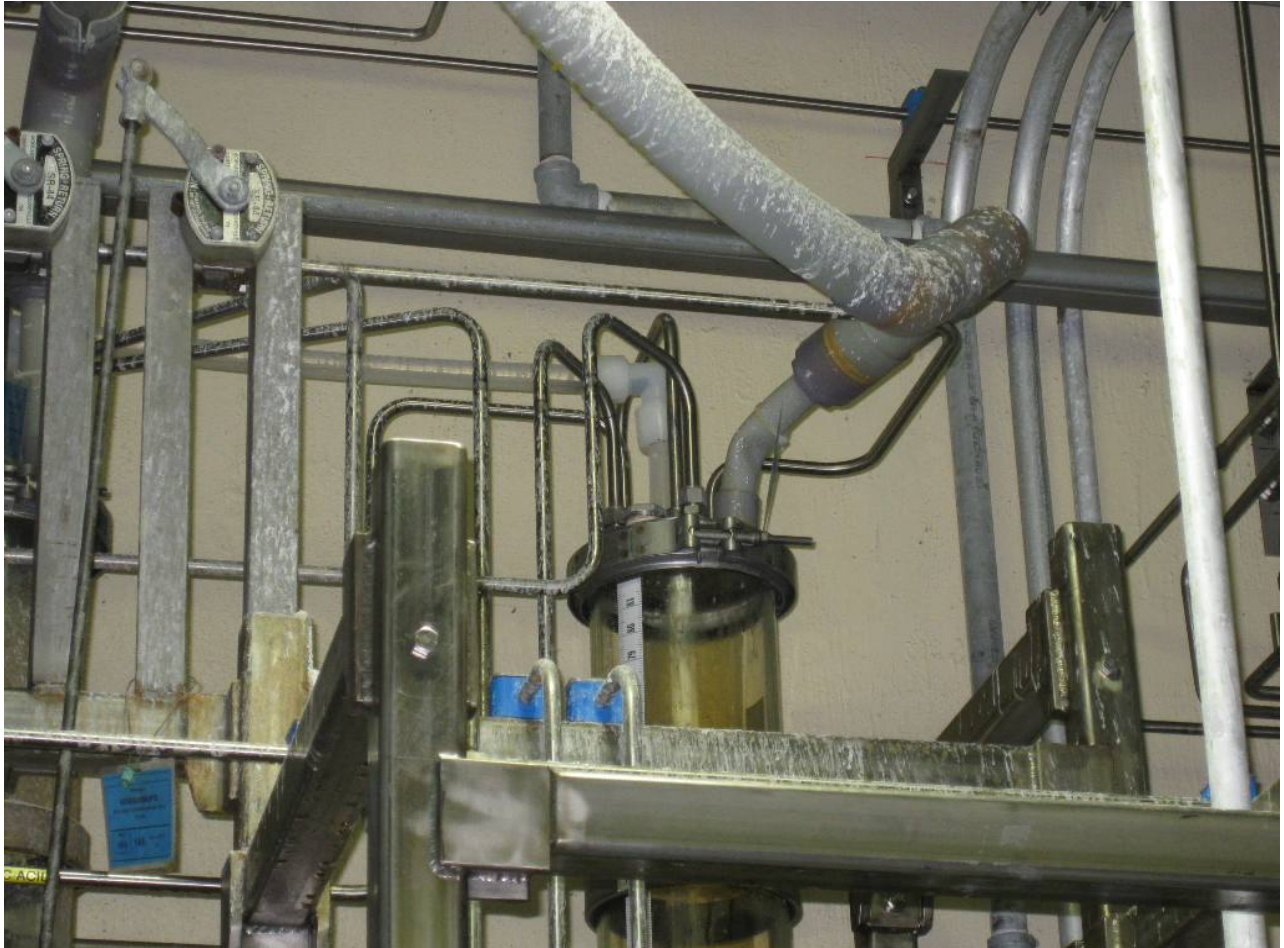
## Damaged Off Gas Piping

The process evolution that resulted in this event commenced at approximately 4:15 a.m. on October 13, 2009. Within a few minutes of commencing the bowl cleaning operation, a vigorous reaction started and operators noted a large amount of NO<sub>x</sub> generation visibly greater than expected. The affected process area is provided with two NO<sub>x</sub> detectors, the upper NO<sub>x</sub> detector is located above the process area and the lower NO<sub>x</sub> detector is located in the worker breathing zone. The first NO<sub>x</sub> alarm was received at time 0435. All NO<sub>x</sub> alarms received were from the upper NO<sub>x</sub> detector and at no time during this event were any NO<sub>x</sub> alarms received in the worker breathing zone.
