UNITED STATES
NUCLEAR REGULATORY COMMISSION

SUBJECT: FORT CALHOUN STATION - NRC FOLLOWUP INSPECTION - INSPECTION
REPORT 05000285/2010007; PRELIMINARY SUBSTANTIAL FINDING

Failure to Maintain External Flood Procedures

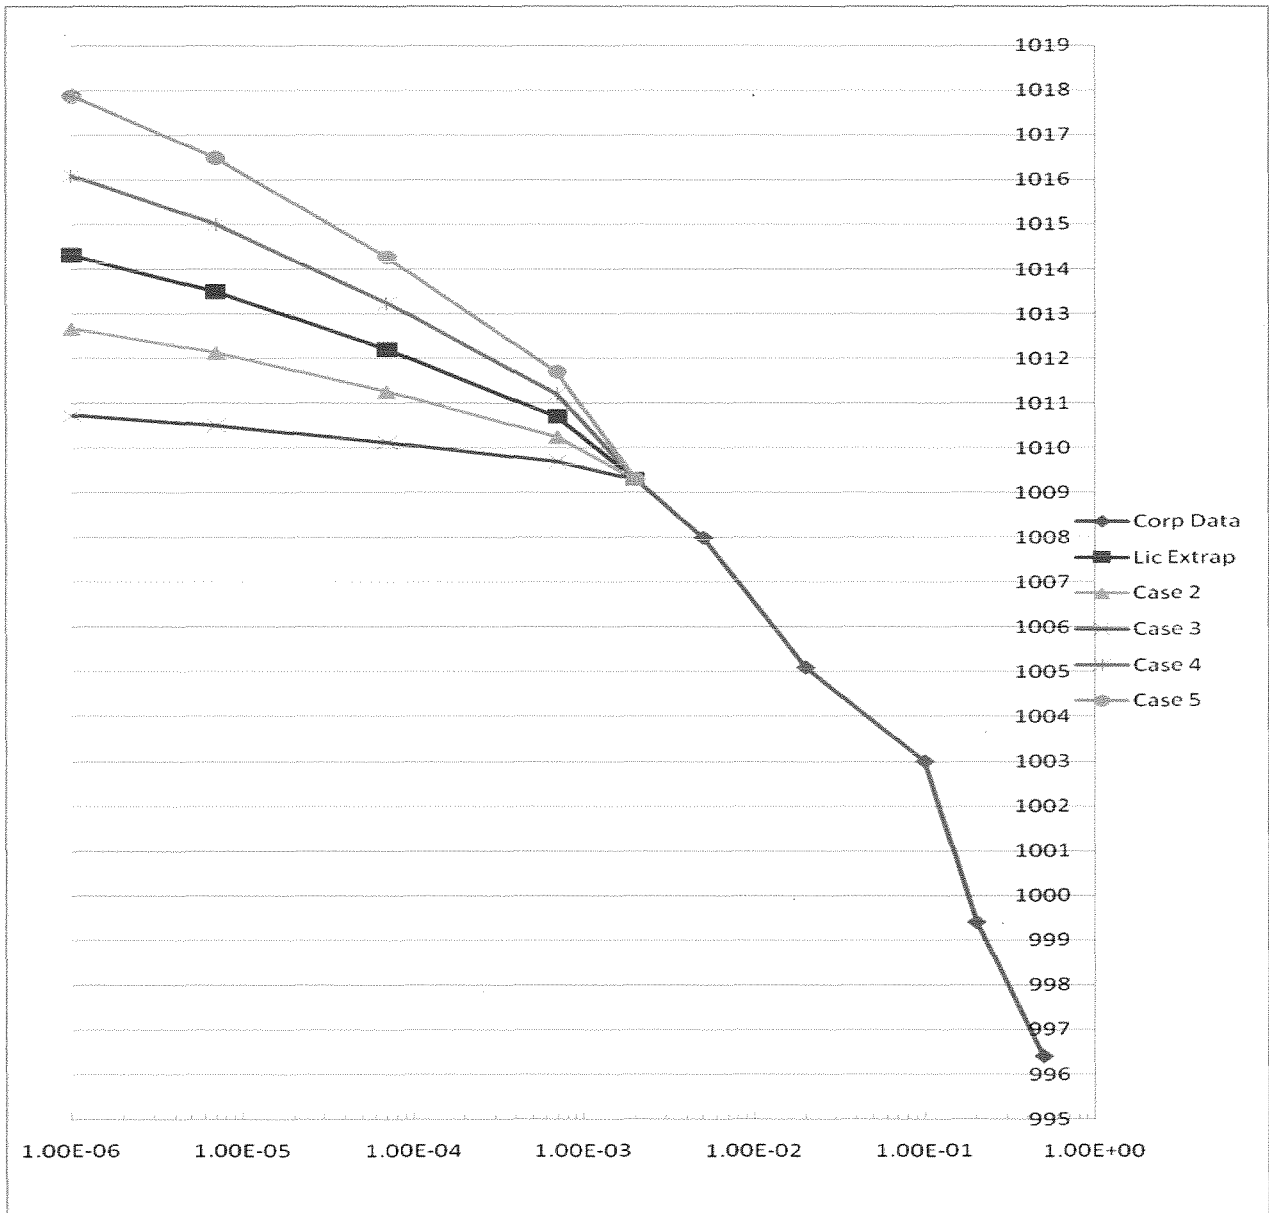
Frequency Extrapolations – Height versus Logarithm of Flood Frequency Excedance

For the sensitivity cases, the analyst targeted the flooding elevation at the 1E-5/year point for comparison. At the 1E-5/year point on the Fort Calhoun flood hazard curve, the flood level was 1013.5 feet MSL. The analyst then constructed alternate curves, two above and two below this base curve. The curves are shown in Attachment 4. The curves were numbered Case 1 through Case 5. Case 3 was the licensee’s estimate and was considered the best available information for this assessment.

It's important to note that Case 1 may be unrealistically low. After almost 100,000 years of additional exposure, the flood elevation at the 1 E-5/year point was a little over 1 foot above that predicted by the Army Corps of Engineers at the 1/500 year point. Likewise, Case 5 may be unrealistically high. The plotted line deviated from the Army Corps of Engineers' estimates at a sharper angle.

Case 3 was the best estimate case specified by the licensee.

Cases 1 and 2 were sensitivity cases that assumed that the licensee's best estimate was overly conservative.

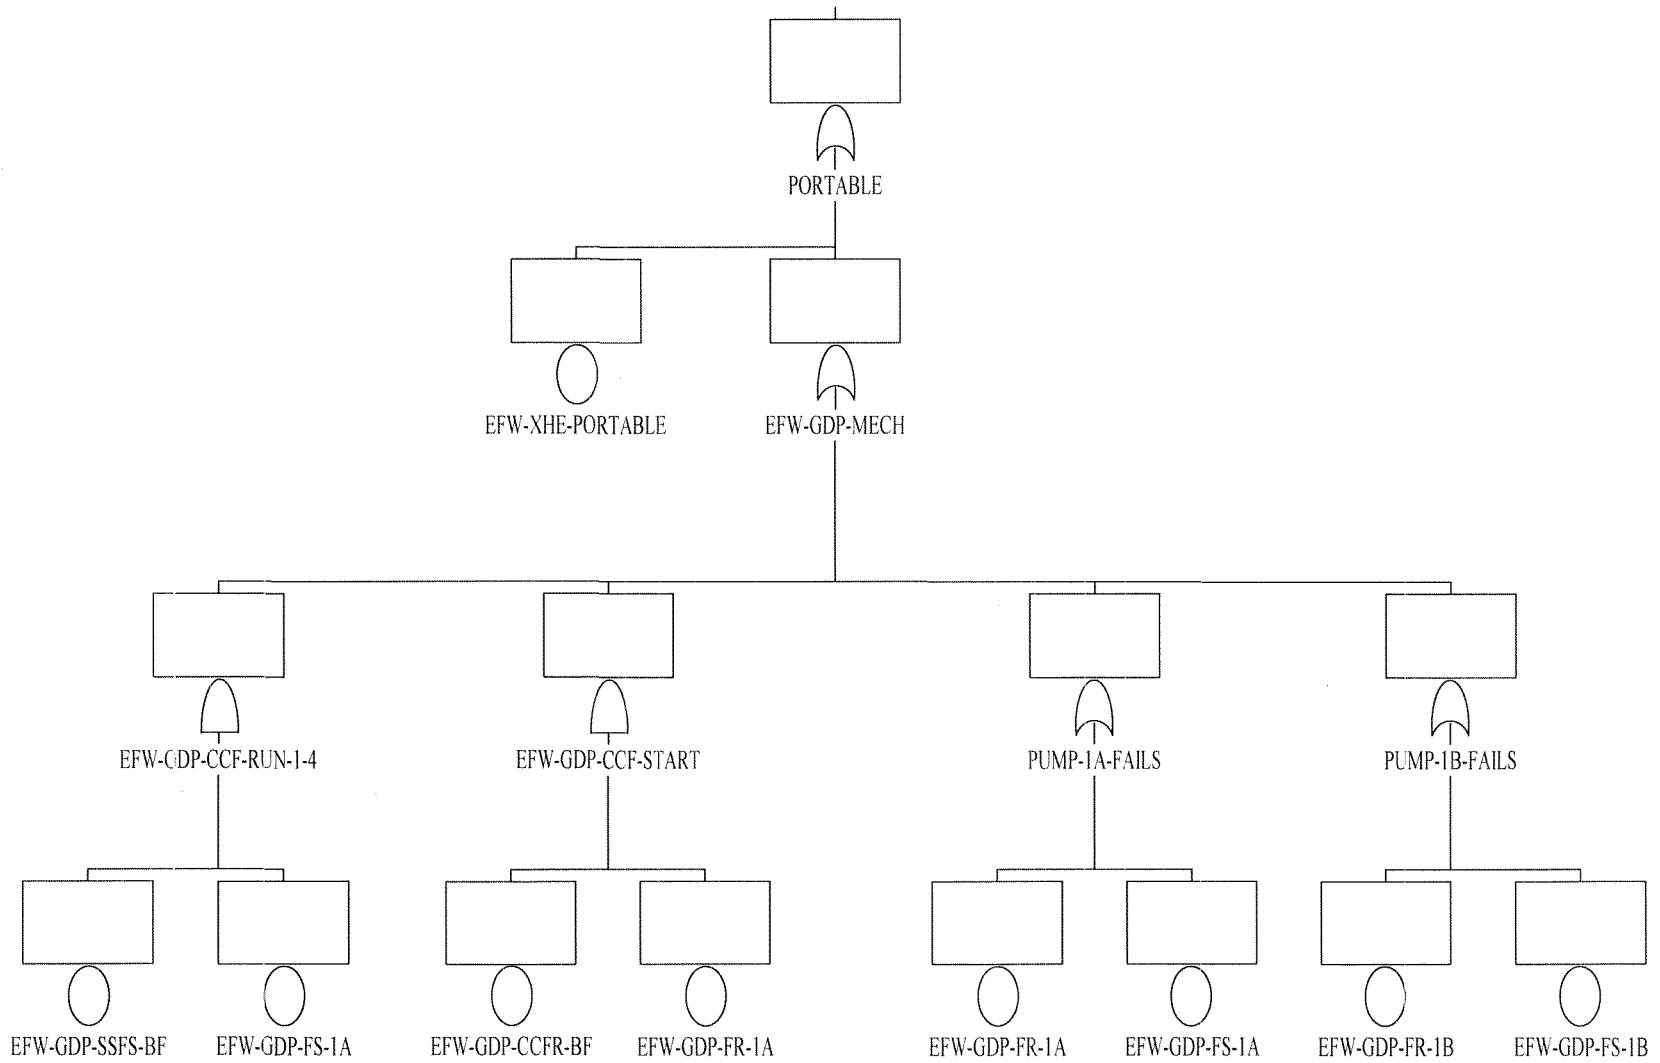
Fault Tree 1 Gasoline Powered Pump System

- g. A fault tree to estimate the failure probability for the gasoline-powered pumps was constructed and solved using the simplified plant analysis risk (SPAR) model. After flooding greater than 1010 feet MSL, the gasoline powered pumps would be the only equipment available to provide makeup water to the steam generators. The fault tree assumed:

- Both pumps must function for the action to be successful.
 - Human error probabilities associated with installing the gasoline powered pump system were evaluated using NUREG/CR 6883, "The SPAR-H Human Reliability Analysis Method," August 2005 (Attachment 3). From this evaluation, the analyst inserted a human error probability basic event into the system fault tree. The SPAR-H worksheets were broken up into two sections, a "diagnosis" section and an "action" section. The diagnosis section evaluated the probability that operators would fail to diagnose the problem, such that mitigating actions would not be taken. The action section estimated the probability that operators (or craftsmen) would fail to successfully install and operate the system.

- The analyst assumed that operators would properly diagnose the flood.
 - The "action" portion of the SPAR-H worksheet was much more difficult to perform and the probability of failure was over-riding (when compared to the diagnosis portion).

- The analyst used the licensee's estimates for gasoline pump failure probability.
 - Other basic components that would have very low failure probabilities, such as manual isolation valves, were not included in the fault tree.

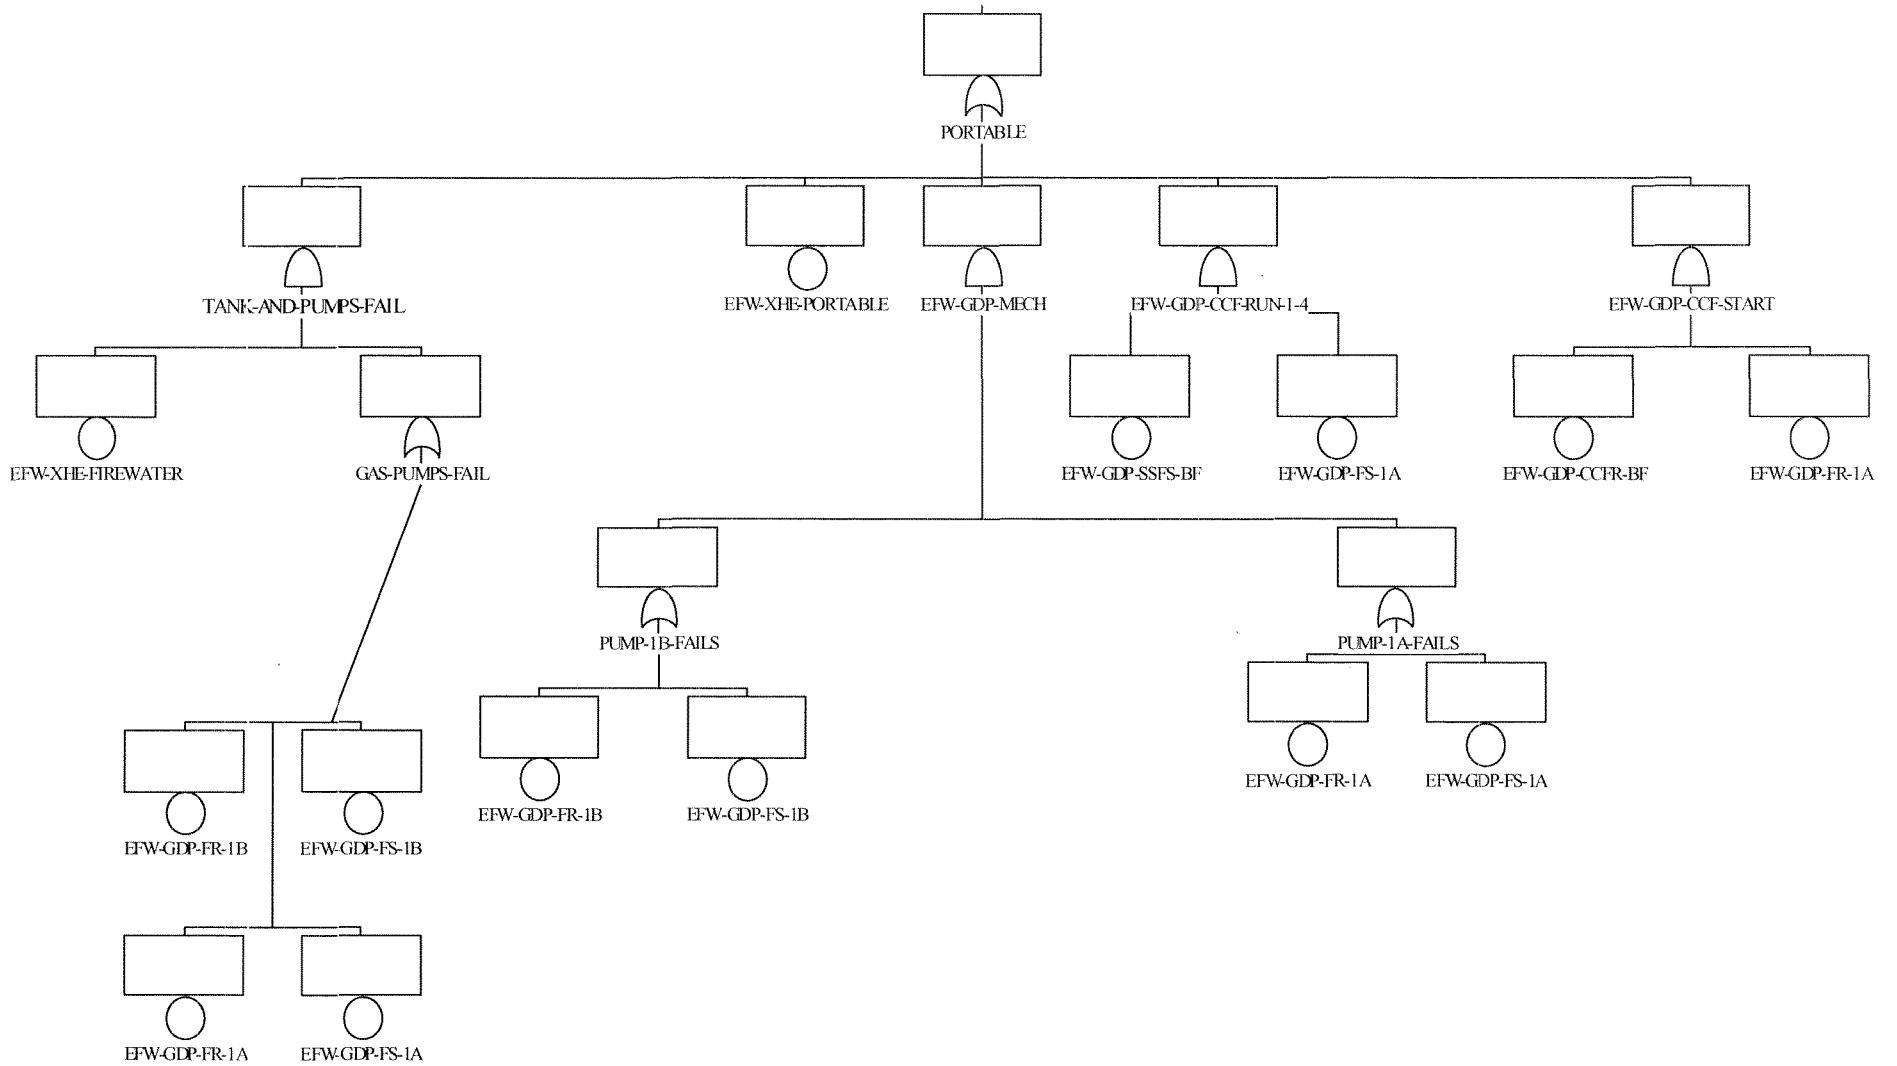
Fault Tree 2
Gasoline Powered Pump System
with Essential Feedwater Storage Tank Refill from Firewater Tank

- c. Alternate Method of Refilling Essential Feedwater Tank (SPAR-H 2, Attachment 3): The licensee proposed an alternate method for refilling the essential feedwater tank. The offsite fire water tank (at a higher elevation across the highway) could be used to refill the essential feedwater tank. The advantage of using this tank was that the reliance on the gasoline-powered pumps would be reduced. Instead of requiring that both gasoline powered pumps remain functional (one to fill the steam generators and one to refill the essential feedwater storage tank), the licensee could have one pump fail and still satisfy the steam generator makeup function.

To evaluate the scenario, the analyst adjusted the gasoline power pumps system fault tree so that a failure of both fire pumps would be needed to fail the system (not just one pump). The analyst added a new basic event to account for the human error probability for the new manual actions. The analyst also made other adjustments to model use of the firewater tank. The adjusted fault tree is shown in Attachment 6, second fault tree.

As shown in the SPAR-H worksheet (Attachment 3, SPAR-H-2) the assumptions for the new human error probability included nominal available time, high stress (fittings hard to find and work under water), moderate complexity, low experience (connecting fittings under water), nominal procedures, missing/misleading ergonomics (location of fittings under water), nominal fitness for duty, and nominal work processes. Instead of a failure probability of 2.56E-2 for the failure of the gas pump system, a failure probability of 1.3E-2 was generated. This would reduce the overall delta-CDF by a factor of two. The resultant delta-CDF was 1.5E-5/year. However, since the challenge of locating and manipulating components under water invoked large uncertainties, this action was not credited in the SDP.
