RE: License No. SUB-1010, Docket No. 040-08027
License Condition 47, Final Groundwater Corrective Action Plan (CAP)

CORRECTIVE ACTION PLAN REPORT

Sequoyah Fuels Corporation

June 14, 2010

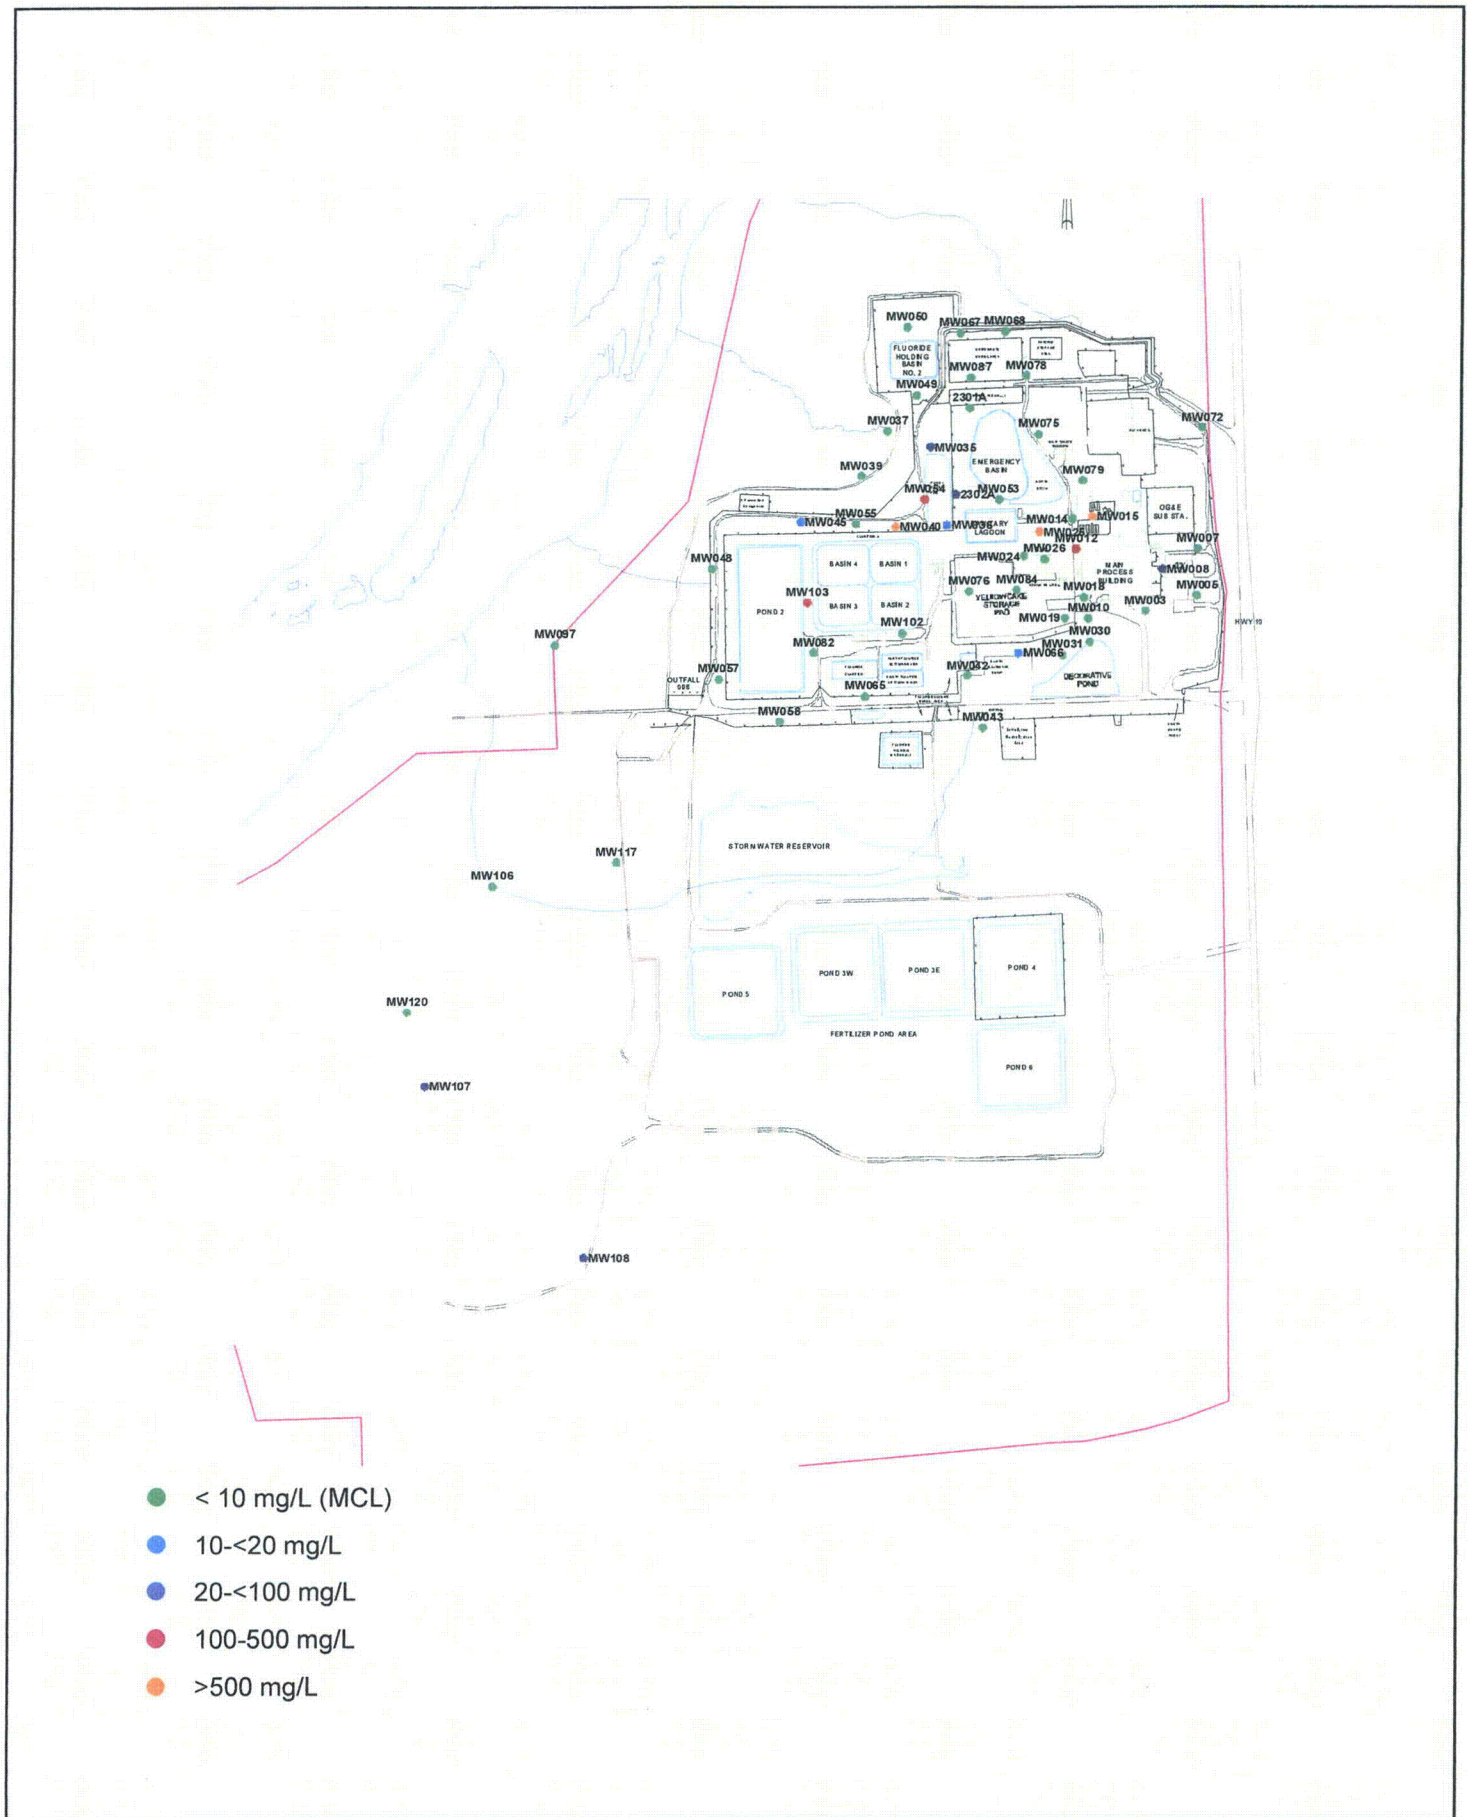
FIGURE 2-20
NITRATE IN TERRACE/UNIT 1 SHALE
GROUNDWATER, 2003

Figure 2-20 shows nitrate concentrations in Terrace/Unit 1 Shale wells during 2002. In the terrace and Unit 1 Shales nitrate impacts to the groundwater are found mostly around the MPB, Clarifier Basins, and Pond 2 area. The nitrate levels found in the Terrace/Unit 1 Shale system varied from 0.5 mg/L to 820 mg/L. The high of 820 mg/L occurred in well MW025 located north of the SX Building. Terrace/Unit 1 Shale wells with nitrate levels above the MCL of 10 mg/L were 2302A, MW008, MW012, MW014, MW015, MW024, MW025, MW035, MW036, MW040, MW045, MW054, MW066, MW103, MW107, MW108, and MW120.

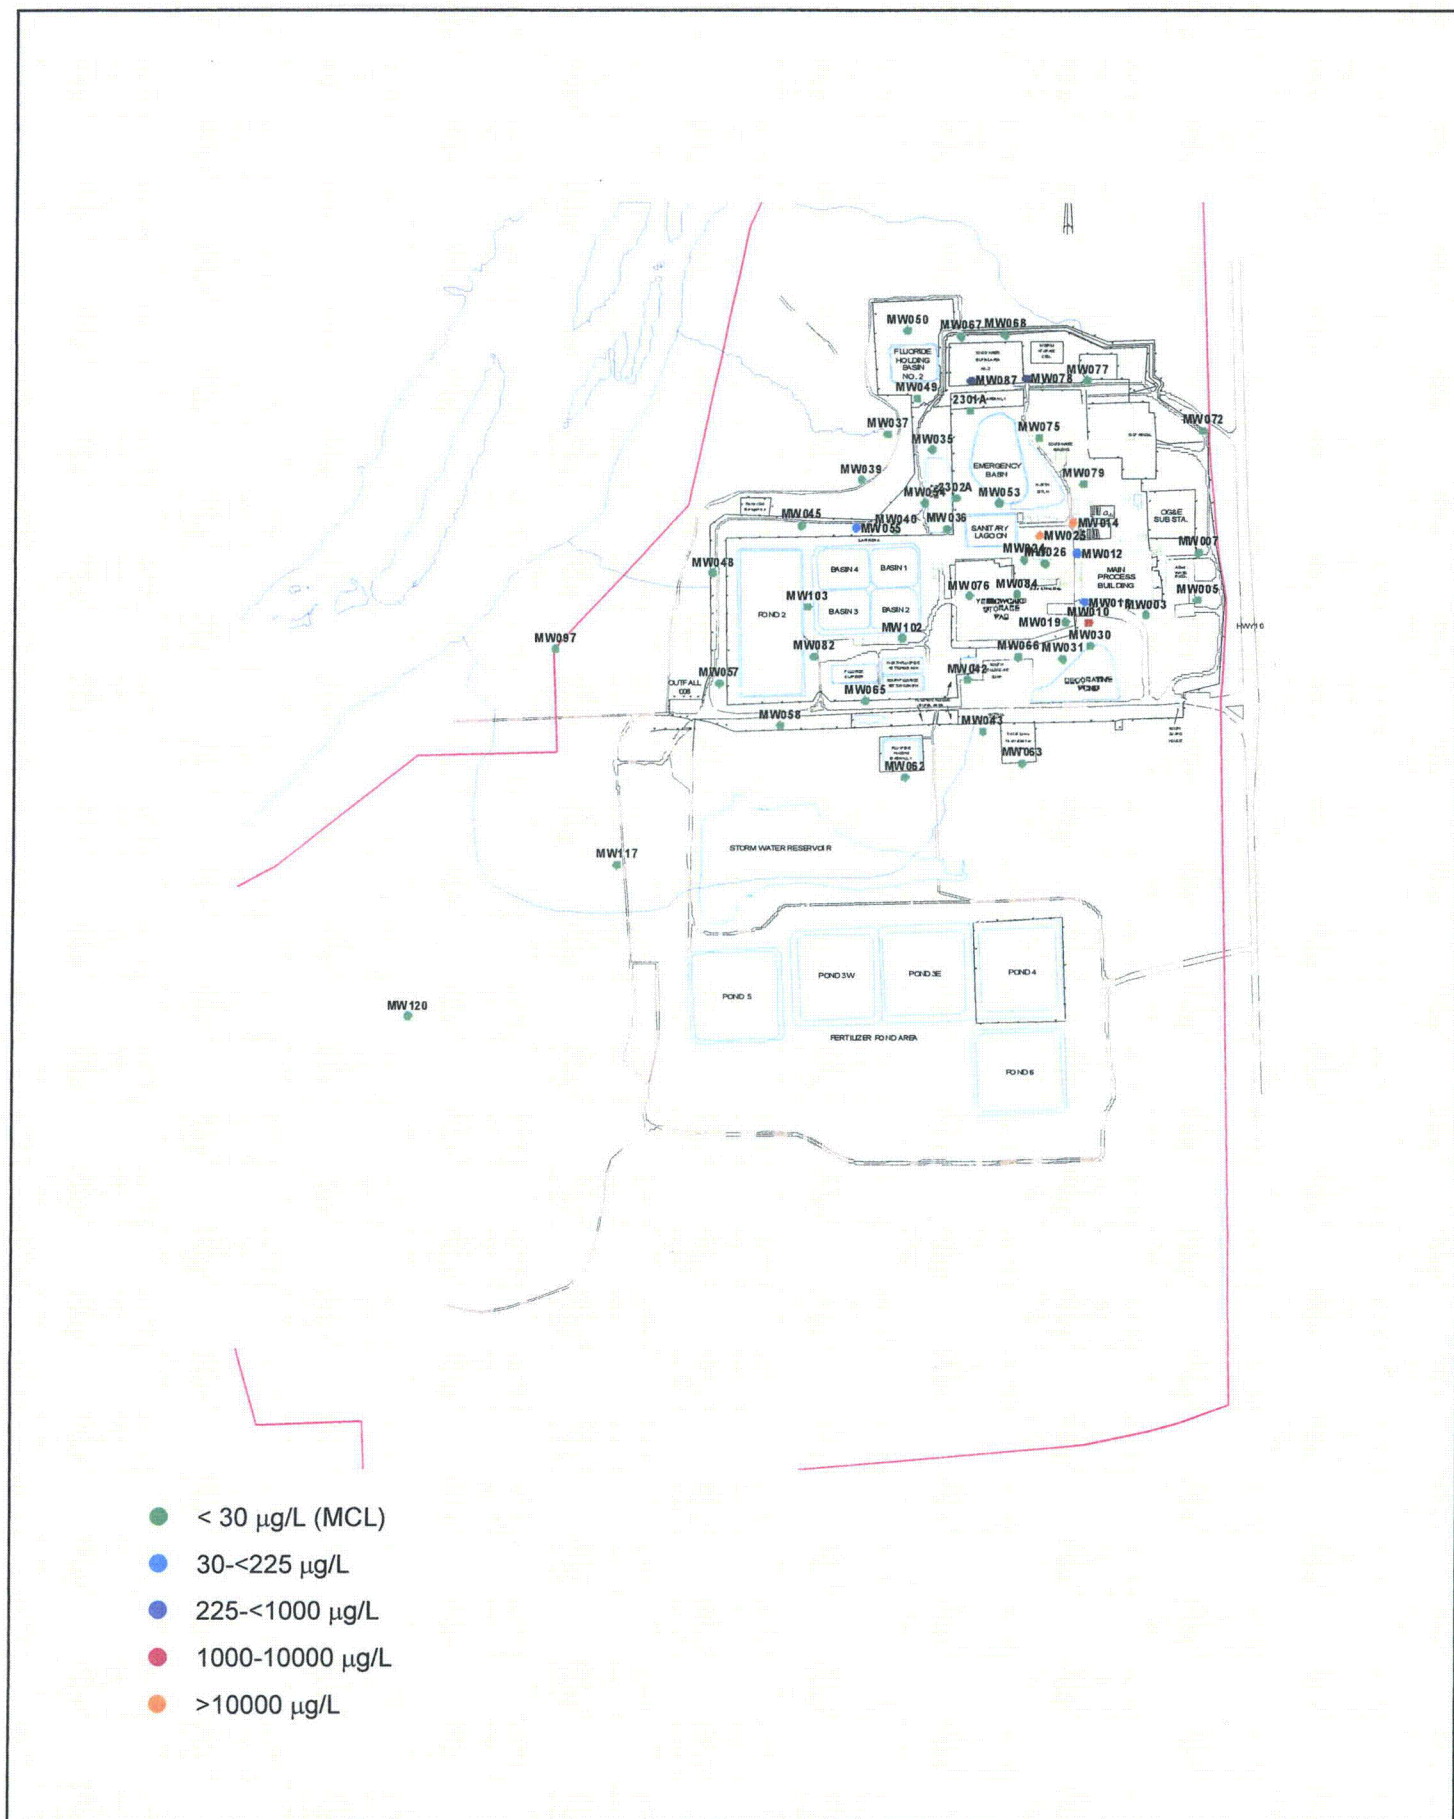
FIGURE 2-22
URANIUM IN TERRACE/ UNIT 1 SHALE
GROUNDWATER, 2003

Figure 2-22 shows uranium concentrations in Terrace/Unit 1 Shale wells during 2002. In the Terrace/Unit 1 Shale system uranium impacts to groundwater are found southwest, west, and northwest of the MPB, north and west of the SX Building, north and west of the Emergency Basin, in the Clarifier Basin areas and in the Solid Waste Burial Areas. The uranium levels found in Terrace/Unit 1 Shale groundwater varied from <1.0 µg/L in several wells to 95,000 µg/L. The high of 95,000 µg/L occurred in well MW025 located north of the SX Building. Unit

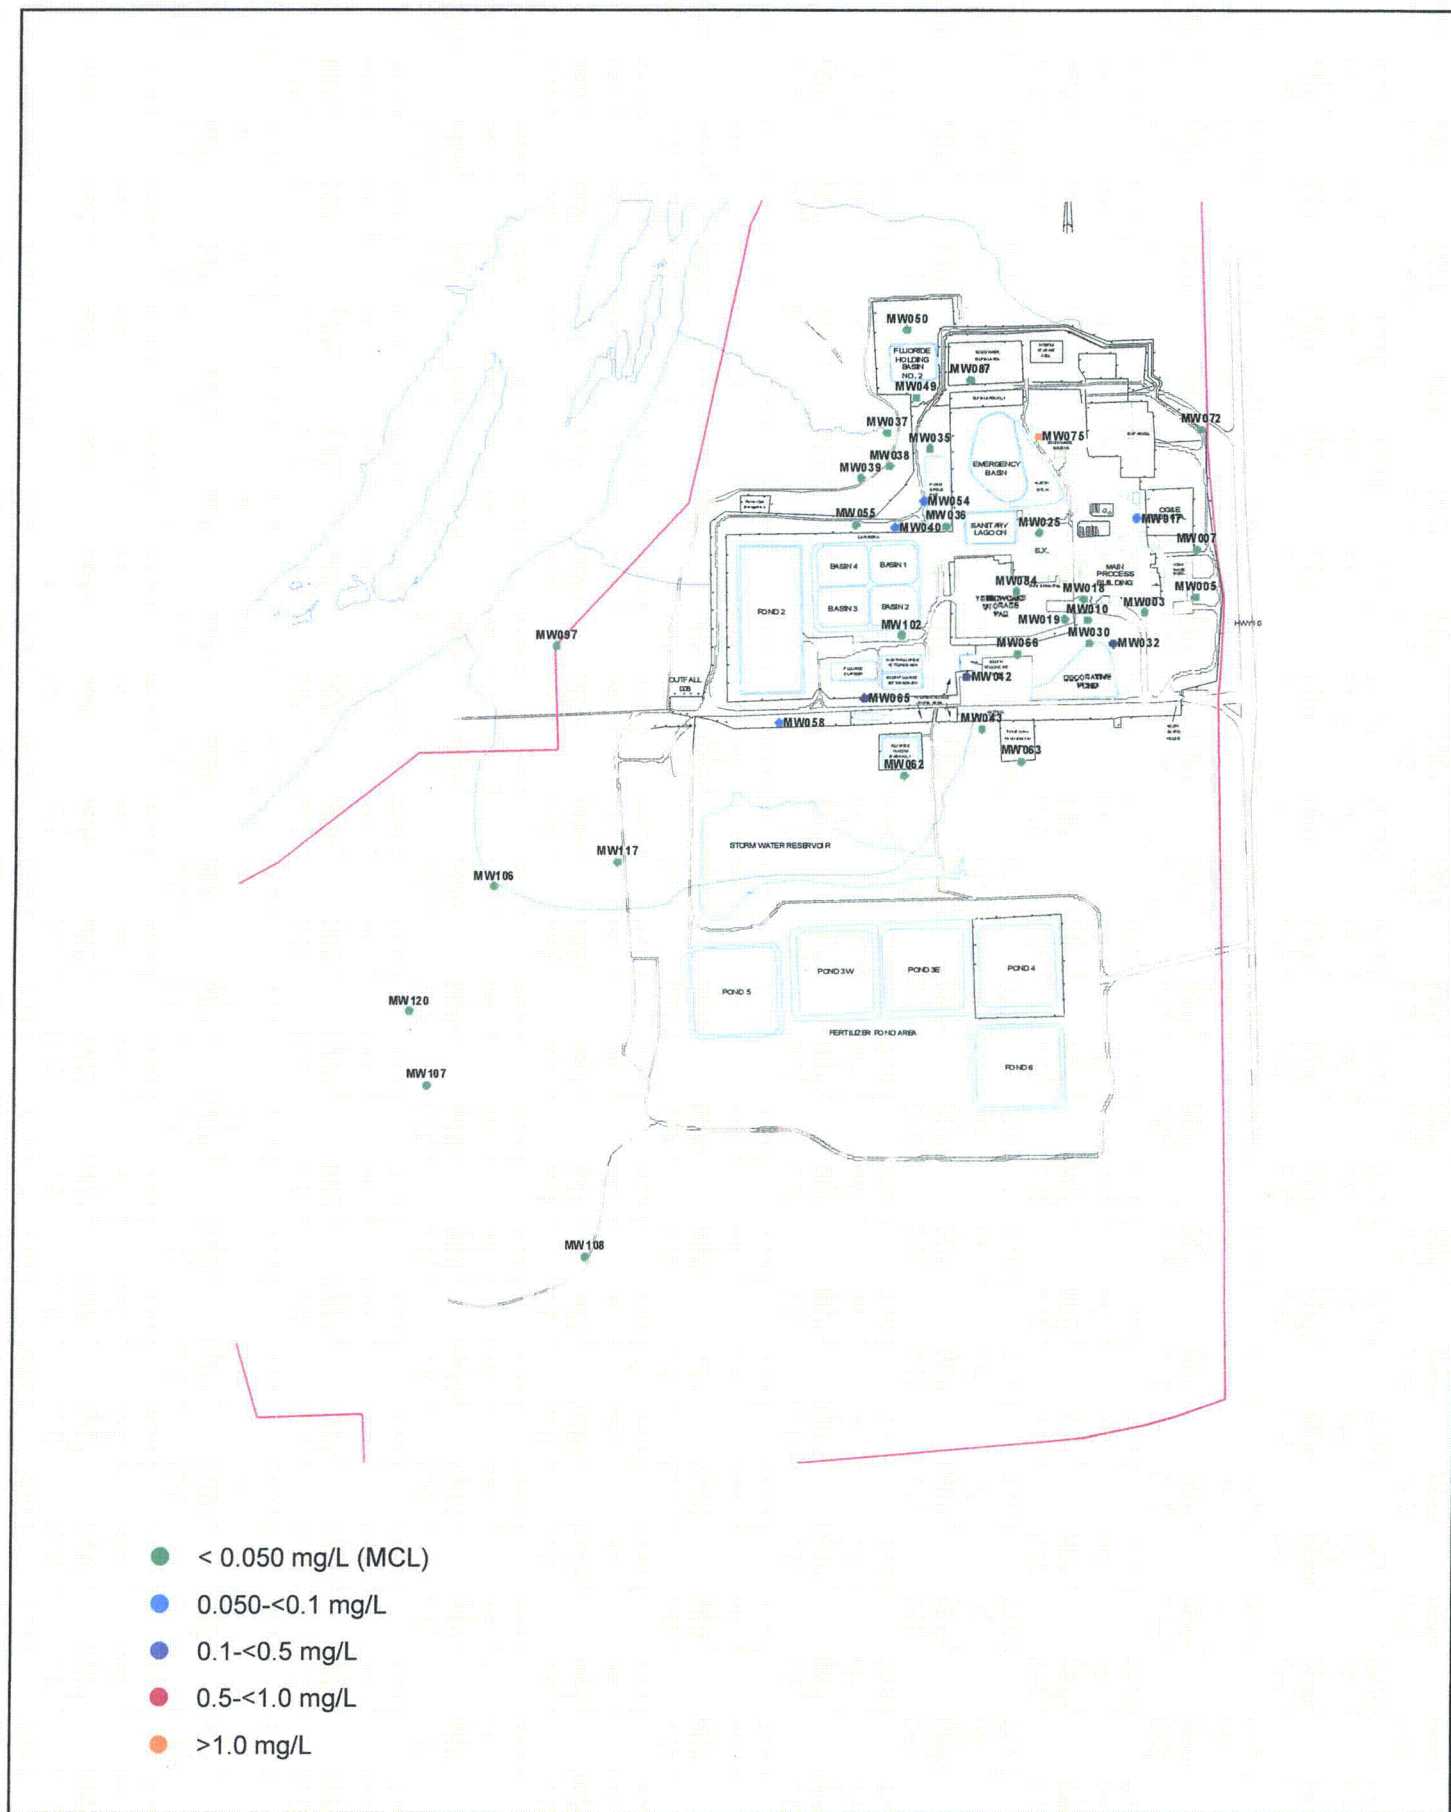
FIGURE 2-24
ARSENIC IN TERRACE/UNIT 1 SHALE
GROUNDWATER, 2003

Figure 2-24 shows arsenic concentrations in Terrace/Unit 1 Shale wells during 2002. In the Terrace/Unit 1 Shale system arsenic impacts to groundwater are present north of the MPB, north of the Clarifier Basins, south of the Fluoride Setting Basins, and north of the Emergency Basin. Arsenic levels found in Terrace/Unit 1 Shale groundwater varied from <0.009 mg/l to 1.28 mg/l. The high of 1.28 mg/L occurred in MW075 located south of the incinerator near the Solid Waste Burial Area No. 2. Terrace/Unit 1 Shale wells with arsenic levels above the MCL of 0.05 mg/L include MW017, MW032, MW040, MW042, MW054, MW058, MW065, and MW075.

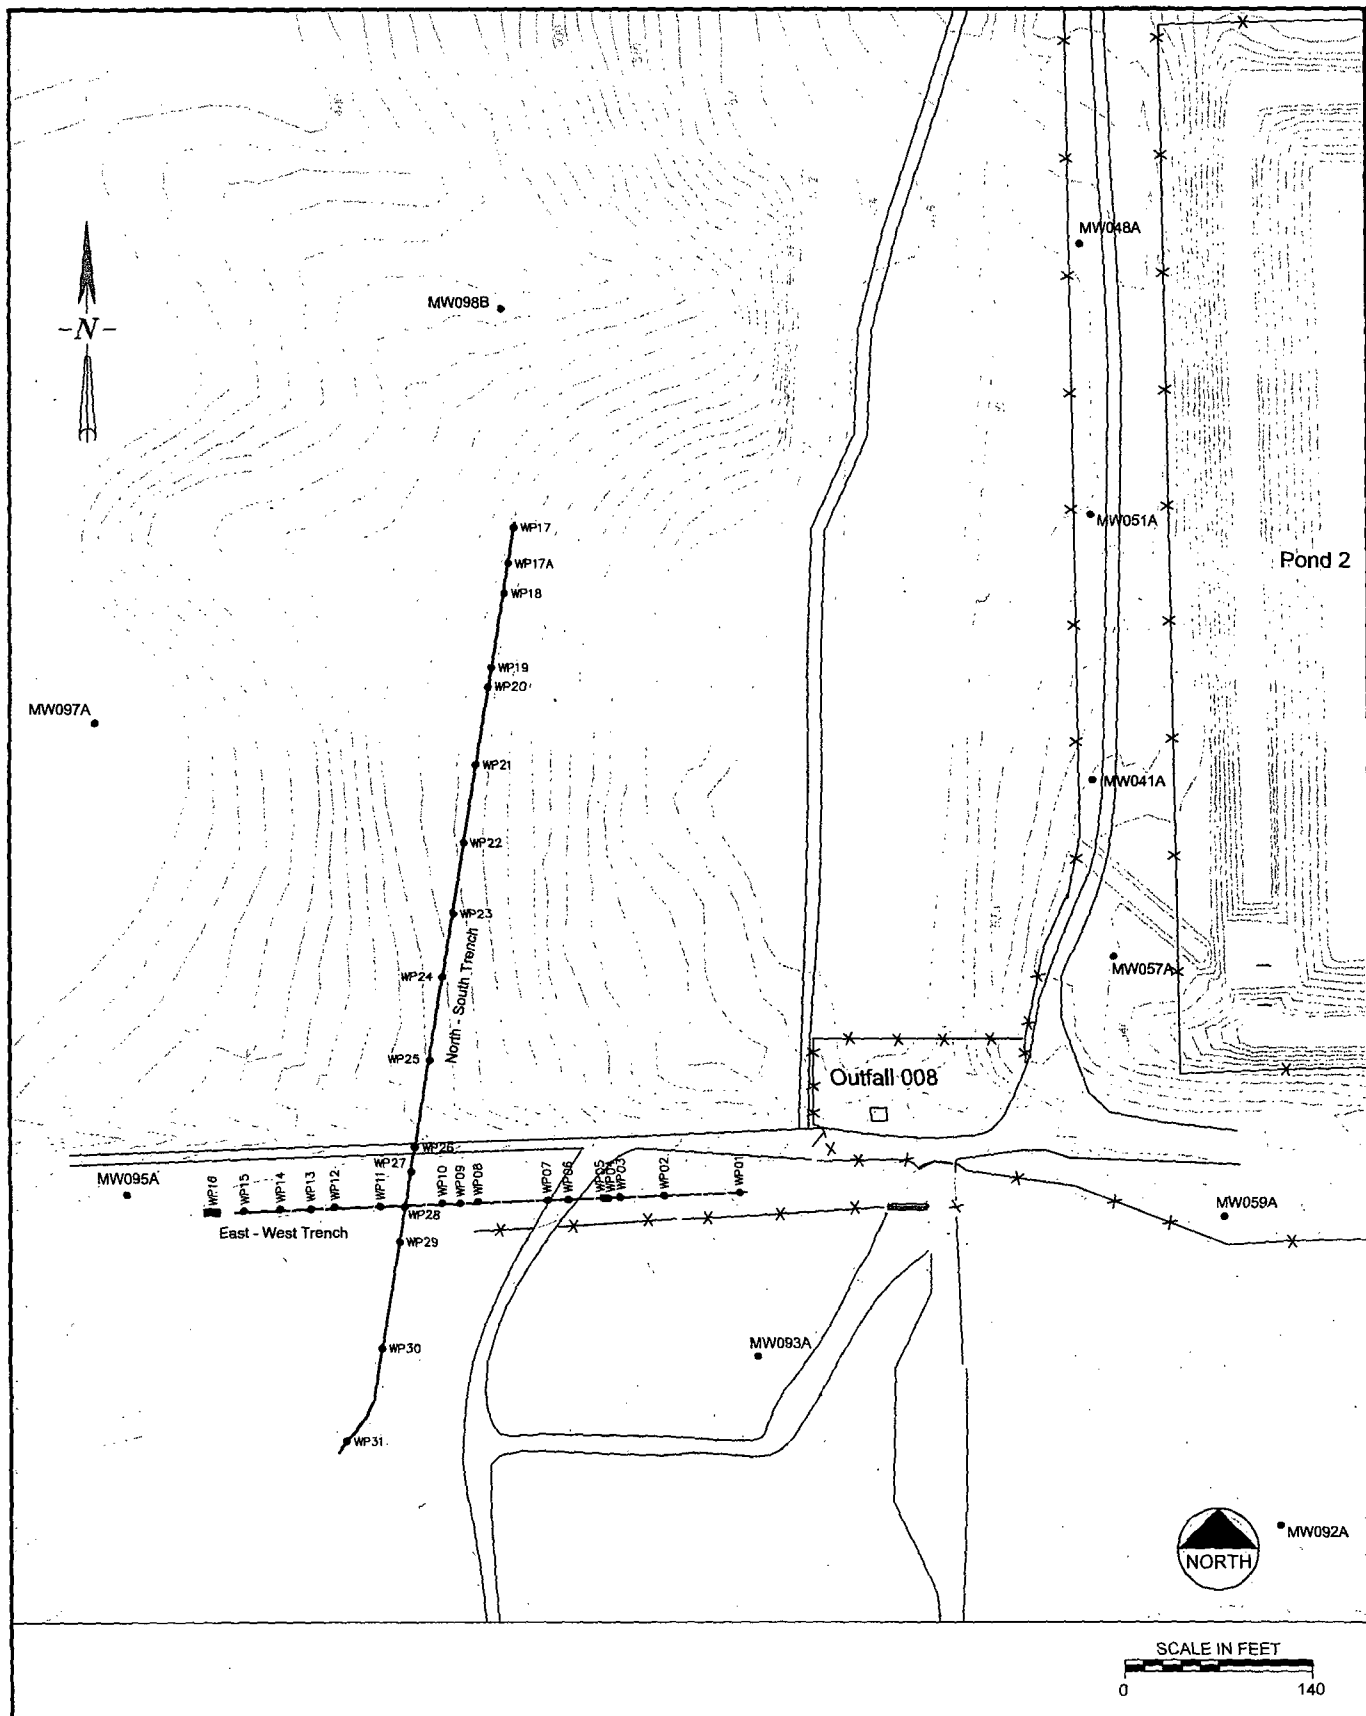
FIGURE 4-1
TRENCH AND WAYPOINT LOCATIONS

An east-west trending excavation south of the Port Road and a north-south trending excavation west of Pond 2 (Figure 4-1) reveal the existence of sandy seams above the Unit 4 Shale. These sandy seams are up to several feet thick and are highly transmissive. Several pits were excavated during the trenching process and significant amount of water filled the pits within a few hours time. Elevated nitrate and arsenic concentrations were found in the waters collected in the trenches and pits, indicating that the sandy seams represent preferential pathways of COC transport.

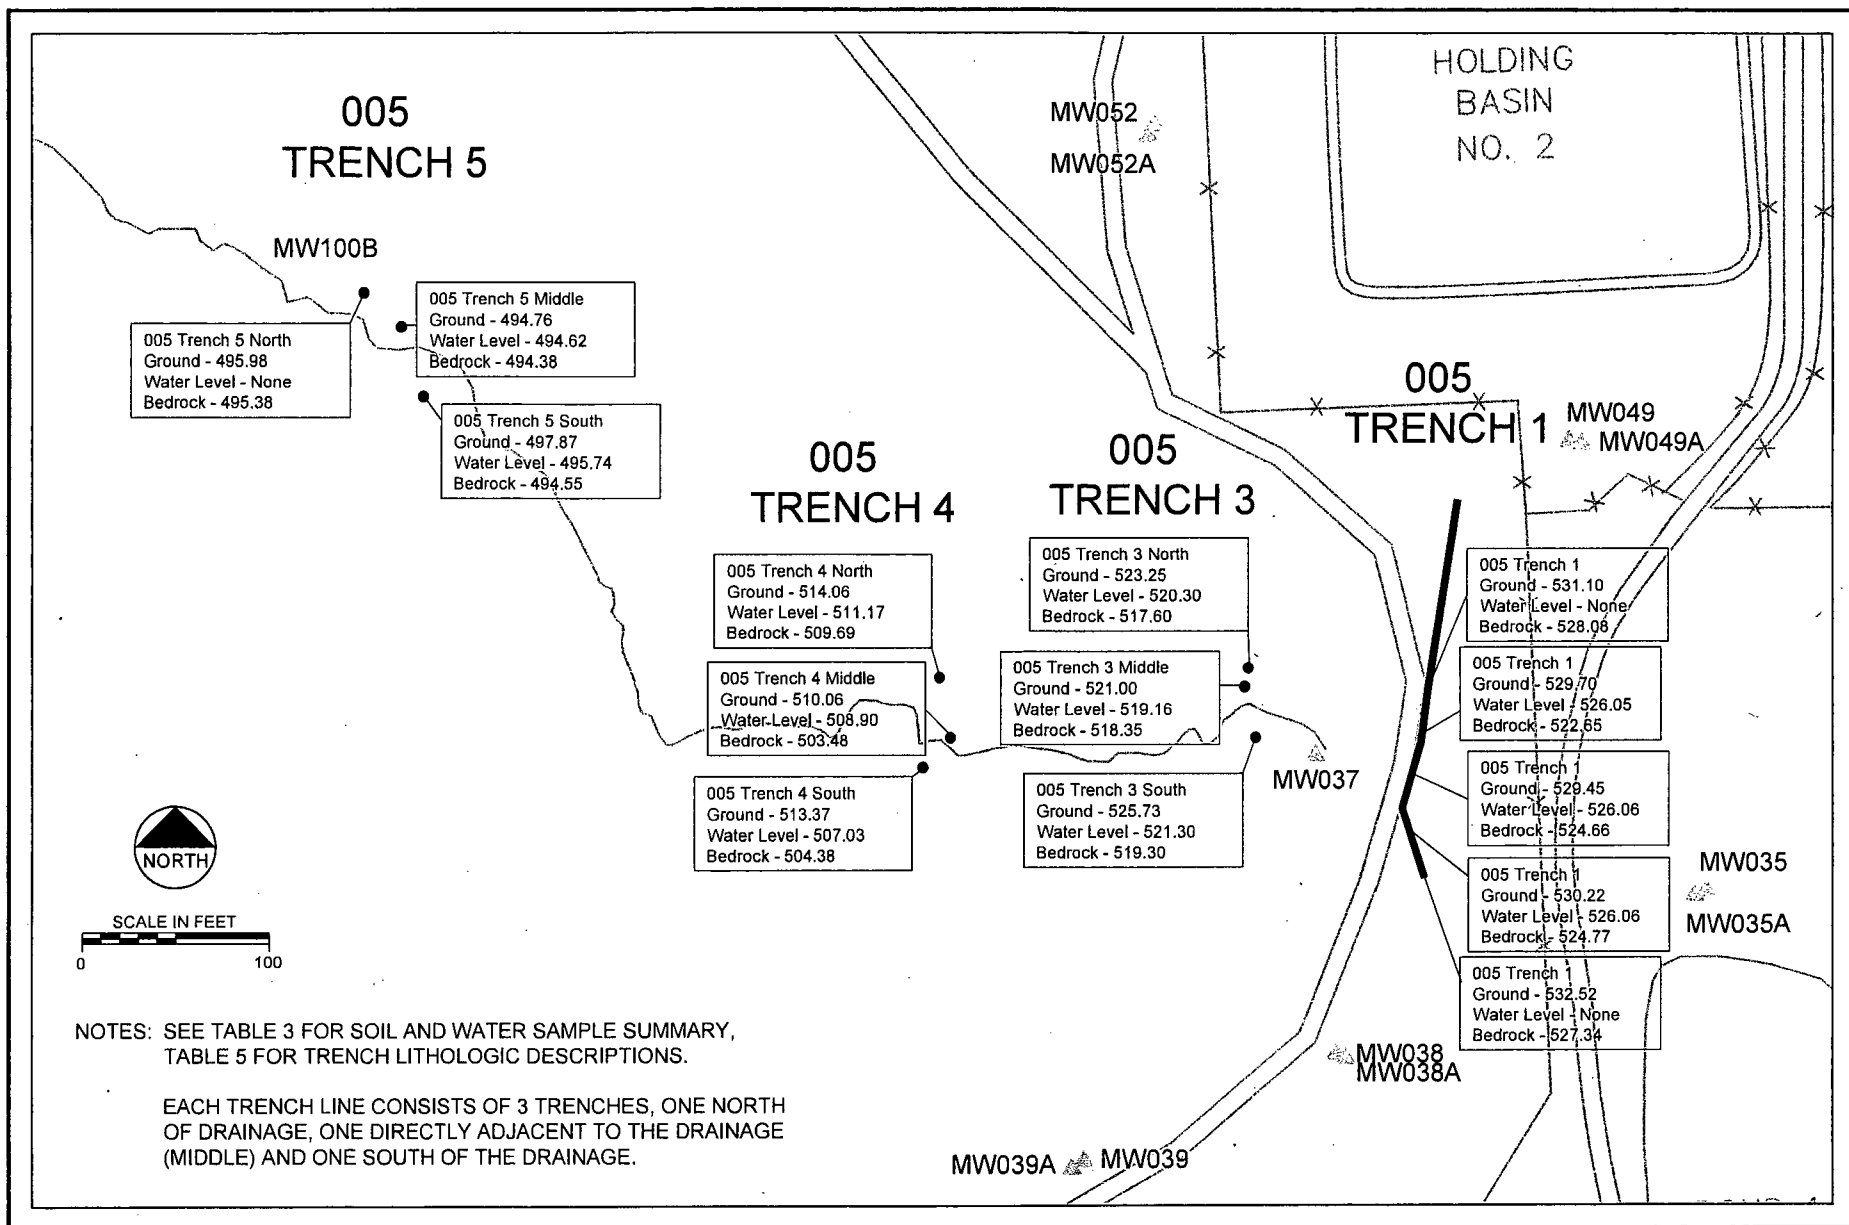
FIGURE 4-3
005 DRAINAGE TRENCHING AND SOIL/WATER SAMPLING LOCATIONS

Recent sampling of the 005 Drainage surface waters indicate elevated levels of uranium and nitrate that were not predicted by, and inconsistent with, groundwater modeling results. It appears likely that fill material placed in the upper end of the 005 Drainage during plant construction may be providing a preferential flow path for impacted groundwater from the SX Building and MPB areas. This is similar to what is observed near MW010. The technical approach for the Supplemental Data Collection process of the 005 Drainage included two components. The first component consisted of excavating a trench in the fill materials at the head of the 005 Drainage between the emergency basin and the existing 005 Sump, south of Fluoride Holding Basin No. 2 (Figure 4-3); this trench is referred to as 005 Drainage Trench 1. The second component consisted of sampling soils and water from small excavations in the banks of the 005 Drainage at various points along its alignment (Figure 4-3).

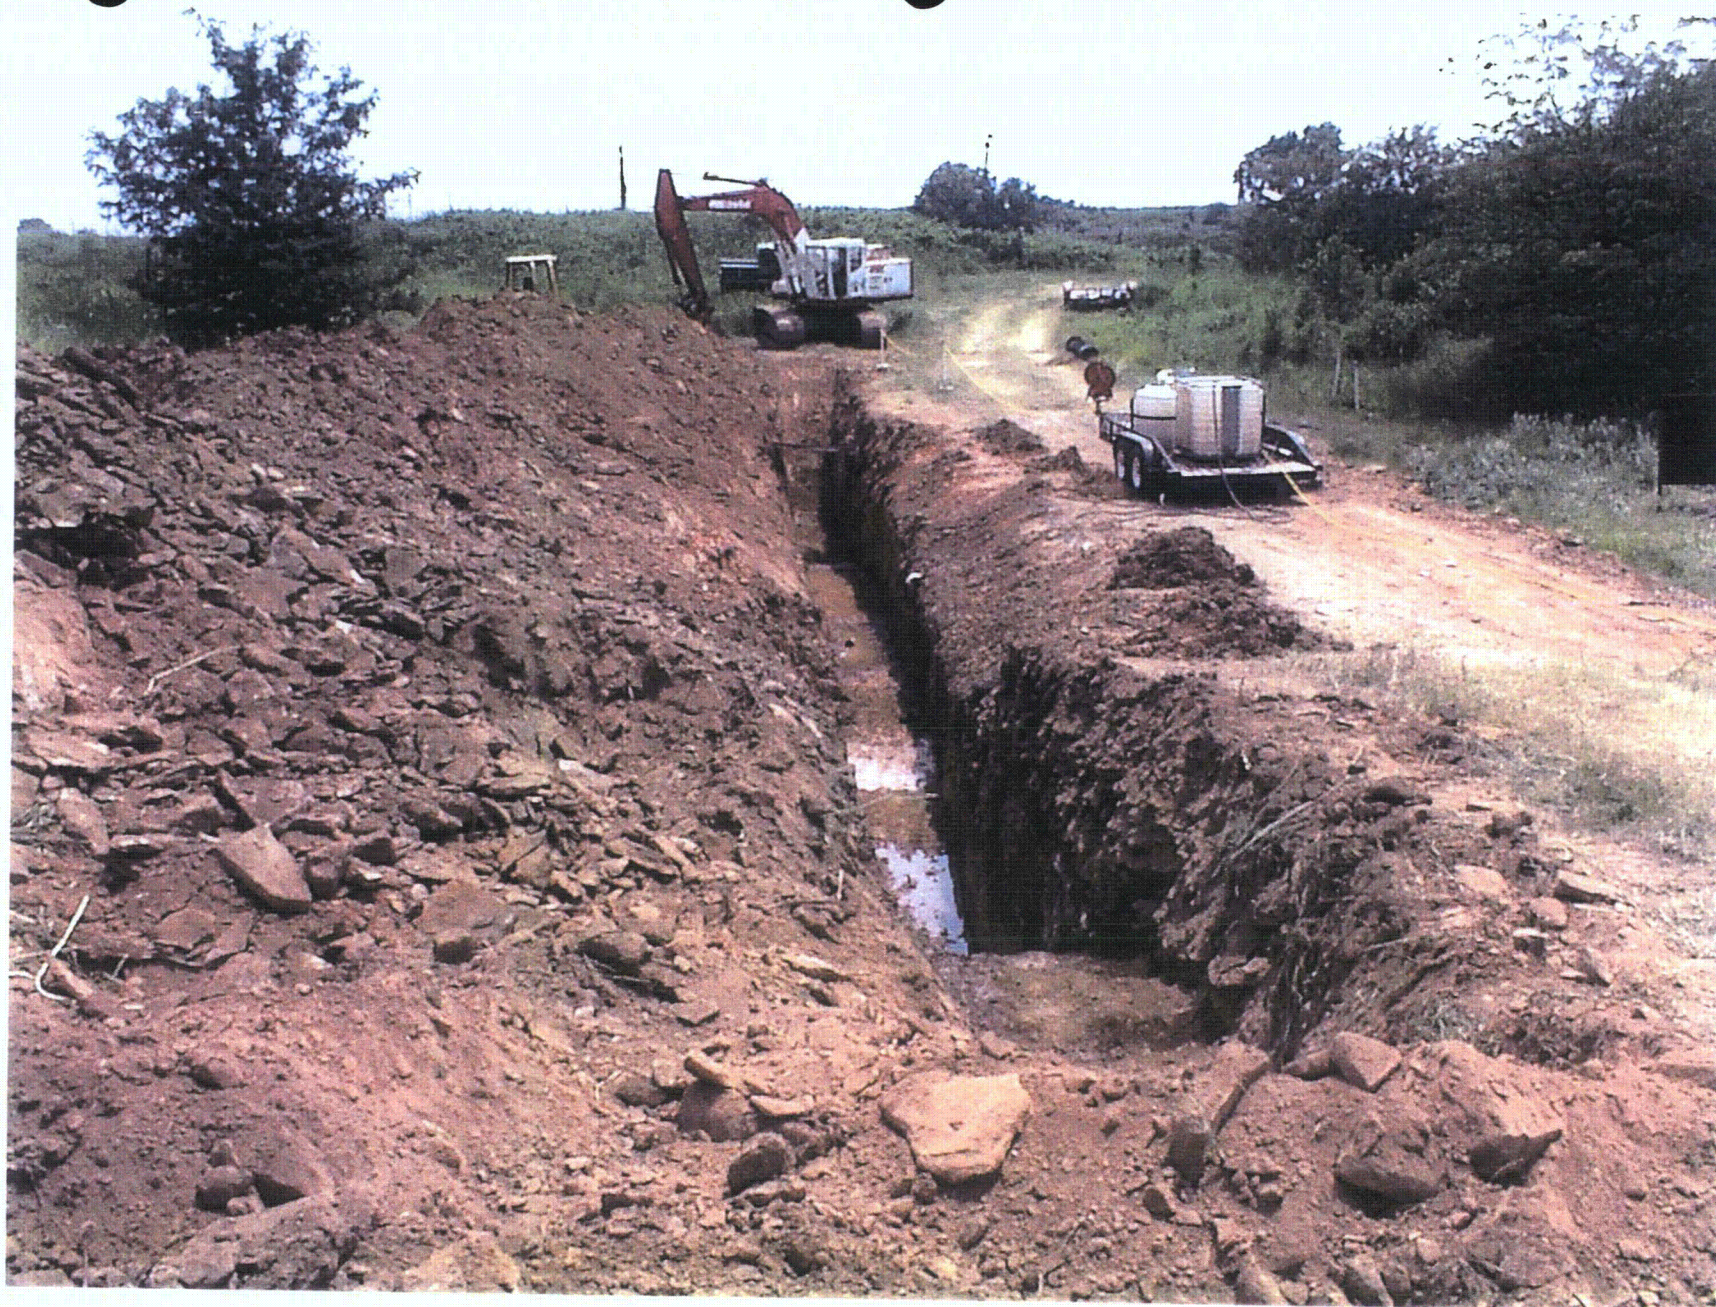
Figure 1. Open trench excavated to the top of sandstone. (Looking South)

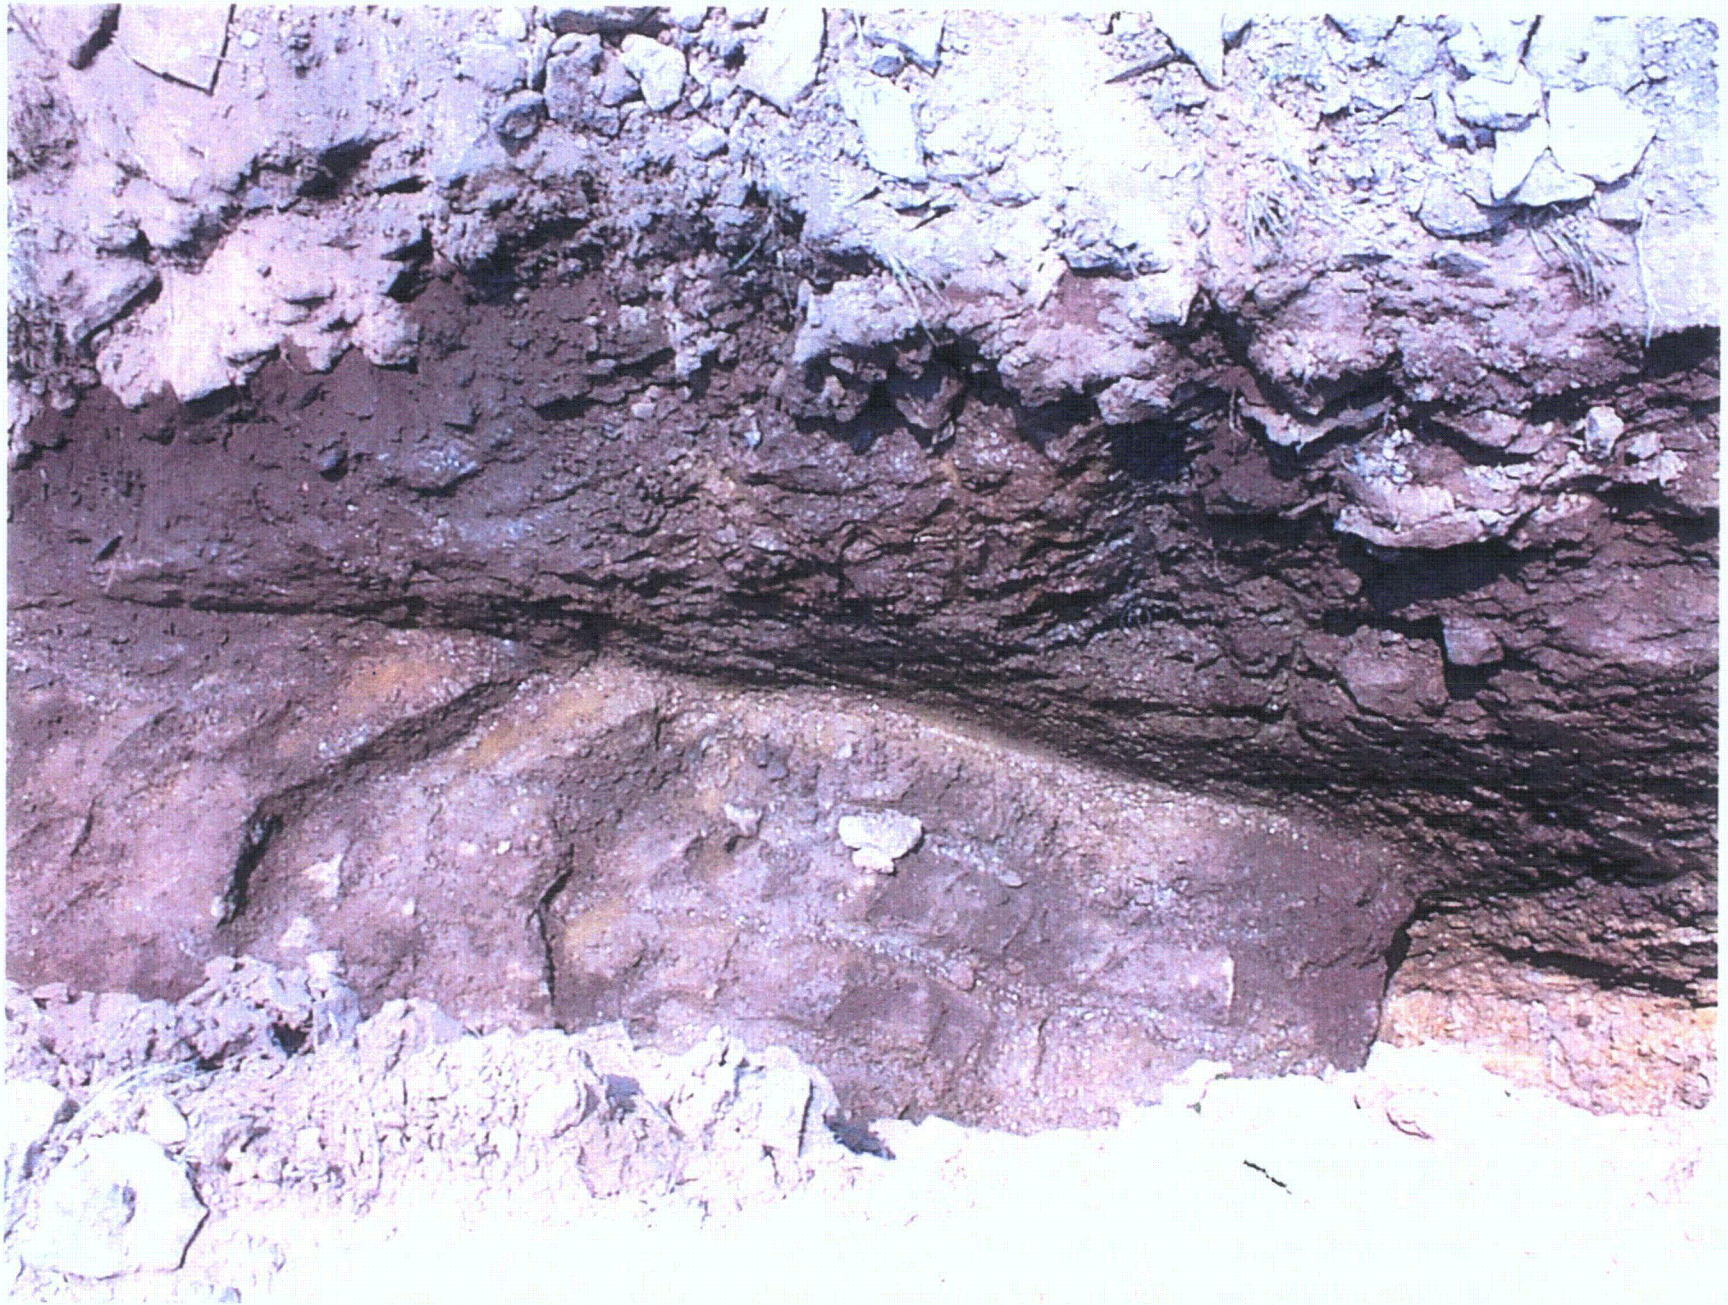
Figure 2. Hump in sandstone surface between 87 and 90 feet north of bottom south end.

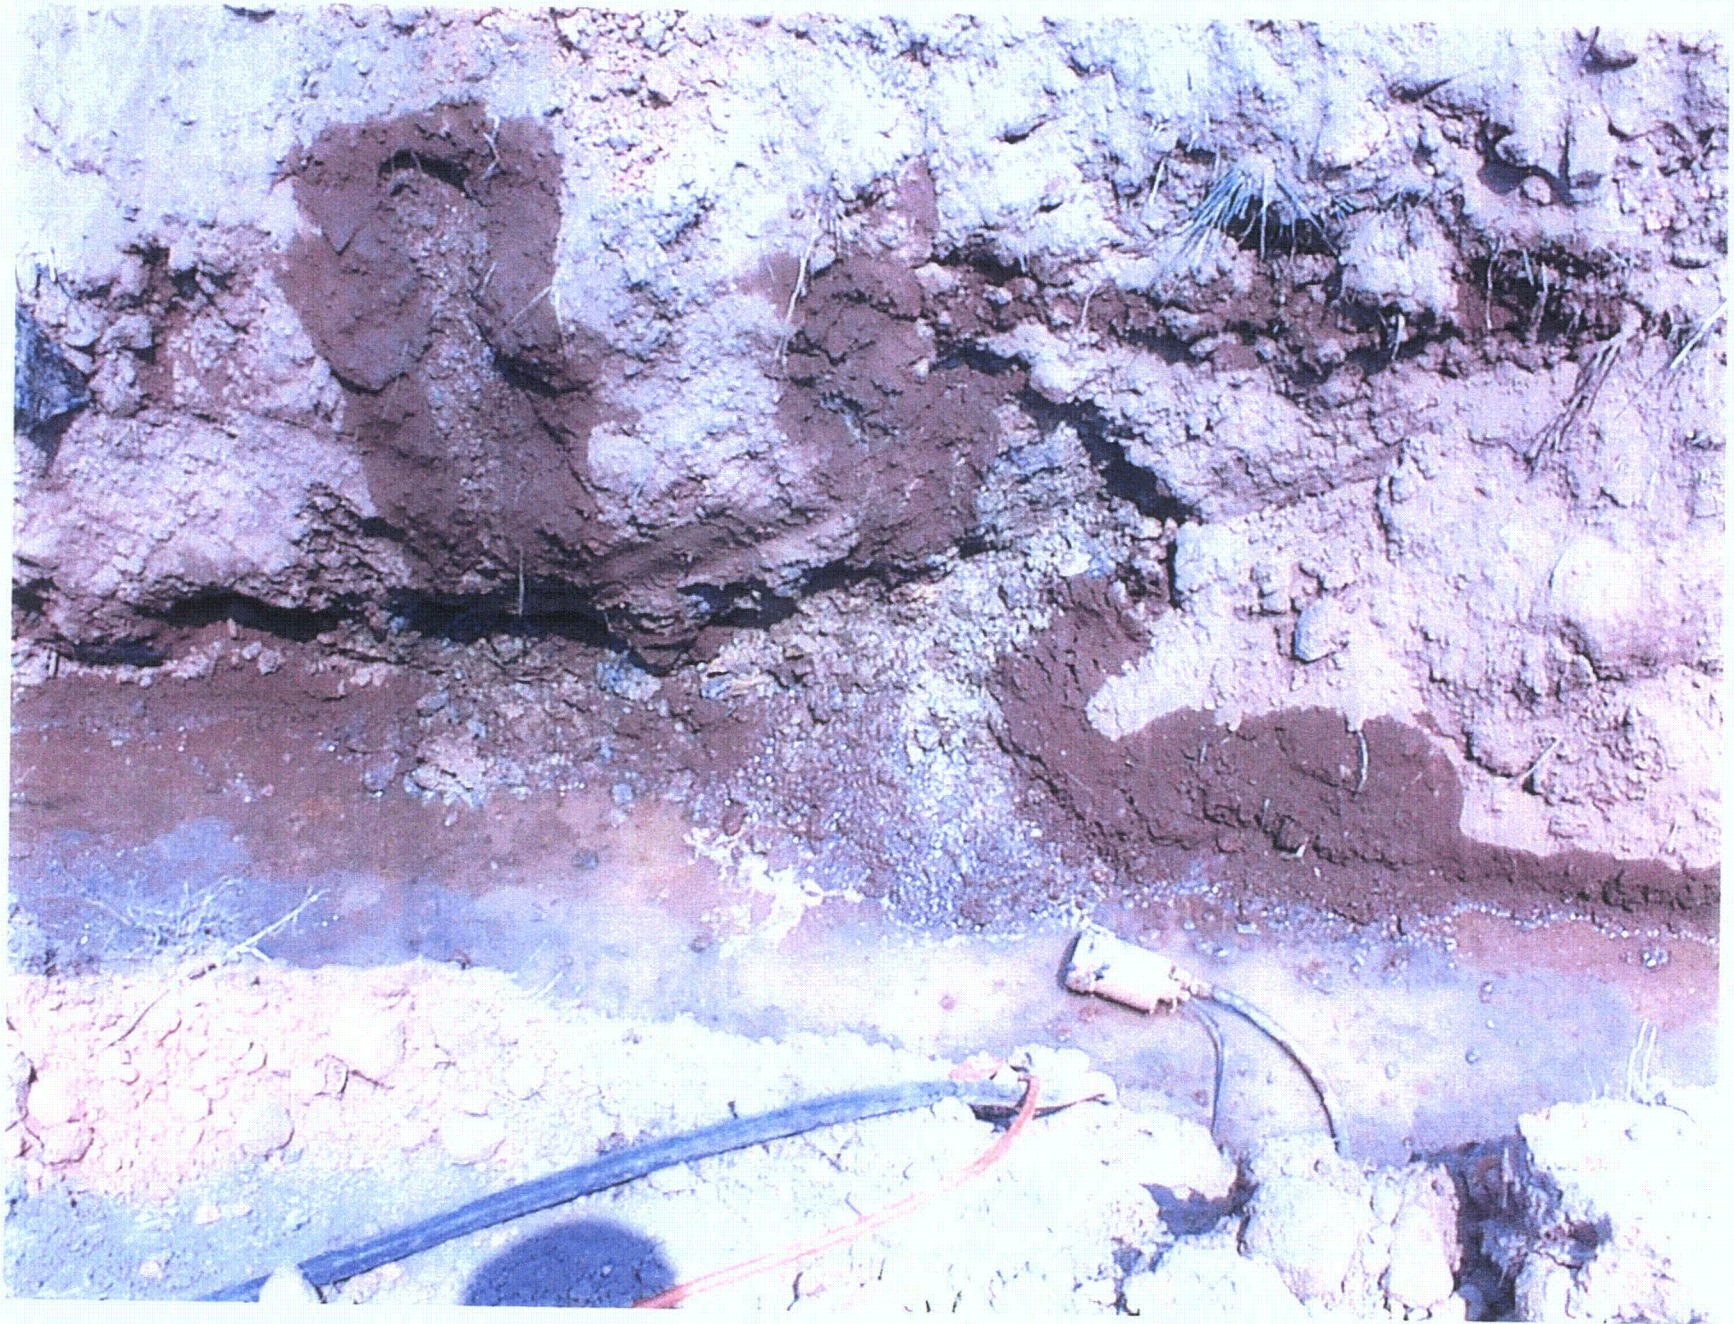
Figure 3. Seepage from east wall of trench - riser pipe placed at this location.

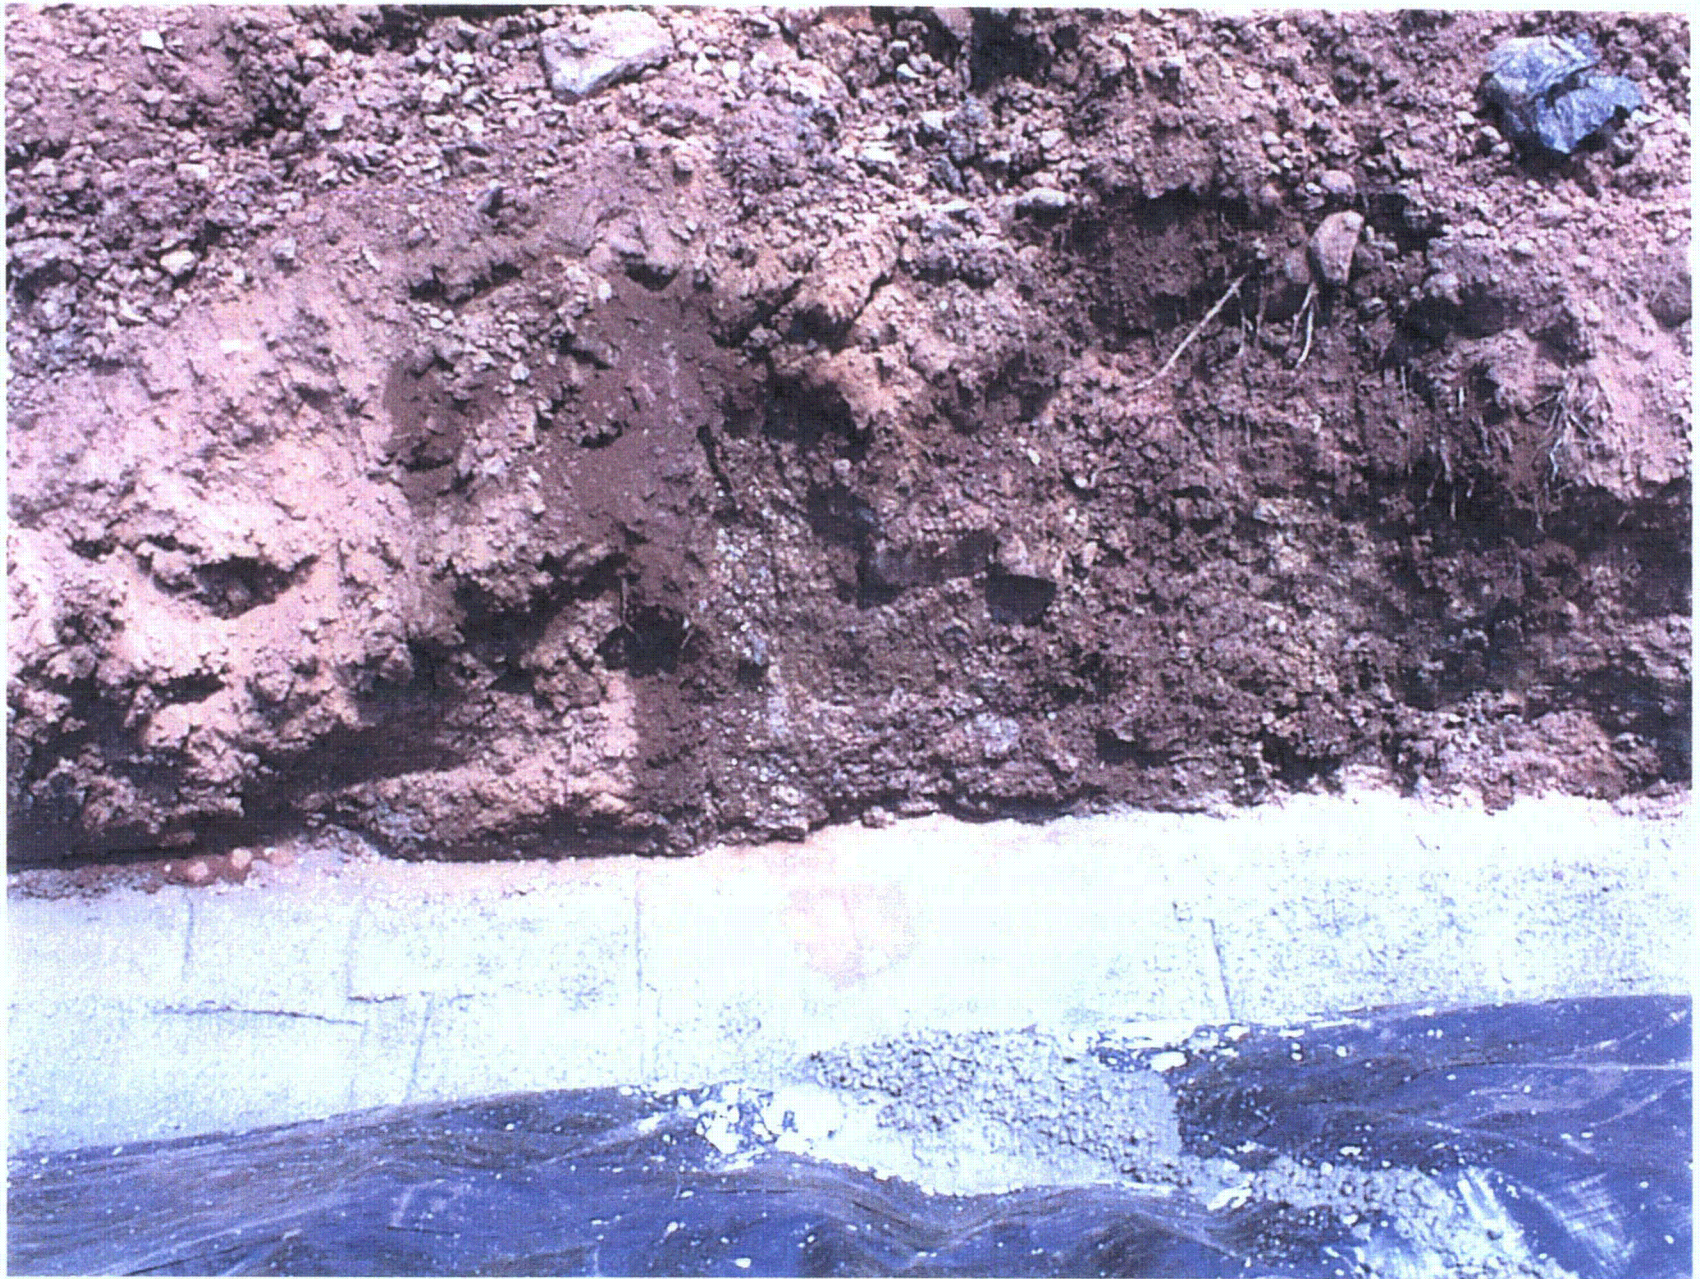
Figure 4. Concrete pour with liner along west bank. (Looking East)
