RE: License No. SUB-1010, Docket No. 040-08027
License Condition 47, Final Groundwater Corrective Action Plan (CAP)

CORRECTIVE ACTION PLAN REPORT

Sequoyah Fuels Corporation

June 14, 2010

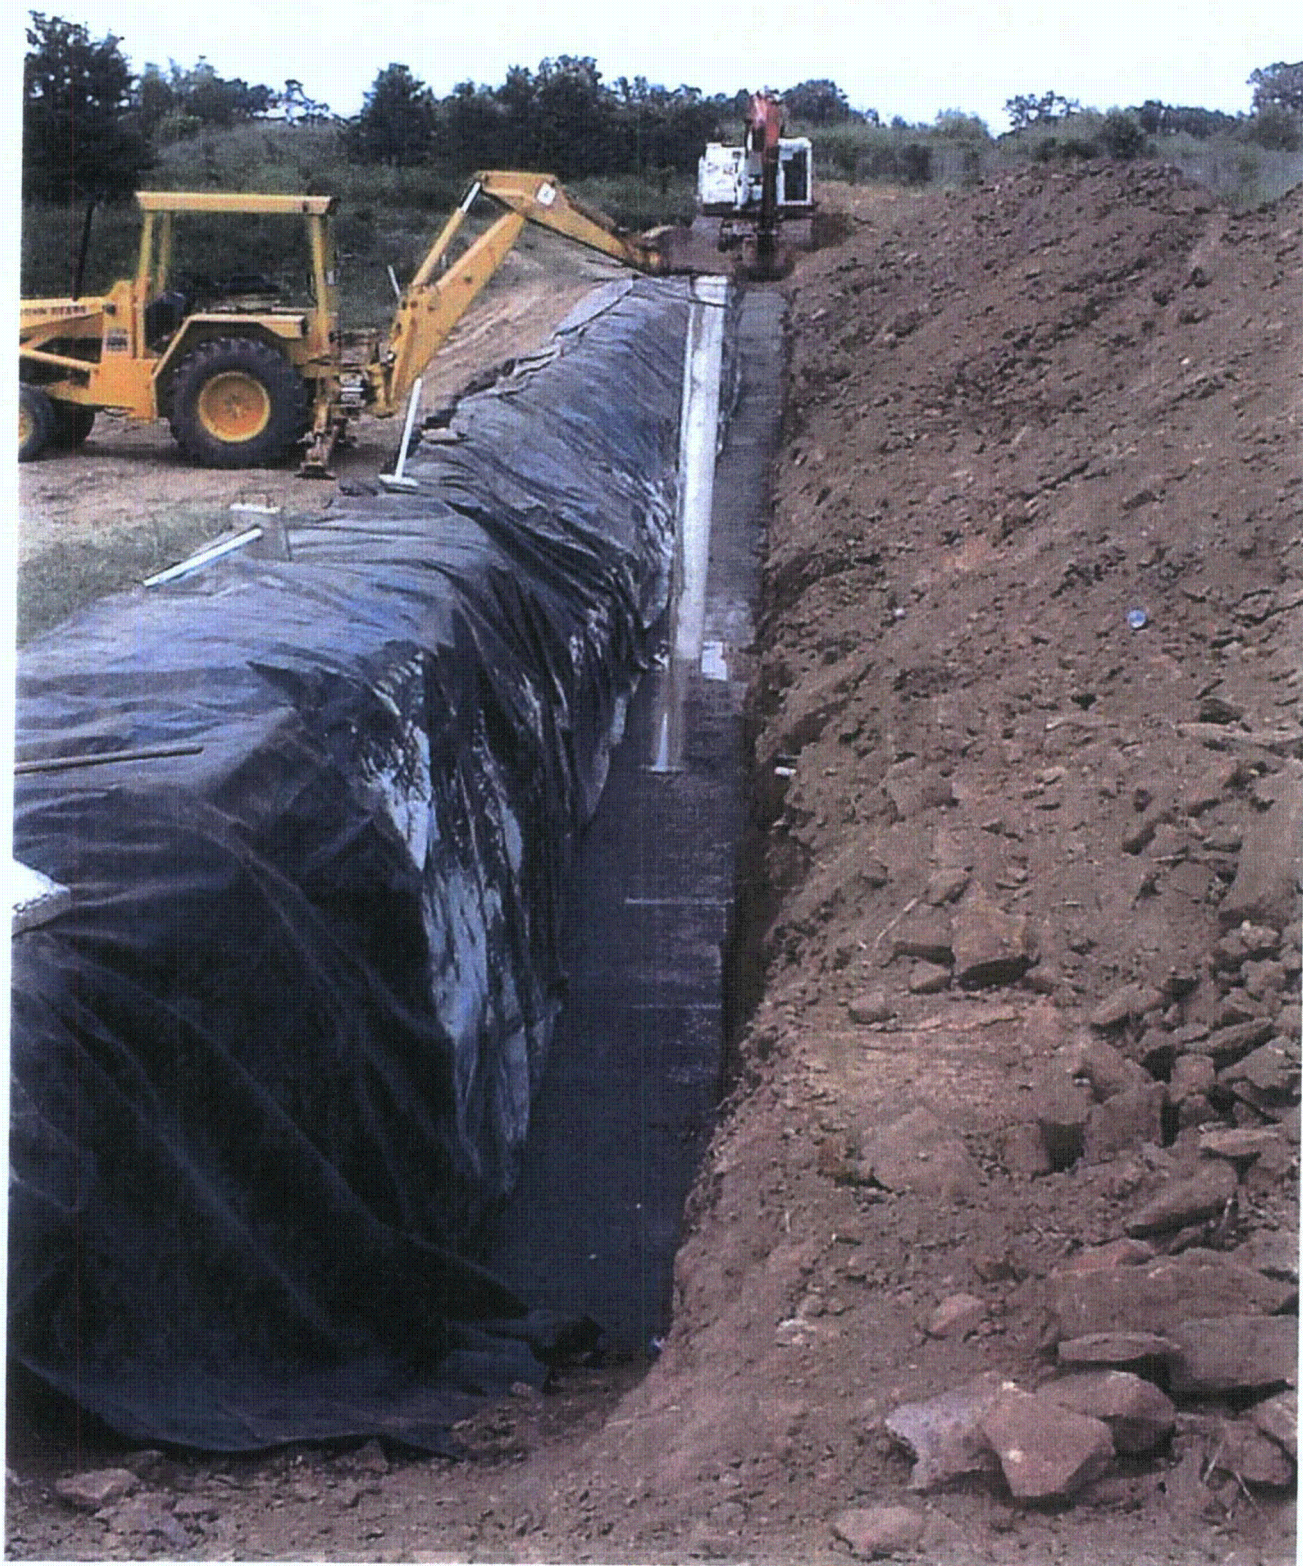
Figure 5. Riser pipe positioned 58' from bottom south end. (Looking North)

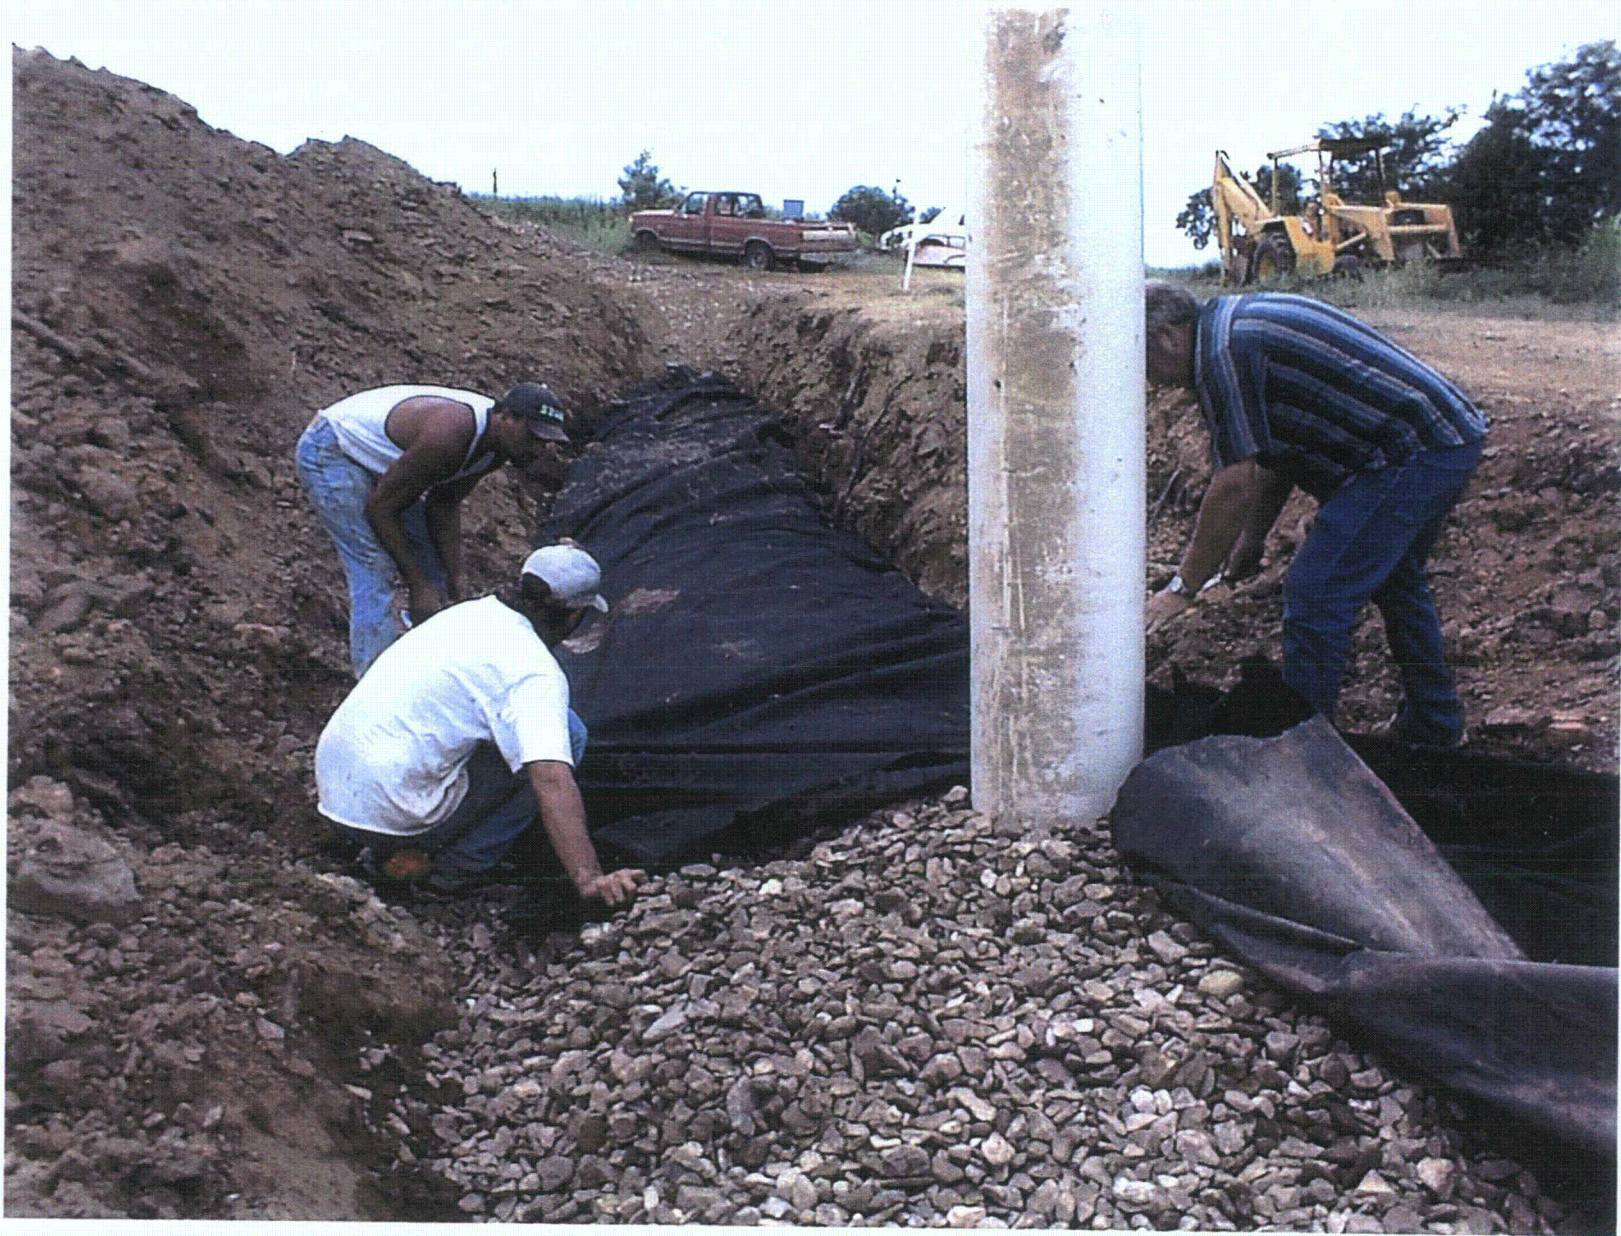
Figure 7. Placement of liner and geo-fabric over gravel. (Looking South)

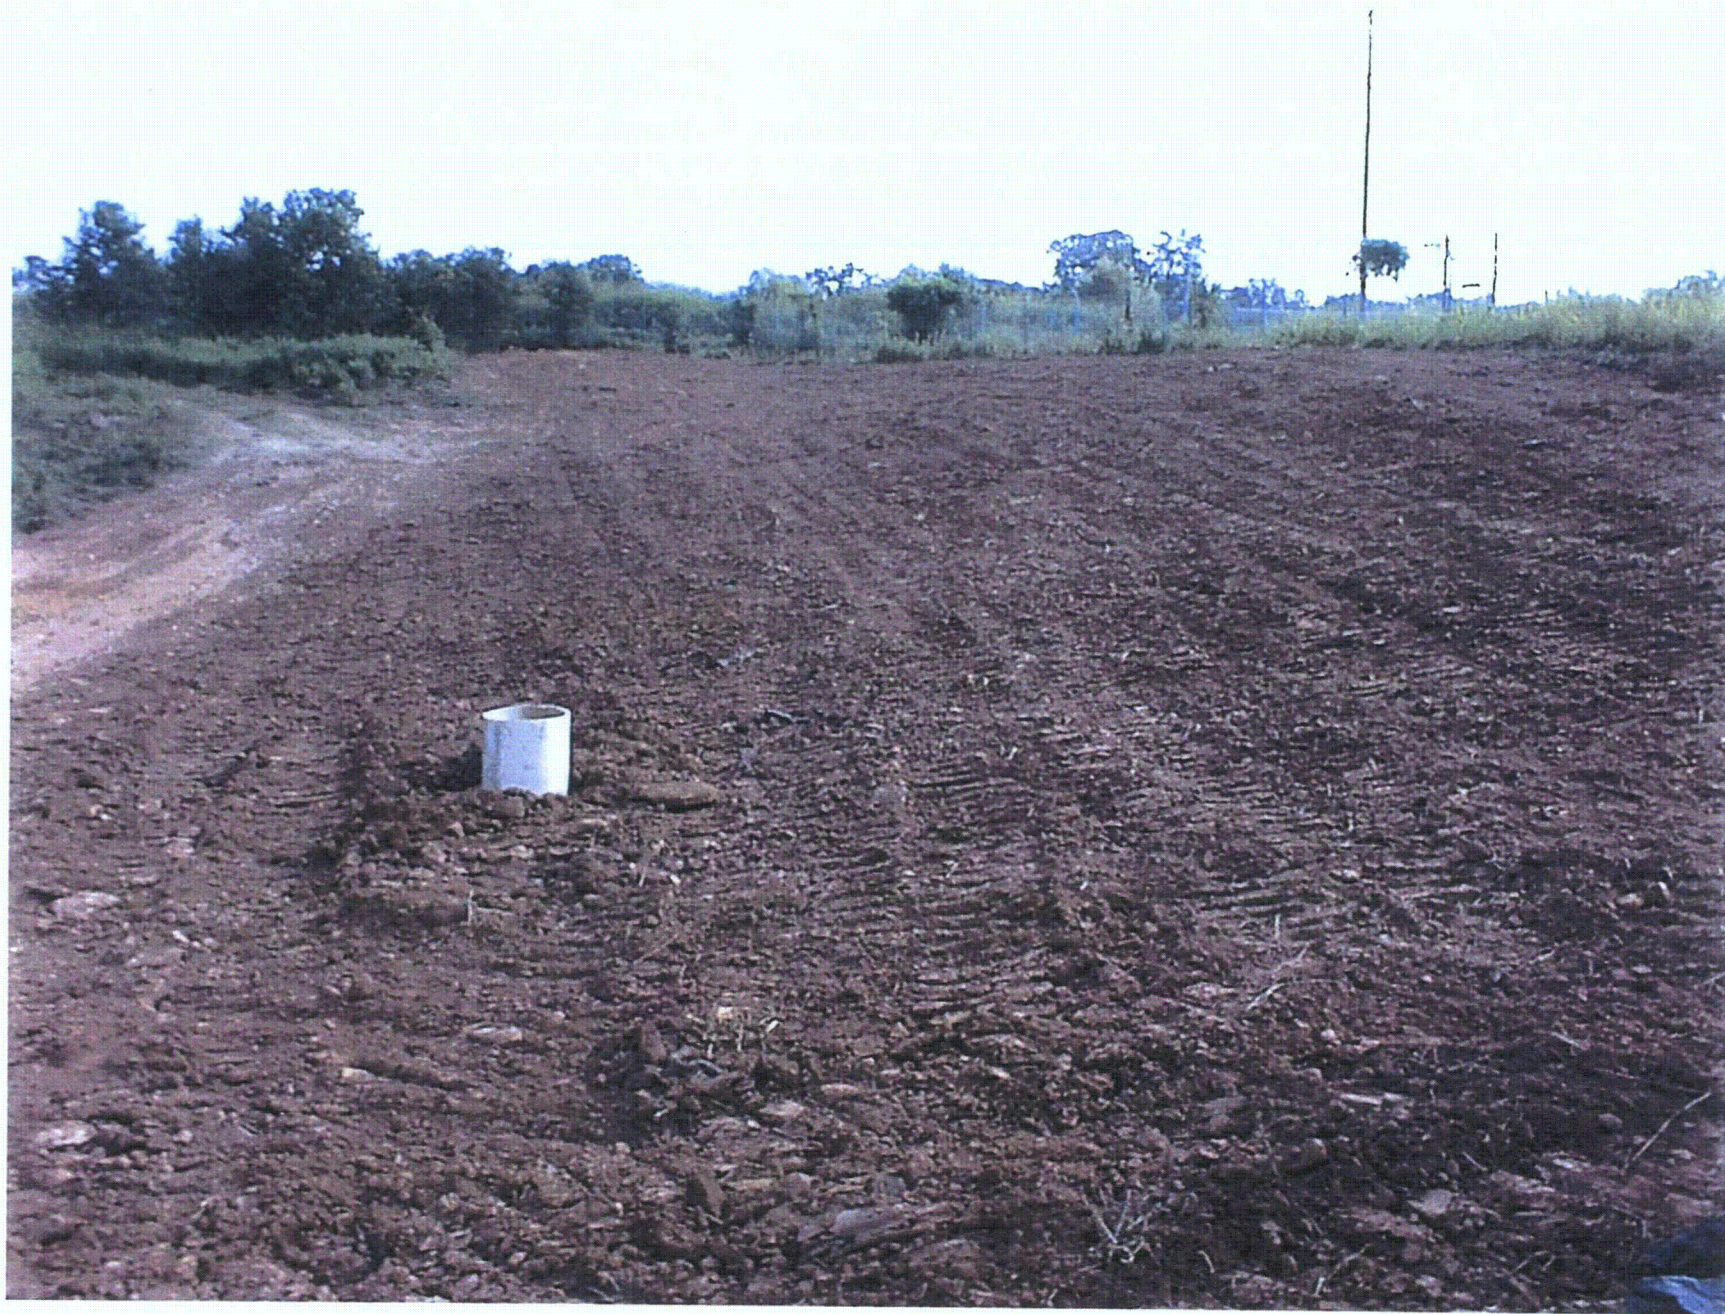
Figure 8. Final grade of area with riser pipe showing. (Looking North)

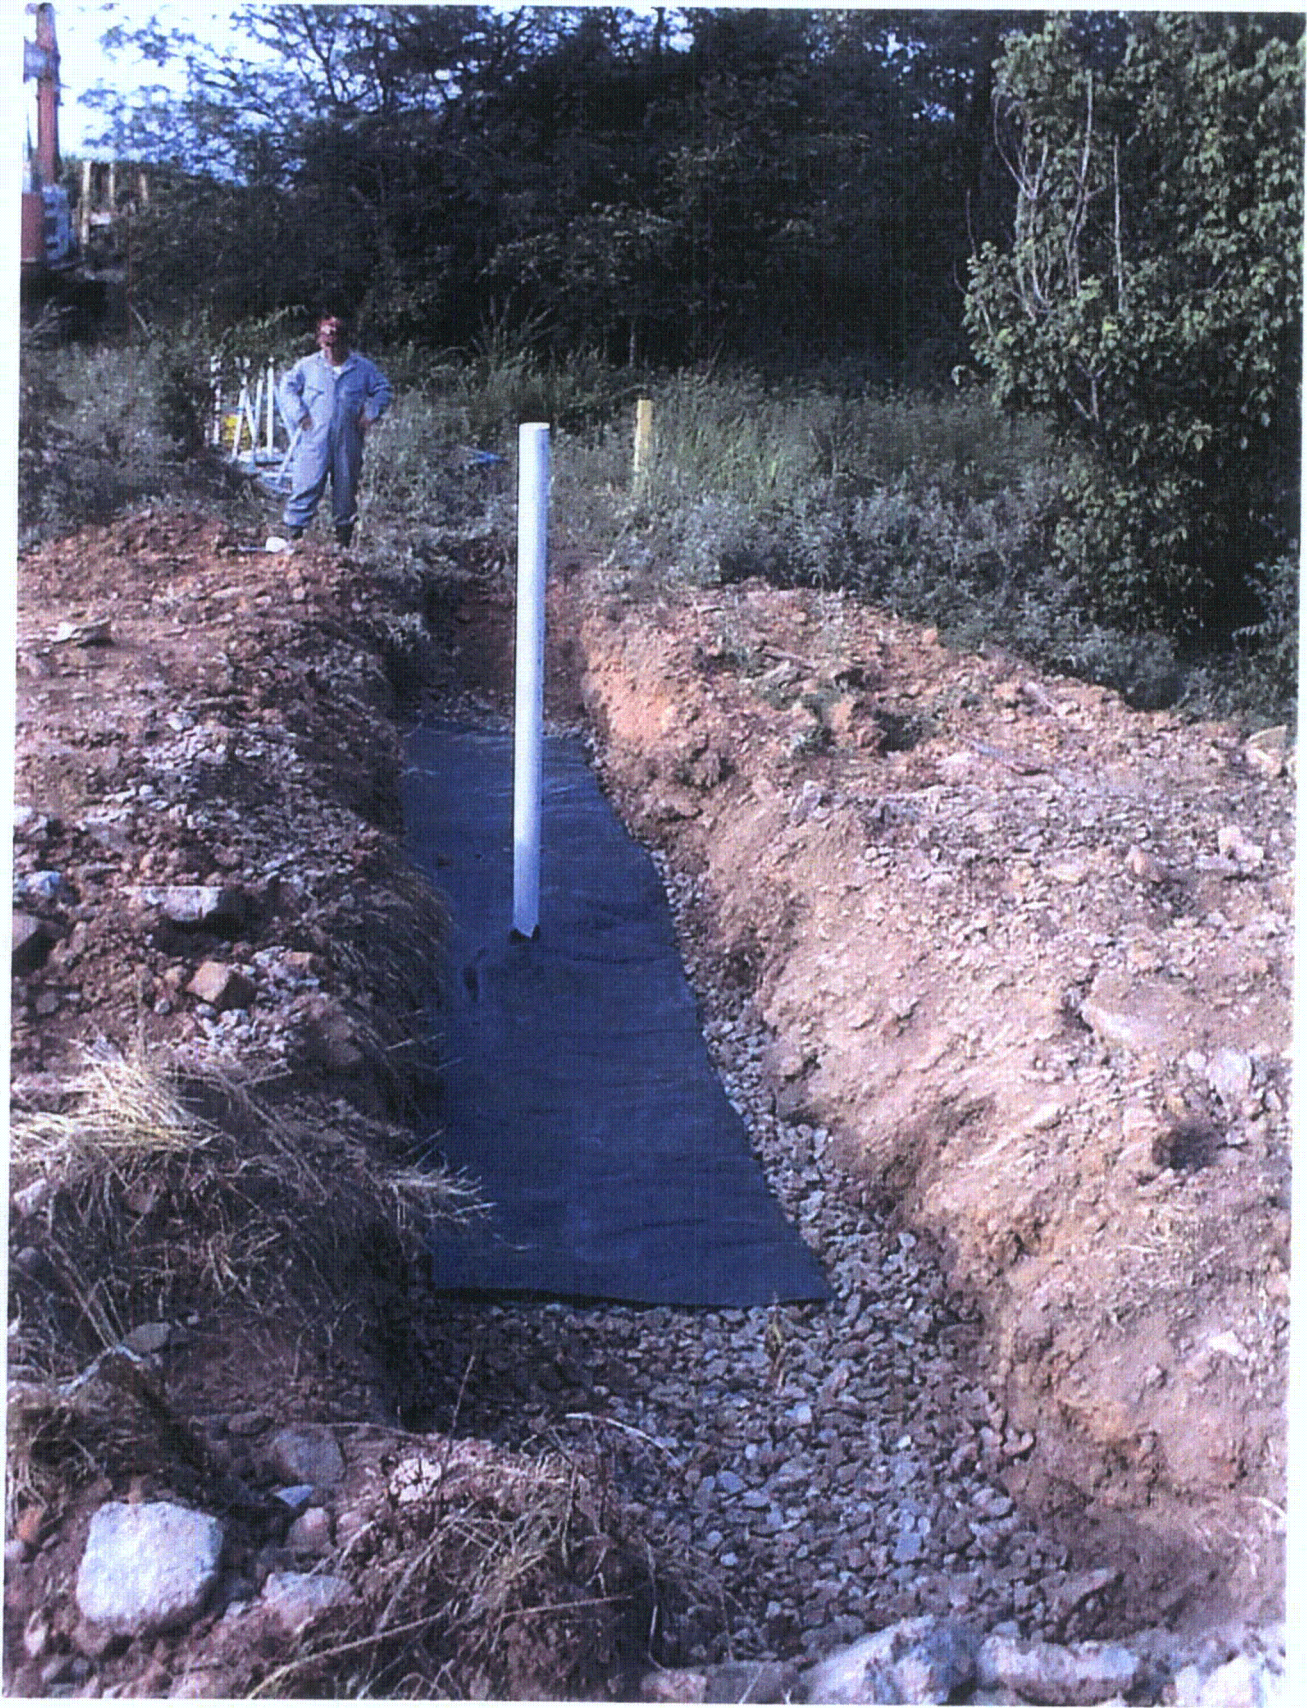
Figure 9. Monitor trench construction. (Looking South)

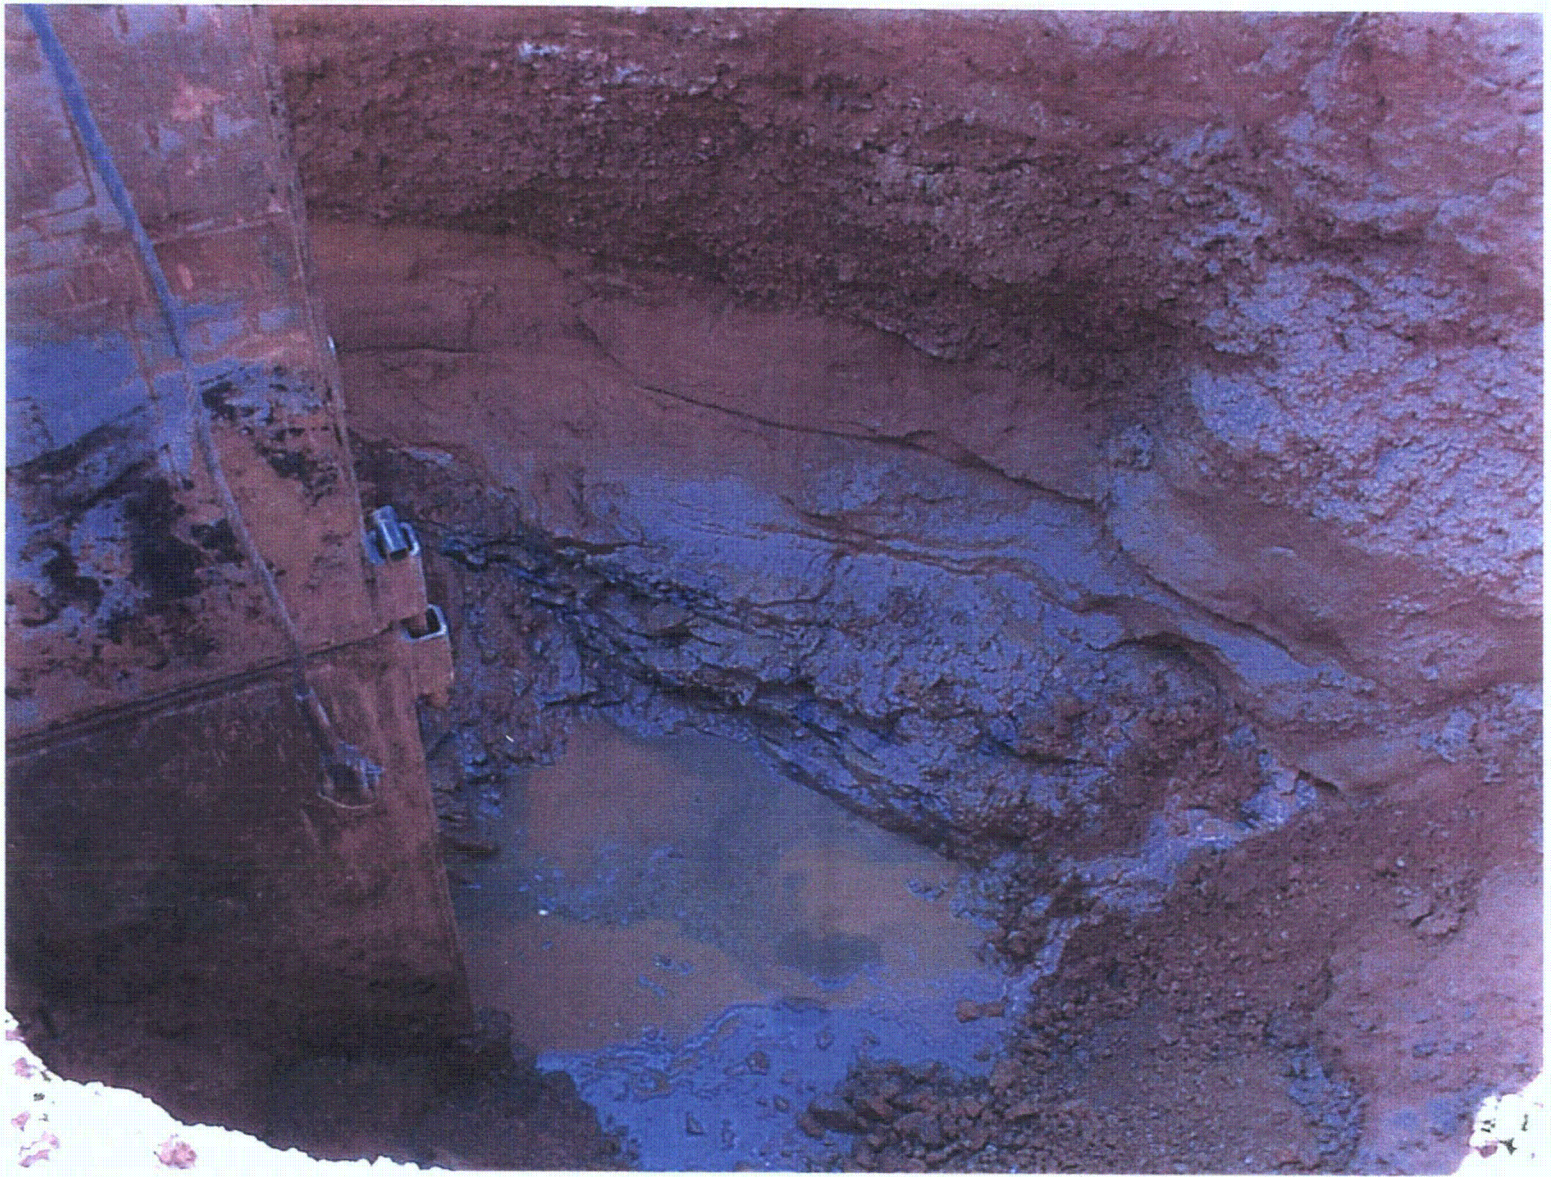
Figure 3. Water entering the excavation (concrete riser pipe location) at the interface of sandy soil and black shale.
