# **Special Inspection Team (SIT) Exit Meeting**

**Braidwood Dual Unit Shutdown  
September 30, 2010**

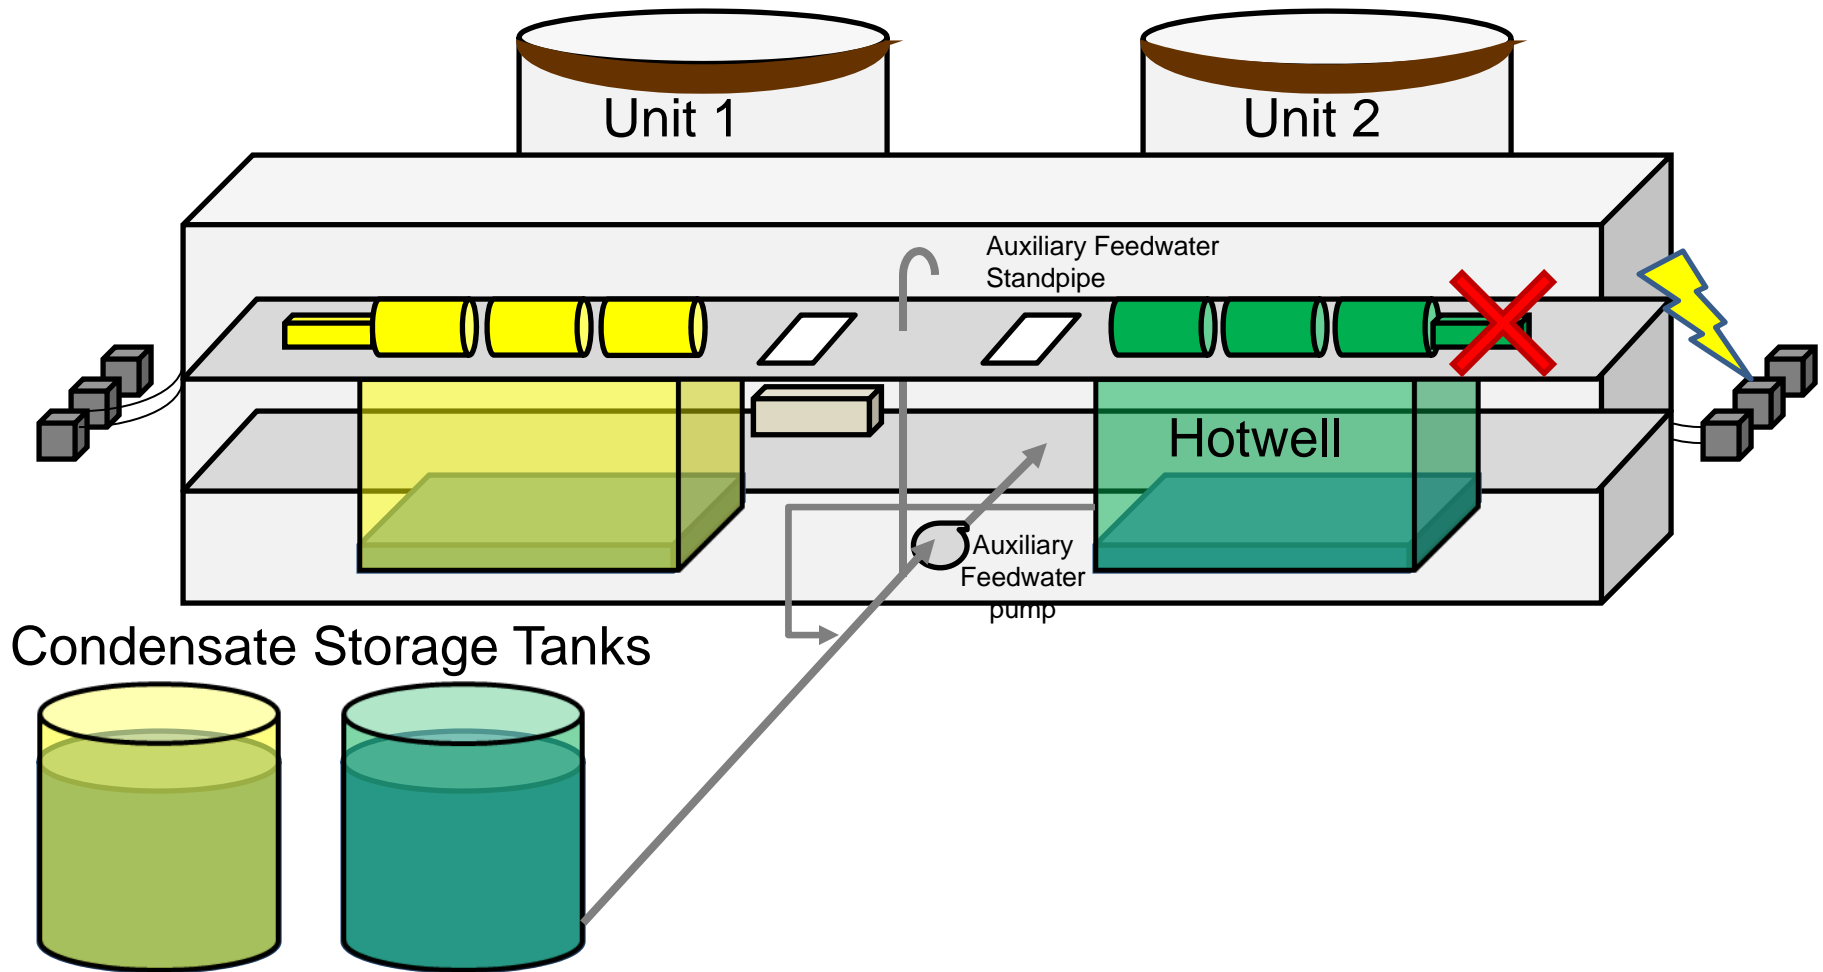
A piece of an air damper broke and caused a fault in the electrical system causing a Unit 2 turbine/generator trip and subsequent reactor trip

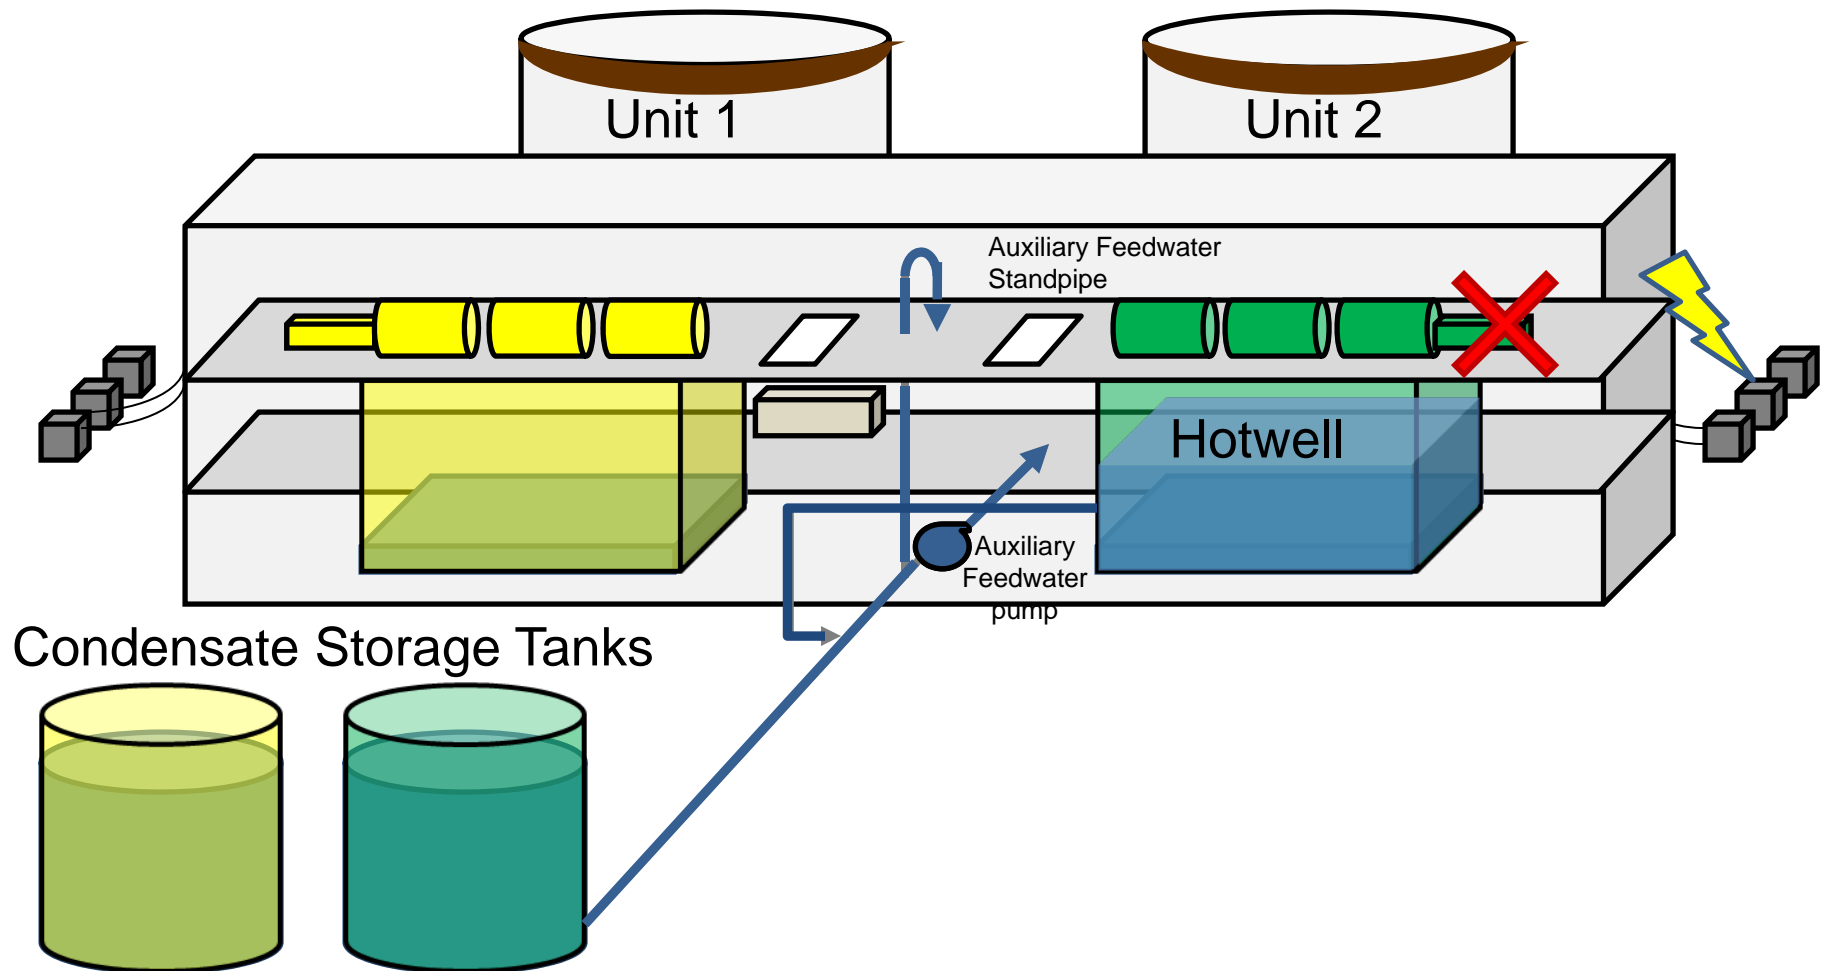
# Water in the auxiliary feedwater header standpipe discharged onto the turbine deck

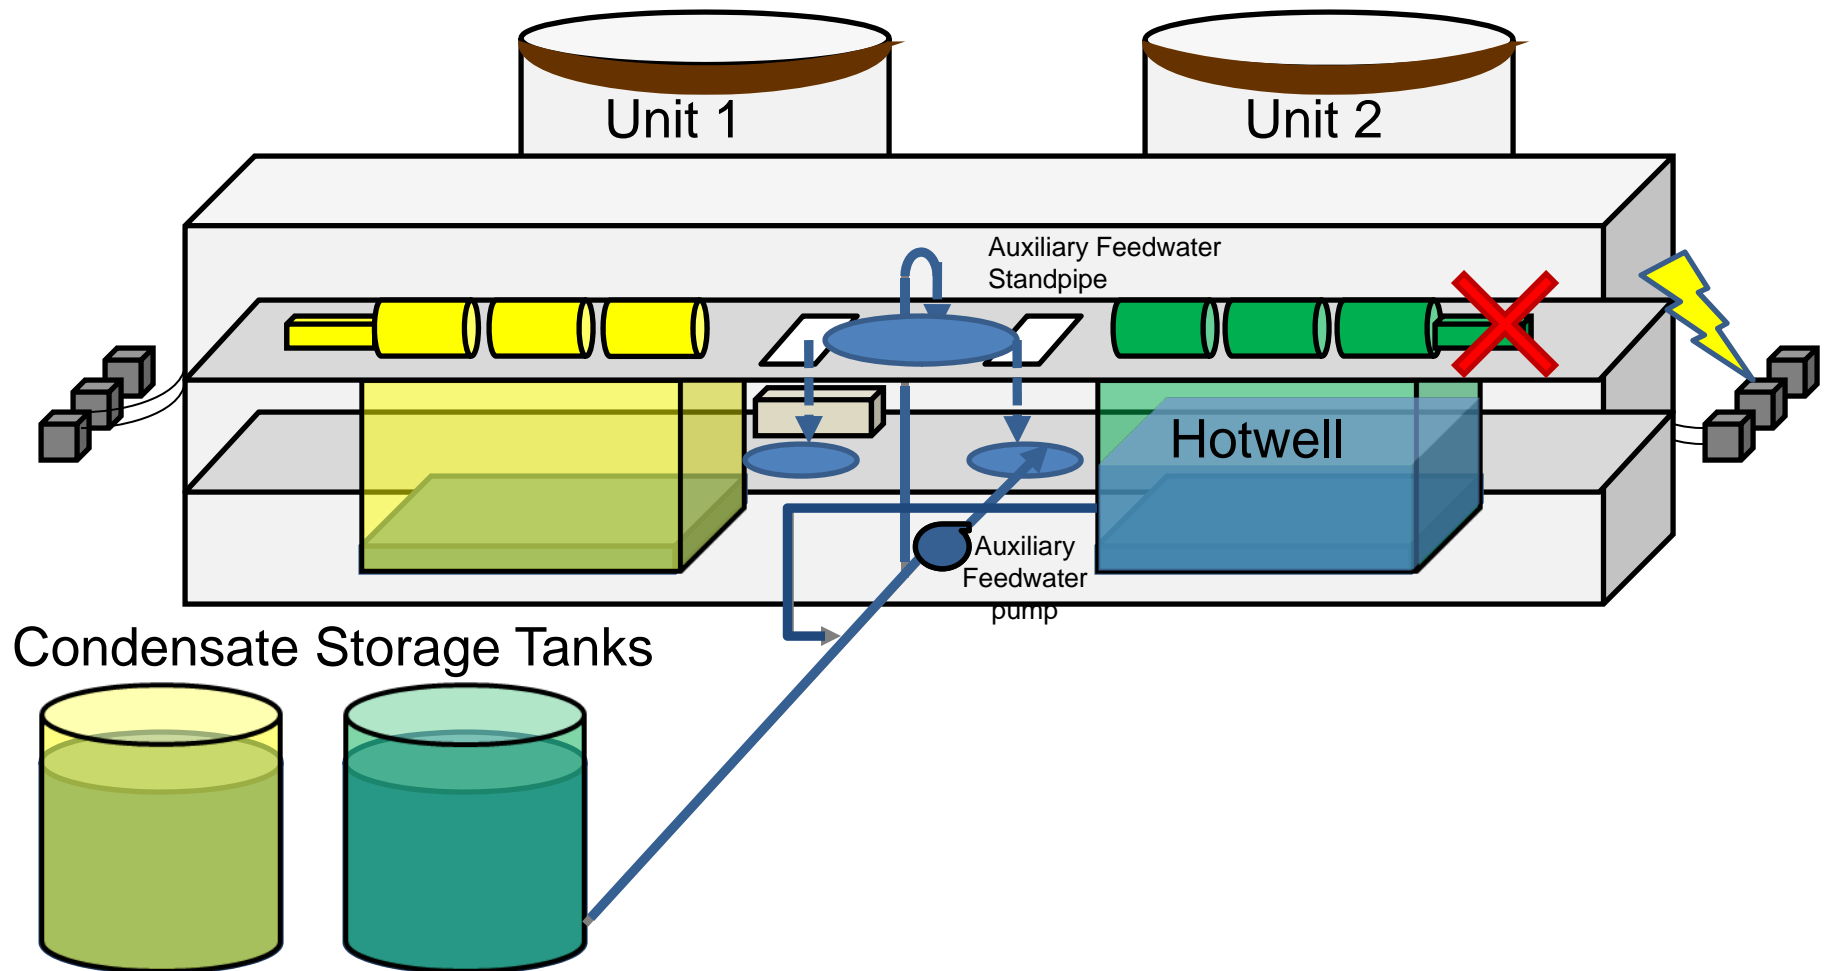
# Water spilled to lower levels in the turbine building through various openings

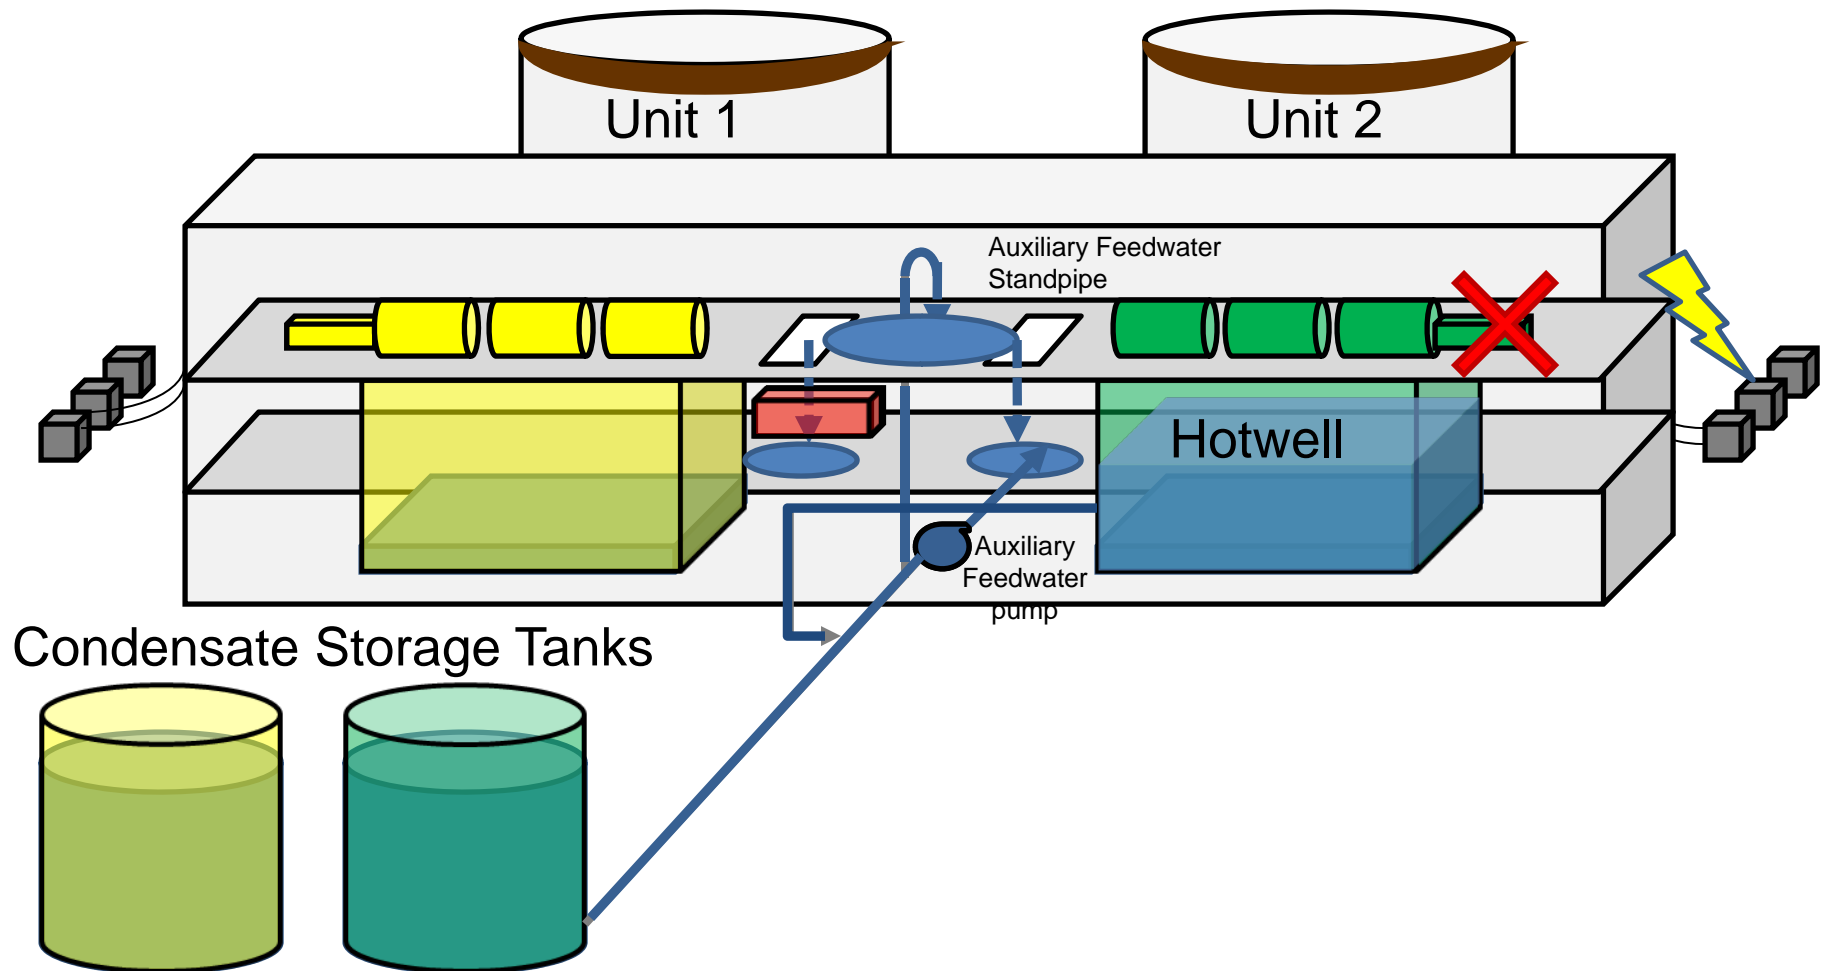
The water entered a non safety-related electrical cabinet that contained Unit 1 circulating water pump electrical circuits

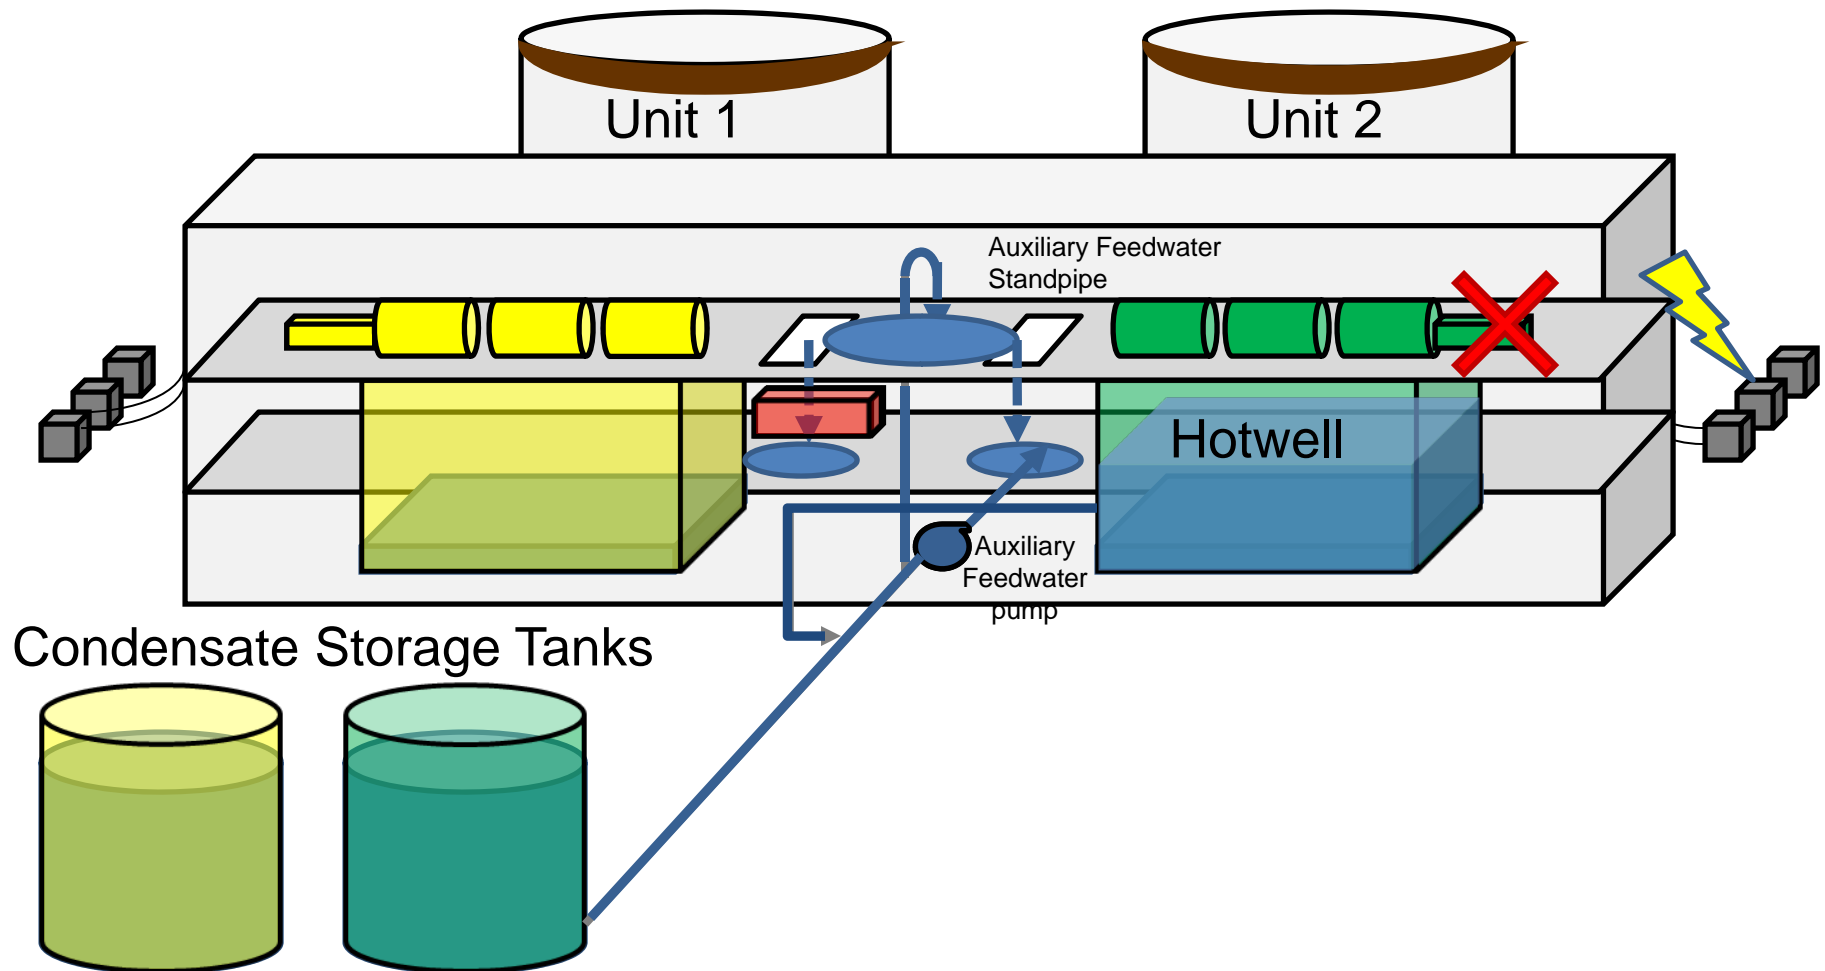
Circulating water pump circuits in the cabinet were damaged and caused 2 of the 3 Unit 1 circulating water pumps to trip off

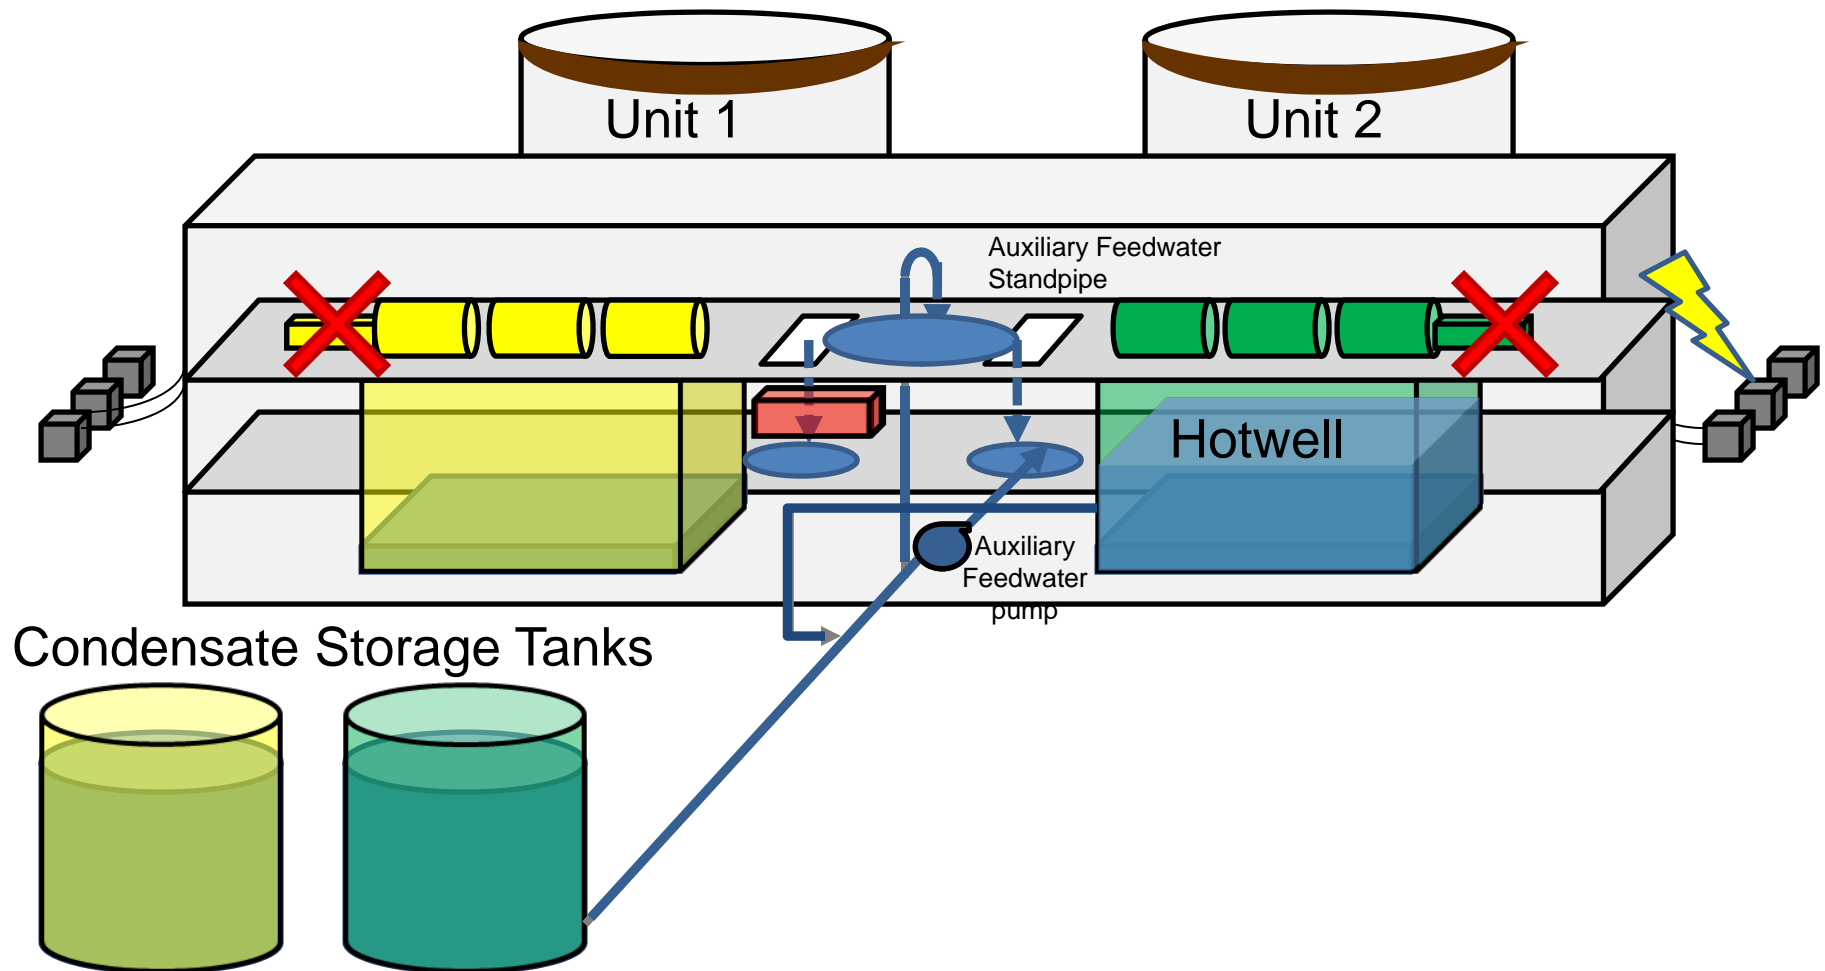
The loss of 2 circulating water pumps resulted in a loss of condenser vacuum, which caused the Unit 1 reactor to trip

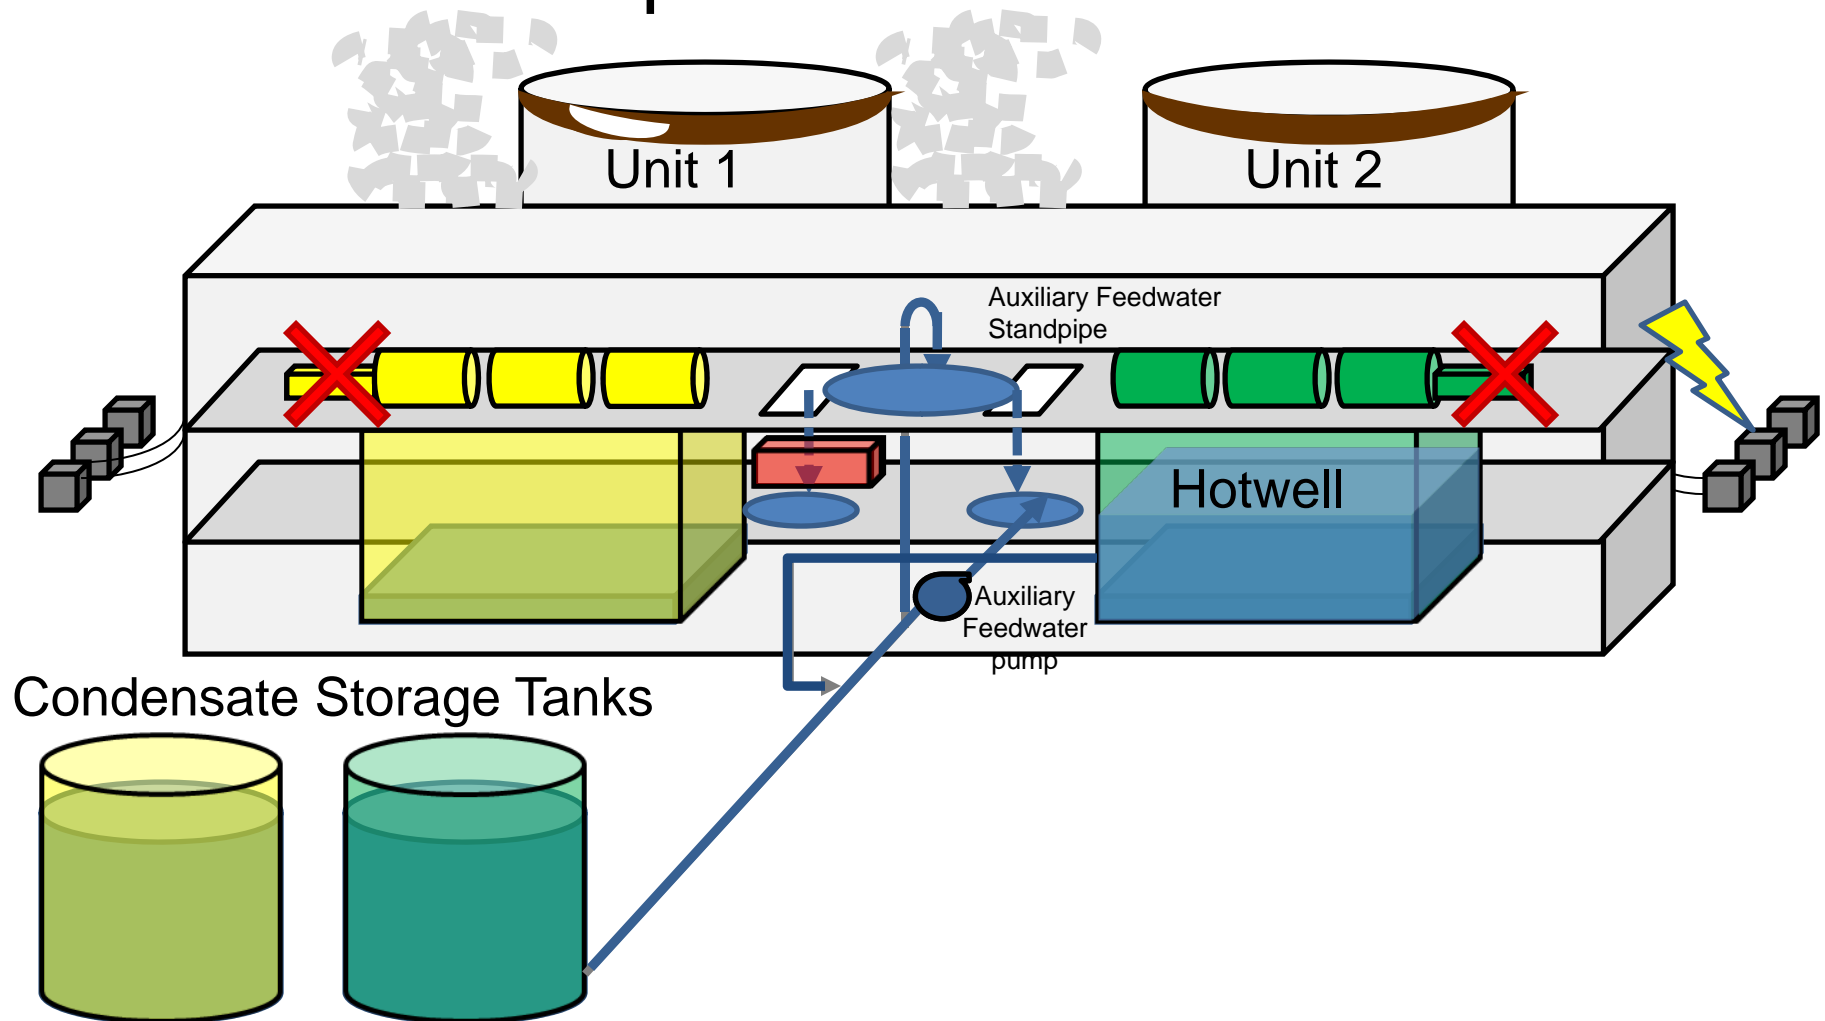
Steam from the safety valves knocked off  
flashing covering an outdoor walkway at the  
top of containment

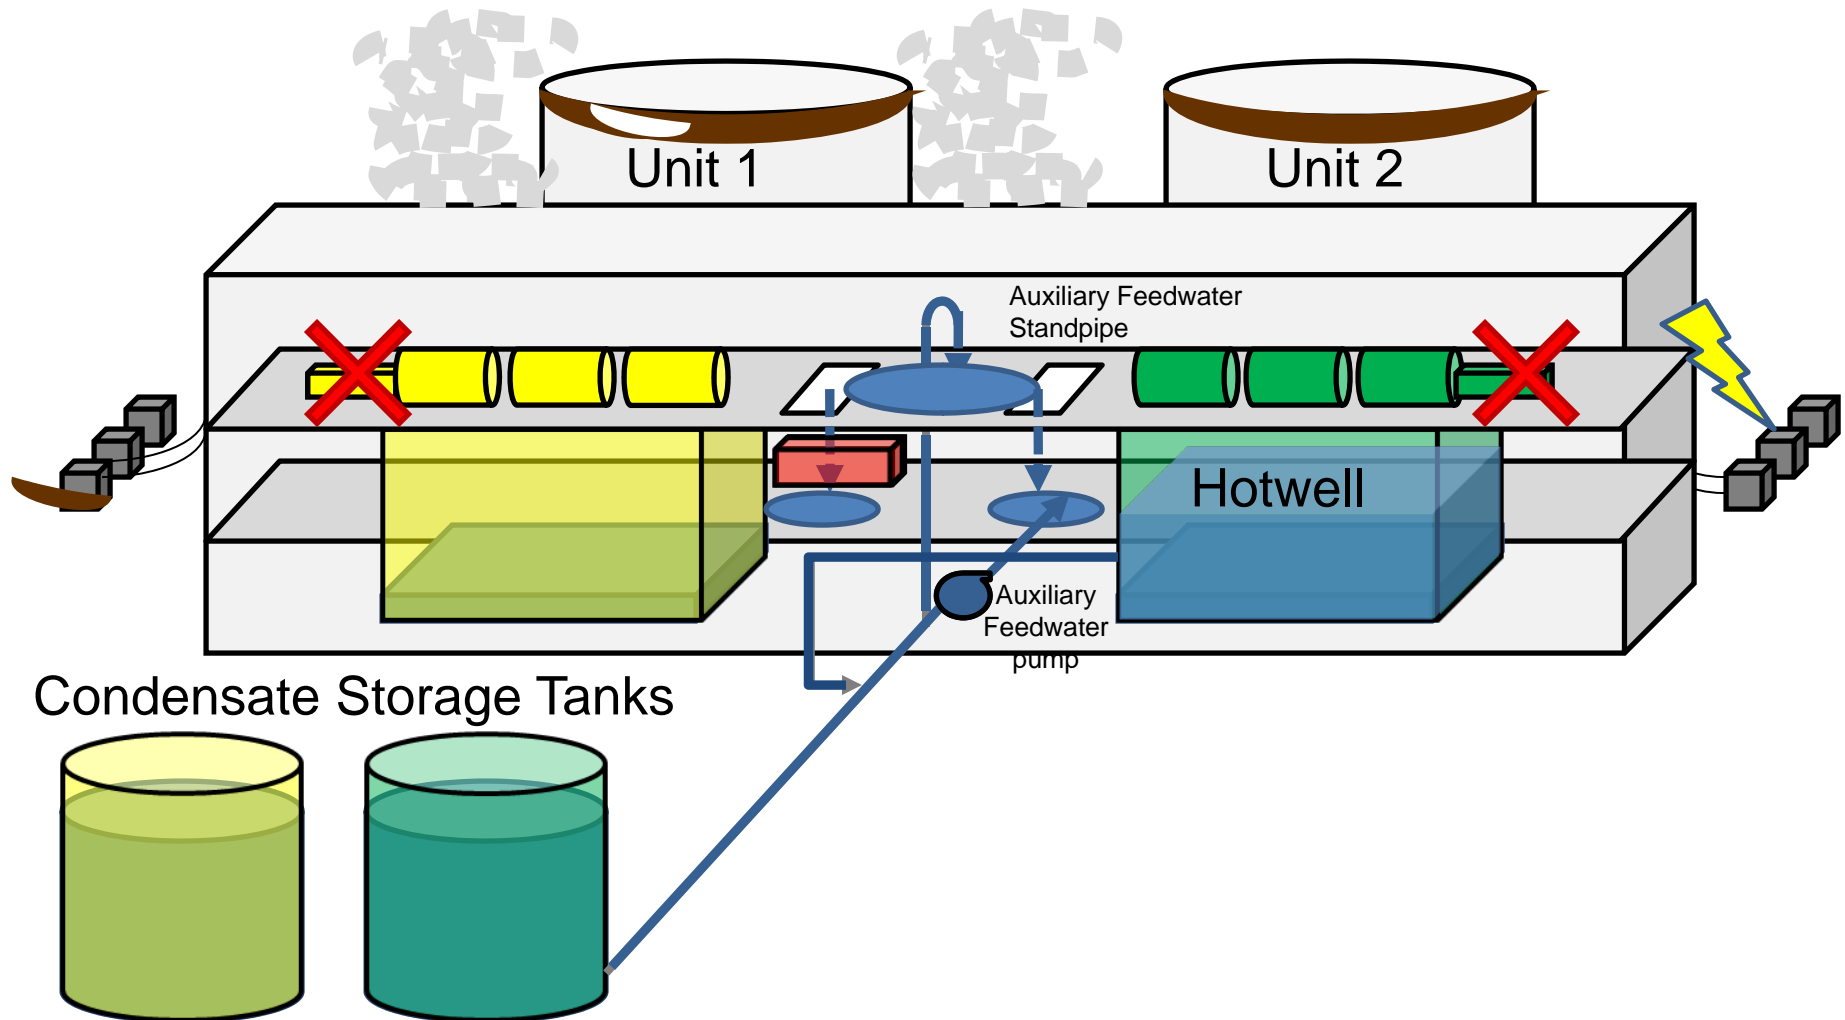
The dislodged flashing landed near the Unit 1 offsite power transformers but did not have an adverse affect

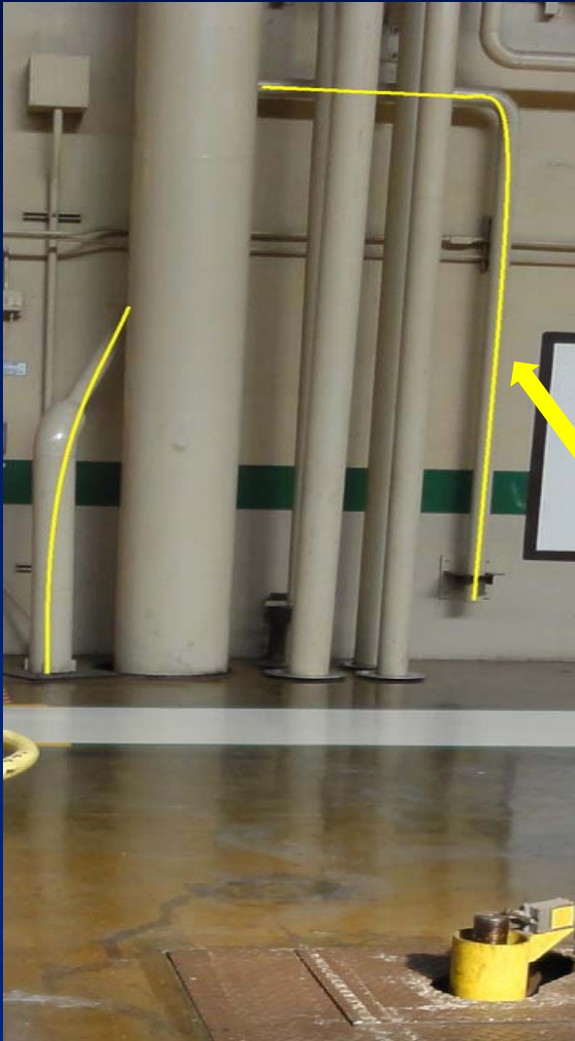
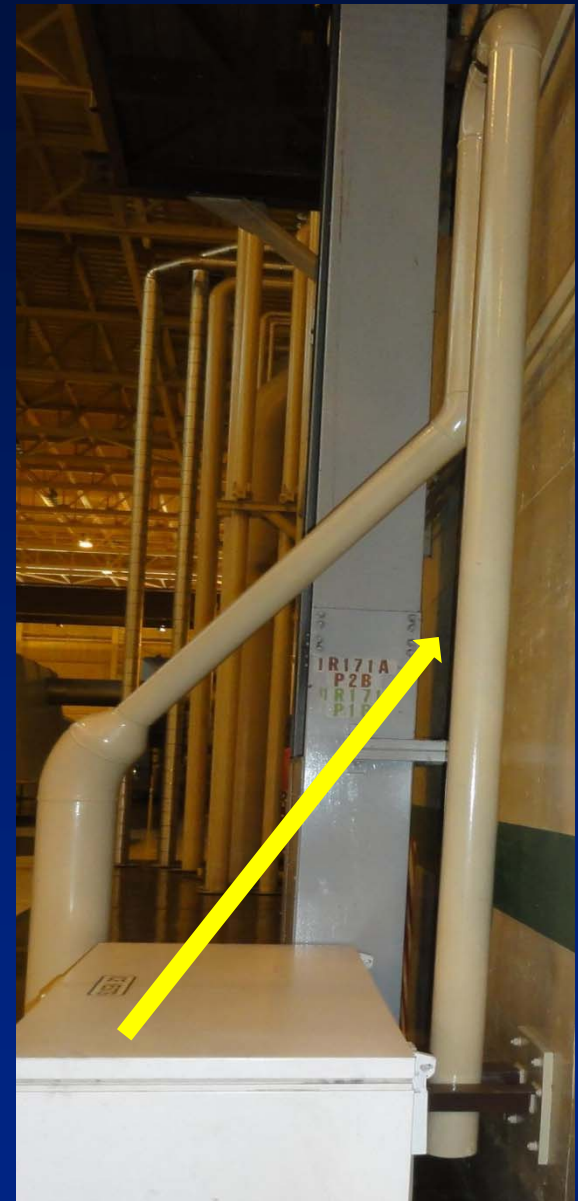
## AFW suction header stand-pipes

- During certain plant operations, this system design allows water to be discharged to the turbine building floor where it flowed to lower elevations.
- It became an expected condition during unit trips and therefore not entered into the corrective action system when it happened.
- Hence, there was no evaluation of the impact of the discharged water to the plant.
- Resulted in a trip of Unit 1.
- Automatic condensate reject changed to manual.

- Potential finding - failure to follow corrective action program procedure to identify, evaluate and correct a condition that adversely affected safe plant operations.
- Finding of very low safety significance (Green).
- Cross-Cutting aspect: Problem Identification & Resolution, Corrective Action Program – Low Threshold (P.1(a)).

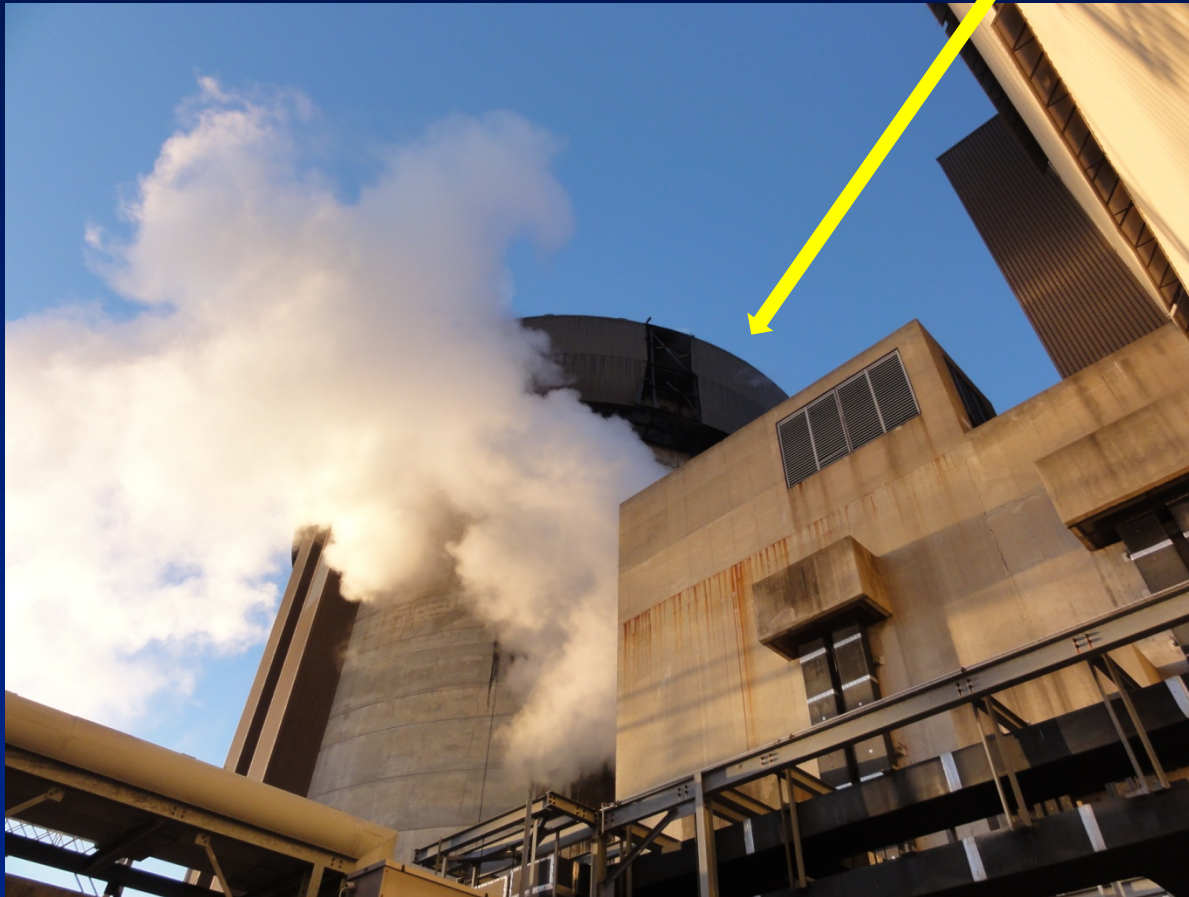
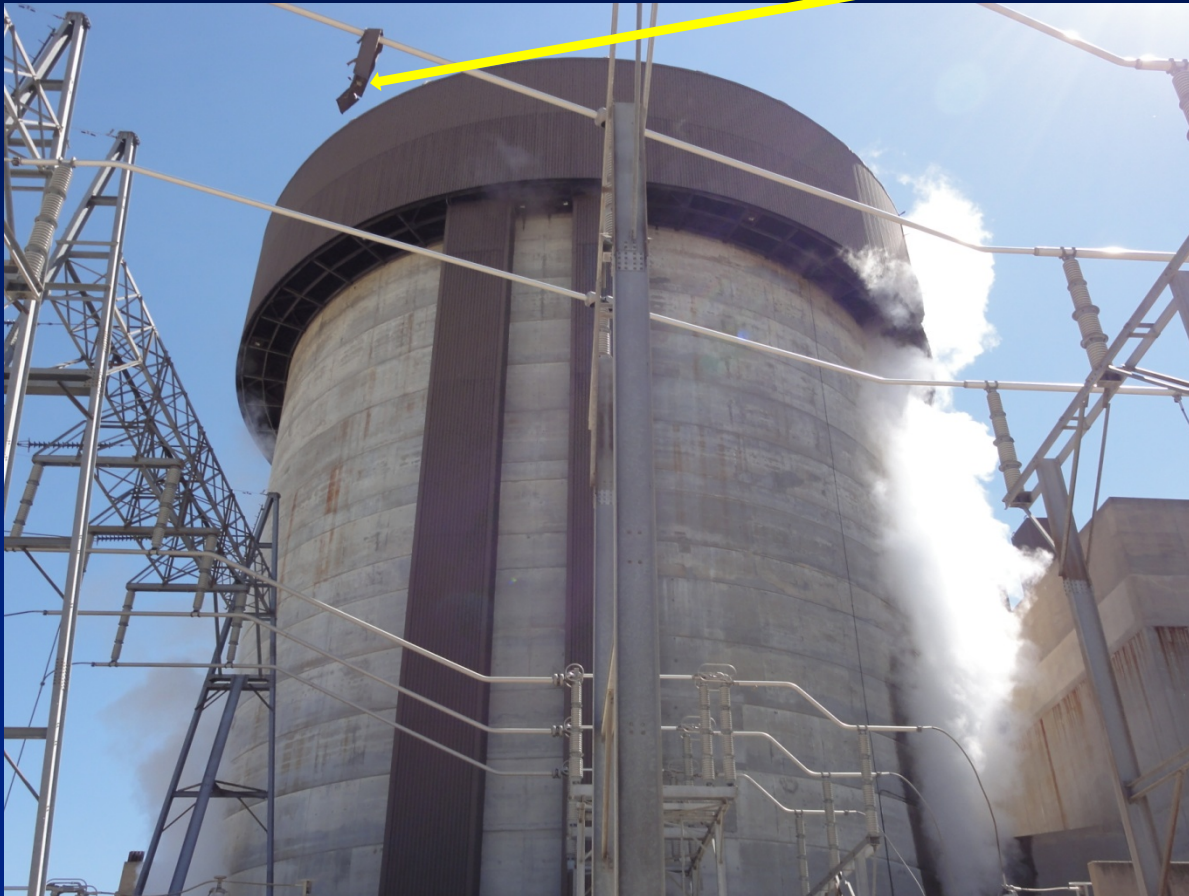
## Finding – Reactor Building Flashing

- Reactor building flashing blown off during steam release and landed on and in the area of the offsite power equipment.
- In 2007, Exelon reviewed experience from another site where siding blown off by a steam release and caused a loss of offsite power.
- The evaluation of that event was inadequate since it did not address previous Braidwood flashing failures and vulnerability of offsite power from debris.
- Flashing has been restrained until permanent solution developed.

- Proposed Finding - failure to adequately evaluate operating experience in accordance with plant procedures for effects of reactor building flashing falling on offsite power equipment.
- Finding of very low safety significance (Green).
- Cross-Cutting aspect: No cross-cutting aspect was identified since it is not considered to reflect current performance.
