**UNITED STATES
NUCLEAR REGULATORY COMMISSION**
REGION II
245 PEACHTREE CENTER AVENUE NE, SUITE 1200
ATLANTA, GEORGIA 30303-1257

**SUBJECT: CRYSTAL RIVER NUCLEAR PLANT - SPECIAL INSPECTION REPORT
05000302/2009007**

The purpose of this inspection was to examine activities associated with the delamination identified in the Unit 3 containment. The inspection was conducted in accordance with the Special Inspection charter issued by the Region II Administrator on October 13, 2009. As part of the inspection, the NRC examined your evaluation of extent of condition, your evaluation of root cause, and your planned corrective action for continued operability. The inspectors interviewed personnel and conducted plant walk downs, including visual examination of accessible portions of the outside and inside surfaces of the containment.

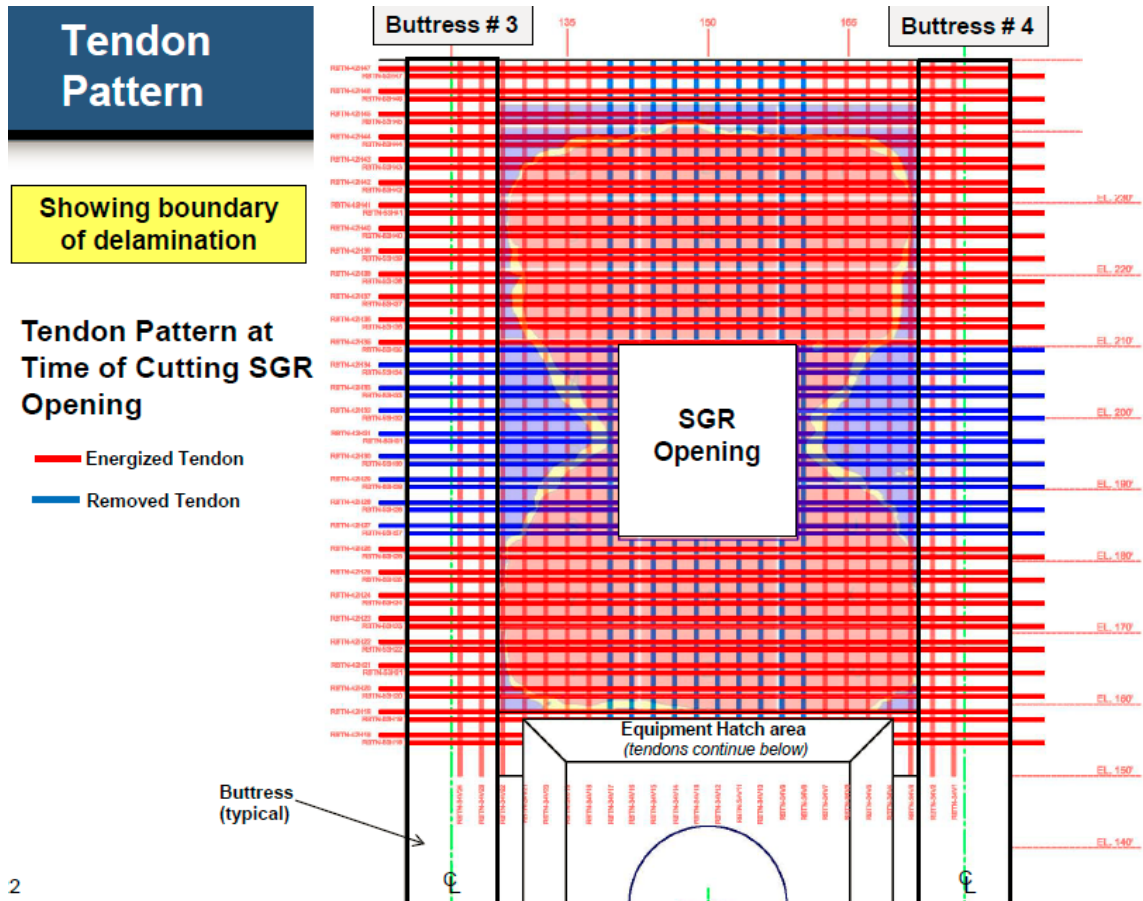
Figure 5.2.1 Tendon Pattern at SGR Opening and Delamination Profile

Bay 3-4 was found to have large delamination with an hour glass shape centered at the SGR opening. The delamination was concluded to be within an area of approximately 80 ft by 60 ft, extending between the edges of the two buttresses in horizontal direction, and from top of the equipment hatch opening to approximately ten feet below the ring girder in the vertical direction. Average mobility values exceeded the potential damage threshold in the delaminated area. Based on core sampling and boroscope examination of core holes, the depth of delamination ranged from three to ten inches, with an average delamination depth between seven and eight inches from the exterior face. The delamination appeared to be in the plane of the hoop tendons. The extent of the delamination was confirmed by the core samples and boroscope examination.

In conclusion, the licensee's root cause evaluation determined that the immediate technical root cause of the delamination event was the redistribution of stresses, as a result of the SGR containment opening activities, resulting in additional stress beyond original containment design. The condition exceeded the fracture capacity/tensile strength of the concrete resulting in cracking along the high stress plane connecting the horizontal tendons. As the cracks propagated and joined, delamination occurred over a wide area. Evaluation of the contributing failure modes identified only one practical technical root cause subject to licensee's control, and that was inadequate scope/sequence of tendon detensioning used in the SGR outage. The licensee stated that the fracture-based computer simulation effort and post-event research by its contractor highlighted the inability (or limitation) of standard industry accepted analysis tools to predict delamination.

The licensee's repair plan to remove and replace the delaminated condition included: (1) additional detensioning of containment; (2) removal of delaminated concrete; (3) installation of reinforcement, including radial reinforcement through the delamination plane; (4) placing of new concrete; (5) retensioning containment; and (6) post-repair confirmatory system pressure testing. The licensee developed new finite element analysis models to predict stresses in the repaired containment wall under design basis loads. Using these and other supporting new analysis models, the licensee planned and implemented additional containment detensioning without causing further delamination. Subsequent to removal of the delaminated concrete, vertical cracks were observed along the vertical tendon lines in the concrete surface between

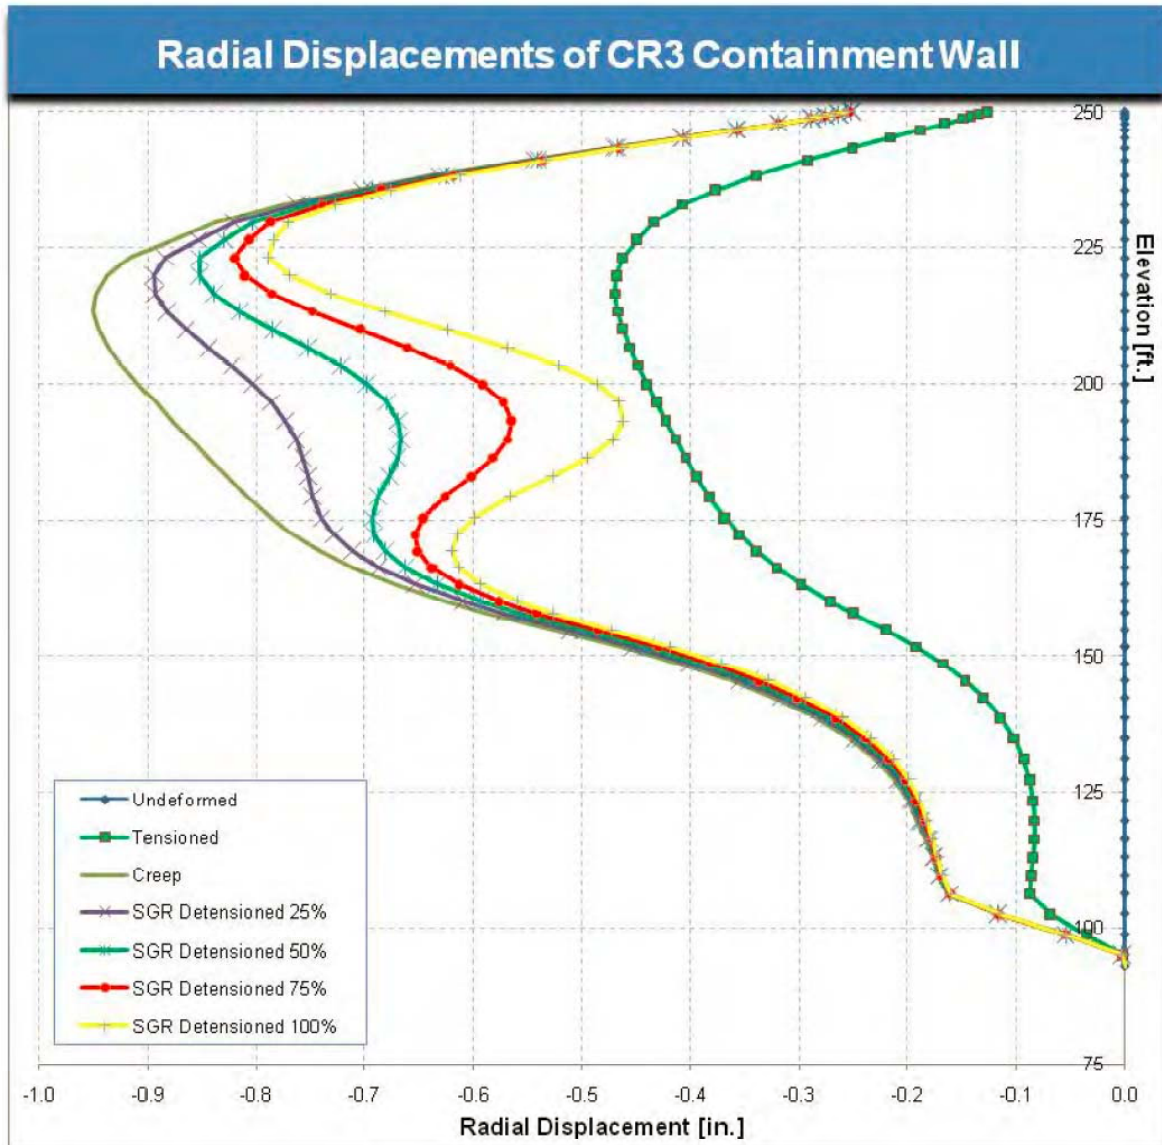
Figure 5.2.2 Bay 3-4 midline vertical profile of radial displacements during progressive SGR detensioning (Note that displacements are plotted to an exaggerated scale)

The licensee stated that, of particular importance in this analysis is that typical industry containment structure analysis tools that were used to calculate the radial tension and assess the delamination potential, when creating containment openings in other similar projects, have consistently shown large margins for stress tolerance to delamination by using average tensile stress values. The licensee stated that its computer simulation, however, had shown that the CR3 containment structure had a lower margin of tolerance to delamination cracking than other plants which have used common industry calculations.

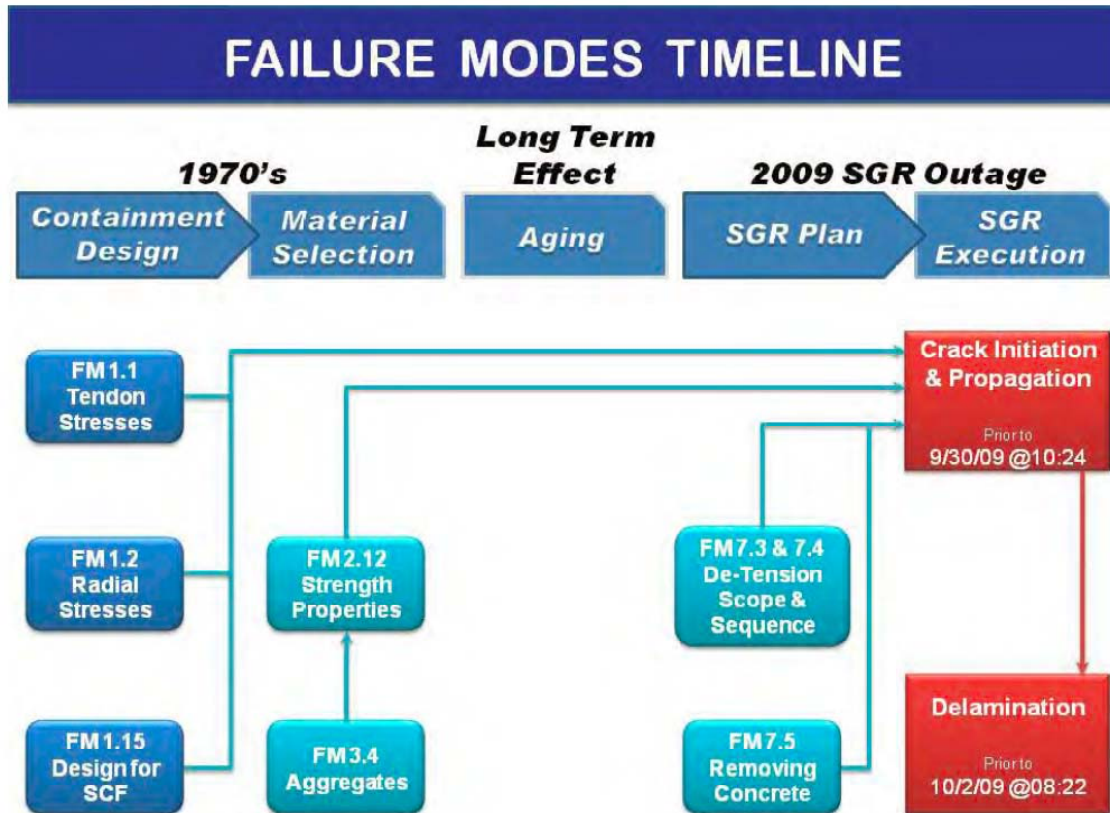
Figure 5.2.3 Failure Modes Timeline

The root cause analysis team identified 75 FMs that could potentially cause or contribute to the delamination of Bay 3-4 of the CR3. These failure modes were binned into nine categories, as indicated below, and subsequently evaluated using a "Support/Refute" methodology to conclude whether or not it was supported as a causal factor.
