**NC STATE UNIVERSITY**

Re: Reportable Event 46484; Radiography Incident  
License No. R-120  
Docket No. 50-297

# **Neutron Imaging Facility Personnel Exposure Incident Report**

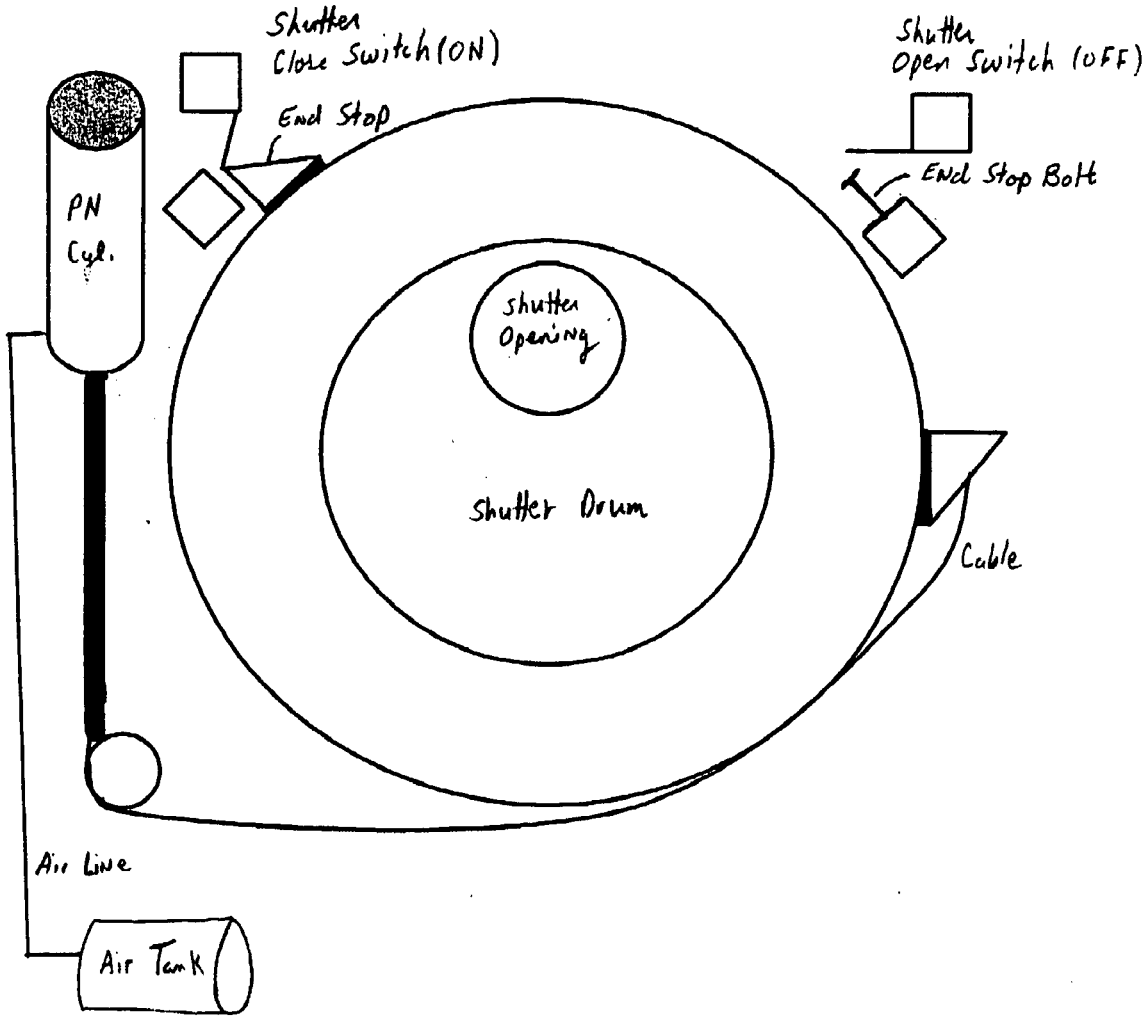
**ATTACHMENT 2 NIF SHUTTER in CLOSED POSITION**

In this incident when the timer reached zero minutes, the 24 volt circuit de-energized and air was vented from the pneumatic cylinder. Normally this would cause the shutter to close by gravity. In this incident the shutter failed to close because it hung-up on the end-stop bolt. [Refer to Attachment 2]

Due to a design flaw, the shutter got hung-up because the shutter drum had moved outward in the axial direction by approximately 0.5 inches over time from repeated opening and closing. This altered where the shutter end-stop was making contact with the end-stop bolt, and the end-stop became jammed on the end-stop bolt.

2. The end stop bolt that prevented the NIF shutter from closing has been replaced with a cylindrical block that is unlikely to get caught on the shutter end stop.

3. A retaining bar has been installed at the base of the shutter to prevent the shutter rotating drum from moving outward.
4. The shutter closed position switch AND a radiation monitor have been connected to the NIF door interlock. The shutter must now be fully closed AND the radiation monitor reading must be below a radiation set point for the NIF door to open from the outside. For egress reasons, the Exit Permit Pushbutton on the inside of the NIF remains as designed causing the shutter to close and the NIF door to open. Similar arrangements with a radiation monitor interlock are being planned for installation at the Primary Piping Vault door and Positron Facility door.

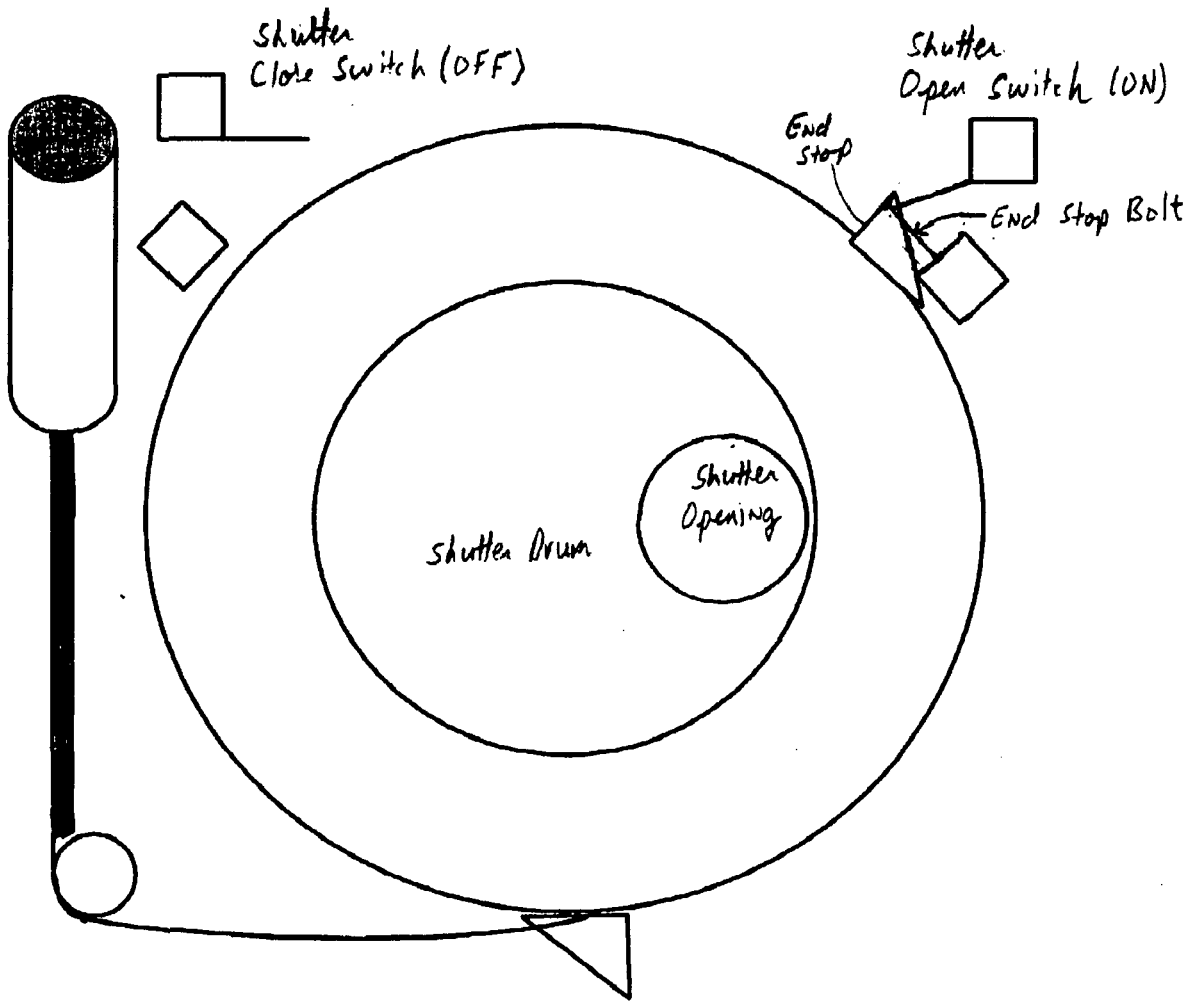
ATTACHMENT 2 NIF SHUTTER in OPEN POSITION

- 2:55 PM        The shutter was opened to start a 7 minute radiography exposure
- 2:57 PM        The radiographer left the reactor room
- 3:02 PM        The time for the radiograph expired on the Shutter Control Computer and air was vented from the pneumatic cylinder. The shutter failed to close due the shutter end stop being hung up on the end-stop bolt.

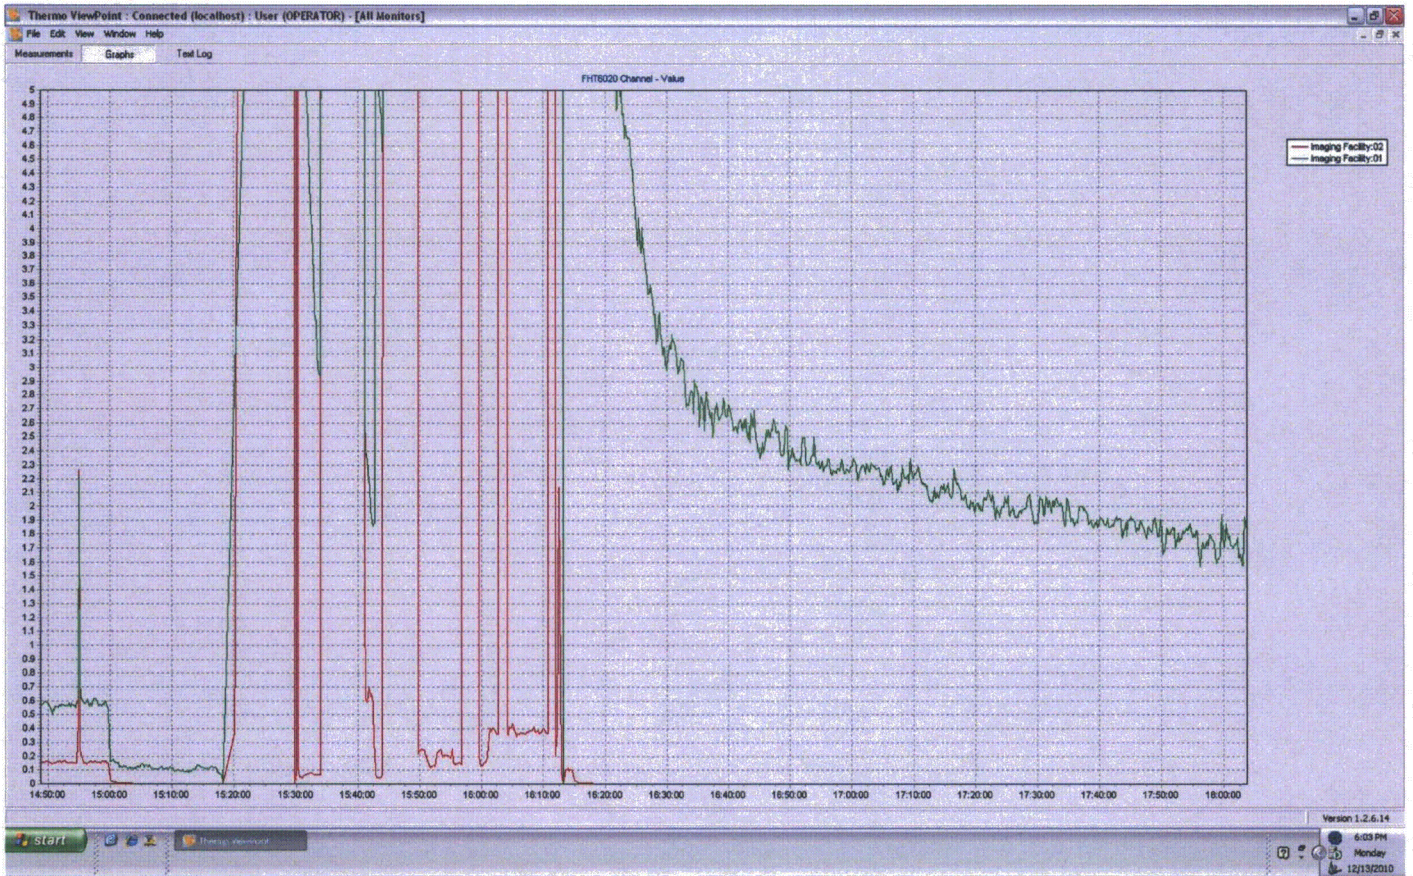
### ATTACHMENT 3 NIF Radiation Monitor Display (screenshot) for 13 Dec 2010

The incident alarms (spikes) are shown on the left side of the display. The remaining display is from the dose evaluation with the radiation detectors located inside the NIF.

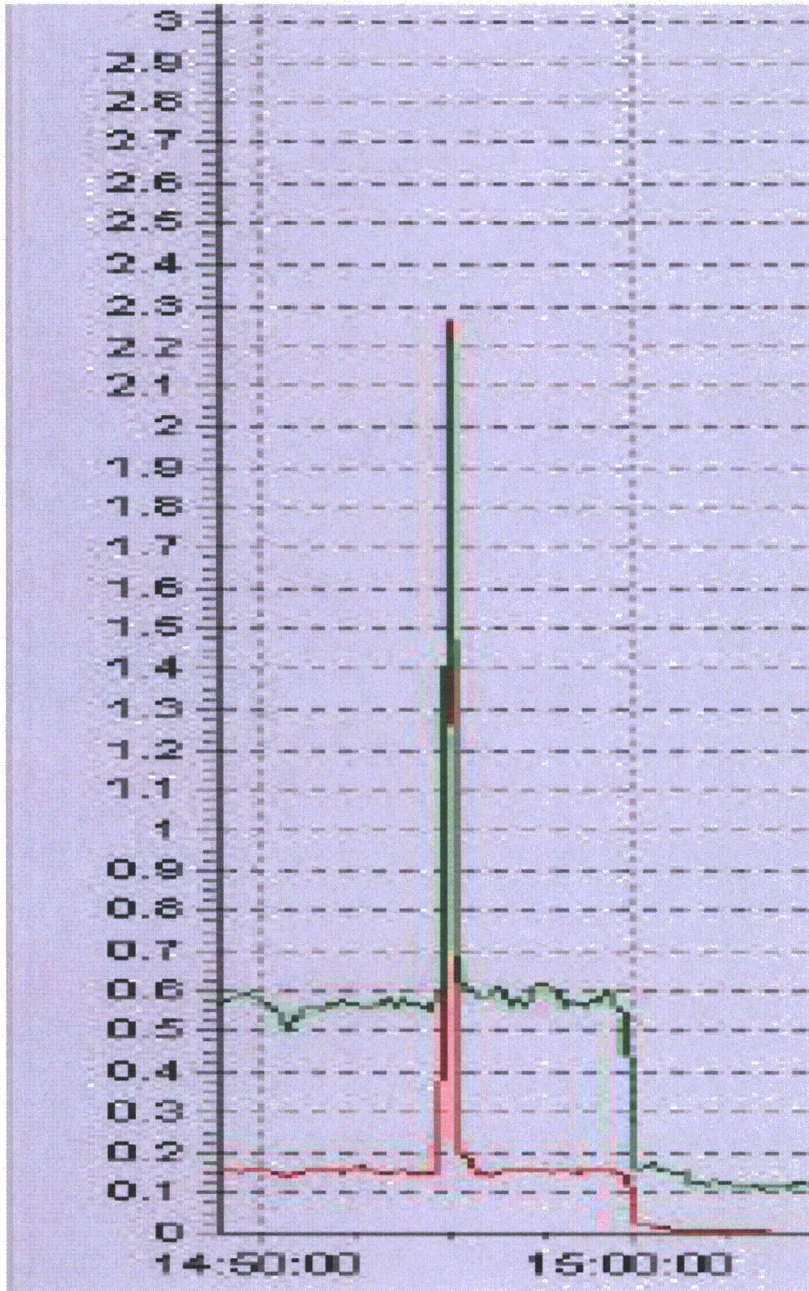
**ATTACHMENT 3 NIF Radiation Monitor Display (expanded screenshot)**

Alarm setpoints are 2 mrem/h for the gamma (green line) and neutron (red line) detectors. Both detectors went into alarm. The time stamp on the radiation monitor computer is 10 minutes slower than the security video computer. Therefore, the alarm (spike) occurred at approximately 3:05 pm, which matches the NIF entry time by the radiographer.
