West Valley Nuclear Services Company, Inc.

Subject : Slurry Fed Ceramic Melter Disassembly Report

SLURRY FED CERAMIC MELTER
DISASSEMBLY REPORT

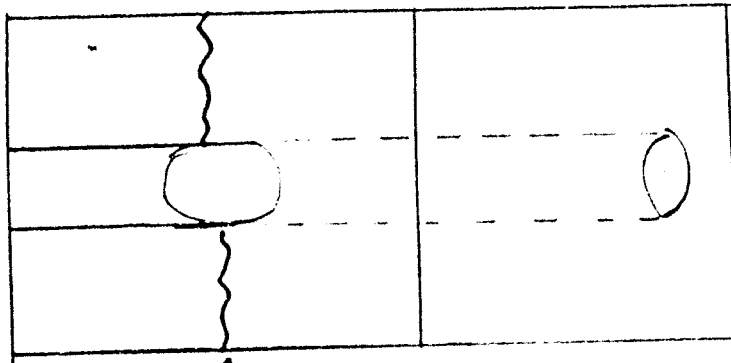
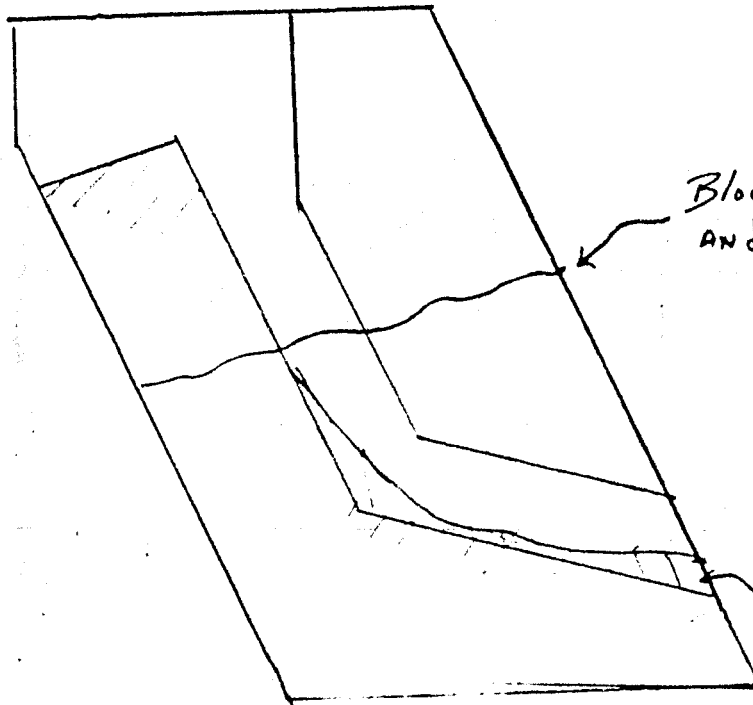
DIAGRAM 3
MONOFRAX-E BLOCK FRACTURE PATTERN

The riser blocks which channeled glass into the discharge chamber and canisters were built from Monofrax-E refractory. There were two Monofrax-E blocks, the east and west discharge riser blocks. The east discharge block had only been used once during testing. Each riser block had a cylindrical passage drilled through it which glass would move to the discharge chamber. Measurements found that dimensions of each Monofrax-E block including the passage were unchanged after five years of operation. Also, there was no measurable wear at the surface of these blocks where a glass line cut would have occurred as it did with adjacent Monofrax K-3 blocks. Inside the passage there was an accumulation of glass or a sludge which rounded any corners. Figure 13 shows one riser block cut in half with accumulations of this material at corners and at the entrance of the passage. Samples of this material have been collected for analyses. Both riser blocks were intact at the start of removal but later broke into three sections. No glass was found on the surfaces between the broken sections which indicated that these fractures occurred during disassembly but both blocks fractured with the same pattern indicating a preference for this block to break in this configuration. (Refer to Figure 14)

Upper section broken
into two sections

Block broken into upper
and lower sections

Accumulation of
Glass in Airlift
Passage

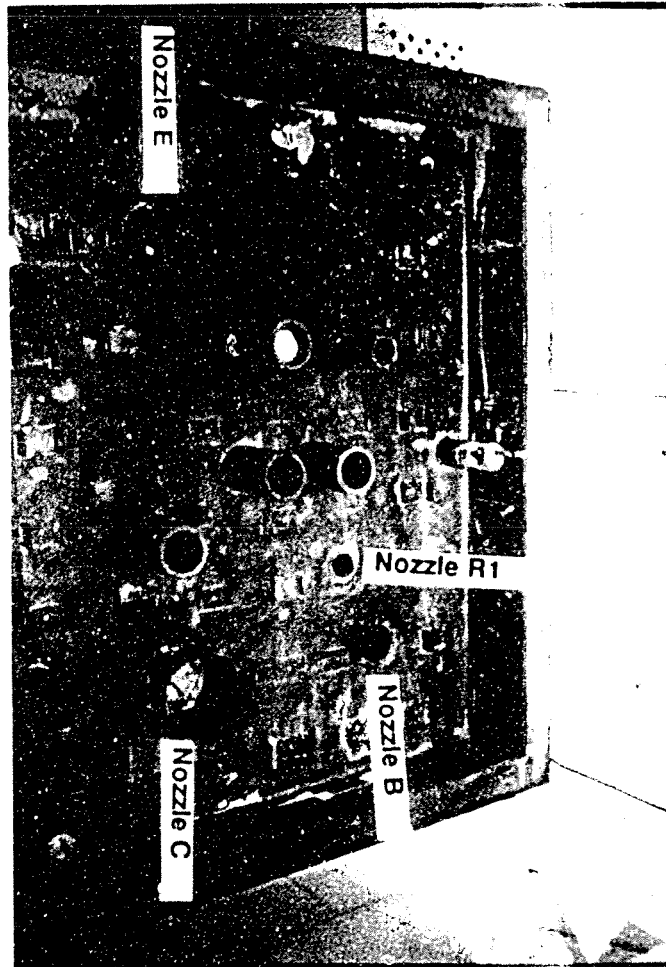
FIGURE 3
MELTER LID AFTER REFRACTORY REMOVAL

Examination of the nine nozzles over the glass pool revealed that they all had gone through visible deterioration or corrosion. This occurred inside the nozzles just below where they were welded to the top of the lid's shell and in some nozzles corrosion extended above the weld. Vapors produced while heating glass condensed inside these nozzles and corroded metal. The larger diameter nozzles were most susceptible to corrosion but even one small diameter nozzle had been completely corroded away from its lower twelve inch long pipe section. Larger diameter nozzles had the thinnest wall thicknesses. Lower sections of some nozzles had been completely corroded apart from the nozzle section above the shell but did not fall into the glass because they were held in place by the surrounding castable. Nozzles B, C, E, and R1 had completely corroded into lower and upper pipe sections with the upper section remaining attached to the melter lid (Refer to Figure 3). Nozzle C had corroded apart and was repaired during

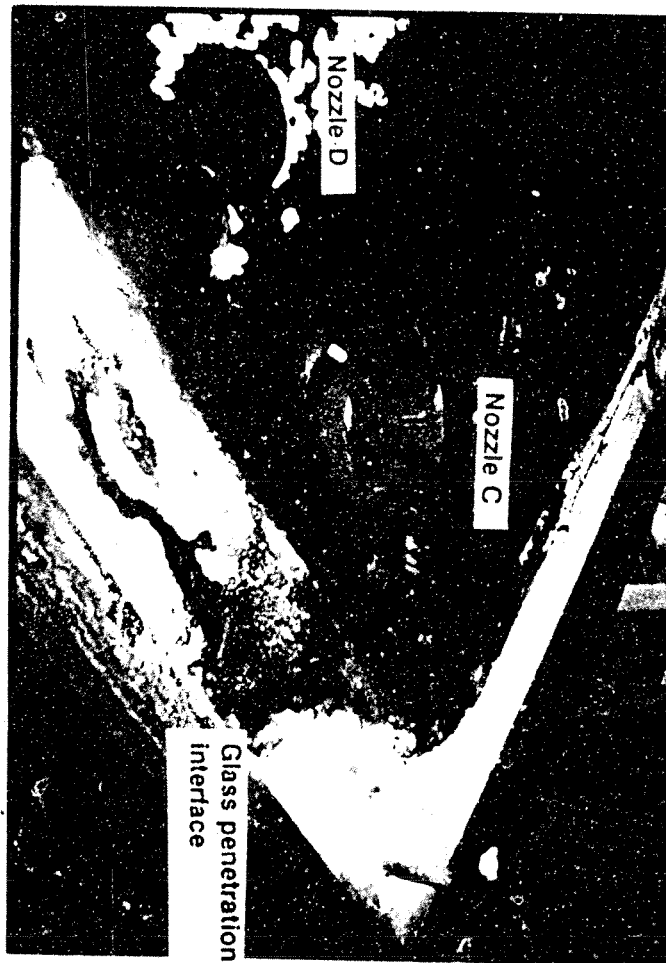
FIGURE 4
MELTER LID NOZZLES C, D, AND G1

When the lid was placed over the melter, a one inch layer of fiberboard was placed into the joint between the lid refractory and the melter plenum refractory. Glass or slurry from the melting chamber had penetrated one inch into this joint except around nozzles G1 and G2. There was a noticeable glass stain around G1 and G2 at the joint that extended into the melting chamber. Fiberboard around the nozzles had corroded creating a path for glass and air to move between the discharge and melting chambers as indicated by this discoloration along the joint. (Refer to Figures 4 and 5)

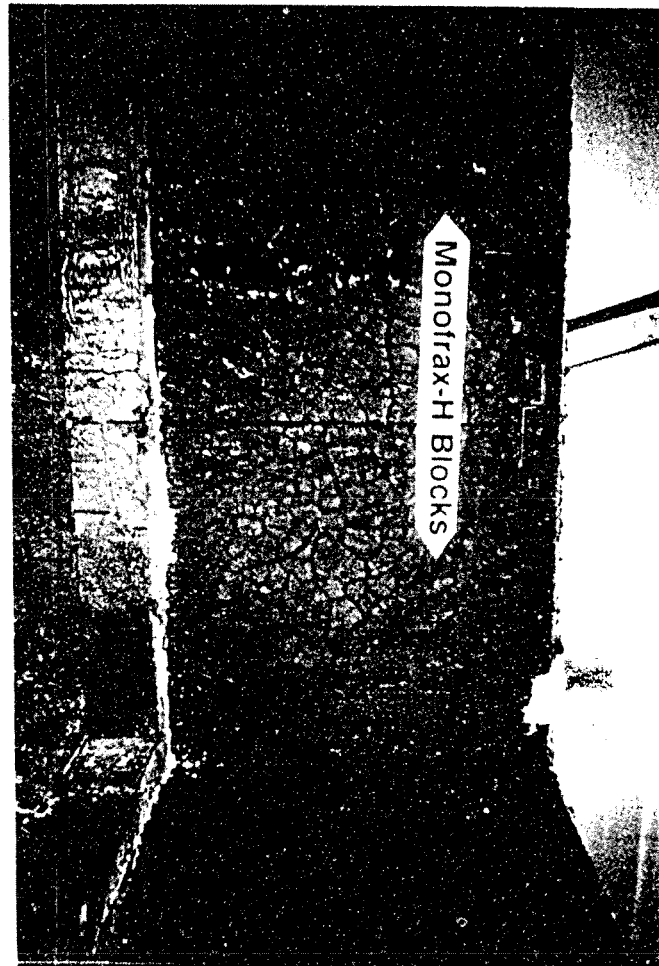
FIGURE 6
SFCM PLENUM

Measurements of Monofrax-H blocks removed from the melter found essentially no wear. The blocks were initially six inches in width and lost a maximum of one quarter inch during testing. The block face inside the plenum was stained brown and had a typical mosaic pattern at its surface. (Refer to Figure 6) Slurry and vapors from the glass pool coated the surface of the lid and plenum refractories and flowed down into the glass pool once the plenum area was heated. Slurry penetrated into joints between Monofrax-H blocks from one-half to one and one quarter inches. (Refer to Figure 7) There was no evidence of slurry penetrating past the joints to the refractory behind the Monofrax-H.

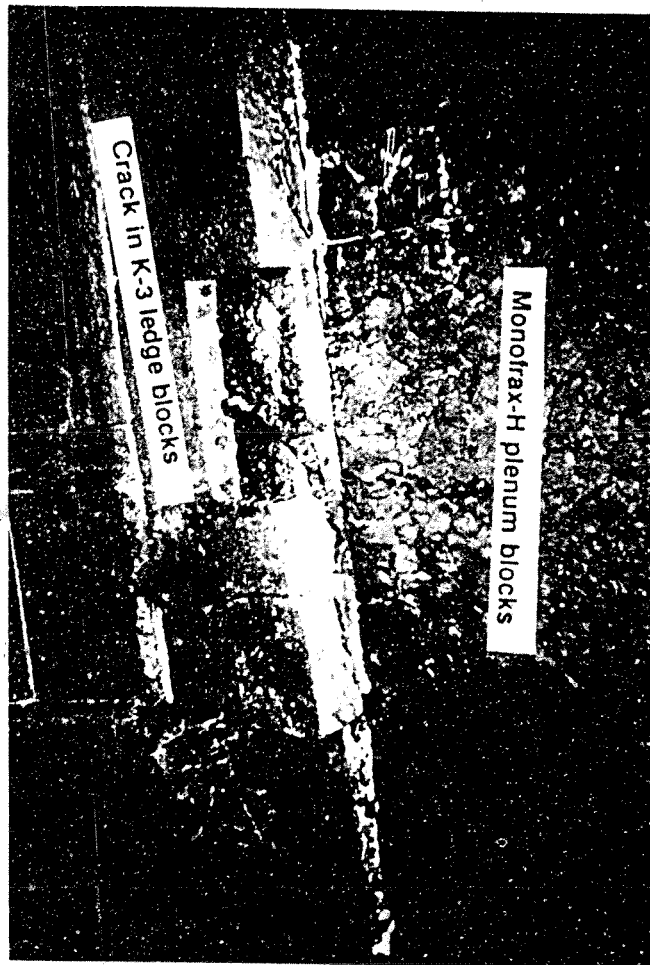
FIGURE 8
MONOFRAX K-3 BLOCKS IN THE LEDGE

The ledge below the Monofrax-H refractory was made from Monofrax K-3 refractory. Melter glass level was normally just below this ledge and these blocks were considered the transition between the plenum and the glass pool. Slurry or partially melted slurry from the glass pool would have reached these blocks dependent on the glass level. K-3 refractory blocks in the ledge were cracked and broken but had little evidence of wear or corrosion. Cracks were most likely a result of thermal shock since plenum temperatures can cycle in relatively short periods of time. Monofrax K-3 is not as resistant to thermal shock as Monofrax-H. Some of these blocks most likely cracked or fractured during rapid cooling resulting from glass removal at melter shut down since glass nor slurry was visible in some fractures. (See Figures 8 and 9)

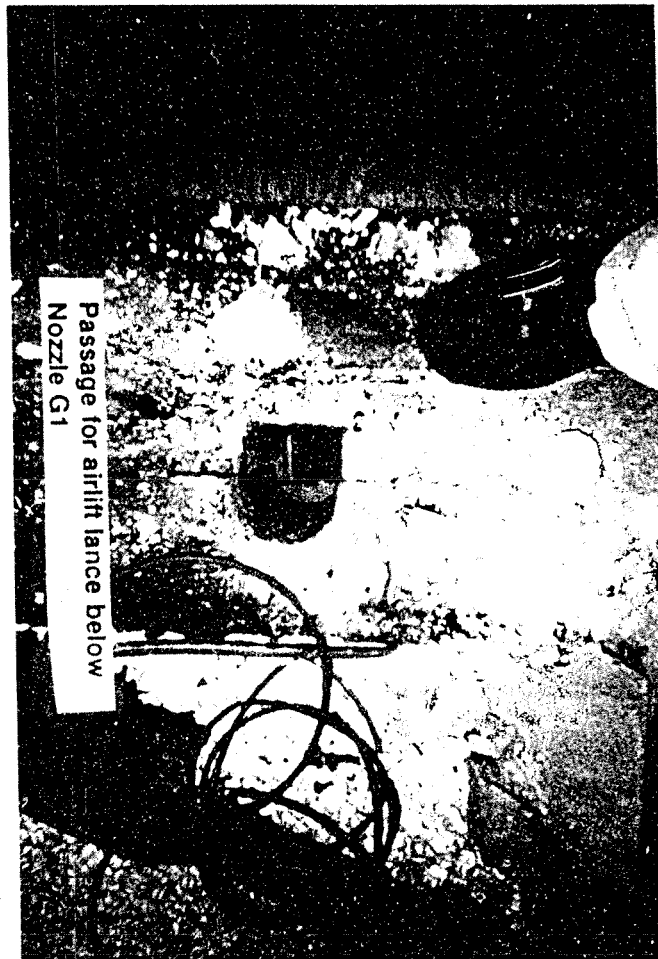
FIGURE 10
REFRACTORY AREA OF NOZZLE G1

A passage was cut down plenum refractory blocks beneath the temporary airlift nozzles, G1 and G2, to the top of the riser blocks discharge passage. The nozzles built from inconel extended twelve inches down each passage but the remaining length was just bare refractory blocks. The passage was cut along two types of refractory, Monofrax-H and Zirmul, which sat over each riser block passage. A view down the passage is shown in Figure 10. Glass stained the passage top to bottom and penetrated into the joint between the two types of refractory blocks. The blocks at worst were only slightly worn along the passage with no glass penetration past their joints.

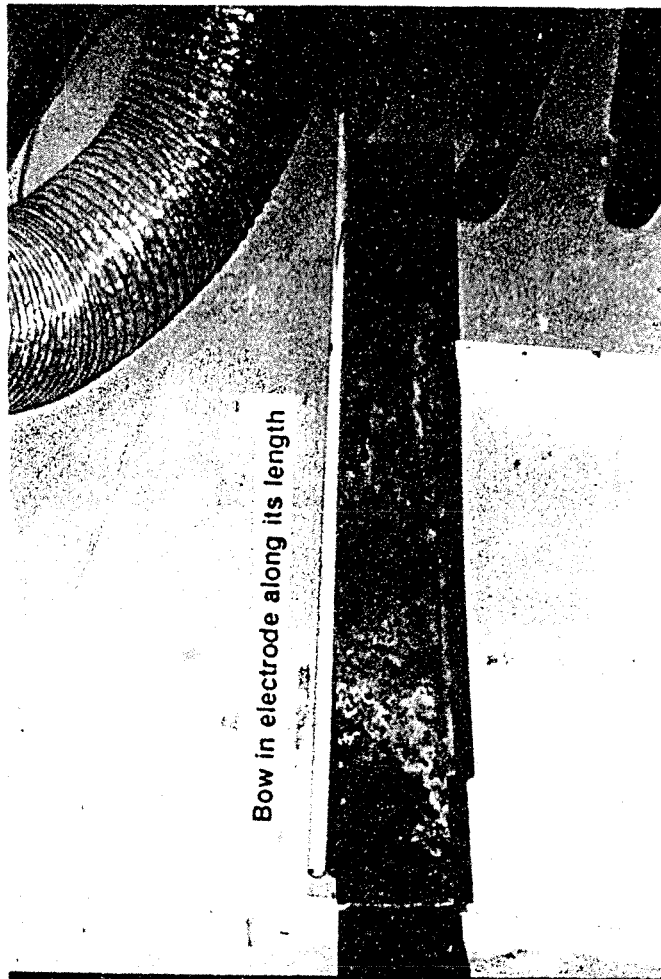
Figure 11
WEST SIDEWALL ELECTRODE

A visual examination of the three electrodes found no major problems. The sidewall and bottom electrodes had sharp corners along their faces indicating little wear or corrosion. There were small nick marks, approximately a half inch long, on the electrode face and the sidewall electrodes were bowed as previously mentioned. But the marks were made during disassembly and the bow was a result of fabrication. Electrodes were turned over to vitrification process personnel for further examination.

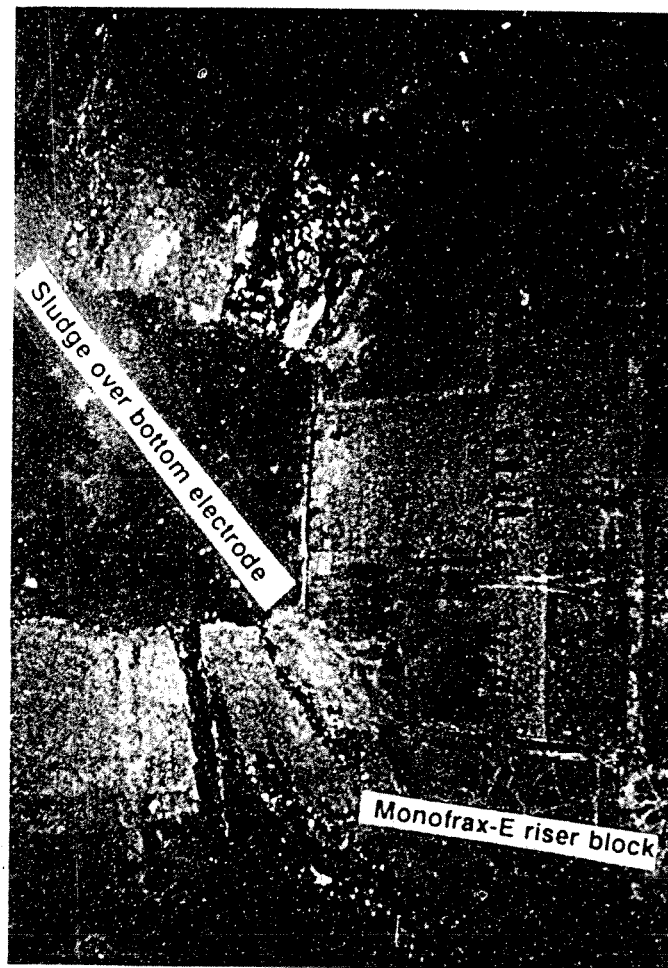
FIGURE 12
BOTTOM ELECTRODE AND NORTH WALL K-3 BLOCKS

significant refractory corrosion occurred in the north and south walls on blocks at the glass/slurry interface. This corrosion, characteristic of a glass line cut, did not occur at the east or west walls because sidewall electrodes not refractory were in these walls. A maximum of one half inch of refractory had been worn away at the center of these blocks resulting in a concave or "C" shape along the glass contact face. These blocks were originally six inches in width. (Refer to Figure 12)

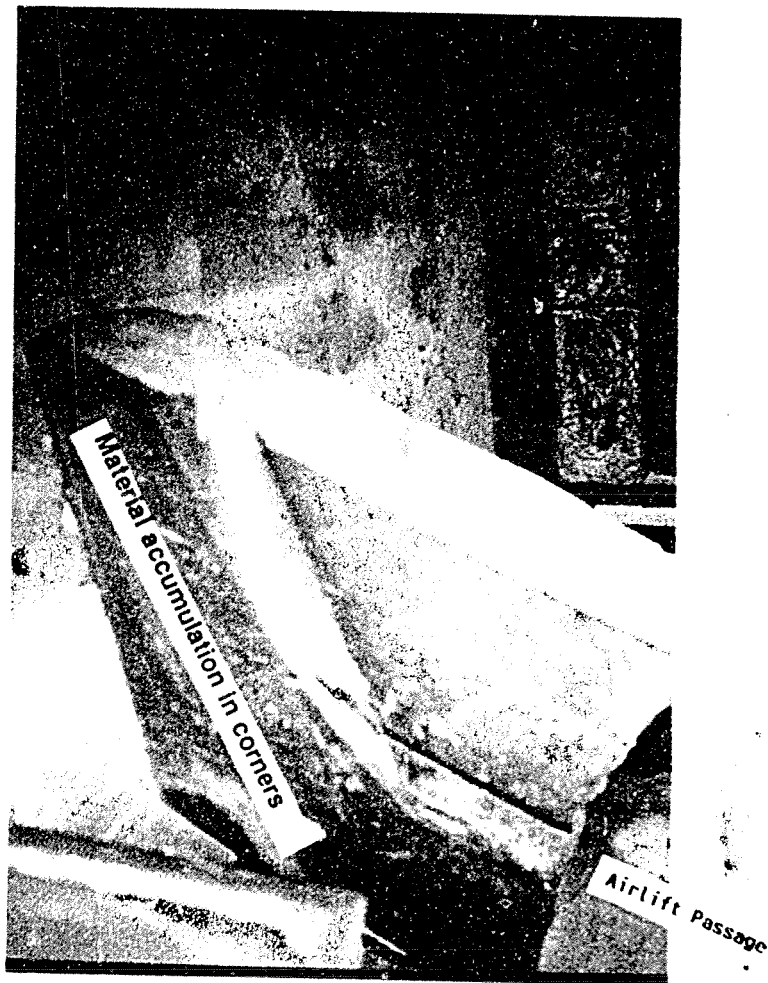
FIGURE 13
MONOFRA-X-E BLOCK SECTIONED IN HALF

Monofrax-E Riser block split in half
