**Subject: April 2011 Inspection Report, Cameco Resources, Permits 603 & 633**

**APRIL 2011 INSPECTION REPORT  
DISTRICT 1/LAND QUALITY DIVISION**

**COMPANY:** Cameco Resources (CR), Highland Ranch, Permit #603  
& Smith Ranch, Permit #633

**DATE OF INSPECTION:** April 20 & April 21, 2011

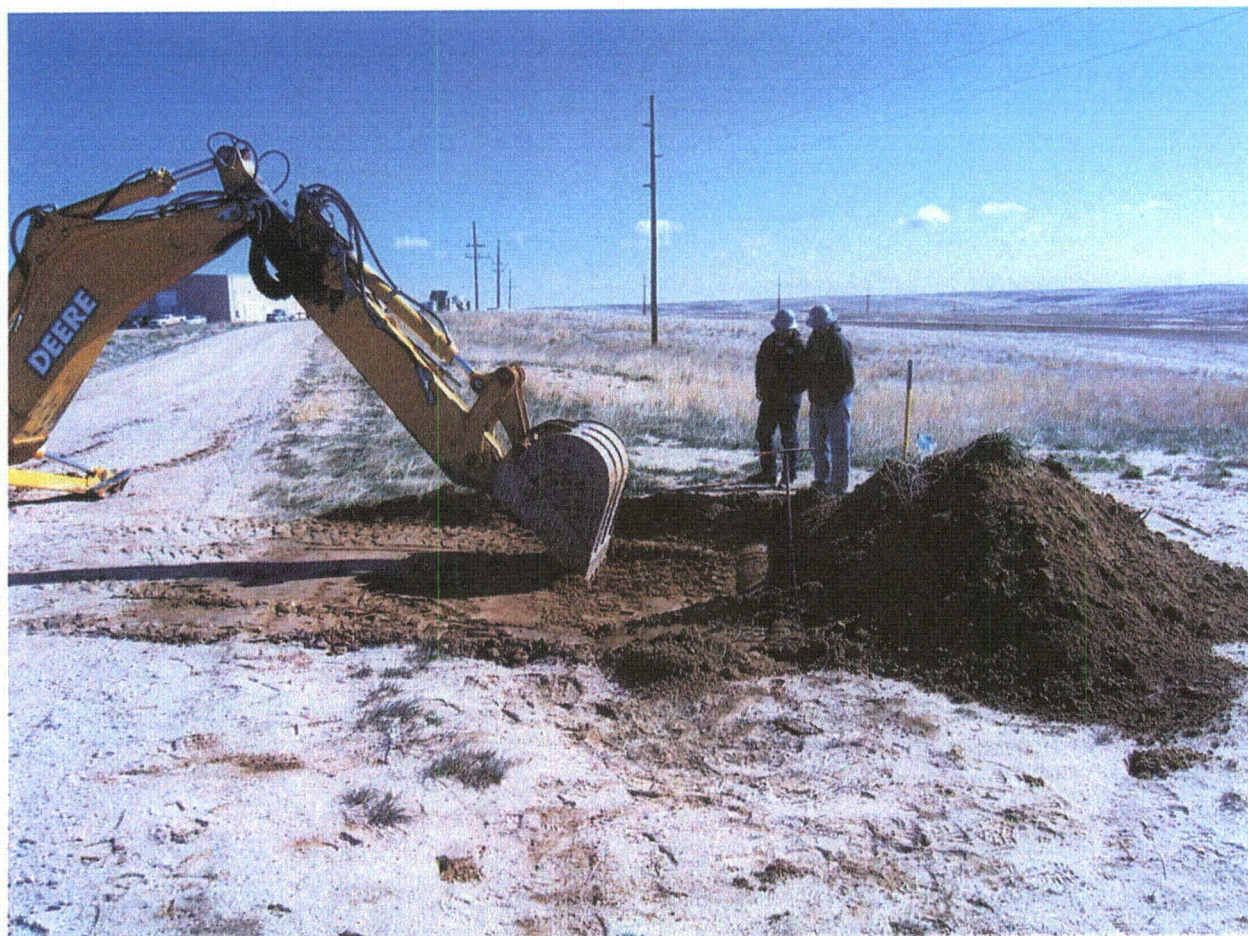
- MU-7 – Inspected holes #732, 793, 780, 704, 762, 2575 & 2521 (results are tabulated below in Table 1). Procedure for drill-hole inspection was to remove the soil cover with a backhoe or hand dig with a shovel, remove concrete cap, measure down to the plug with a 300' tape measure/probe, and replace concrete cap (**Figures 1-3**). None of the holes were in compliance with the two feet from surface requirement. Of the 20 holes inspected, 13 had the concrete plugs located and removed; 7 were not located. Of the 13 holes measured for depth to plug gel, all exceeded the required depth of two feet below surface. The depth varied from approximately 50 feet to 200 feet below surface. According to CR, they used a "plug gel"

*Figure 1 – Abandoned drill-hole inspection; digging to locate the drill cap*

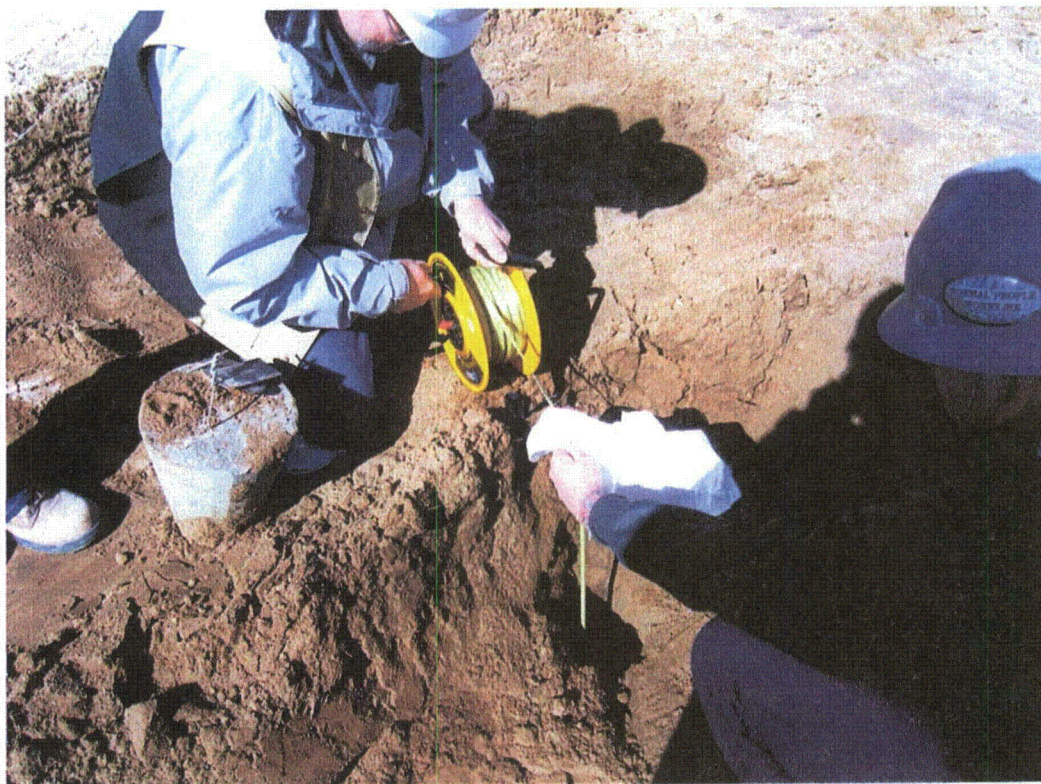
- 1 The abandoned drill holes inspected for the depth to the seal (drilling mud) were found to be at significant depths below surface varying from 46 to 198 feet below surface. CR states that the drill mud although filled to the top of the hole settles back to the static water level. During the investigation, groundwater was only encountered in two holes and it was questionable whether or not the water was associated with an aquifer or with the drill mud.

*Figure 2 – Measuring depth to plug gel*

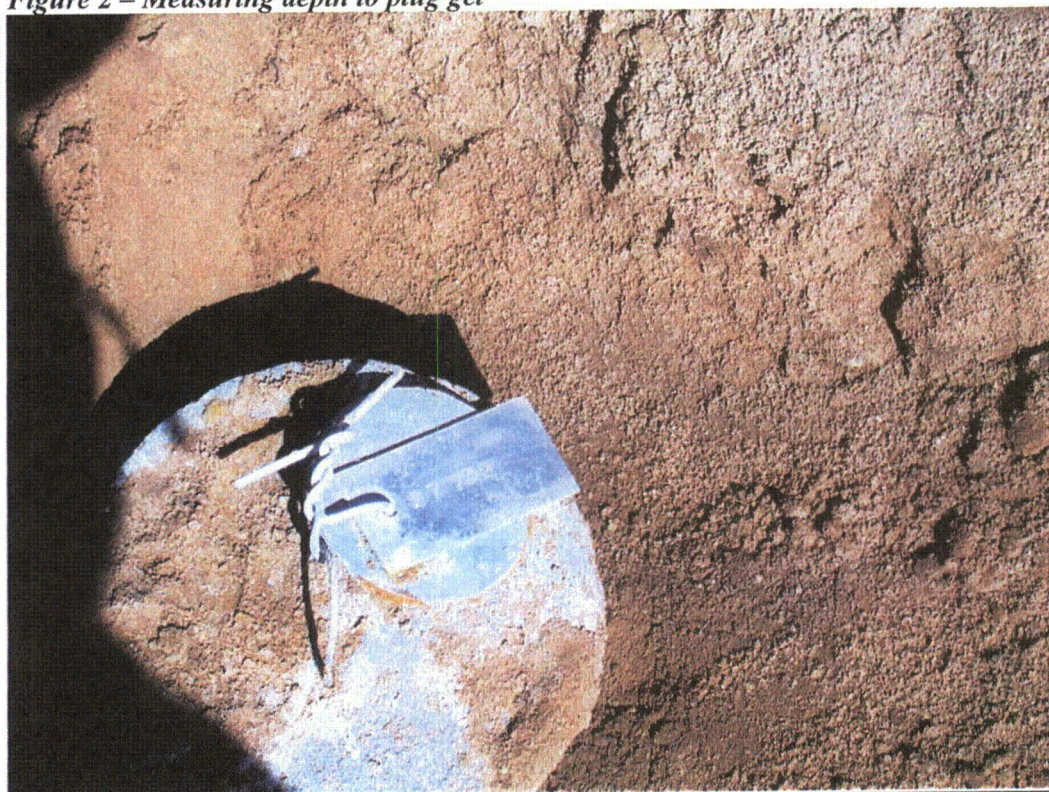
*Figure 3 – Concrete cap from Well #732*

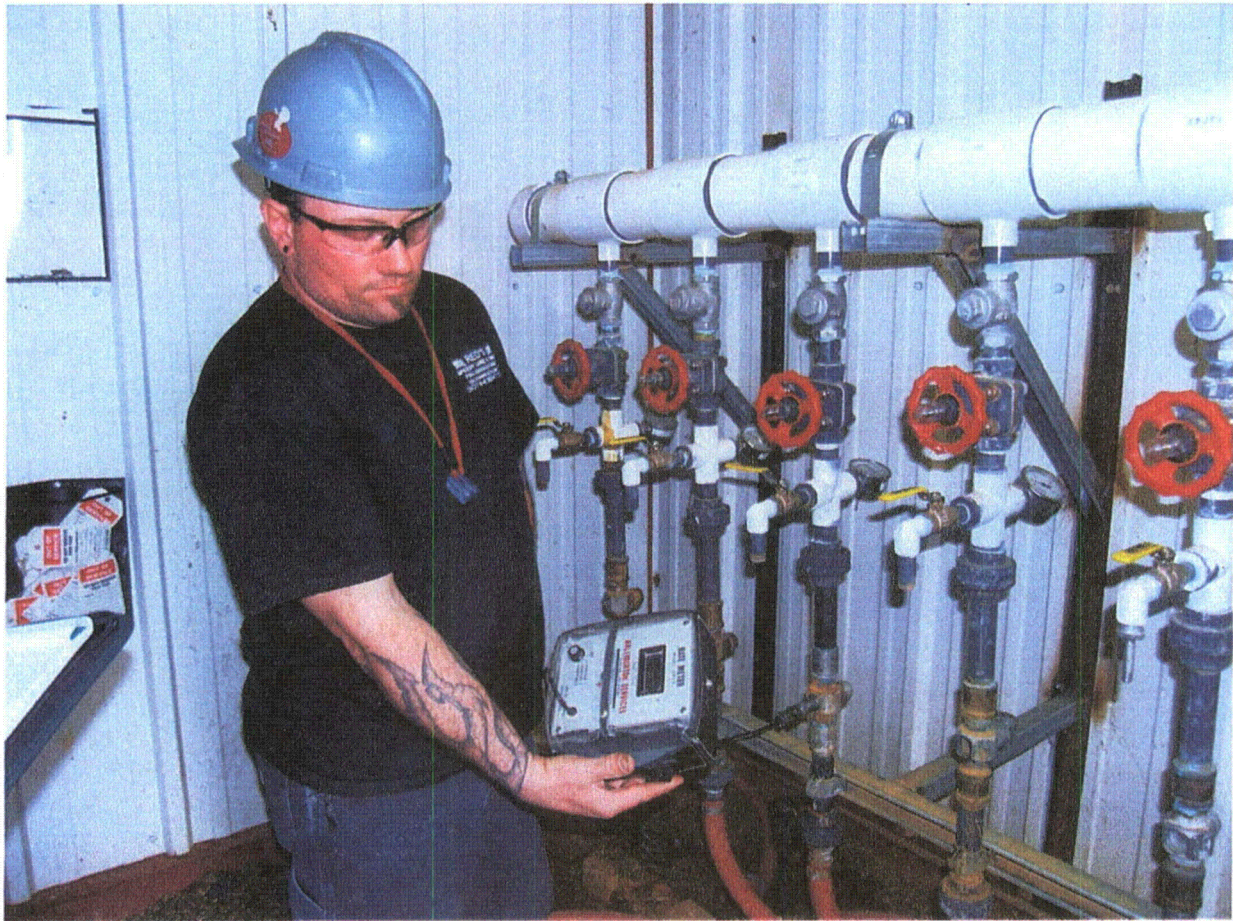
- Satellite #2 – LQD met with the Satellite #2 Operator Cory Griffiths. He explained the modifications made to MU-D and indicated that DP 17 & 18 are pulling with the drift water and that a different restoration well was started today running at 14 gpm. MU-C was also discussed. Mr. Griffiths indicated that based on hand-held flow meter results in the header house, well CP 175 is running at 16 gpm and CP 169 is running between 17-18 gpm. These wells are being utilized to pull back the well on excursion. He also indicated that wells 20, 16, 15 and 17 are in RO and waste disposal is directed to the Vollman, Morton 120, and SHRUP 9 deep disposal wells with plans to start up additional disposal through PSR2 and the irrigator starting next month. Pam requested that the reported flows be verified with LQD at this time using a flow meter for the specified wells (**Figure 4**). Using a Halliburton DR-3 Rate Meter, flows were verified and results are tabulated in Table 2 below.

*Figure 4 – Flow Meter Verification at header house*

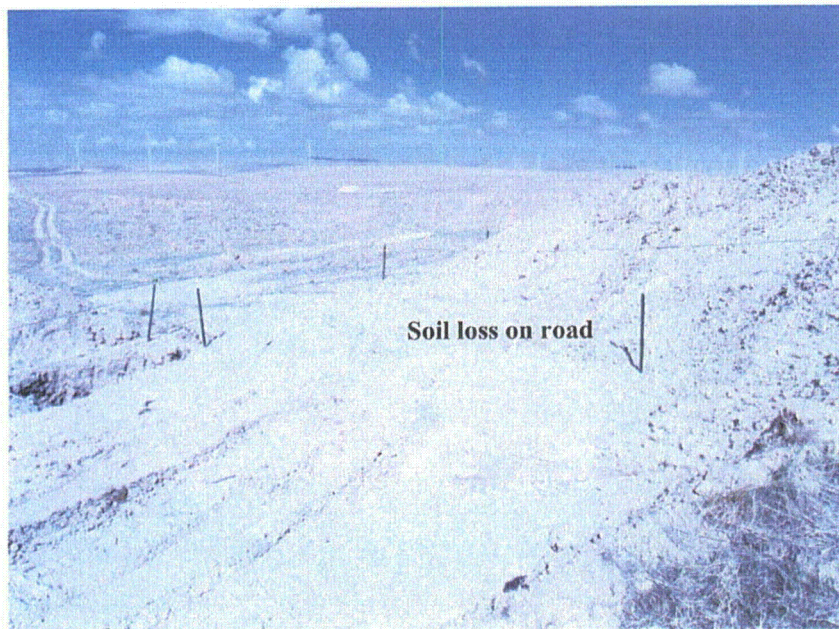
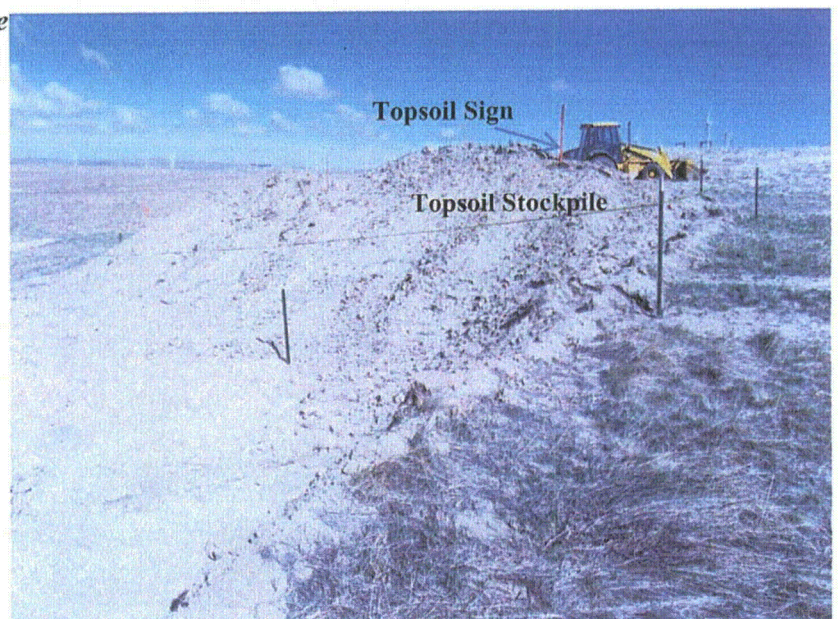
**MU-10:** During the investigation of the first P&A drill site, LQD observed topsoil salvage and protection at a nearby drill site. The topsoil pile was located on a hillslope and there was no erosion control to protect the downslope side of the pile (**Figure 5a & 5b**). Soil was eroding from the stockpile onto a road leading to the drill site. In addition, sediment control was not installed around the disturbance area allowing sediment from the disturbance to wash onto native areas (**Figure 6**).

- 4 Salvaged topsoil stockpiles continue to be poorly protected in areas of active drilling operations. The instances noted during the inspection include topsoil stockpiles located on slopes without tow ditches or berms to contain the soil in the stockpile on the downslopes sides of the piles. These instances resulted in loss of soil to the downslope disturbed areas. Failure to protect topsoil is a violation of WEQA, § 35-11-406 (b)(viii). Therefore, enforcement action is recommended.

***Figure 5a Drill site; unprotected topsoil pile***

***Figure 5b Drill site; unprotected topsoil pile***

***Figures 5a and 5b – Topsoil stockpile on slope above access road to well, not protected on downslope side; topsoil loss on road***

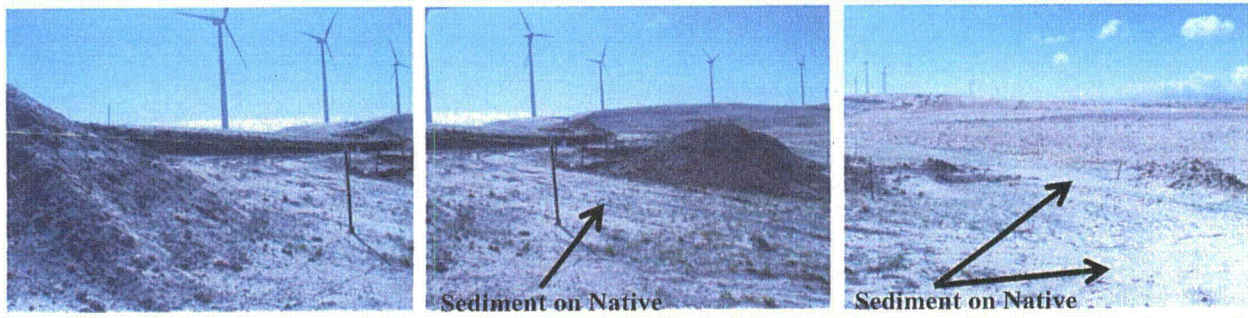
- 3 Significant deficiency in sediment and erosion control continues to be a very high concern for LQD at the SHRUP mine sites. The lack of sediment control in the Mine Unit 10 development areas and the lack of sediment controls associated with exploration/delineation drilling activities on and/or adjacent to the permit boundaries are a repeat violation that LQD has tried to impress upon the operator as a serious problem. The inspectors have encountered numerous instances of sediment on native areas as a result of mining related disturbances. According to the WEQA, § 35-11-415 (b)(viii), *"The operator...shall...prevent, throughout the mining and reclamation operation...the pollution of surface and subsurface waters on the lands affected..."* and according to the Wyoming Land Quality Division Noncoal Rules and Regulations (R&R), Chapter 3, Section 2(c)(i)(A), *"All topsoil or approved surface material shall be removed from all areas to be affected in the permit area prior to these areas being disturbed..."*. The disturbance in Mine Unit 10 does not include adequate sediment control with significant sediment being deposited on native areas. Also, the exploration/delineation drill sites associated with CR's drilling activities in the southwest area of the permit does not include adequate sediment control resulting in sediment and drilling mud depositing on native areas. Therefore, enforcement action is recommended.

**Figure 6** *Drill site without sediment control resulting in sediment on native ground*

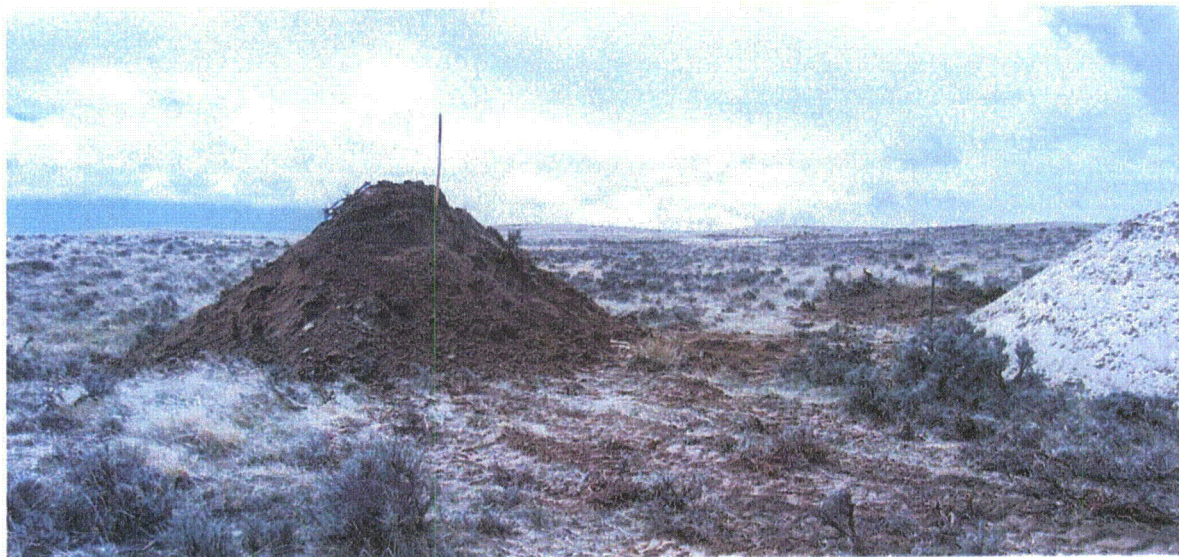
Topsoil piles in and around active drilling operations were inspected in proposed Mine Unit 10. The topsoil piles were absent of any erosion control protection (ditches/berms, wattles, seeding) (**Figure 7**). The topsoil piles were located approximately 20 feet from the drill sites on all the wells observed in the development area (approximately 10-15 sites). It was apparent that the piles were not being combined into a larger pile serving the area of disturbance as was discussed with CR to mitigate previous topsoil compliance concerns. The drilling supervisor indicated that the topsoil piles were not completed yet and they will be adding to them or combining piles. He stated that the piles will be complete sometime next week and erosion control will be added. The stockpiles were not only unprotected but also had vehicle disturbance due to the wellfield activity (**Figure 8**).

**Figure 7** *Topsoil pile in MU10 without erosion control*

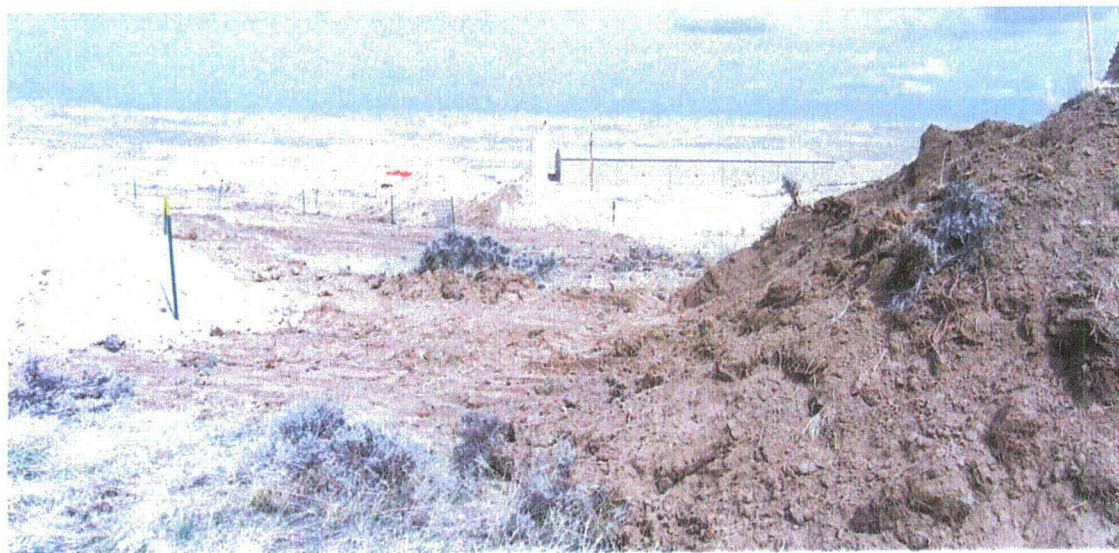
**Figure 8** *Topsoil pile in MU-10 without erosion control or protection from mine disturbances*

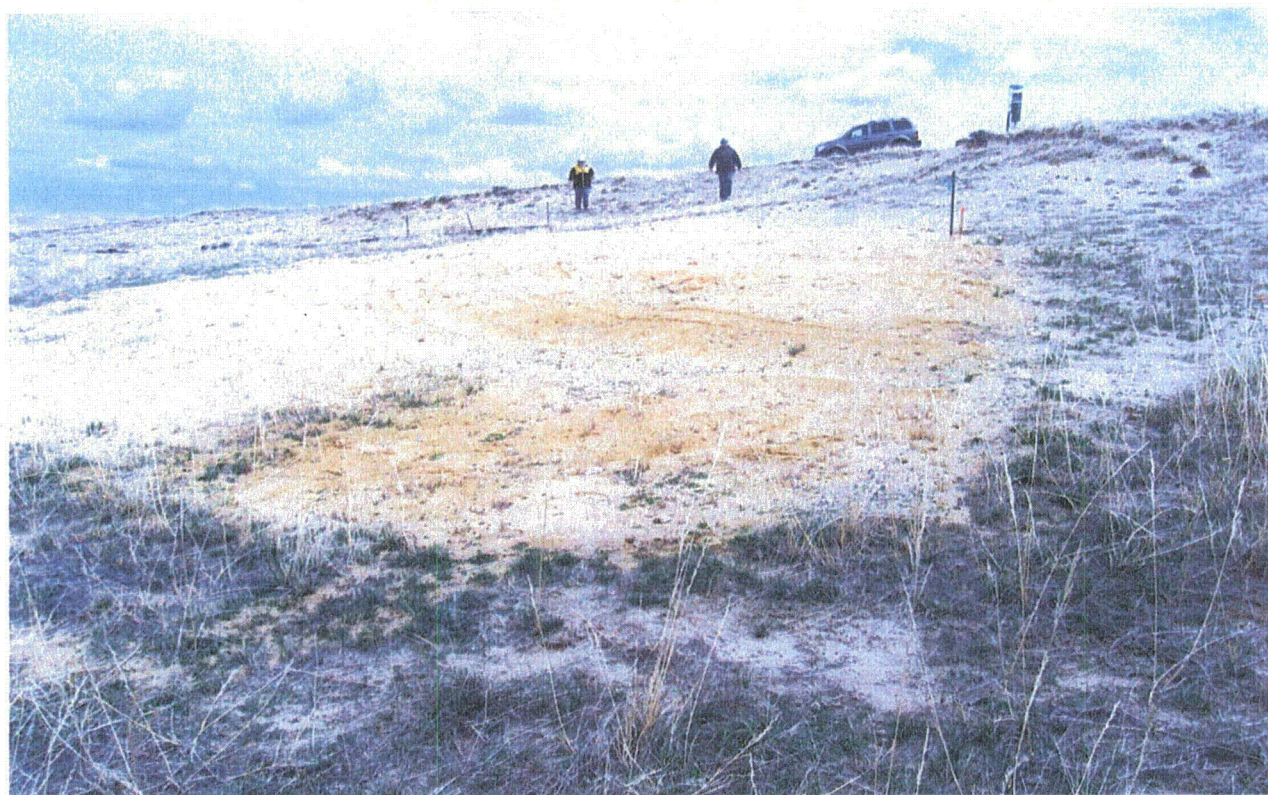
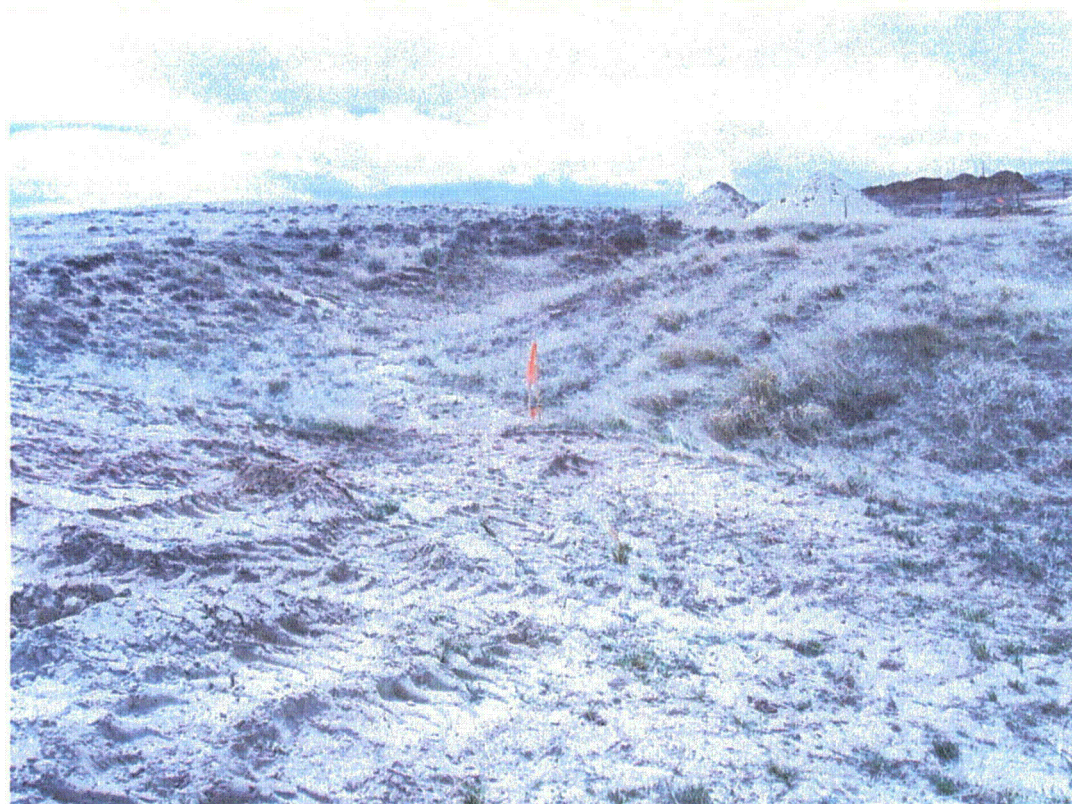
It was noted that very little sediment control was installed throughout the entire mine unit disturbance (**Figures 9a & 9b**). Silt fence was noted in two shallow drainages in poor repair, filled with sediment (**Figures 10a & 10b**). As a result of the poor effort in controlling erosion, sediment was washing onto native, unstripped areas throughout the wellfield development area.

**Figure 9a** *Disturbance area on slope without sediment control*

**Figure 9b** *Disturbance in drainage without sediment control*

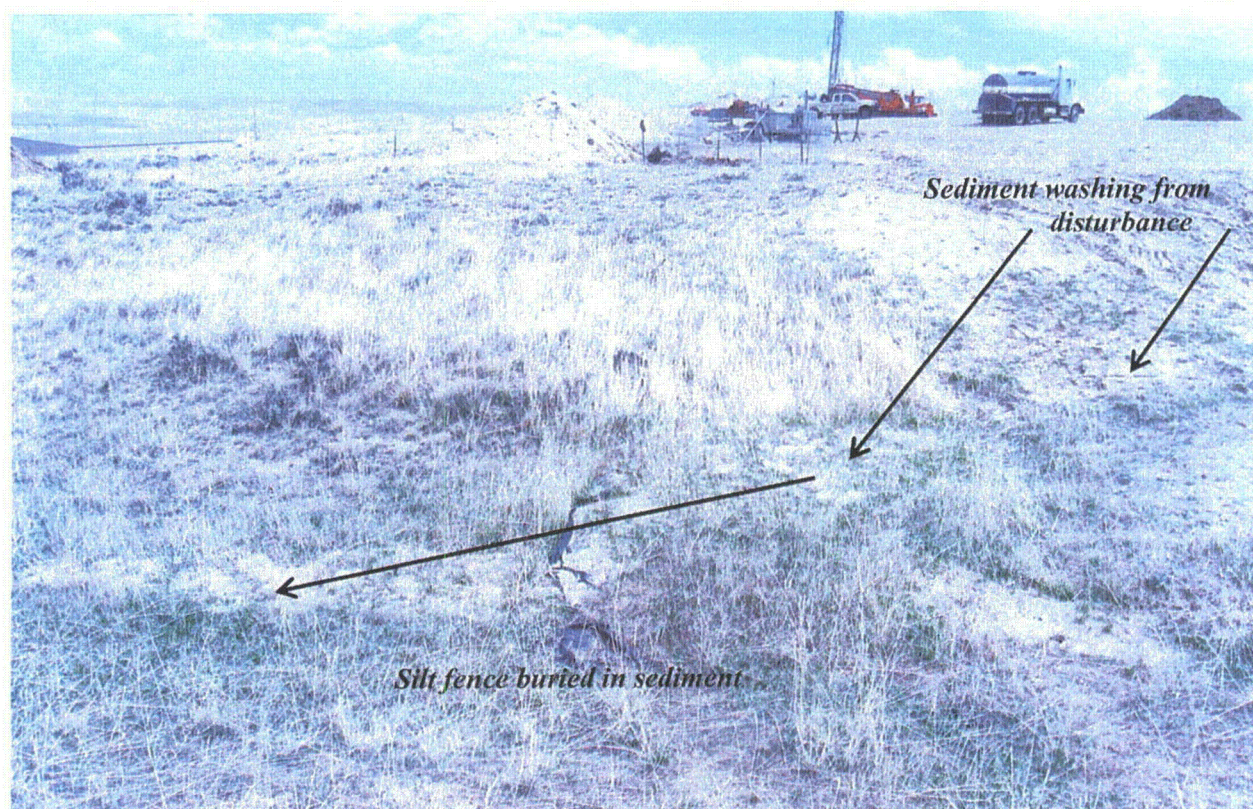
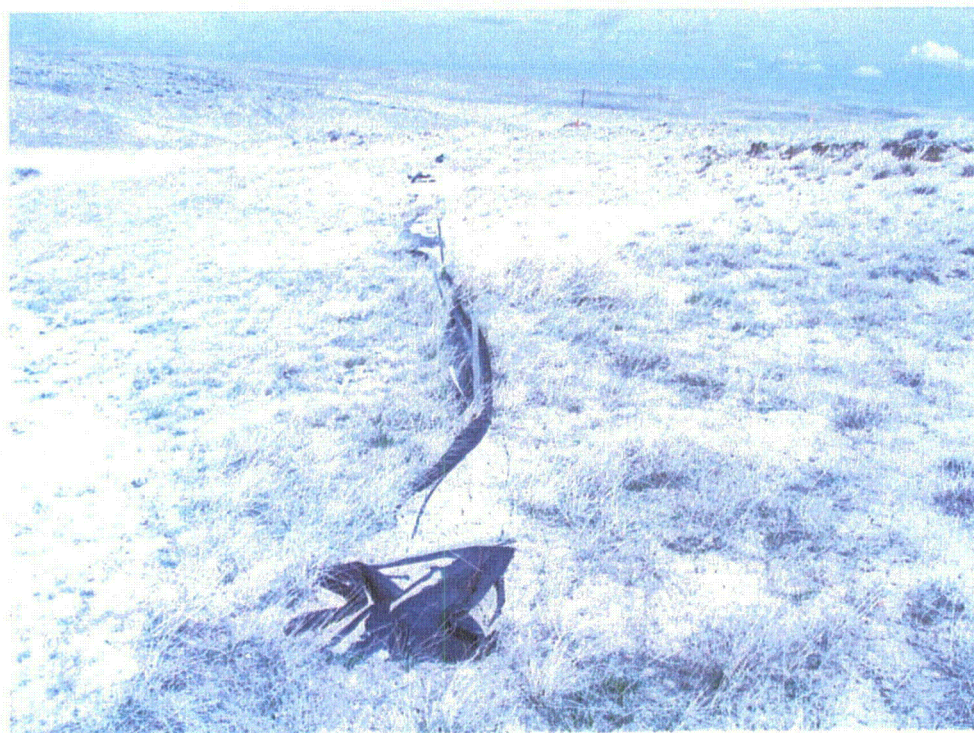
**Figure 10a** *Silt fence poorly maintained and not effective in controlling sediment in MU-10*

**Figure 10b** *Poorly maintained silt fence in MU-10*

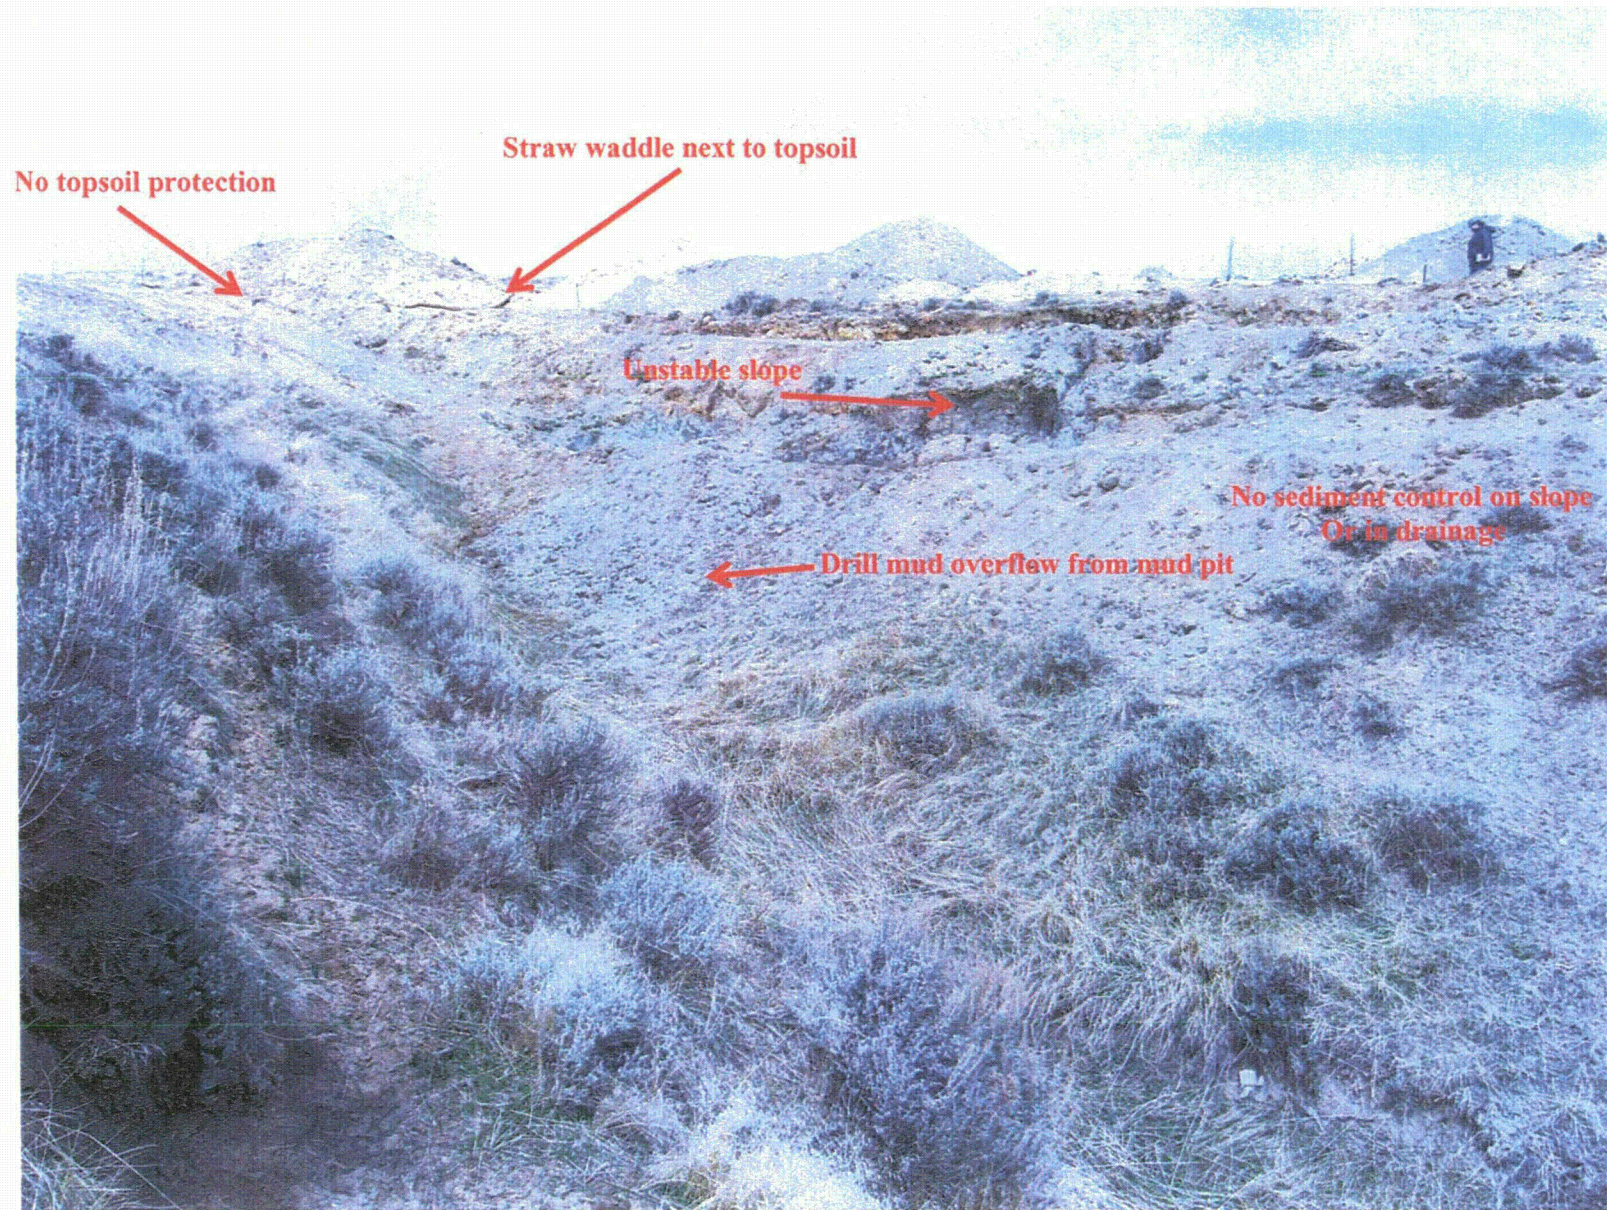
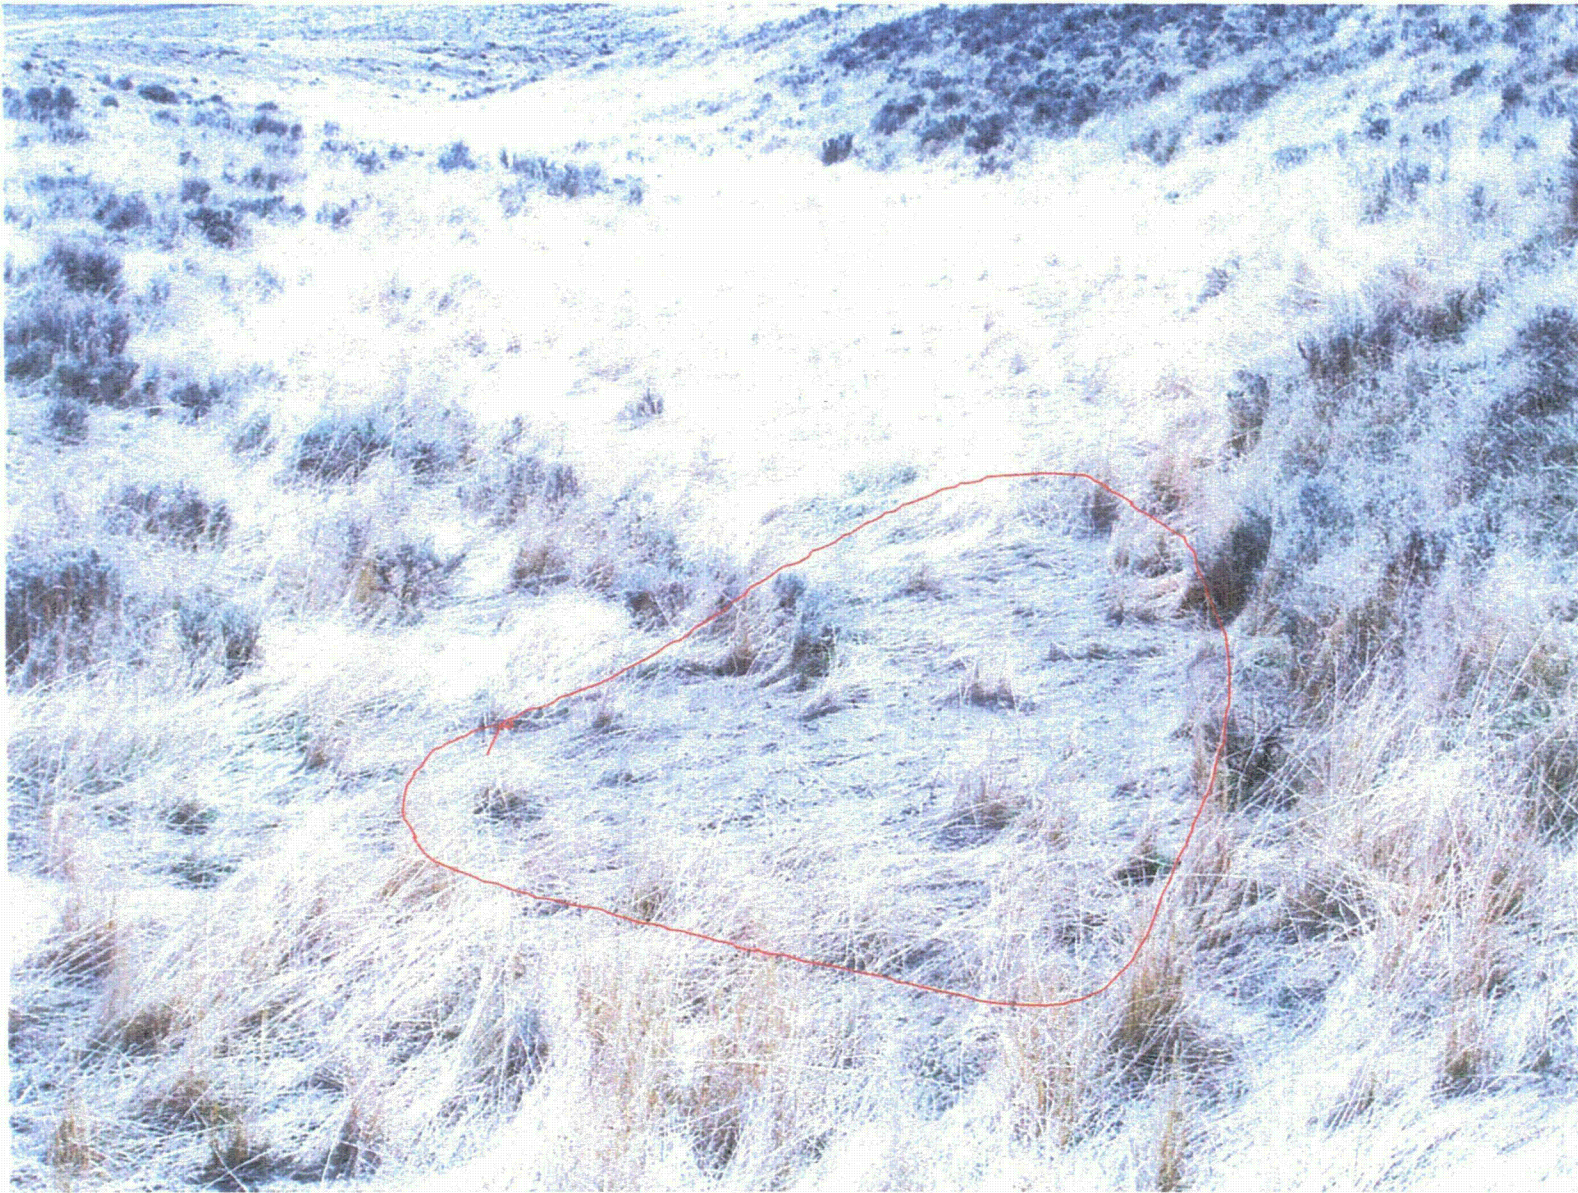
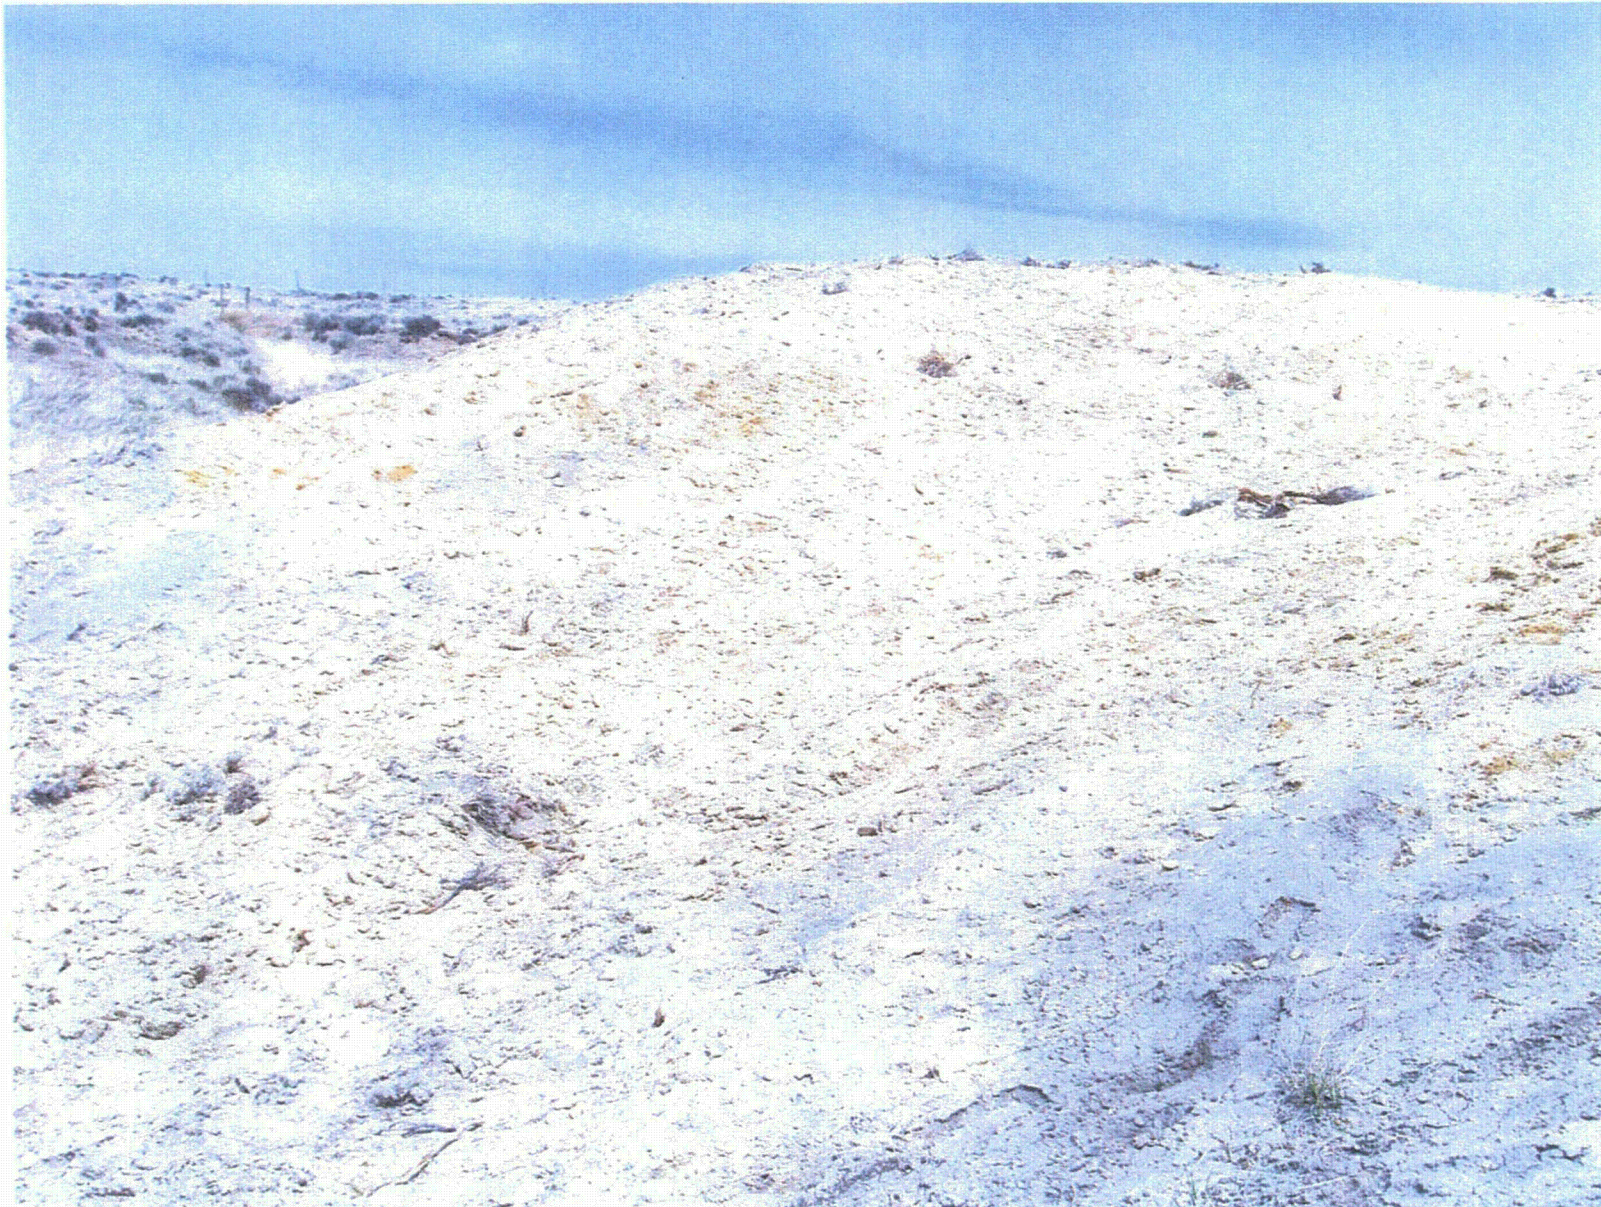
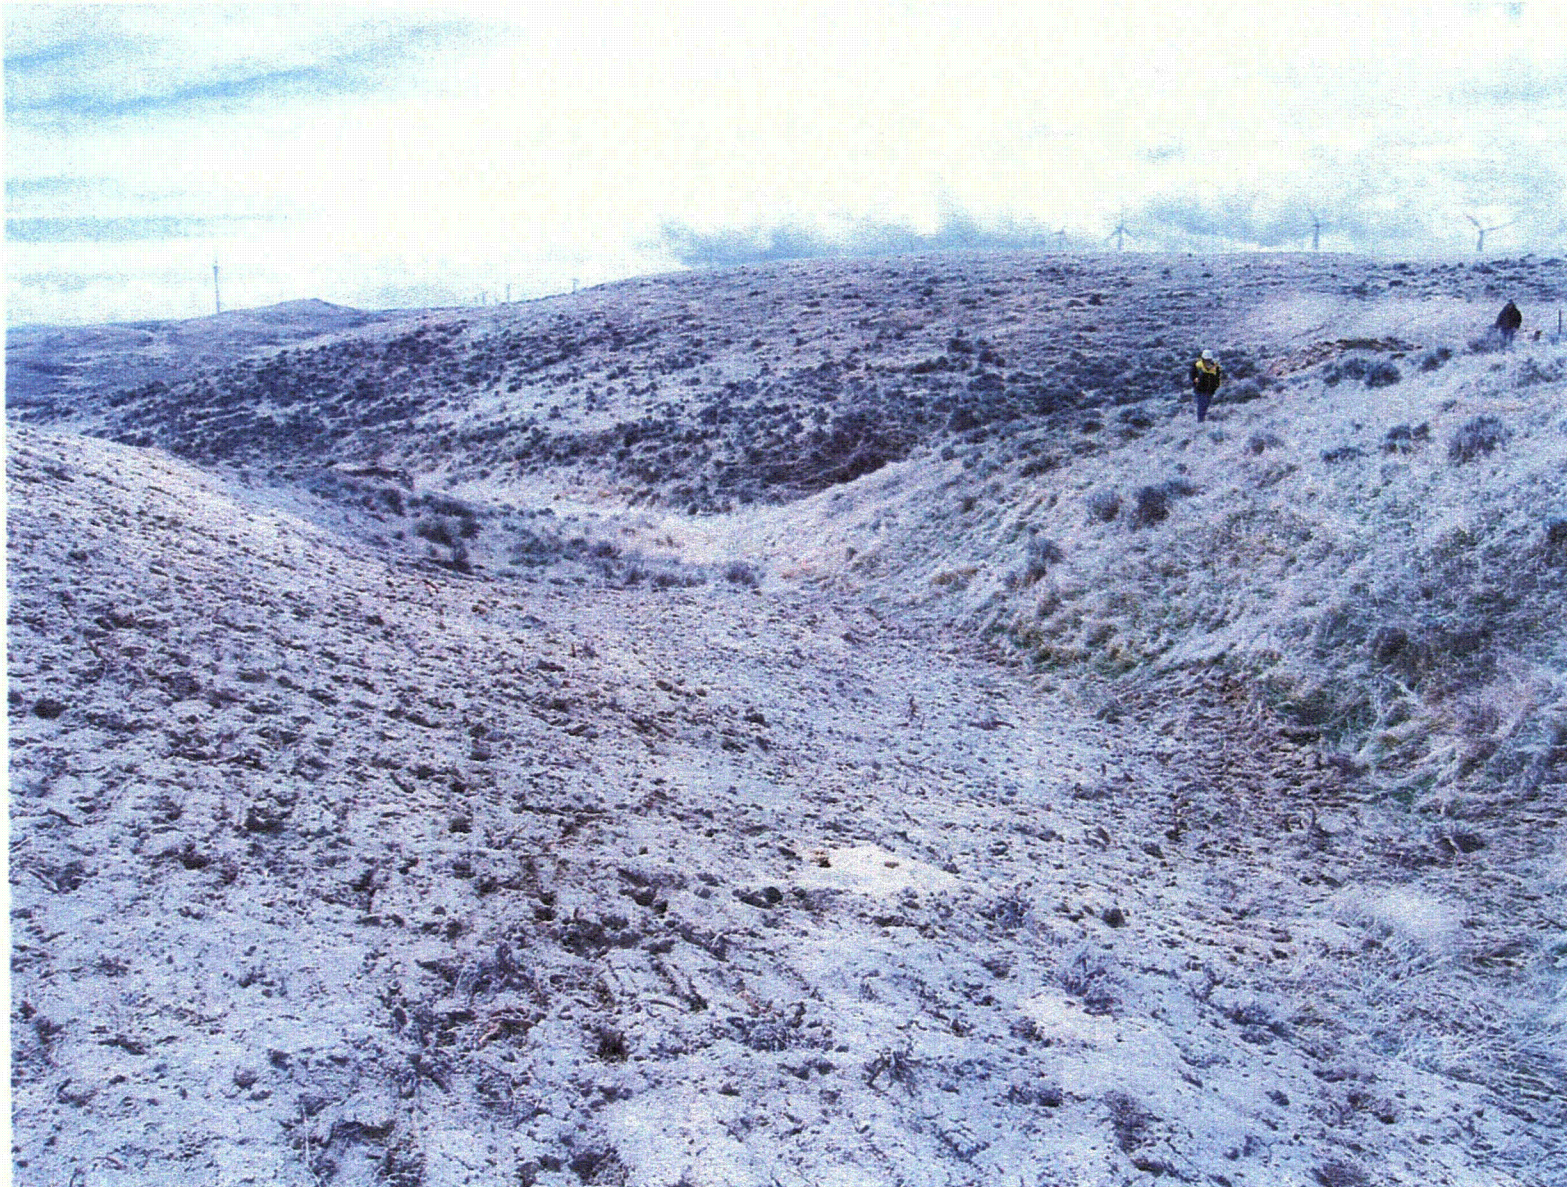
LQD requested to view the west side of the operations (west of MU-9) where disturbed areas were observed the previous day while completing drill-hole inspections. Upon inspection of these areas, it was found that drilling activities were not using sediment control, topsoil protection measures, controlling drilling fluid from entering drainages or ensuring stable slopes following the drilling activity (**Figures 11a, 11b, 11c, and 11d**).

*Figure 11a Drill site on slope; drill mud spilled onto native, unstable drill pad, lack of sediment control in drianage, lack of topsoil protection*

*Figure 11b – Drilling mud in drainage approximately 50 feet downslope from the drill site in Figure 11a*

*Figure 11c Disturbance from another drill site with no sediment control used on the slope*

*Figure 11d Sediment and drill mud in drainage below the disturbance in photo 11c*

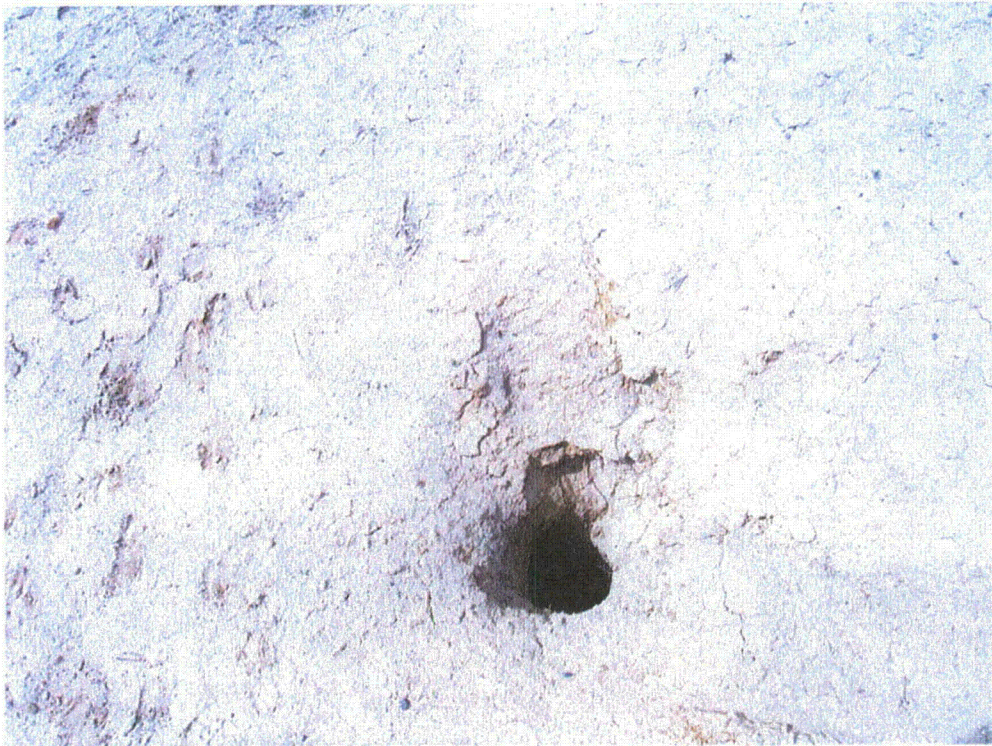
In the same area of the drill holes inspected in Figures 10 and 11 above, an open drill hole was discovered. With the drilling activity in the general proximity (approximately 50-75 feet from those drill sites). This hole was easily found, yet no effort was made to cap or plug the hole (**Figure 12**).

- 2 An open drill hole was discovered by the inspectors and subsequently confirmed to have been drilled by a previous operator for the Smith Ranch mining operations. Regardless of the timeframe of the drilling activity, open drill holes on the permit or associated with the

exploration activities of the permit are the responsibility of the operator. The open hole is a violation of WEQA § 35-11-404(c) and enforcement action is recommended.

*Figure 12 – Open abandoned drill-hole*

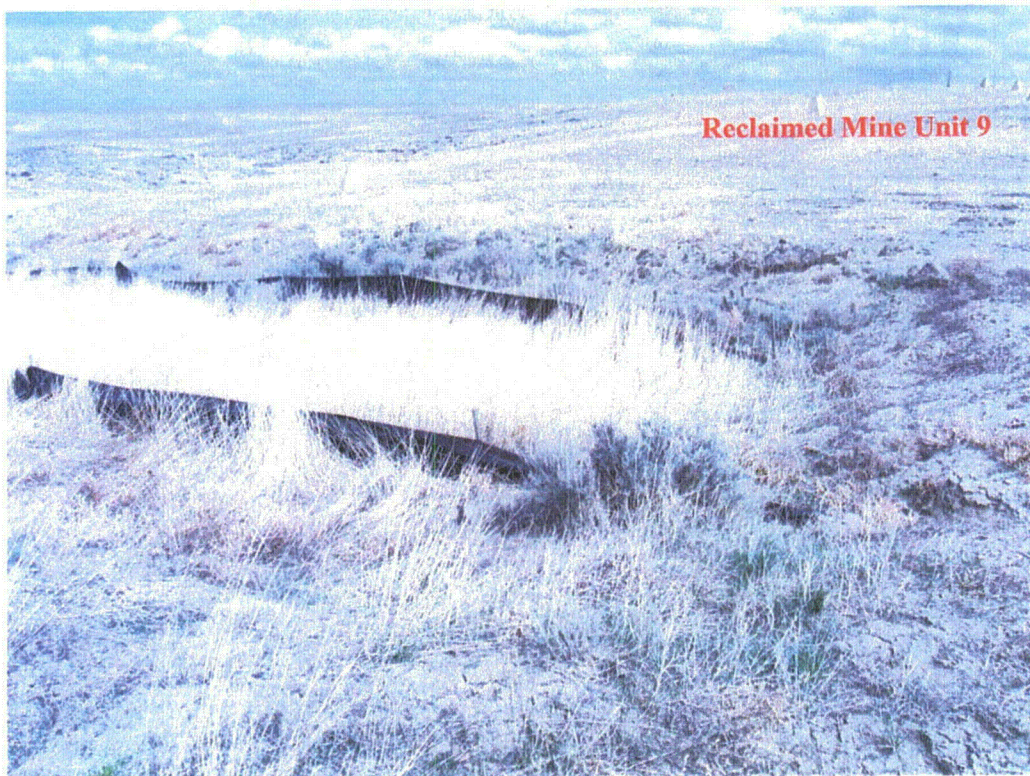
The temporary reclamation in Mine Unit 9 near header house 9-11 was thoroughly inspected. Erosion control measures are in place including silt fence and straw wattles. The drill seeding that occurred in fall 2010 was crimp mulched with straw. There was very early indication of seed germination. A large stack of straw blankets was staged in the middle of the reclaimed wellfield and CR reports these will be installed this summer (**Figure 13**).

*Figure 13 MU-9 temporary revegetation is completed in the wellfield (fall 2010).  
Sediment control is in place around the perimeter of the reclamation to protect the native areas*
