**Subject: April 2011 Inspection Report, Cameco Resources, Permits 603 & 633**

**APRIL 2011 INSPECTION REPORT  
DISTRICT 1/LAND QUALITY DIVISION**

**COMPANY:** Cameco Resources (CR), Highland Ranch, Permit #603  
& Smith Ranch, Permit #633

**DATE OF INSPECTION:** April 20 & April 21, 2011

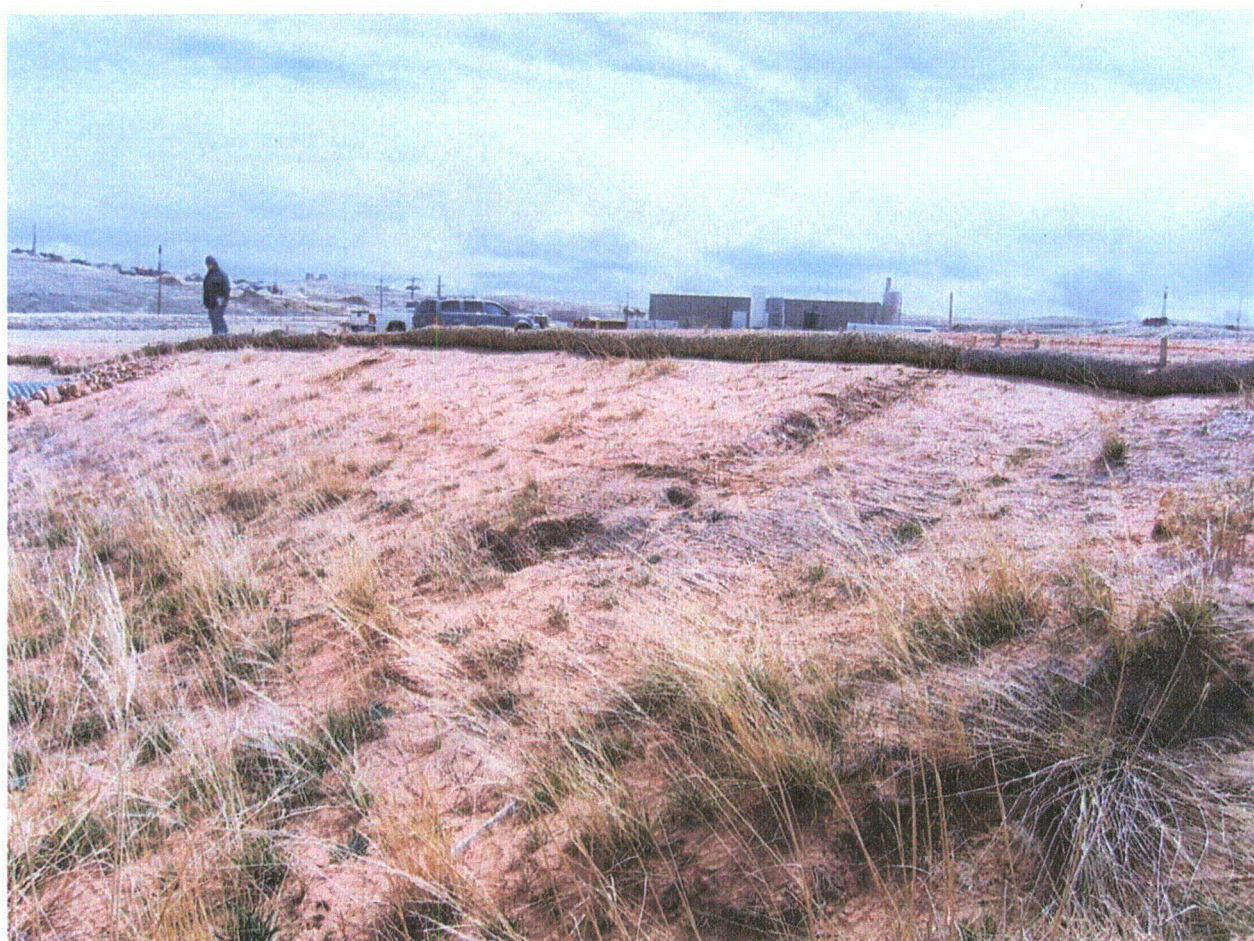
Drainage work around SR-2 was inspected. Rip-rap, terracing, straw wattles and vegetation is in place. Sediment is accumulating near the top of the slope near the road which appears to be coming from the road. The lower slopes appear stable with little additional accumulation of sediment (**Figure 14**).

***Fig. 14— Slope stabilization and erosion control next to road near SR-2***
