**UNITED STATES  
NUCLEAR REGULATORY COMMISSION**  
REGION II  
245 PEACHTREE CENTER AVENUE NE, SUITE 1200  
ATLANTA, GEORGIA 30303-1257

**SUBJECT: NRC SPECIAL INSPECTION REPORT NO. 70-1113/2011-006 AND NOTICE  
OF VIOLATION**

Special Inspection Team Charter  
Global Nuclear Fuel - Americas  
Failure to Maintain Mass Control in HEPA Filter Housing

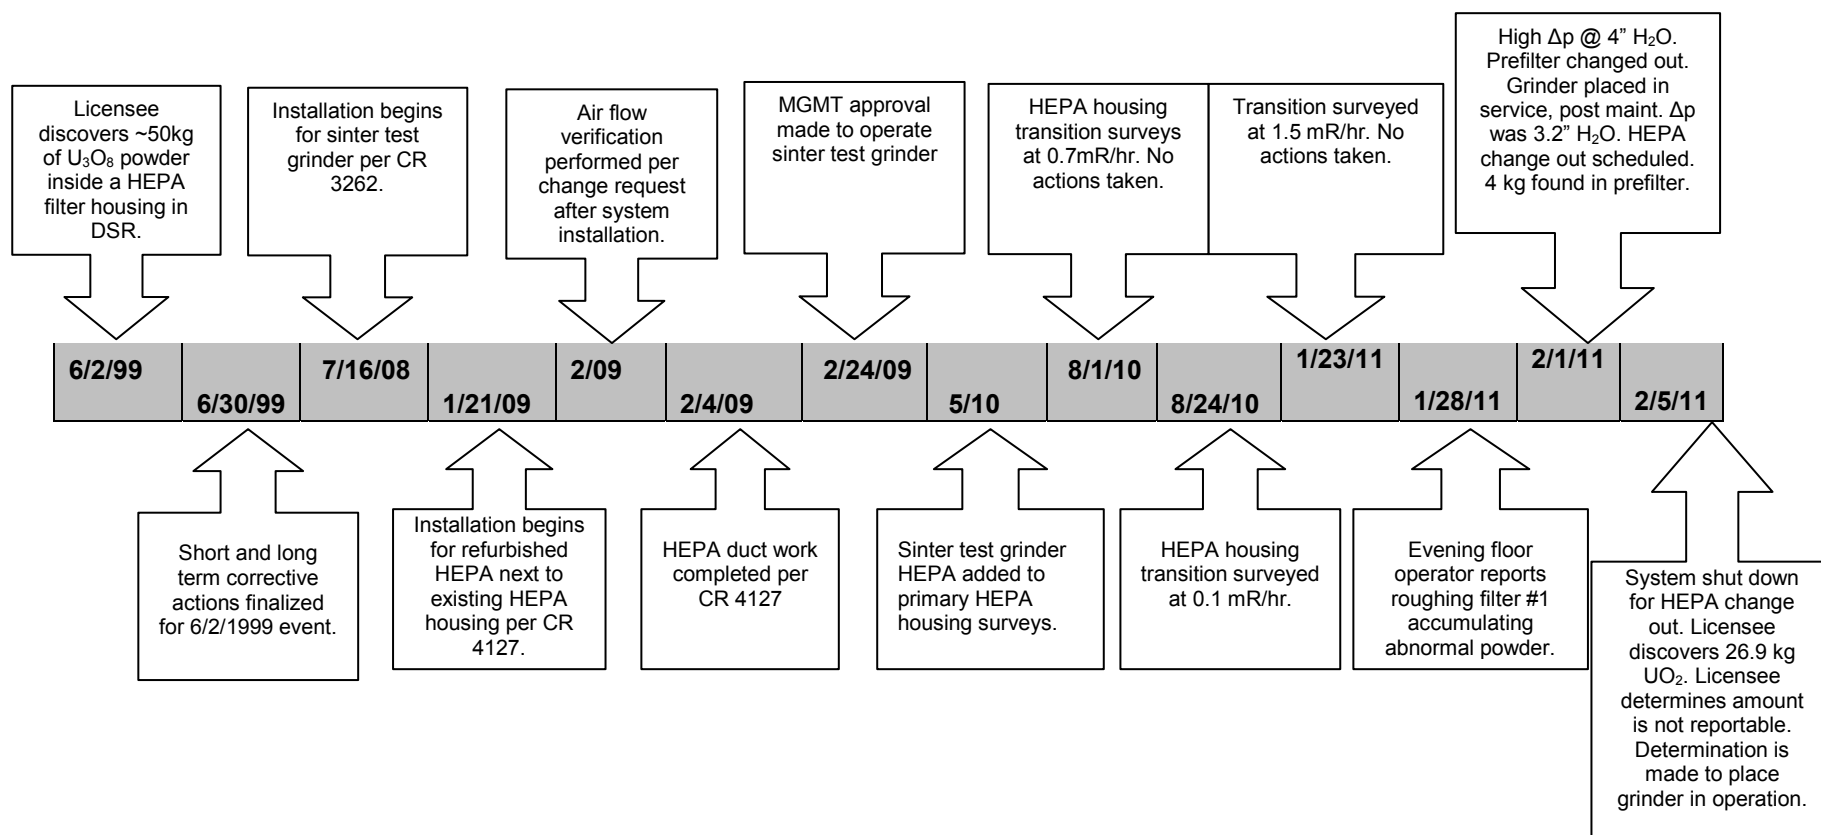
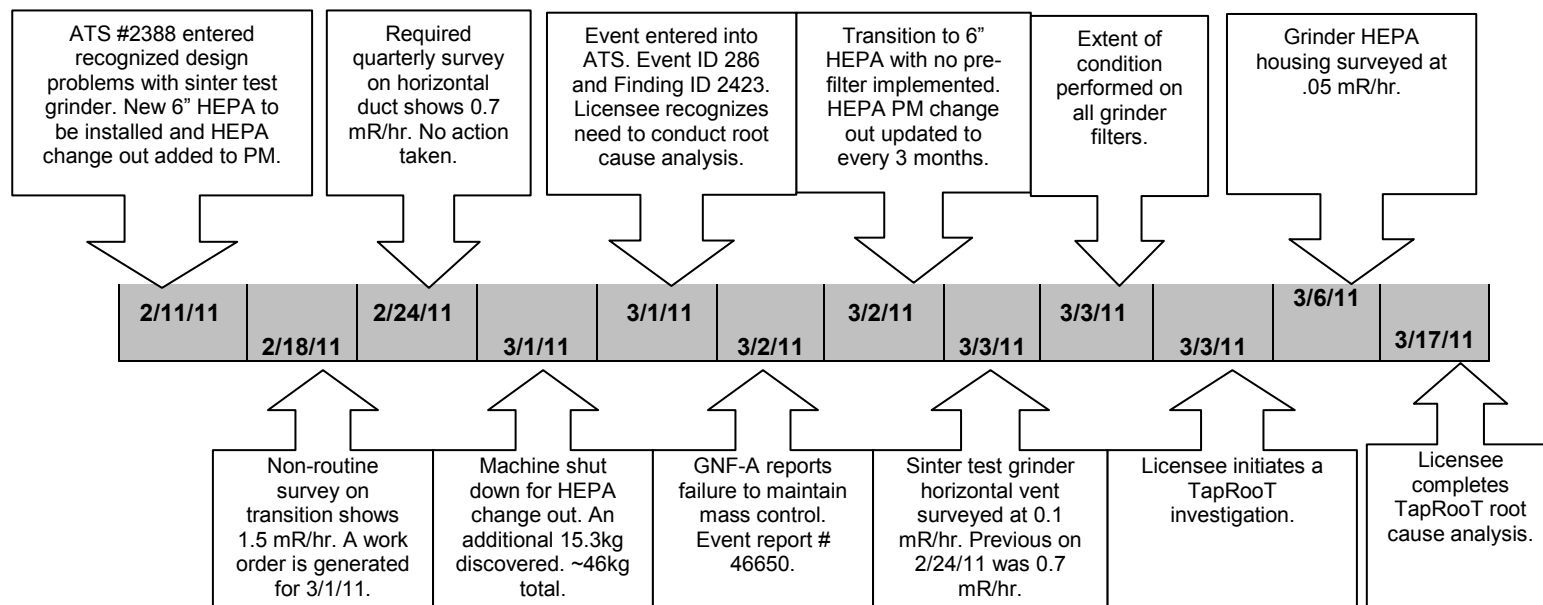
**Figure 2-a: Timeline of events leading up to the loss of mass control in the sinter test grinder and subsequent responses**

Through interviews of licensee personnel and review of licensee records, the team developed a timeline associated with the event surrounding the loss of mass control in the sinter test grinder HEPA enclosure. The timeline is shown in Figure 2-a and 2-b.
