Pressurized Water Reactor  
B&W Technology  
Crosstraining Course Manual

Chapter 15.0

Rancho Seco Loss of ICS Power

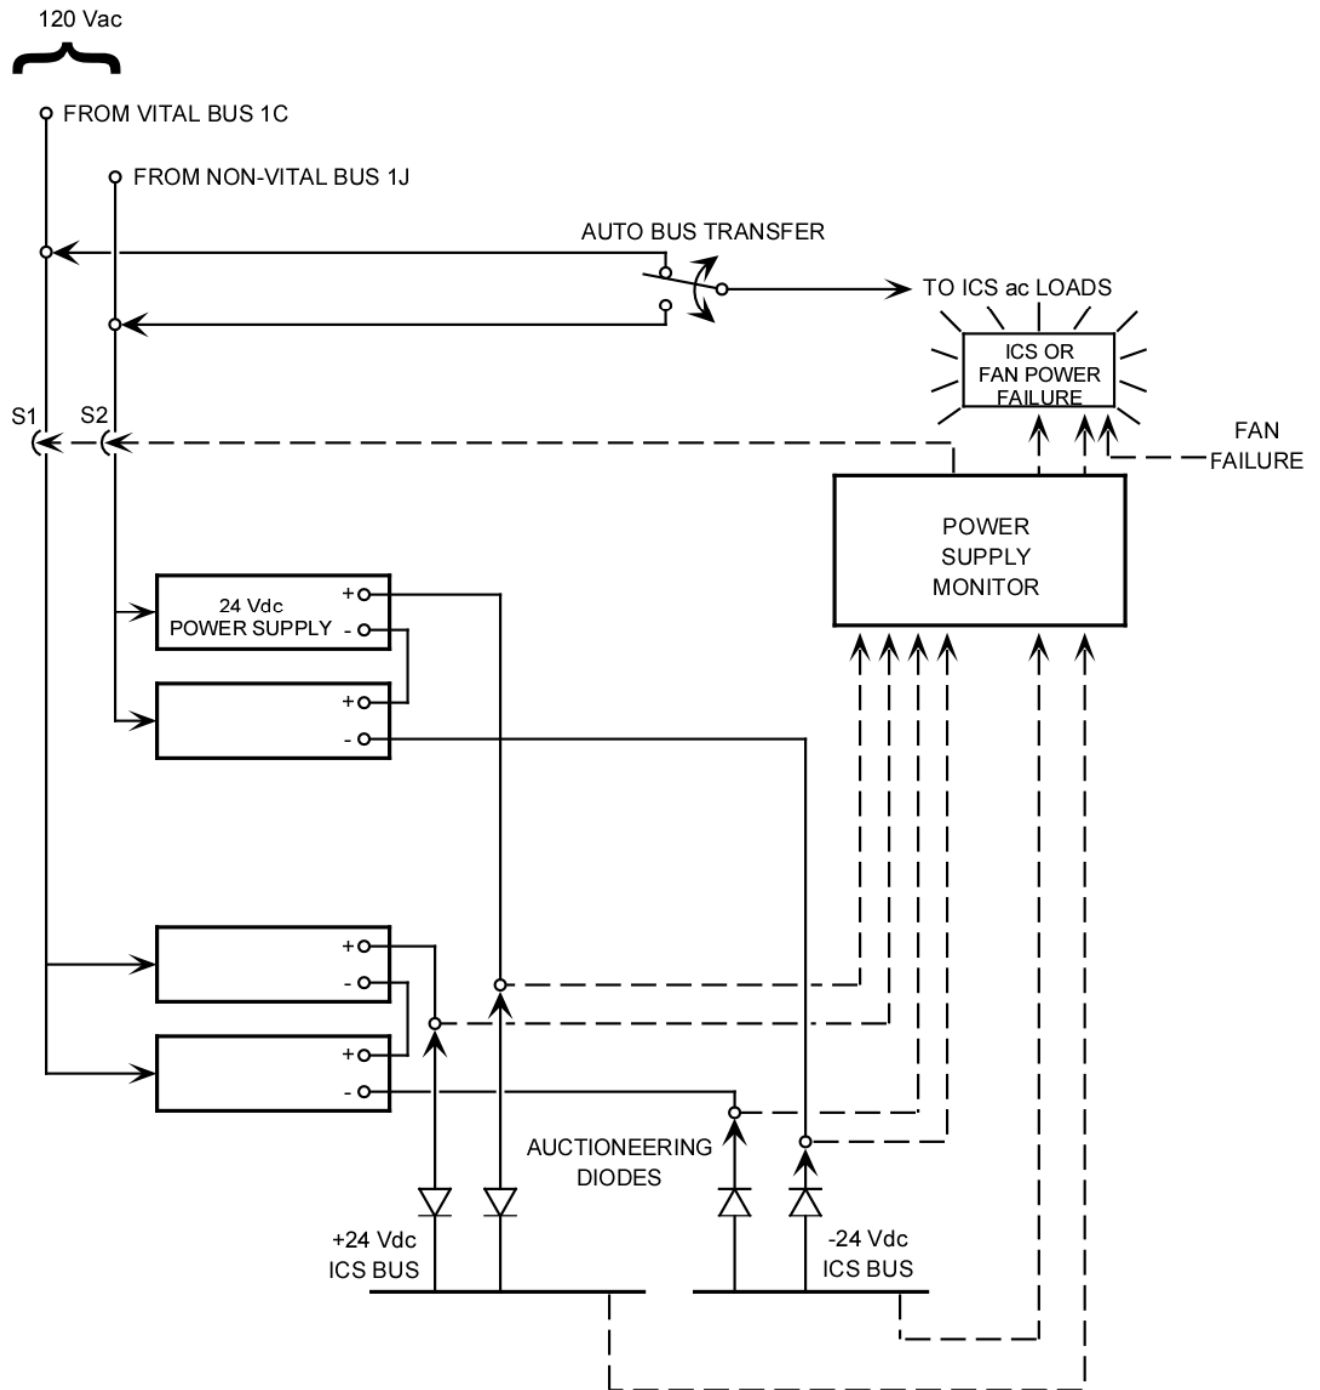
Figure 15-1 ICS Power Supplies

The loss of ICS dc power was caused by a failure of the power supply monitor which opened switches S1 and S2 (Figure 15-1). The loss of input power resulted in a zero voltage on the +/- 24-vdc busses in the ICS. At zero volts, the main feedwater regulating valves and the startup regulating valves assumed a 50% open position. Since voltage was lost, the main feedwater pumps dropped to minimum speed. With the reactor at 76% power and almost no feedwater flow to the once-through steam generators for RCS heat removal, an overheating event started even though the turbine bypass and atmospheric dump valves were 50% open due to the loss of ICS power. With reduced heat removal, the reactor's energy causes an increase in RCS temperatures. The increase in temperatures results in an increase in pressurizer pressure and pressure level. The pressurizer spray valve was manually opened in an effort to lower RCS pressure.

There are redundant dc power supplies for the ICS, whose outputs are auctioneered to provide +24 Vdc and -24 Vdc power for use in various modules within the ICS. The outputs of each of the +24 Vdc and -24 Vdc power supplies are monitored by a single power supply monitor (PSM) module, which will alarm in the control room if the output voltage of any of the dc power supplies drops to 23.5 Vdc. The PSM also senses the auctioneered output of each pair of power supplies and will trip open the input switches, S1 and S2, if the voltage

on either output bus drops to 22 Vdc. This results in interrupting all dc power within the ICS. This is a designed response to prevent voltage fluctuations from causing the ICS to behave in an erratic or unpredictable manner.

Early findings determined that the PSM trip setpoint was drifting. Significant to the event was the finding that small amounts of resistance, as little as one ohm, in series with the “sensed” voltage to the PSM could cause tripping of the PSM. During the troubleshooting process it was found that the time delay drop of switches S1 and S2 was much shorter than the manufacturer's tolerance.

During inspections of the physical wiring in the ICS cabinets, and in an attempt to identify the source of a possible increased input resistance, the technicians found that the input lead wire to the  $\pm 24$  Vdc monitor had an improperly crimped connection at the +24 volt bus bar in cabinet one. In fact, the lug fell free from the wire when it was disconnected from the bus. This wire is an internal cabinet wire installed by the vendor prior to delivery of the cabinets.

Following the discovery of the improperly crimped connection, the Quality Control group inspected the remainder of the factory and field wire terminations in ICS and NNI cabinets, and found numerous deficiencies in the quality of the wire terminations in these cabinets. The root cause for the loss of the ICS power was identified as the loose connection. The factory bus wiring has been replaced with current standard wiring.

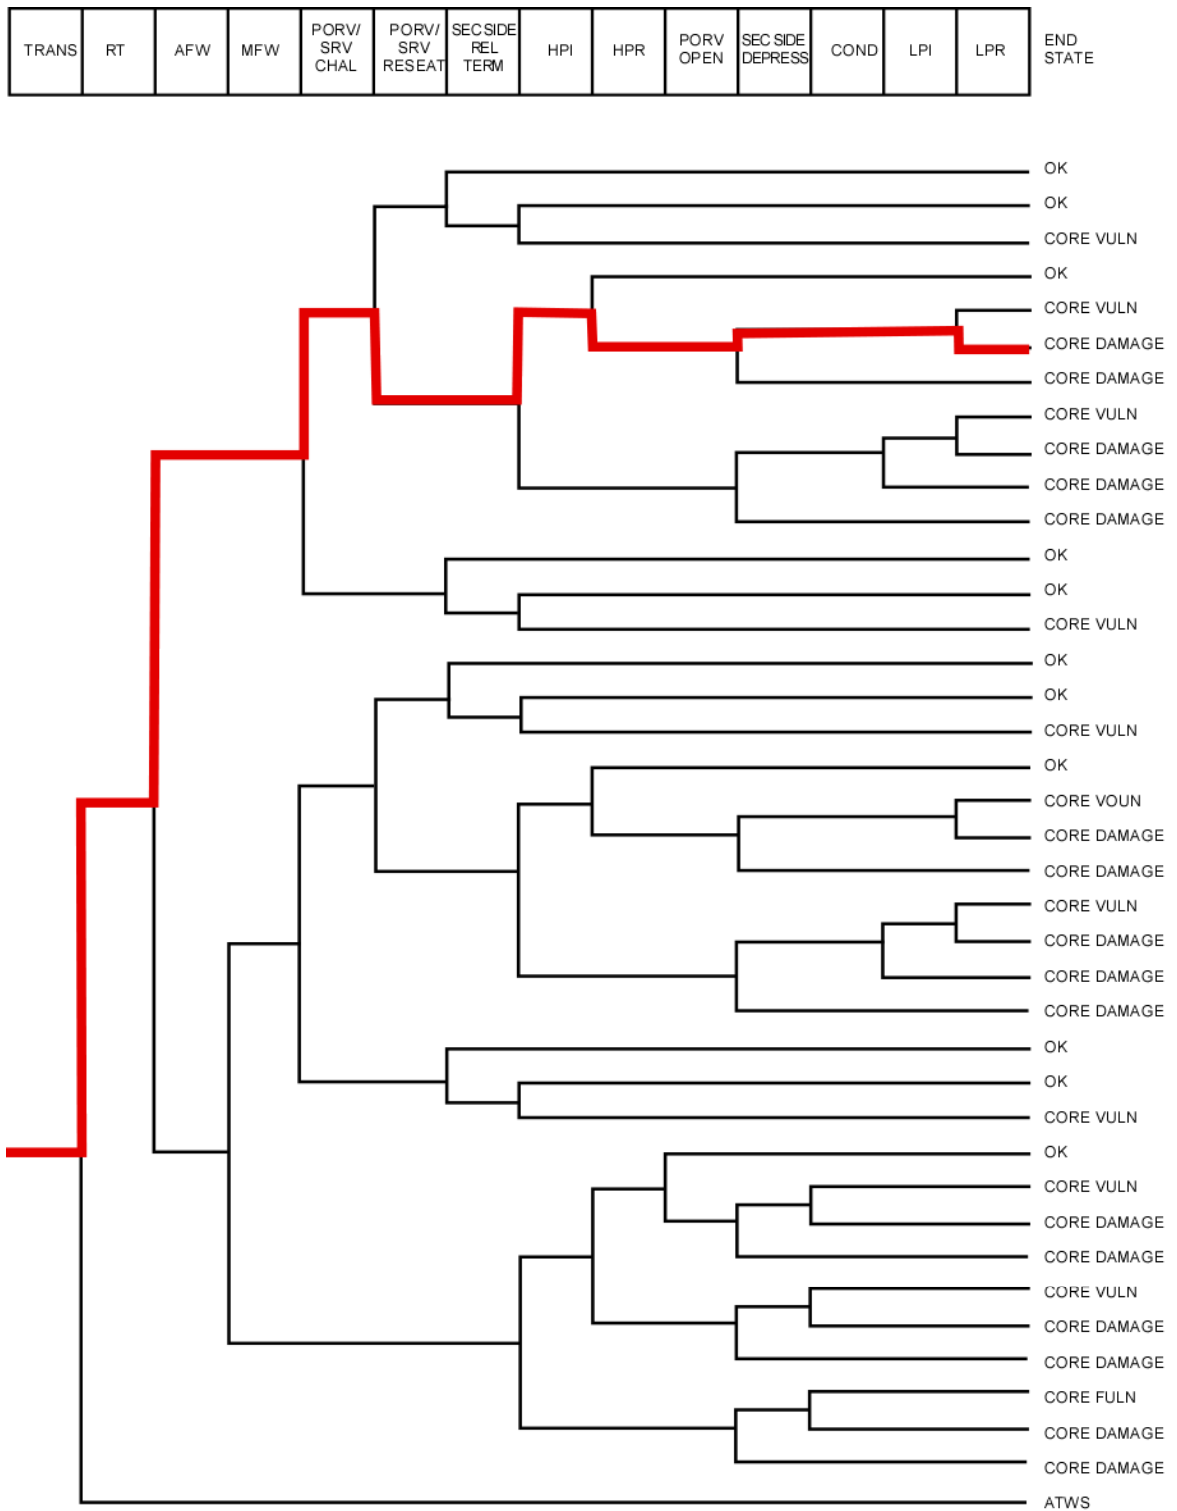
**Figure 15-7 Dominant core Damage Sequence Event Tree**

The major core damage sequence is shown in Figure 15-7. The sequence involves a transient initiator, successes of AFW and MFW, failure of the PORV to reseal, and HPI. The conditional probability of this sequence is  $3.0\text{E-}5/\text{Rx-yr}$ .
