SUBJECT: LER 87-014-00: on 870514, Groups II, III & IV isolations & standby gas treatment initiation occurred. Caused by inadequate premainenance review. Piping & instrument diagram will be revised. Personnel counseled. W/870616 ltr.

LICENSEE EVENT REPORT (LER)

FACILITY NAME (1) Duane Arnold Energy Center (DAEC)										DOCKET NUMBER (2) 0 5 0 0 0 3 3 1										PAGE (3) 1 OF 0 4																													
TITLE (4) Groups II, III, and IV Isolations Due to Inadequate Pre-Maintenance Review																																																	
EVENT DATE (5) 0 5 1 4 8 7										LER NUMBER (6) 8 7 - 0 1 4 - 0 0										REPORT DATE (7) 0 6 1 6 8 7										OTHER FACILITIES INVOLVED (8) None																			
OPERATING MODE (9) N										THIS REPORT IS SUBMITTED PURSUANT TO THE REQUIREMENTS OF 10 CFR §: (Check one or more of the following) (11)										FACILITY NAMES None										DOCKET NUMBER(S) 0 5 0 0 0																			
POWER LEVEL (10) 0 1 0 0										20.402(b)										20.405(c)										X 50.73(a)(2)(iv)										73.71(b)

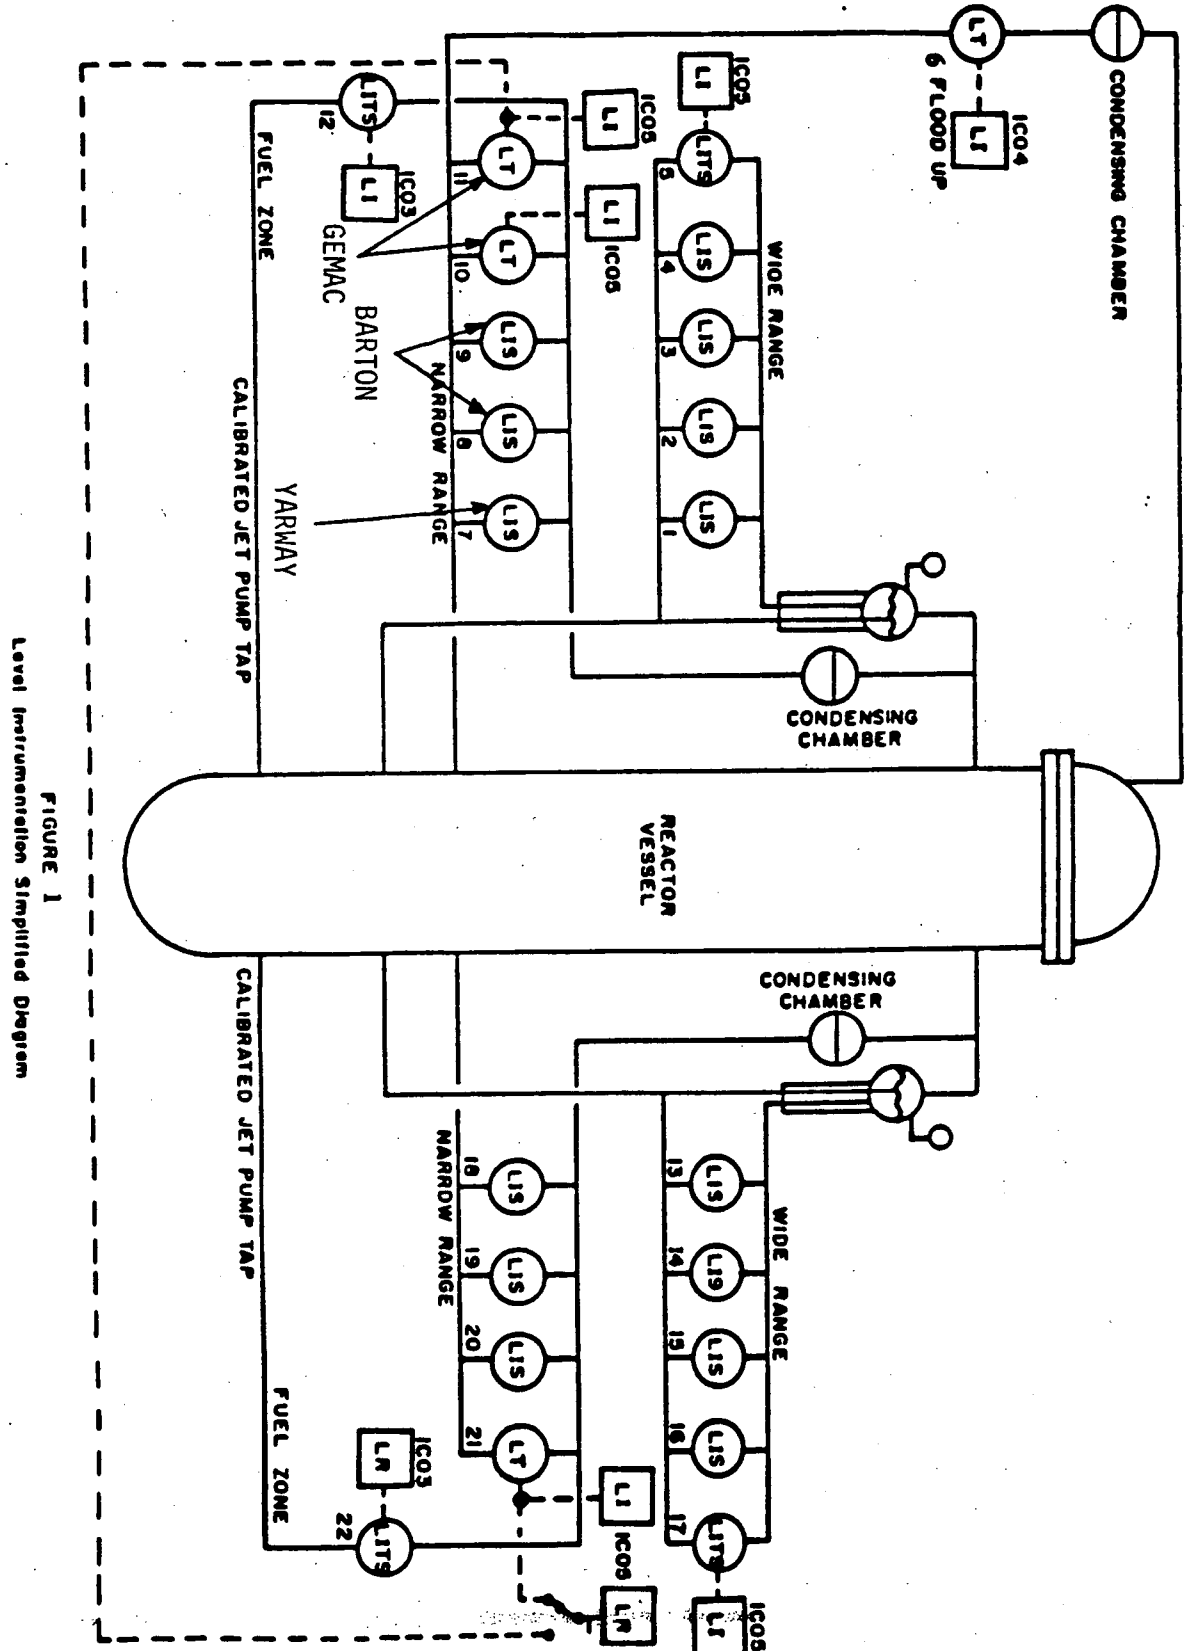
FIGURE 1
Level Instrumentation Simplified Diagram

On May 14, 1987 at 2254 hours with the plant shut down for the cycle 8/9 refuel outage and approximately 20% of the core reloaded, Groups II, III, and IV isolations, and Standby Gas Treatment (SBGT) (EIS System Code Identifier BH) initiation occurred during planned maintenance work on the high side rack shutoff valve for the Feedwater Control (JB) GEMAC level transmitters (JB-LT-4559, & JB-LT-4561). The intention was to drain off the high side of the reference leg to the GEMAC transmitters. The draining of the high side of the transmitters has no effect on any system trips. The Reactor Protection System (RPS, JC) received a low reactor water level signal (170 inches above top of active fuel (TAF)) when operations personnel attempted to drain the high side reference leg of the GEMAC level transmitters. GEMAC level transmitters (LT-4559 and LT-4561), Narrow Range YARWAY level switch (LIS-4561), and Narrow Range BARTON level switches (LIS-4592A, & LIS-4592B) share a common instrument line (see figure 1). Isolation and draining of the high side of the narrow range GEMAC level transmitters also effects the low side of the YARWAY and BARTON level switches. LT-4559 and LT-4561 are installed in a transposed configuration in comparison with LIS-4592A, LIS-4592B, and LIS-4561, i.e., the high and low pressure taps are reversed. This unique equipment configuration is not readily apparent on the applicable Piping and Instrument Diagram (P&ID, M-115), and upon draining of the intended high side of the GEMAC transmitter, the low side of the BARTON and YARWAY switches were also drained. Hence, this caused a low reactor water level (170 inches above TAF) signal to be received, and Group II through IV isolations, and SBGT system initiation. Group V valves were tagged out at the time of the event so isolation of these valves did not take place.

The intermediate cause of the event was the uniqueness of the equipment installation and lack of detail on P&ID M-115.

The root cause of the event was determined to be personnel error. Utility licensed operations personnel and contract maintenance personnel did not fully understand the relative configuration of the level transmitters. The effects of the isolation and draining the low pressure side of the YARWAY and BARTON level switches were known but not identified since the P&ID did not identify the unique installation of the GEMAC Transmitters.

As immediate corrective actions, the Operations Supervisor alerted operations personnel and the training department to this unique equipment configuration (GEMAC high-low vs YARWAY & BARTON low-high). As additional corrective actions, P&ID M-115 is being revised to include a high and low insignia to be placed next to the transmitters and level switches in question, also the GEMAC transmitters high pressure and low pressure isolation valves will be labeled in the field during the on-going equipment labeling project. In addition, maintenance and operations personnel will be required to read this LER to stress the importance of accurate Corrective Maintenance Action Request (CMAR) pre-work reviews.
