SUBJECT: LER 86-020-01: on 861015, charcoal beds of control bldg
 standby filter units inadvertently sprayed w/water &
 rendered inoperable. Caused by inadequate procedure. Procedure
 is being revised. W/870713 ltr.

FACILITY NAME (1) Duane Arnold Energy Center (DAEC)	DOCKET NUMBER (2) 0 5 0 0 0 3 3 1	PAGE (3) 1 OF 0 6
--	--------------------------------------	----------------------

Inadvertent Deluge of Standby Filter Units Due to Inadequate Procedure

Subject: Duane Arnold Energy Center
Docket No. 50-331
Op. License DPR-49
Licensee Event Report No. 86-020 Revision 1

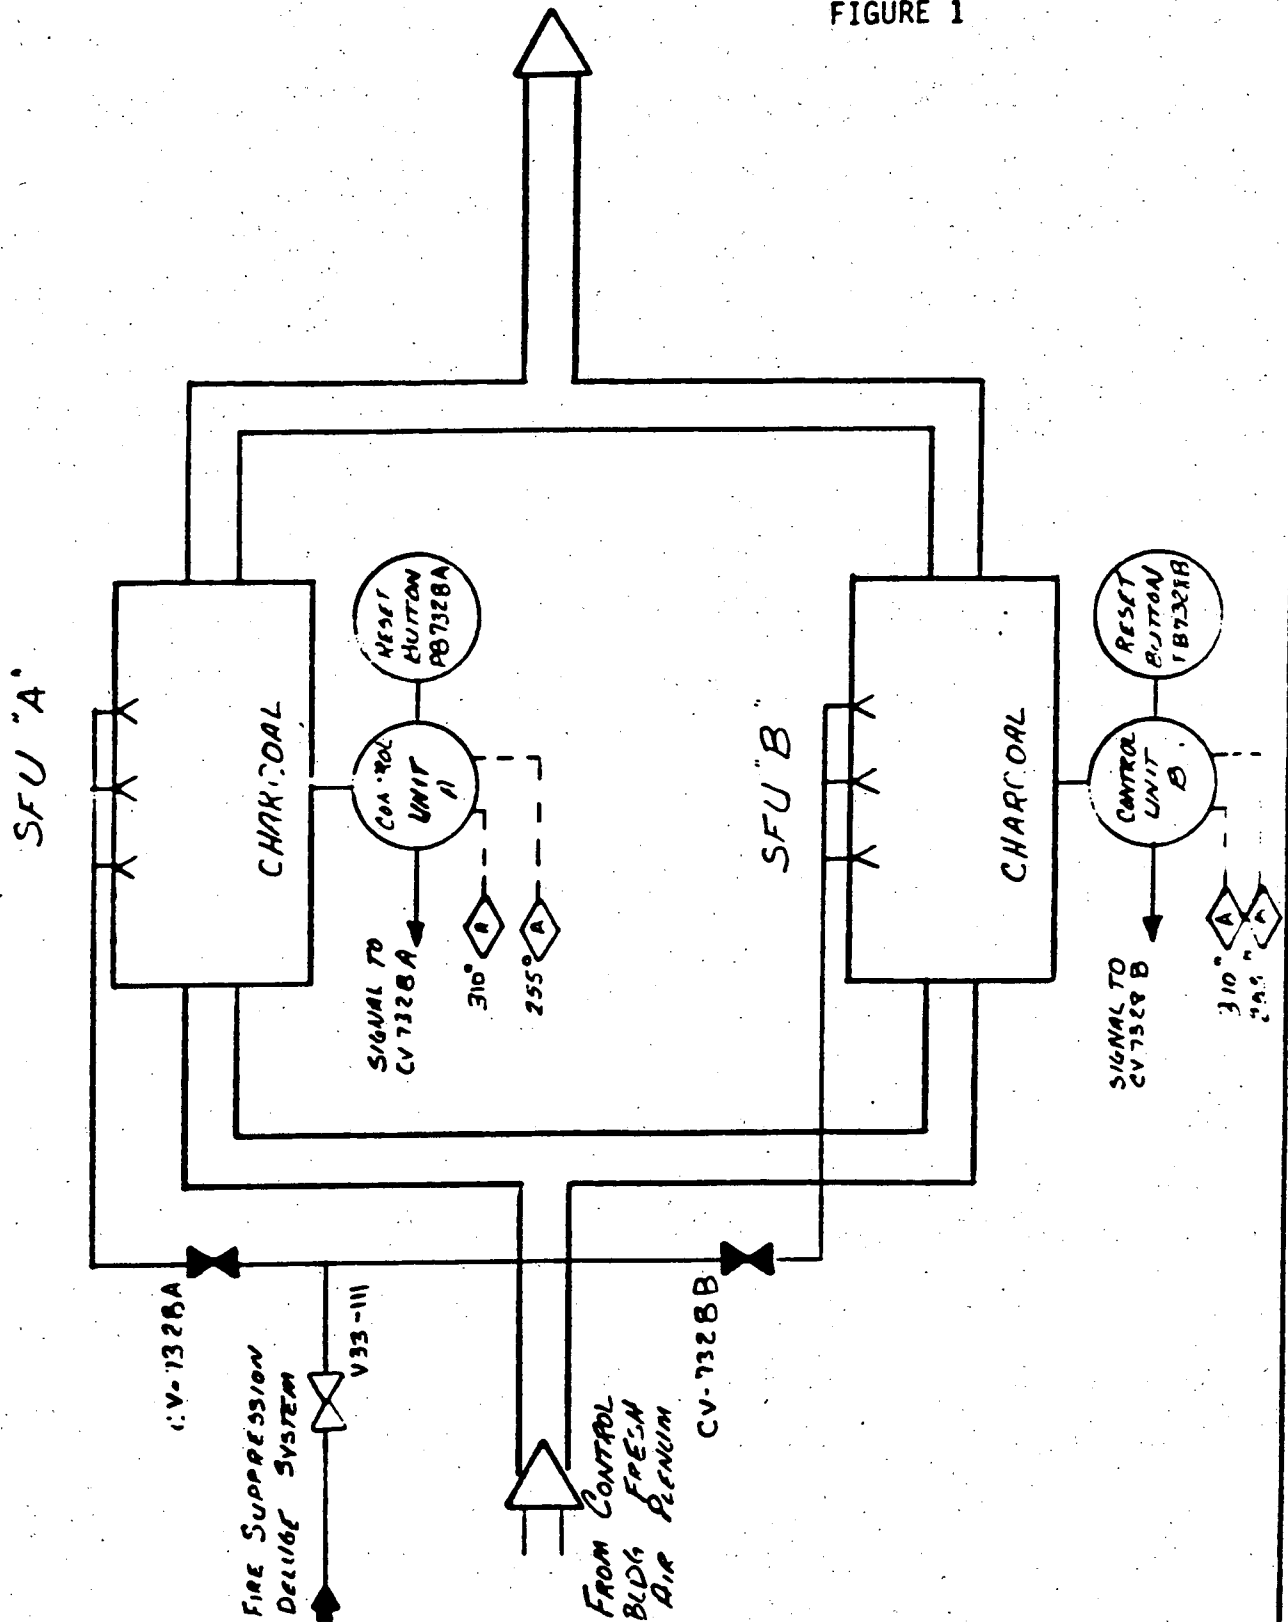
FIGURE 1

Each control unit monitors the temperature in the SFU charcoal bed. If the temperature reaches 255° F an alarm is sounded and a permissive signal is sent to the normally closed deluge isolation valve control that will allow manual opening. These valves for the A and B trains respectively are CV-7328A and CV-7328B (EIIS Code VI-TCV-7328A and VI-TCV-7328B). If the temperature reaches 310° F an alarm is annunciated in the Control Room and the deluge isolation valve automatically opens (see figure 1).

However, during the functional testing the 310° automatic initiation alarm sealed open the normally closed SFU isolation valve. Clearing the Control Room alarms did not break the seal-in logic and close the valve. To close this valve and break the seal-in logic, reset button (PB7328A and PB7328B) must be pressed. Since the instructions did not require pushing the reset button, the carbon beds of the Standby Filter Units were sprayed with water when the deluge system was unisolated.

The cause of the event was an inadequate procedures. The maintenance instructions should have included a step to push the reset buttons (PB7328A and PB7328B) (EIIIS Code VI-IS-7328A and VI-IS-7328B) to reset the valves. The Control Room annunciators are actuated by the temperature switches. So no control room indication was present that showed the deluge valves were open after the test signals were removed and the annunciators reset.

The charcoal filters of the Standby Filter Units were replaced. The preventive maintenance procedures will be revised before it is next scheduled to be worked to include pushing the reset button when the test is completed. As a further corrective action, an engineering review has been initiated to consider installing 2 deluge isolation valves, one for each train of the SFU's. This will allow isolation for testing and maintenance of one deluge train while leaving the other in service. Also an engineering request has been initiated to change the control room annunciator to indicate valve position rather than temperature switch acutation.
