SUBJECT: Forwards response to request for addl info re control room  
 habitability evaluation.Attachment A to ltr describes 900919  
 event & design mods planned. ✓

Subject: Duane Arnold Energy Center  
Docket No: 50-331  
Op. License No: DPR-49  
Response to Request for Additional  
Information Regarding DAEC's Control  
Room Habitability Evaluation  
Reference: Letter, C. Shiraki (NRC) to L. Liu (IELP)  
dated August 2, 1991  
File: A-107a

## RESPONSE TO REQUEST FOR ADDITIONAL INFORMATION

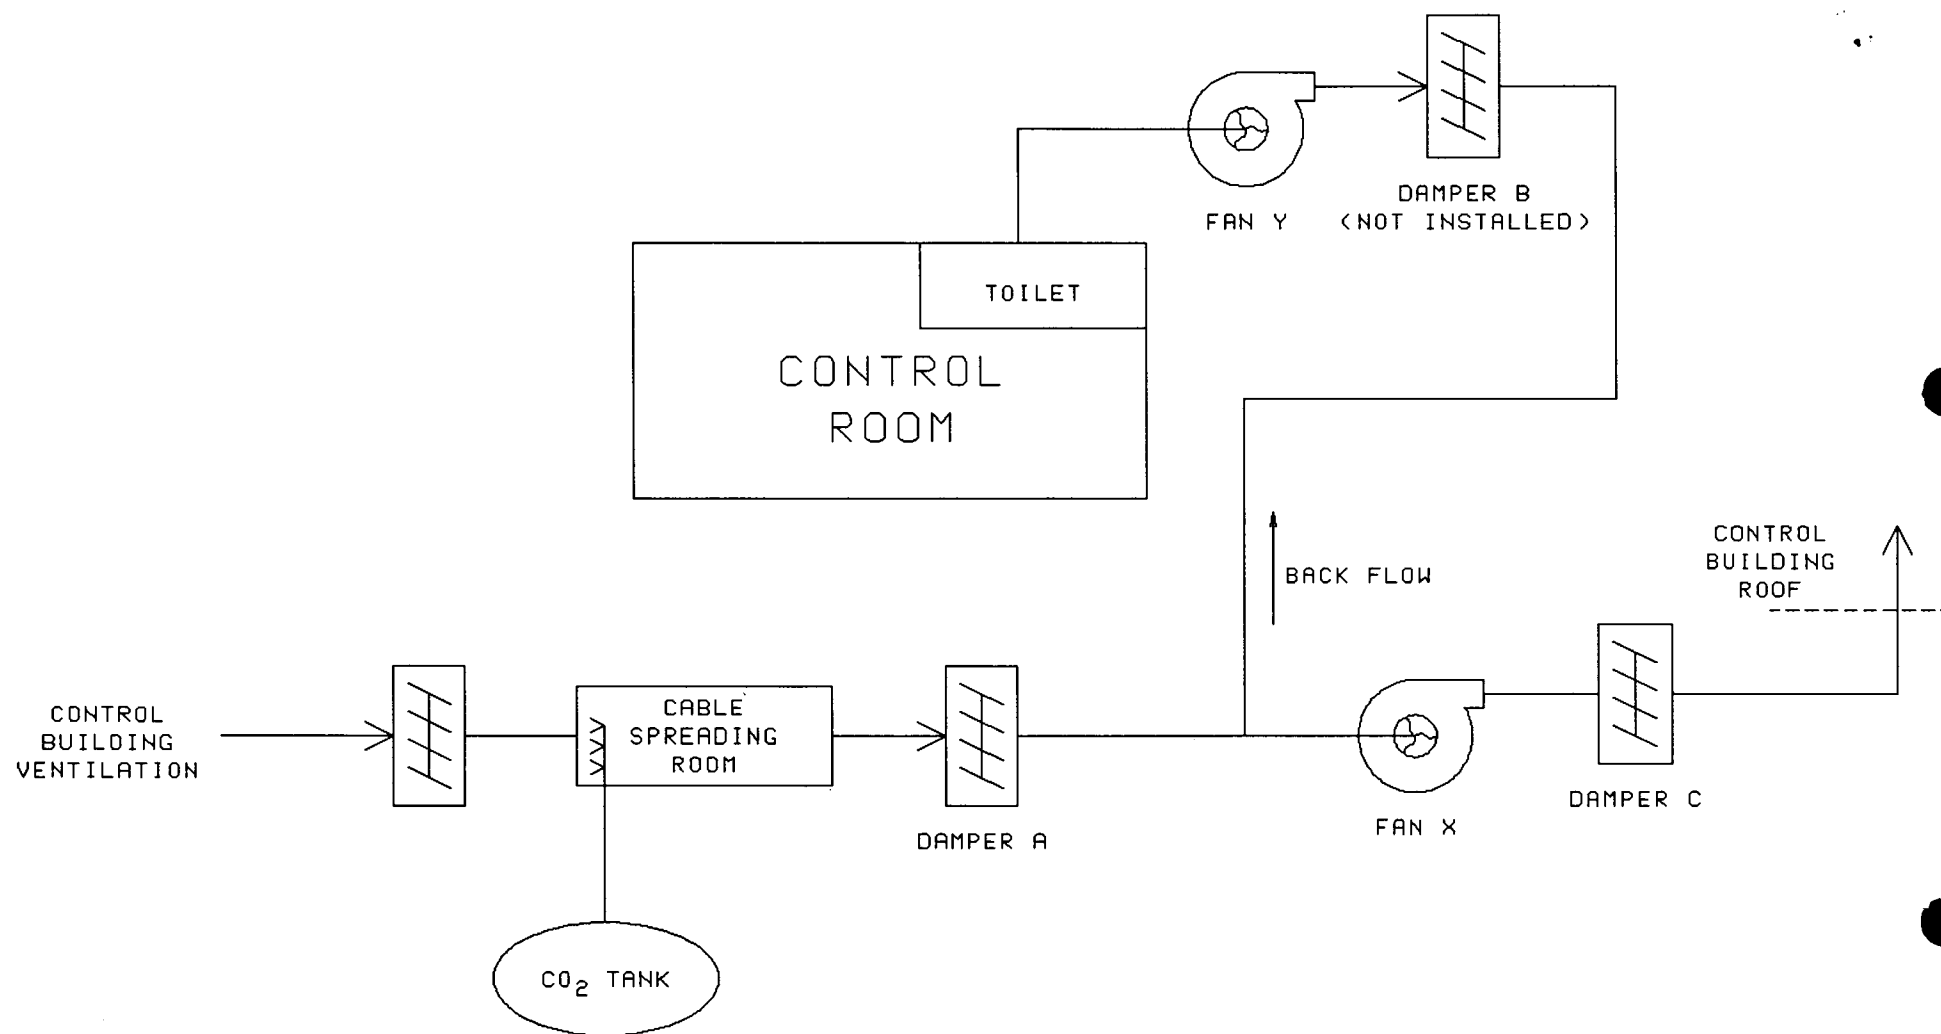
CONTROL BUILDING VENTILATION  
(Simplified)

The modifications to the ventilation system were completed in May 1974. Additional fire dampers were installed in the Cable Spreading Room and the CO<sub>2</sub>-actuated logic on the room exhaust damper (see Damper A Attachment B) was replaced with 360 degree F fusible links. The exhaust damper would then remain open until the fusible links sensed an actual fire (360 degrees F) thereby maximizing the availability of a vent path to prevent overpressurization of the Cable Spreading Room.

It was during the investigation of the September 19, 1990, event that we identified that the backdraft damper (see Damper B) which was intended to prevent air from backflowing into the Control Room from the Cable Spreading Room was never installed. Design documentation has always reflected a damper in the line and consequently, its presence was assumed in the later habitability evaluations. Despite vigorous efforts, we are unable to explain its absence. Additionally, we determined that upon CARDOX actuation, the room exhaust fan (see Fan X) secures and the fan's discharge damper (see Damper C) closes, effectively blocking the intended vent path. Therefore, the 1974 ventilation modifications were ineffective in that a CARDOX initiation can still pressurize the Cable Spreading Room and, without the backdraft damper, CO<sub>2</sub> can backflow into the Control Room.

Design modifications have been initiated which will address the backflow through the control room exhaust fan (see Fan Y) and ensure the proper venting of the Cable Spreading Room in the event of a CARDON initiation. These design changes will be complete prior to shutdown for the Cycle 11 refueling outage. Additionally, post-modification testing will be performed during the Cycle 11 outage to verify the effectiveness of these modifications. Upon successful completion of this testing, the Control Room habitability evaluation described in UFSAR Section 6.4 will be revised to reflect the analysis of and corrective actions resulting from the September 19, 1990 event.
