Action Request Print: 080501182

Description (General Tab)

Type	ID	CRC	Functional Description
EQ-MEL	S22420MG003	Critical-A	"NEIL" EMERGENCY DIESEL GENERATOR 2MG003

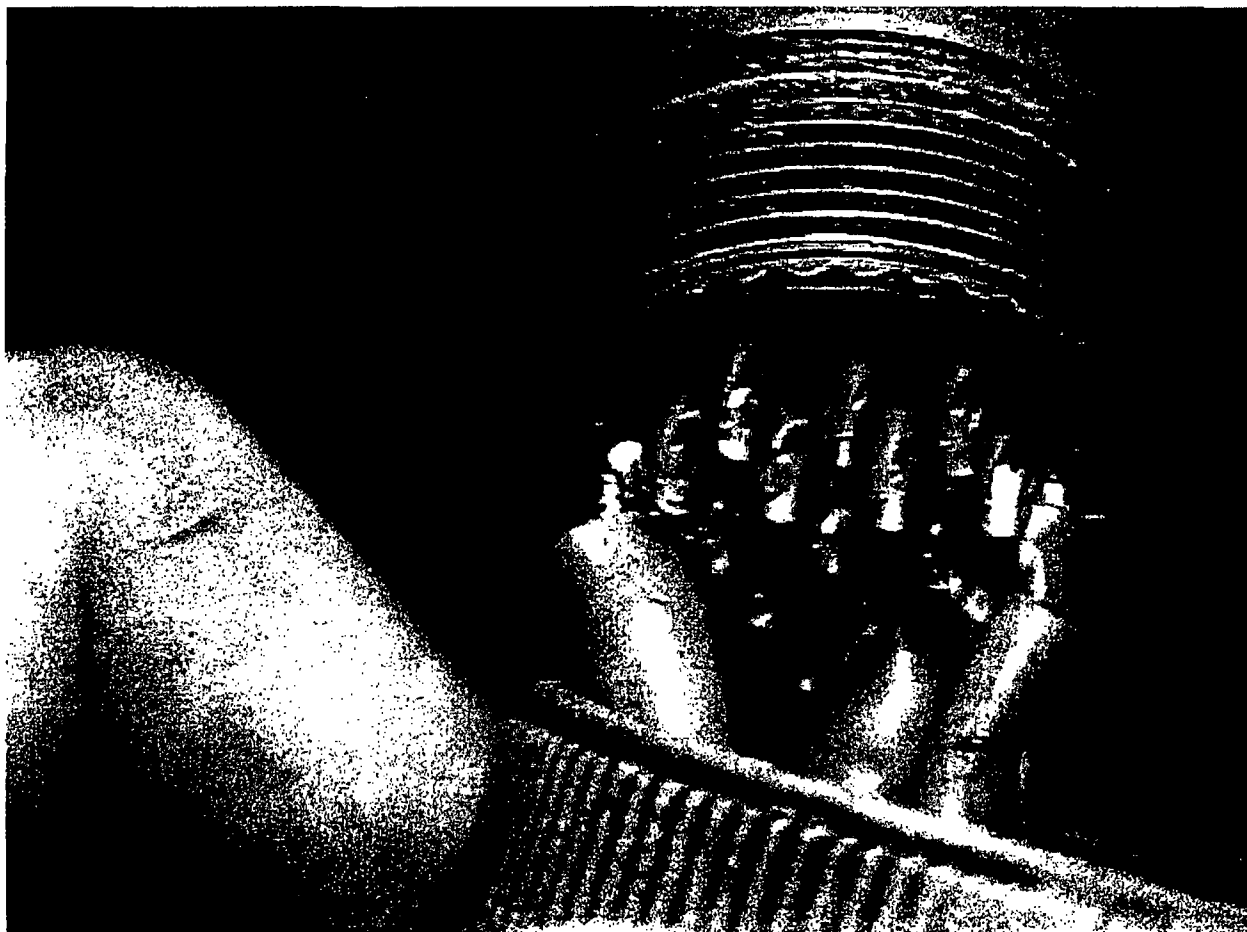
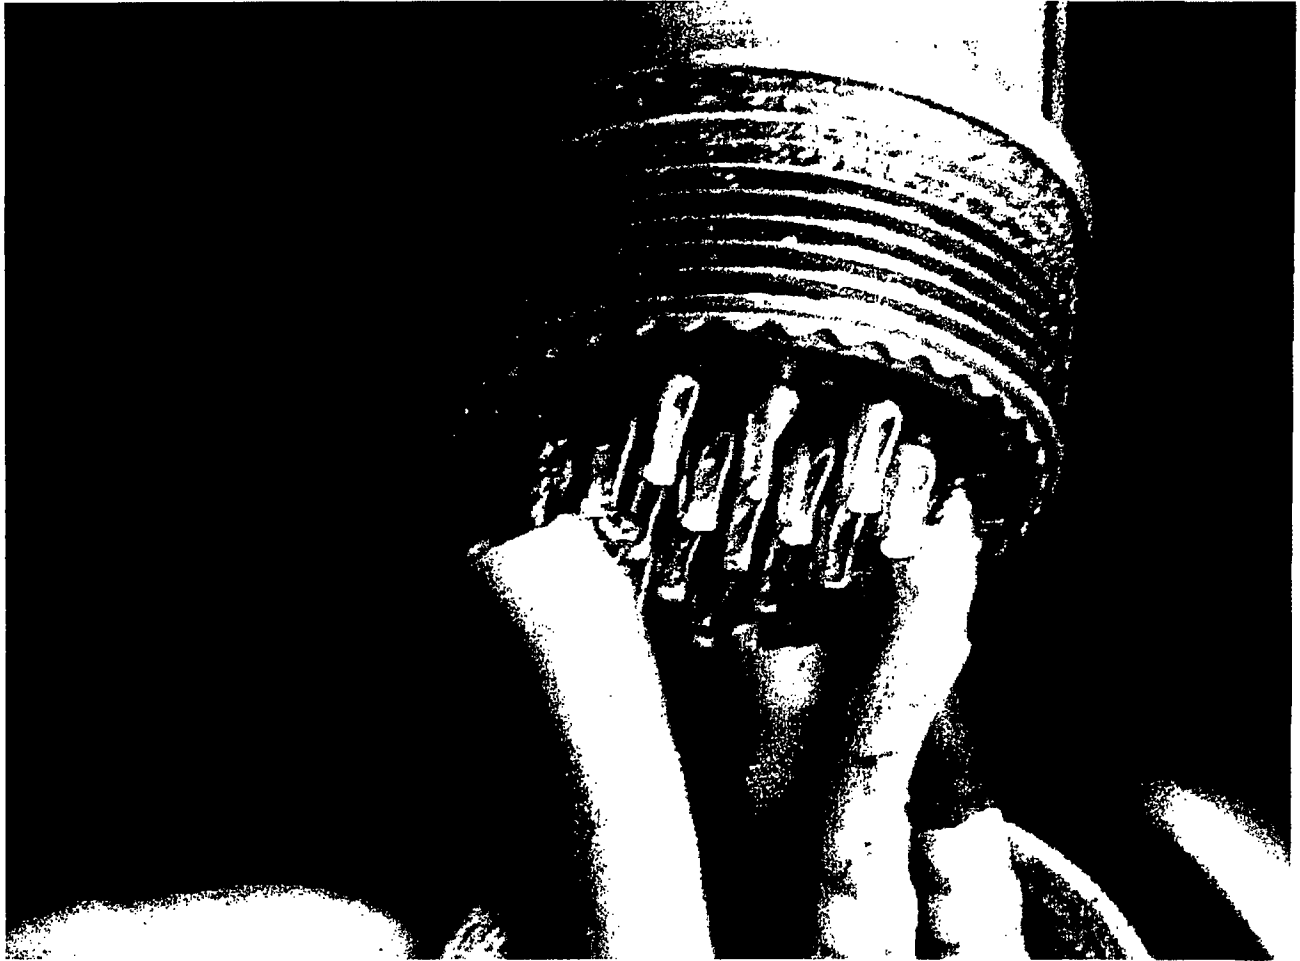
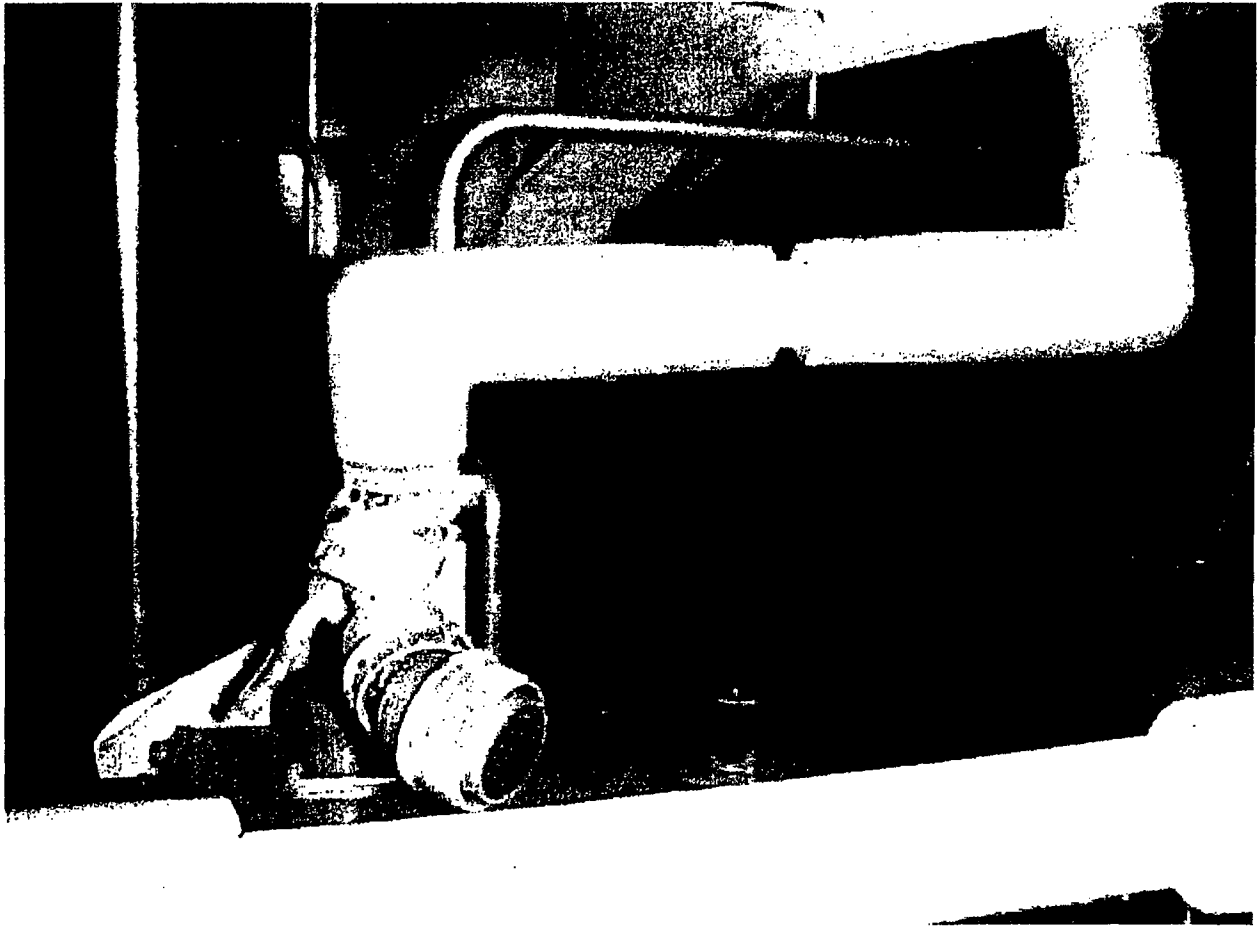
1. ENG #2 AMPHENOL CONNECTOR ATTACHING WIRE ASSY TO EGB WOODWARD GOVERNOR NEEDS TO BE REPLACED. THE SOLDER AT THE CONNECTOR IS DEGRADING AND IN FAIR FUNCTIONAL CONDITION. (SEE ATTACHED PICS)

2. BOTH ENGINES HAVE FIXED CONDUIT RUNNING FROM TERM BOXES 373 AND 375 ON EAST AND WEST END OF MOTORS. FROM THE TERM BOX'S THE RIGID CONDUIT RUNS THROUGH SEVERAL 90 DEGREE RIGID 90 DEGREE BODIES ALL THE WAY UP TO THE GOVERNORS WITH ONLY THREE INCHES OF WIRE ASSEMBLY TO PLAY WITH BEFORE CONNECTING TO GOVERNORS. REQUEST ENGINEER EVALUATION OF RUNNING FLEX CONDUIT AT LEAST OVER THE LAST SEVERAL FEET FROM THE FIRST (T) CONDUIT BODY. (SEE ATTACHED PICS)

3. ENGINE #1 THE LAST TWO 90 DEGREE BODY AND T BODY ARE VERY LOOSE MOVE EASILY. UNABLE TO TIGHTEN WITH OUT REMOVING WIRE ASSEMBLY ATTACHED TO WOODWARD GOVERNOR.

Conduit between electronic governor and the mechanical governor is loose and needs to be retightened or replaced prior to making 2G003 Operable.

Discussed with Electrical Engineering (Battish) and the concern is not that this condition renders the EDG Inoperable, but rather that the EDG (2G003) would be returned to service in a degraded condition which could eventually lead to failure of the wiring between the electronic and mechanical governors. The EDG's have been in service for over 25 years with the current conduit configurations and we have not seen any failures to date. The loose conduit is a long term wear issue which could eventually cause a failure of the wiring or amphenol plug connections due to the excessive vibrations when the EDG is running. Any EDG would be considered Operable with loose conduits, but should be repaired at earliest opportunity.

Notification text -- Replace or Repair the loose flex conduit referenced in the AR.
