SONGS - MEng-SEng. Report:

**ASSESSMENT OF THE IMPACT OF THE DEGRADED CONNECTIONS BETWEEN
BREAKER 2D201 AND BATTERY 2B008 ON THE FUNCTIONALITY-OPERABILITY
OF THE BATTERY 2B008**

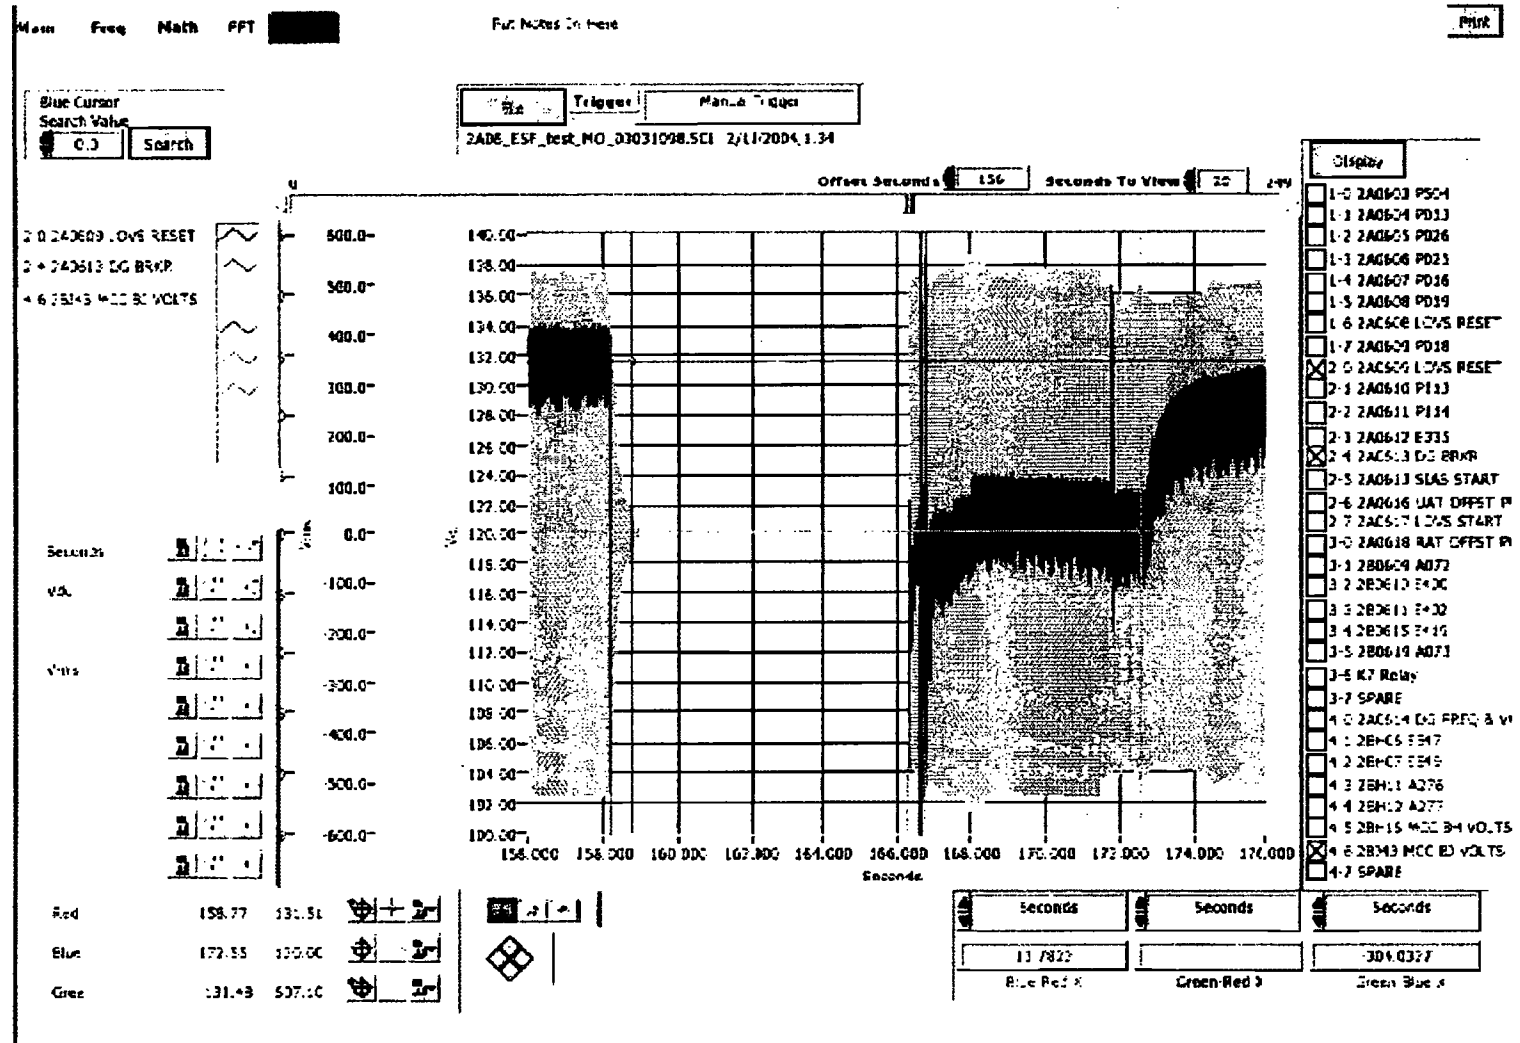
- Figure 1 shows a trace from an ESF test carried out on 2/11/2004.
- Figure 2 shows a trace from an ESF test carried out on 11/29/2007, almost three years after the 2D002 breaker replacement.
- Figure 3 shows a trace from an LOVS test carried out on 1/28/2008, just a few weeks before the discovery of the degraded condition of the connections.

Figure 1 – ESF test on affected circuit on 2/11/2004 before the breaker replacement. Test duration of the test about 15 seconds.

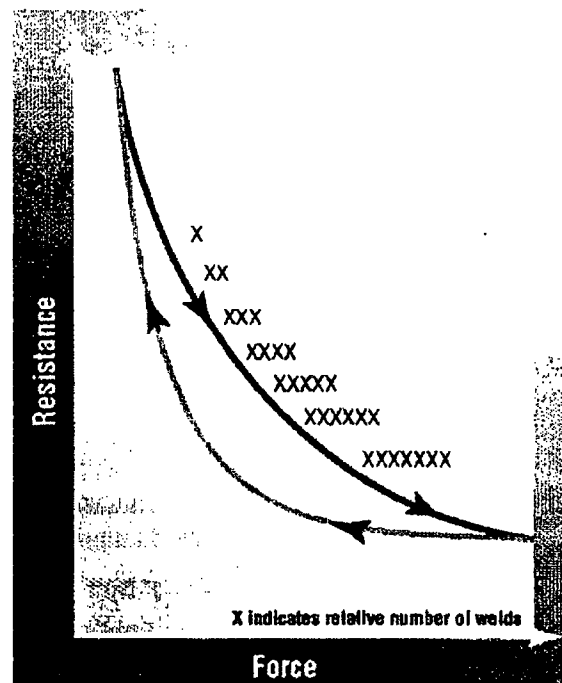
All the aforementioned are in accordance with the assumption based on existing knowledge (as shown graphically in Figure 5), that once a clean contact was established on March 2004, losing pressure did not immediately result in an increase of contact resistance. This only happened after the 4-day period of swing-charger current flowing thru the impacted joint.

Figure 5 [4] – Contact theory says that contact points are actually cold welds. If the high contact force is decreased, the contact resistance remains constant and does not increase until a much lower force is reached.
