Three Mile Island Nuclear Station, Unit 1
Renewed Facility Operating License No. DPR-50
NRC Docket No. 50-289

Subject: Response to Request for Additional Information - Relief Request RR-11-01
and RR-11-02

Response to Request for Additional Information - Relief Requests RR-11-01 and RR-11-02

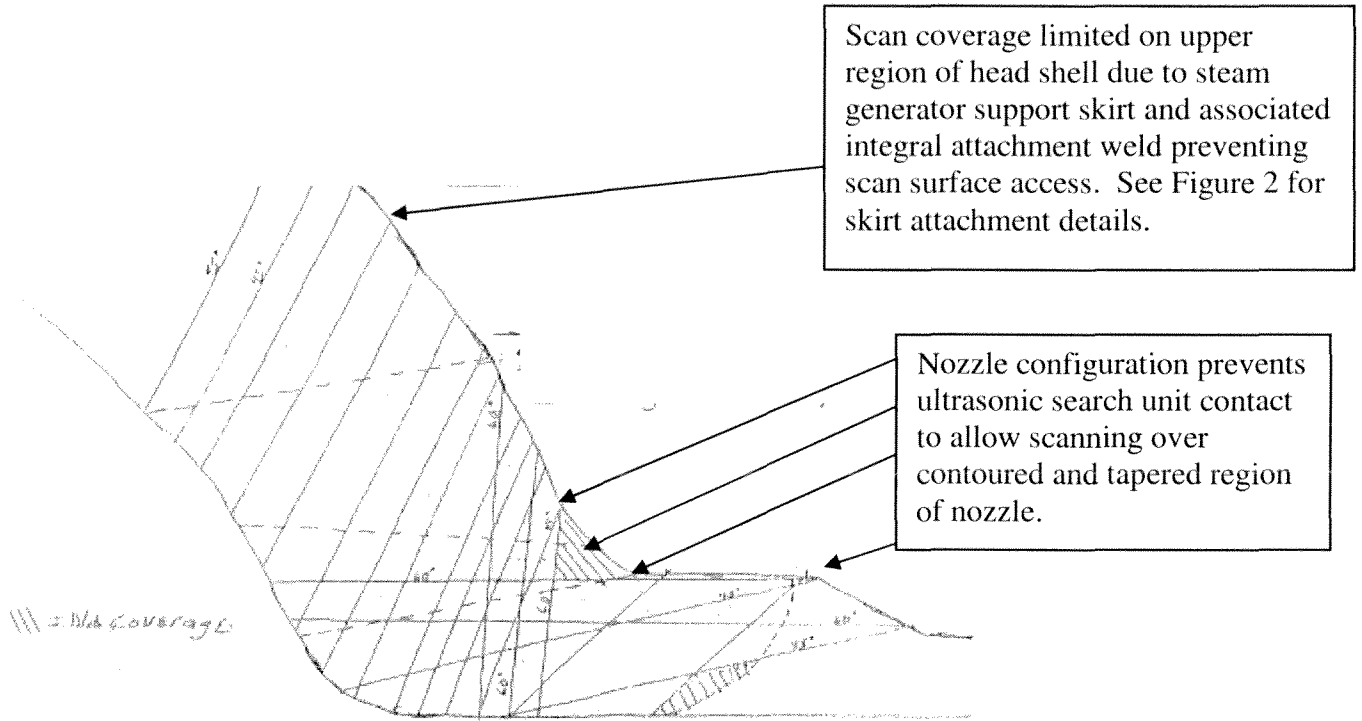
Figure 1
NDE Data Report Coverage Plot for Welds RCH0001ASG0003N and RCH0001ASG0004N.

Figure 1 below is a duplication of Figure 1 from Relief Request RR-11-01 with annotations noting the examination limitations due to the nozzle configuration. Figure 2 below provides a steam generator lower head configuration that includes the steam generator support skirt attachment that limited examination coverage from the head shell (applicable to welds RCH0001ASG0003N, RCH0001ASG0004N, RCH0001BSG0008N, and RCH0001BSG0009N).

As indicated in Relief Request RR-11-01, the steam generators were replaced during the 2009 refueling outage. These nozzle welds are no longer in service; therefore, application of additional examination techniques is no longer practical. The currently installed steam generators were designed to eliminate similar examination limitations.

Note that welds RCH0001BSG0008N and RCH0001BSG0009N are identical in design.

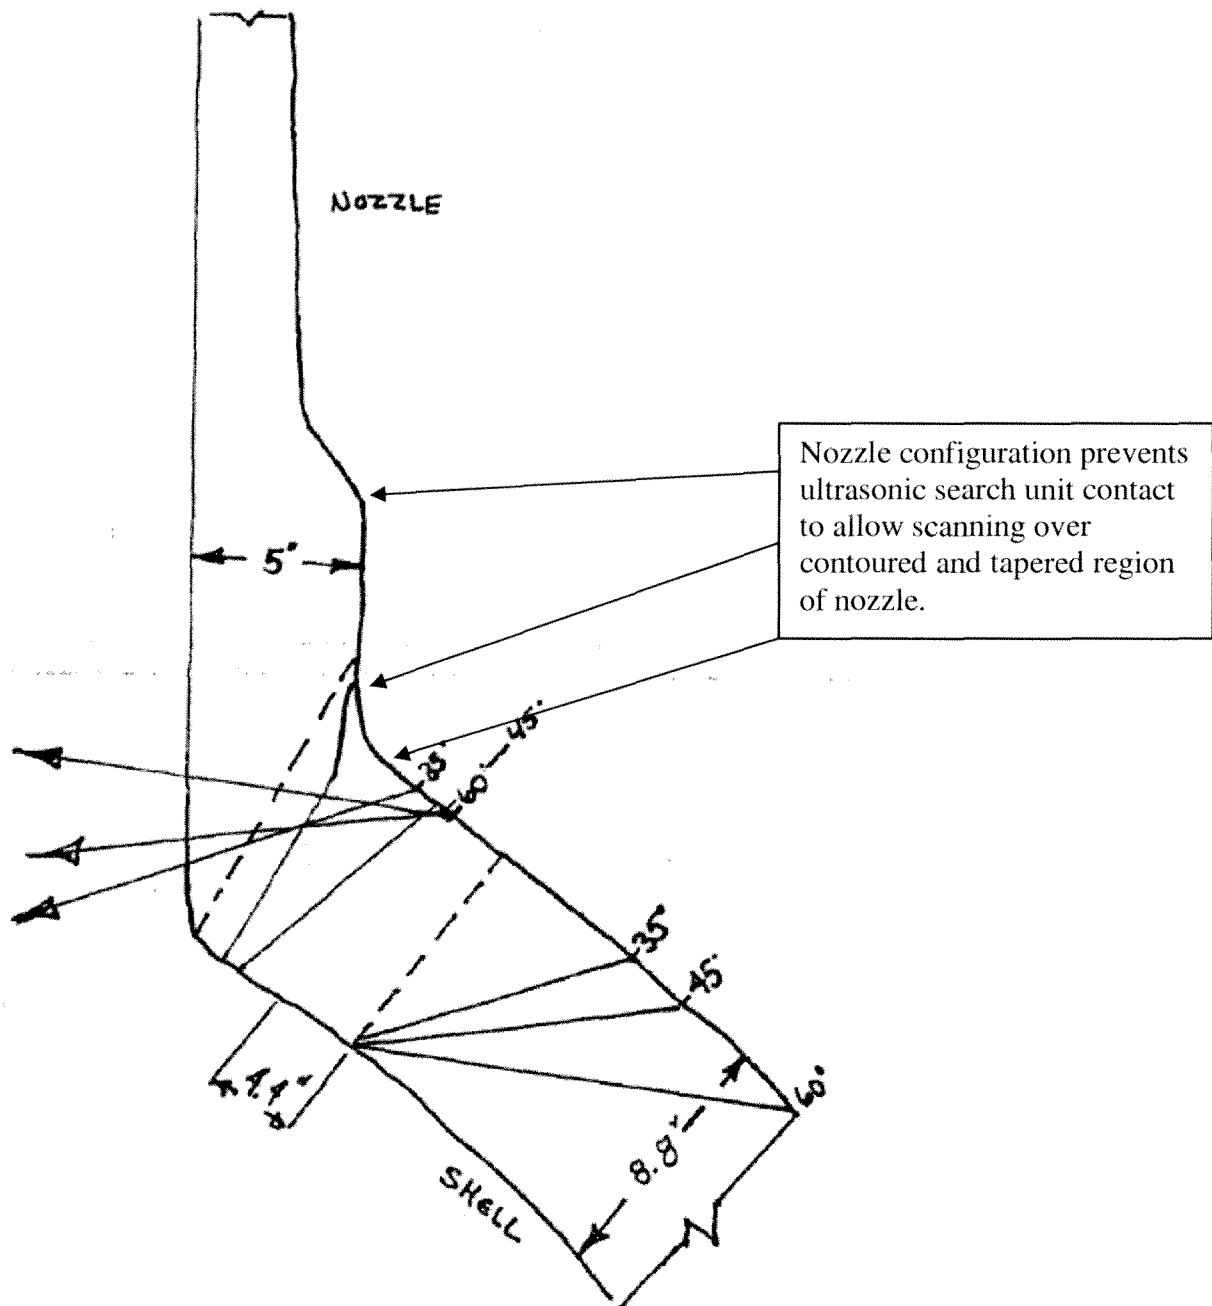
Figure 3
NDE Data Report Coverage Plot for Welds RCH0001ASG0002N and
RCH0001BSG0010N

Figure 3 below is a duplication of Figure 2 from Relief Request RR-11-01 with annotations noting the examination limitations due to the nozzle configuration. The annotations and configuration are applicable to welds RCH0001ASG0002N and RCH0001BSG0010N.

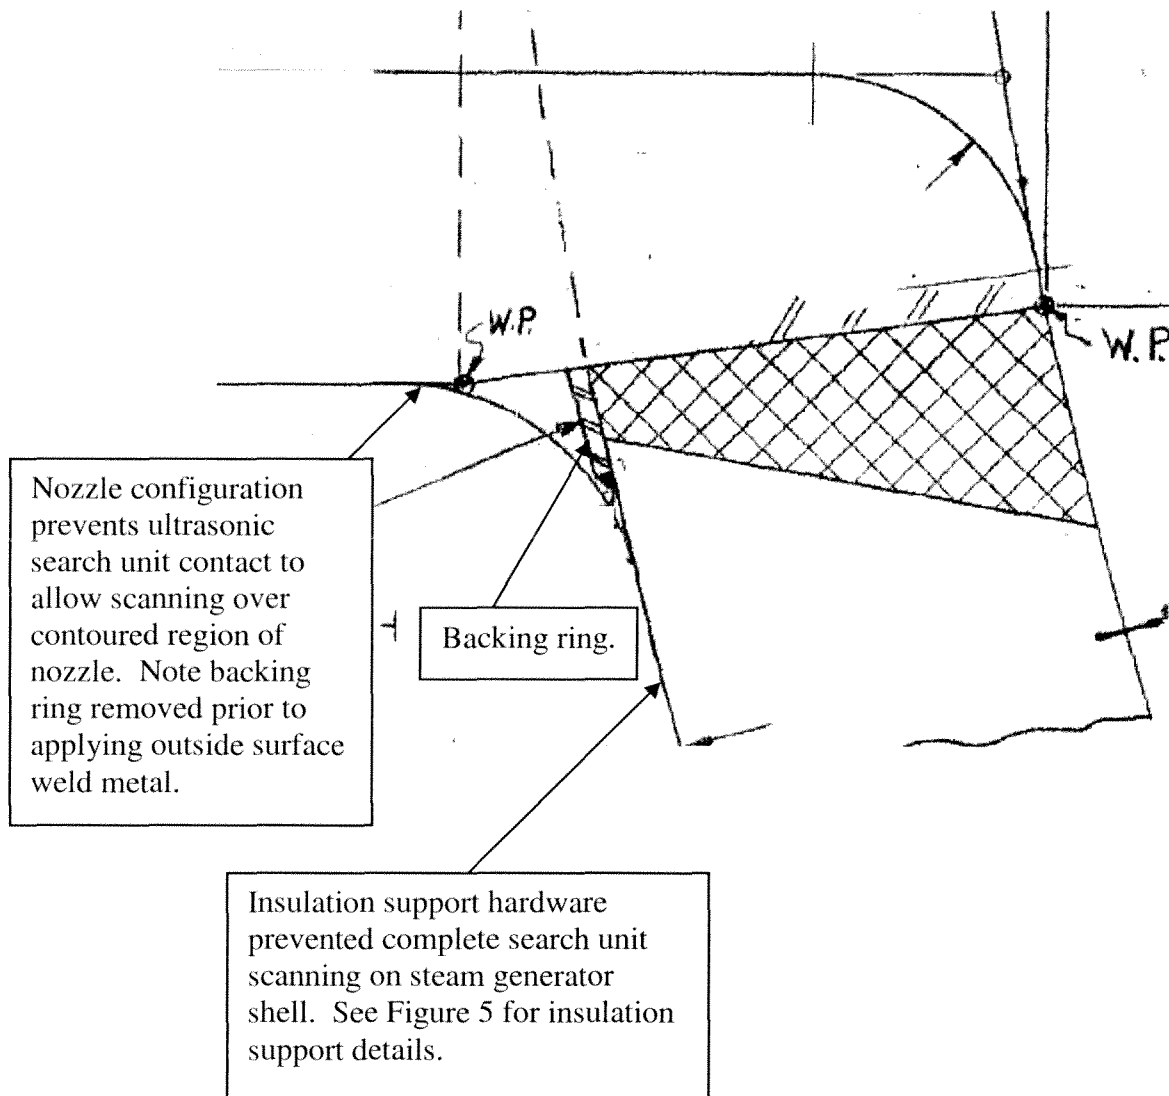
Figure 4
Weld RCH0001BSG0030N Design

Figure 4 below provides a design configuration for weld RCH0001BSG0030N along with limitation annotations. Figure 5 below provides an insulation configuration with annotations identifying support steel locations that limited examination coverage for weld RCH0001BSG0030N.

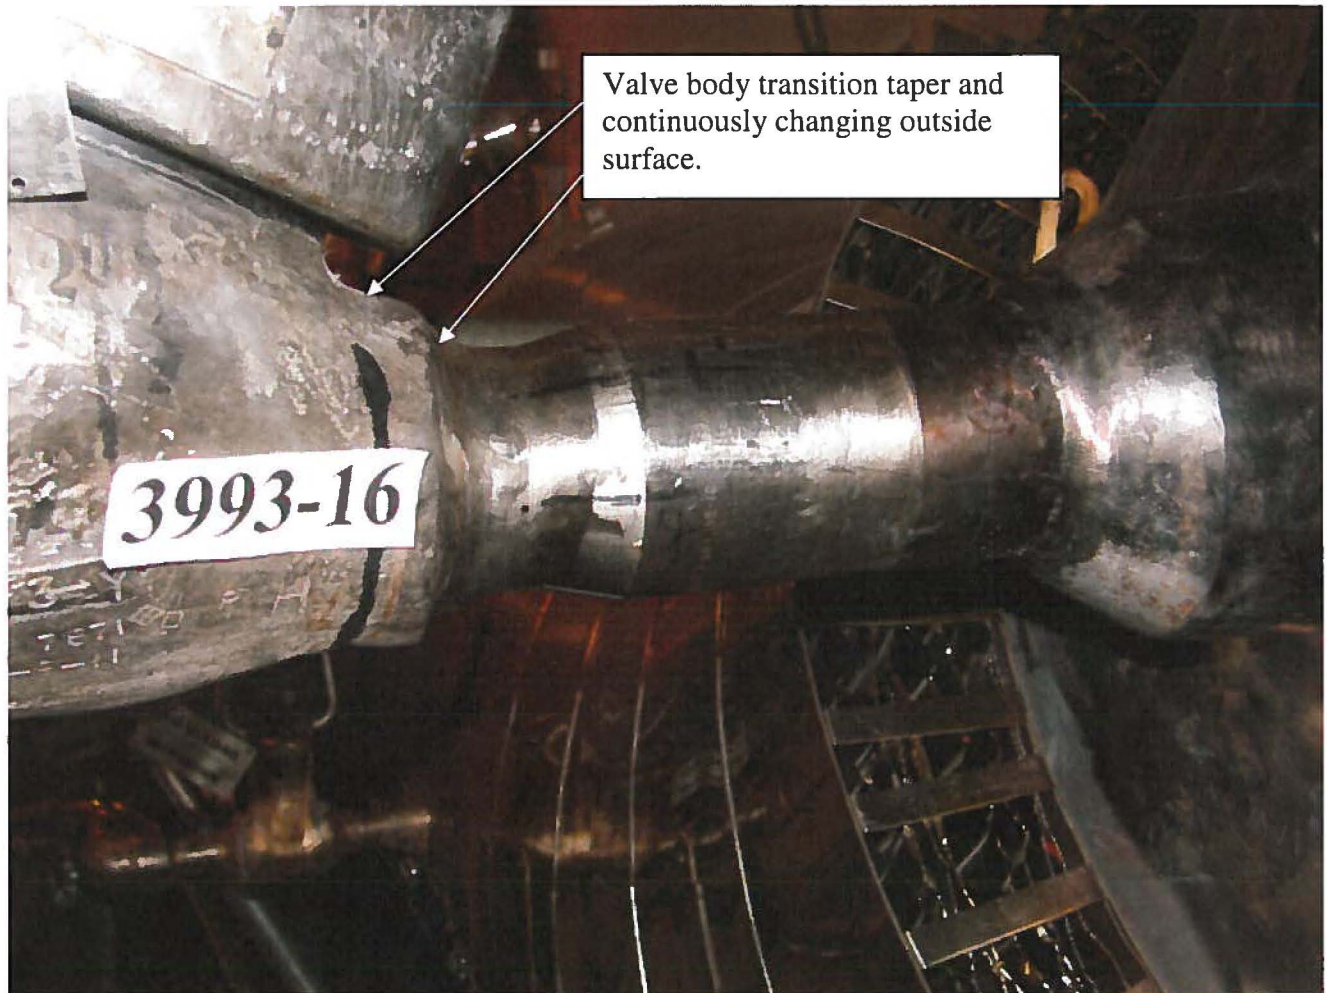
Figure 6
Valve to Safe End Valve Configuration

1. The submittal states that due to valve geometry, code coverage is limited to 50%. Please describe Exelon's best effort attempt to achieve maximum coverage in/through the cast austenitic stainless steel portion of these welds.

While not PDI qualified for detection of flaws on the far side of an austenitic weld, the 70° shear wave examination interrogates the far side of the weld along with a lower adjacent segment of the Cast Austenitic Stainless Steel (CASS) valve body. There are no additional ultrasonic examination methods beyond the techniques described that will provide meaningful and reliable examination results. The valve body is constructed of A351-CF8M material (CASS) for which there are no ASME Section XI, Appendix VIII / Performance Demonstration Initiative qualified examination techniques. Current UT examination techniques have not demonstrated reliable performance in CASS material due to sound attenuation. The valve configuration has a tapered transition at the edge of the weld and a continuously changing outside surface contour which limits ultrasonic search unit contact (see Figure 6 below).

There is no change to the valve configuration. The safe-end design, however, was modified to move the safe-end outside surface taper further away from the valve to allow full examination coverage of the safe-end side of the weld including adjacent base material. The removed safe-end did not provide adequate surface area for UT examination on the safe-end side of the weld. This resulted in the pre-service examination coverage improvement when compared to the original configuration.
