Characterization of Flaws in U.S. Reactor Pressure Vessels

Validation of Flaw Density and Distribution
in the Weld Metal of the PVRUF Vessel

Pacific Northwest National Laboratory

U.S. Nuclear Regulatory Commission
Office of Nuclear Regulatory Research
Washington, DC 20555-0001

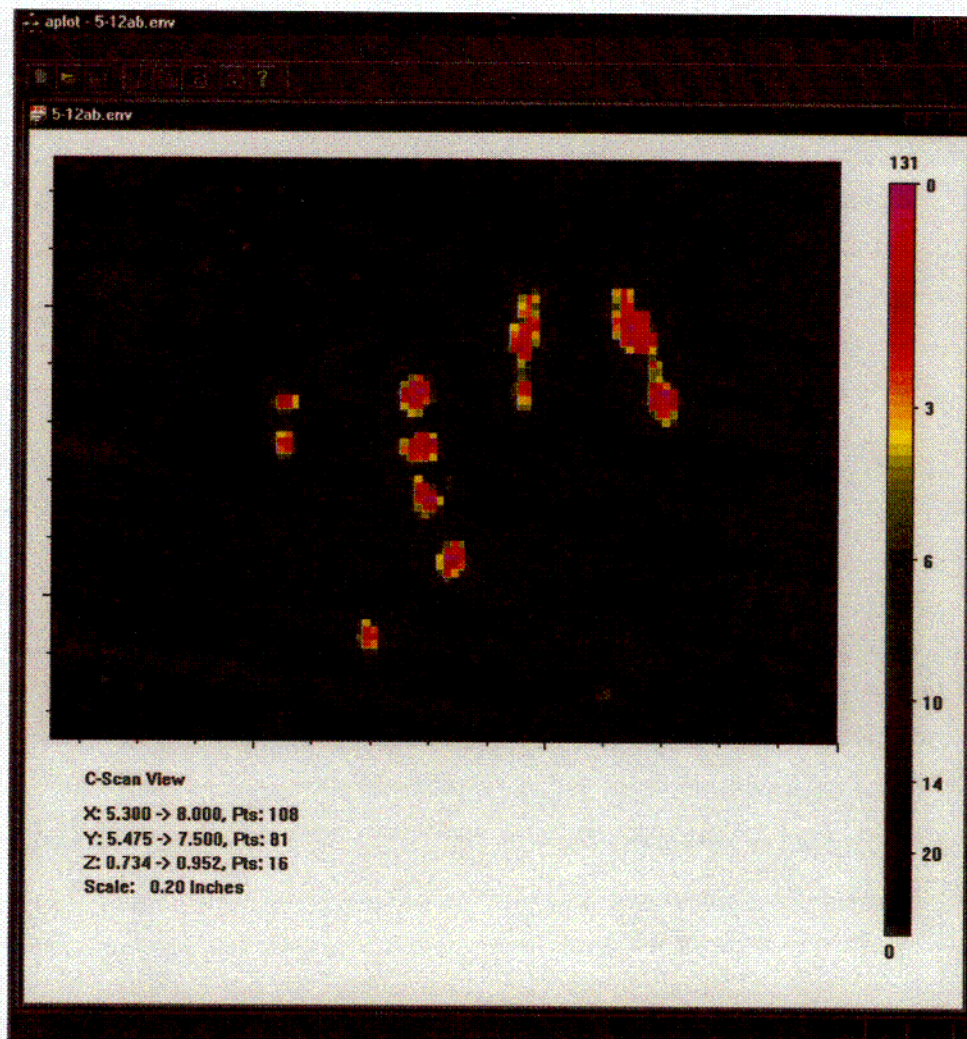
Figure 3.4 SAFT-UT Inspection of a Large Cluster of Weld Flaws in the Mid-Wall Portion of the Vessel Beltline Weld. The through-wall direction, vessel "Z", is on the abscissa and labeled as X: 5.475 -> 8.000 inches in the image. The distance along the beltline weld, vessel "Y", is on the ordinate and labeled as Y: 5.475 -> 7.500 inches.

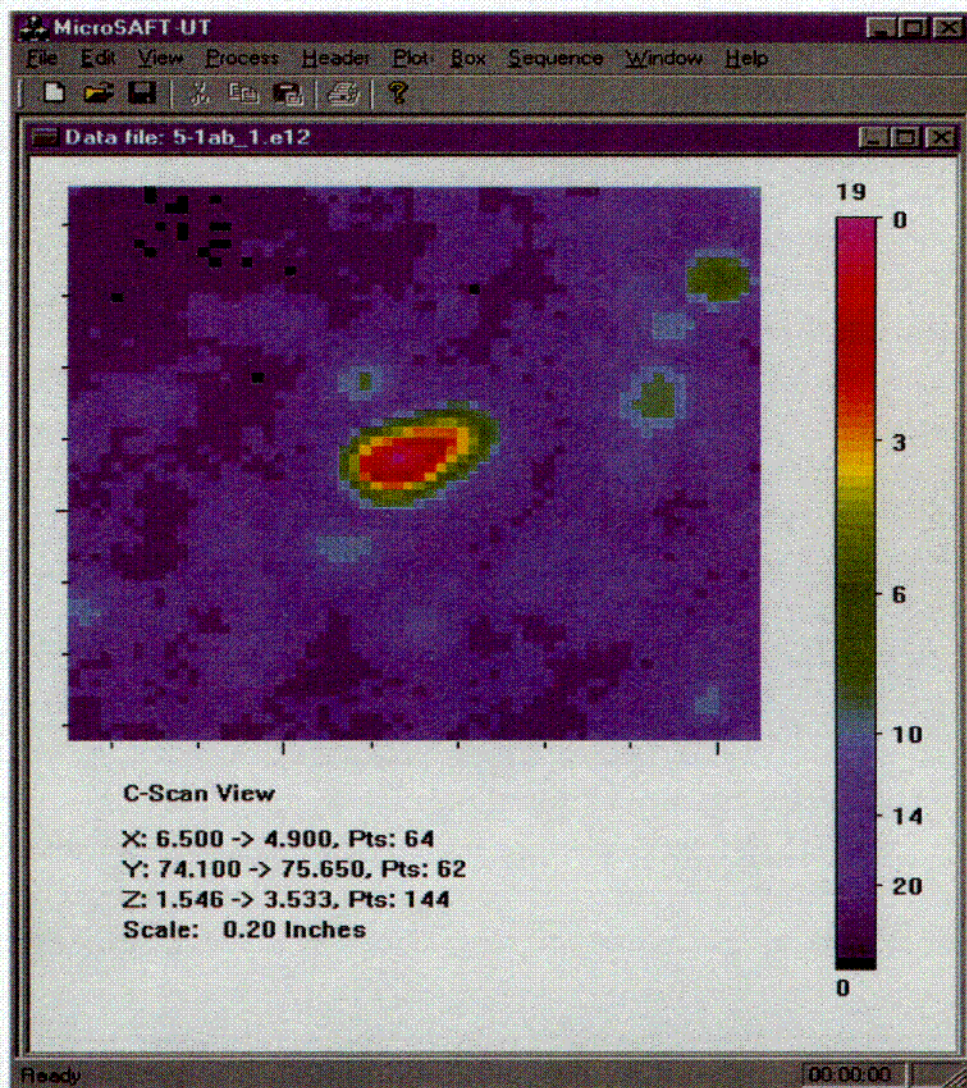
Figure 3.5 Weld-Normal UT Image of Flaw Indication Characterized as Extended Lack of Fusion. Clad is to the right in the figure.

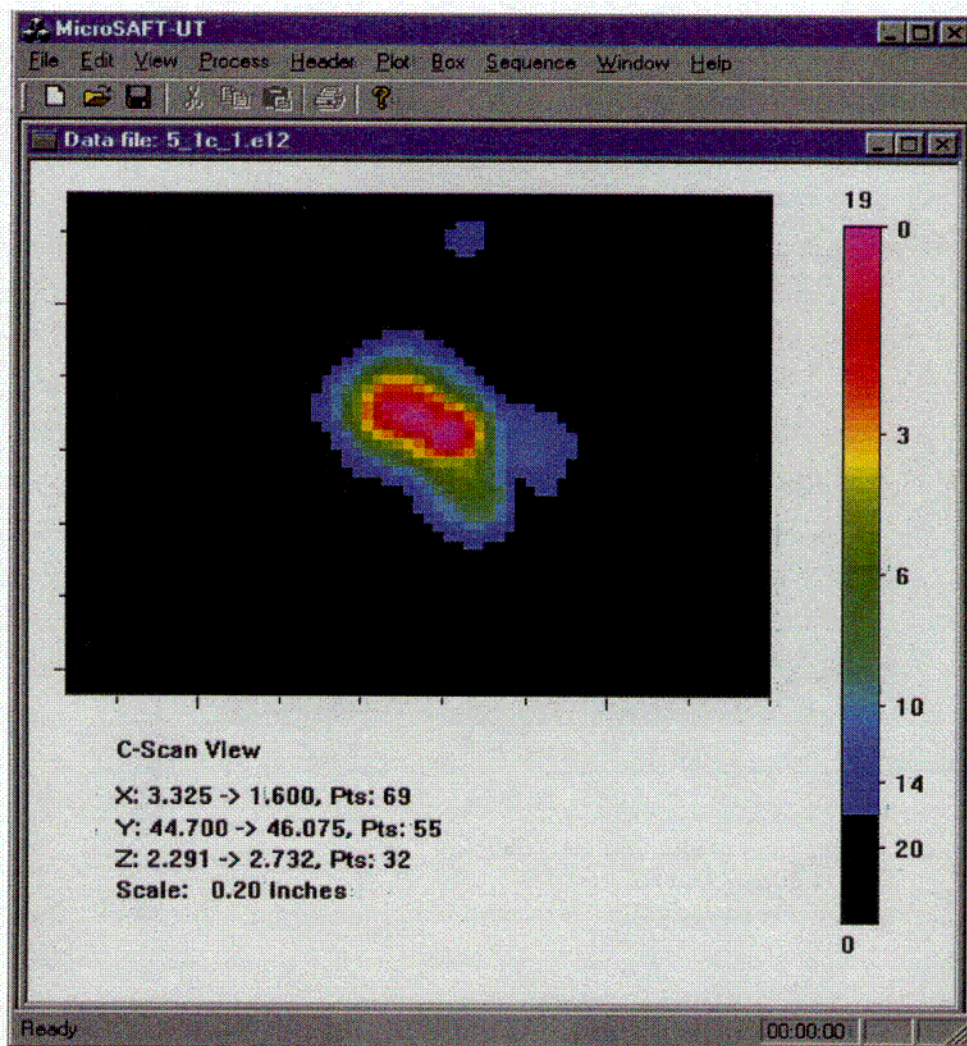
Figure 3.6 Weld-Normal Flow Indication Characterized as Extended Lack of Fusion.
Clad is to the right in the figure.

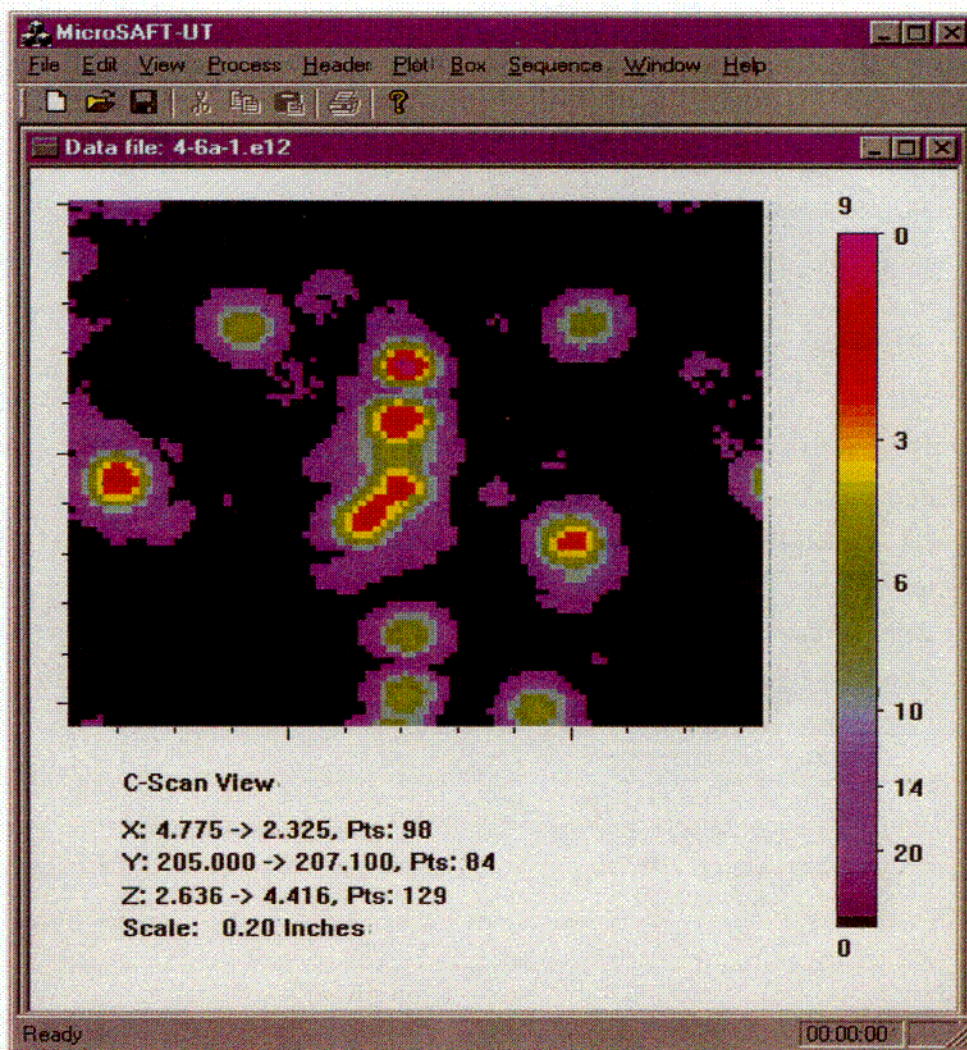
Figure 3.7 Weld-Normal Ultrasonic Testing Flaw Indication Characterized as Long Lack of Fusion. Clad is to the right in the figure.

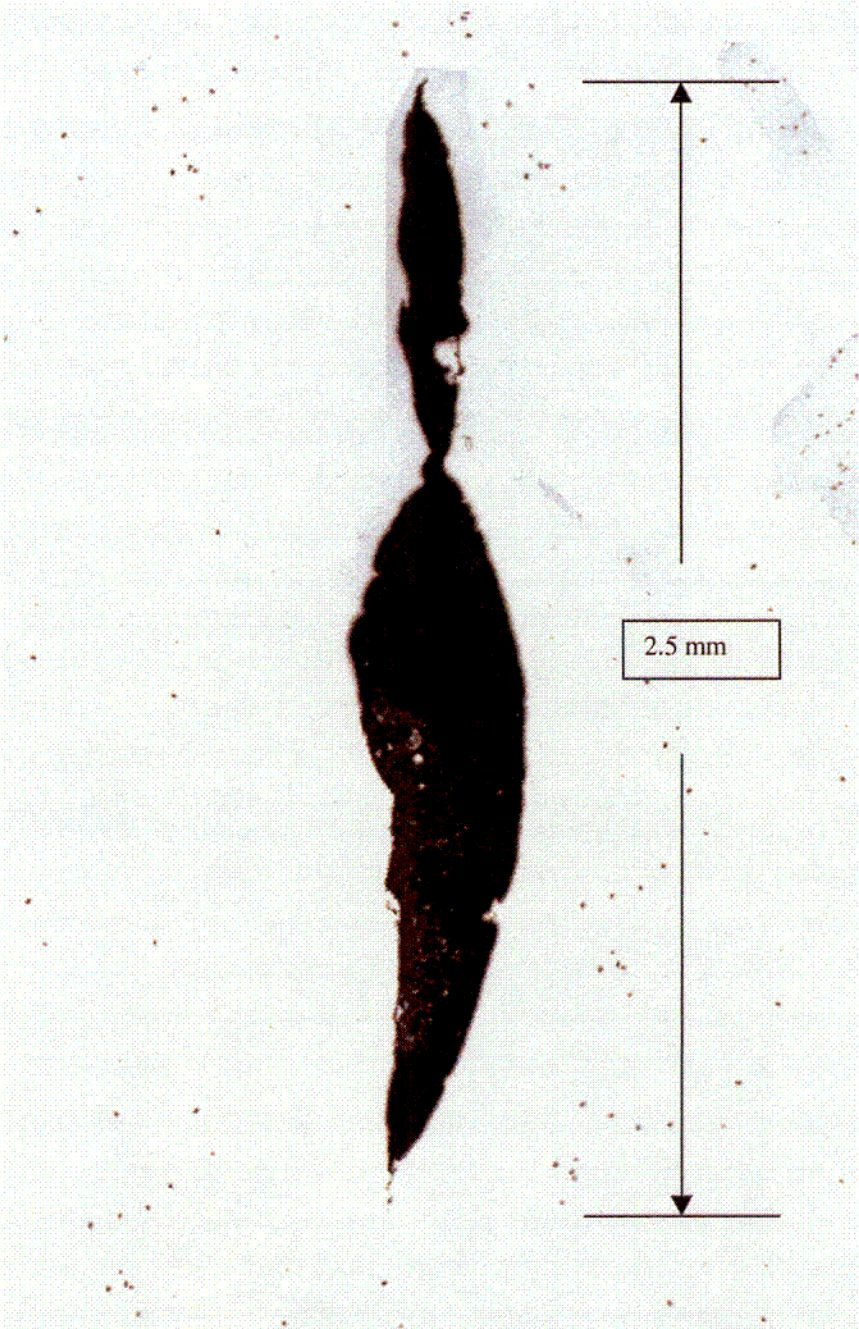
Figure 3.55 Micrograph of a Cross-Section of One Weld Flaw from the Large Cluster. The through-wall extent of the flaw is 2.5 mm. The flawed area contains slag. Tails are visible on both flaw ends.

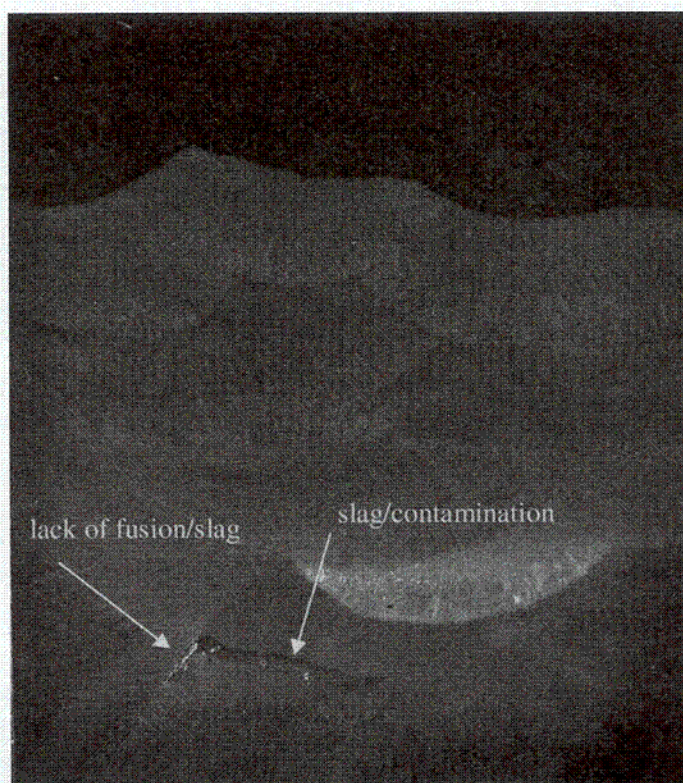
Figure 3.63 Micrograph of Cube 5-10EB1-IIbIIc Showing Complex Flaw Above First Tandem Arc Weld Passes

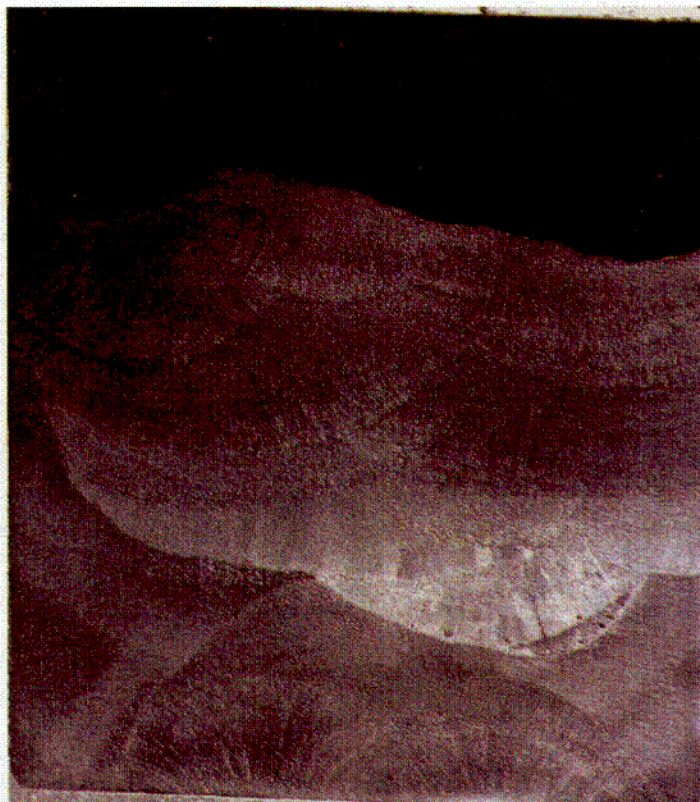
Figure 3.65 Micrograph of Cube Showing Failed Weld Bead

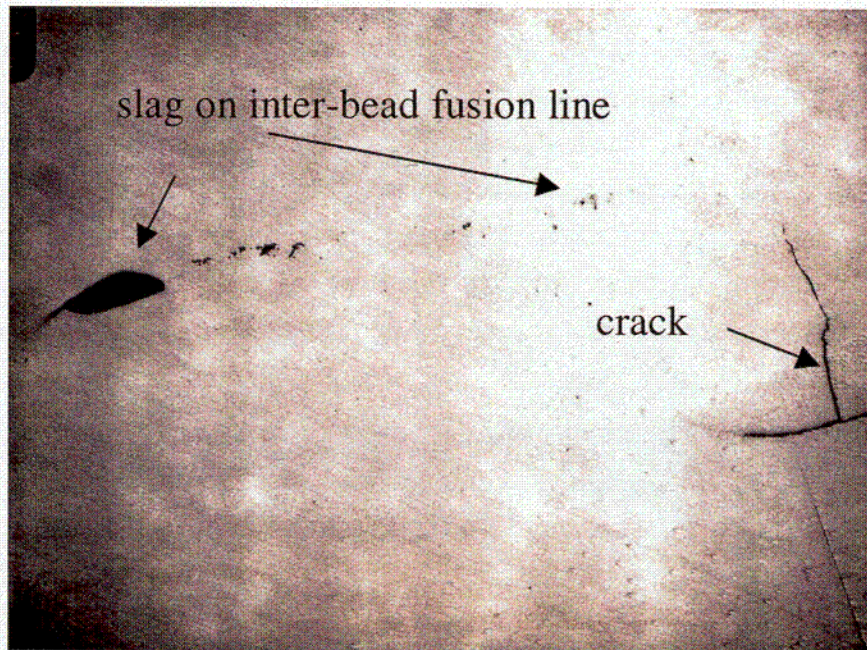
Figure 3.66 Micrograph of Cube 5-10EB1-IIbIIc Showing Flaws in the First Weld Pass of the Back-Fill

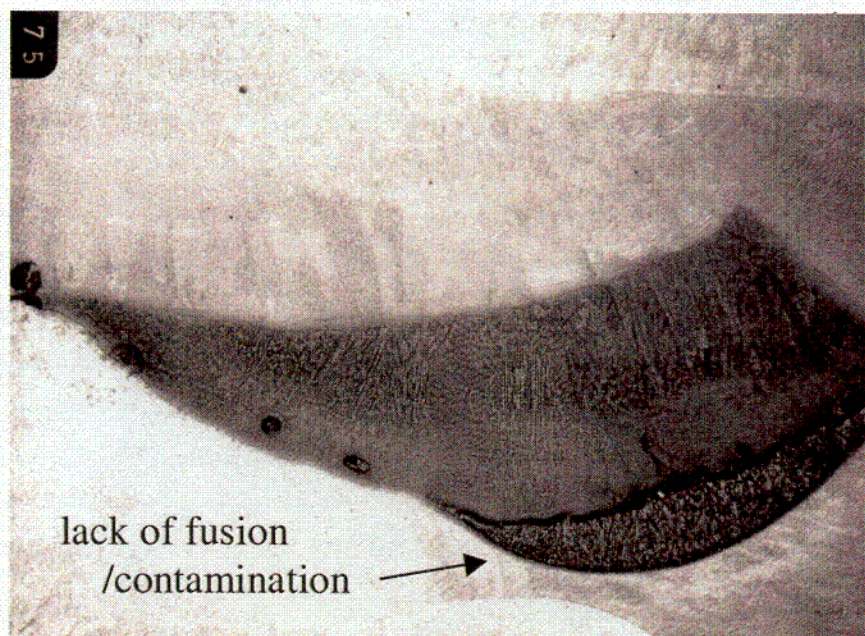
Figure 3.67 Micrograph of Cube 5-10EB1-IIbIIc Showing Contamination of the First Weld Pass of the Back-Fill

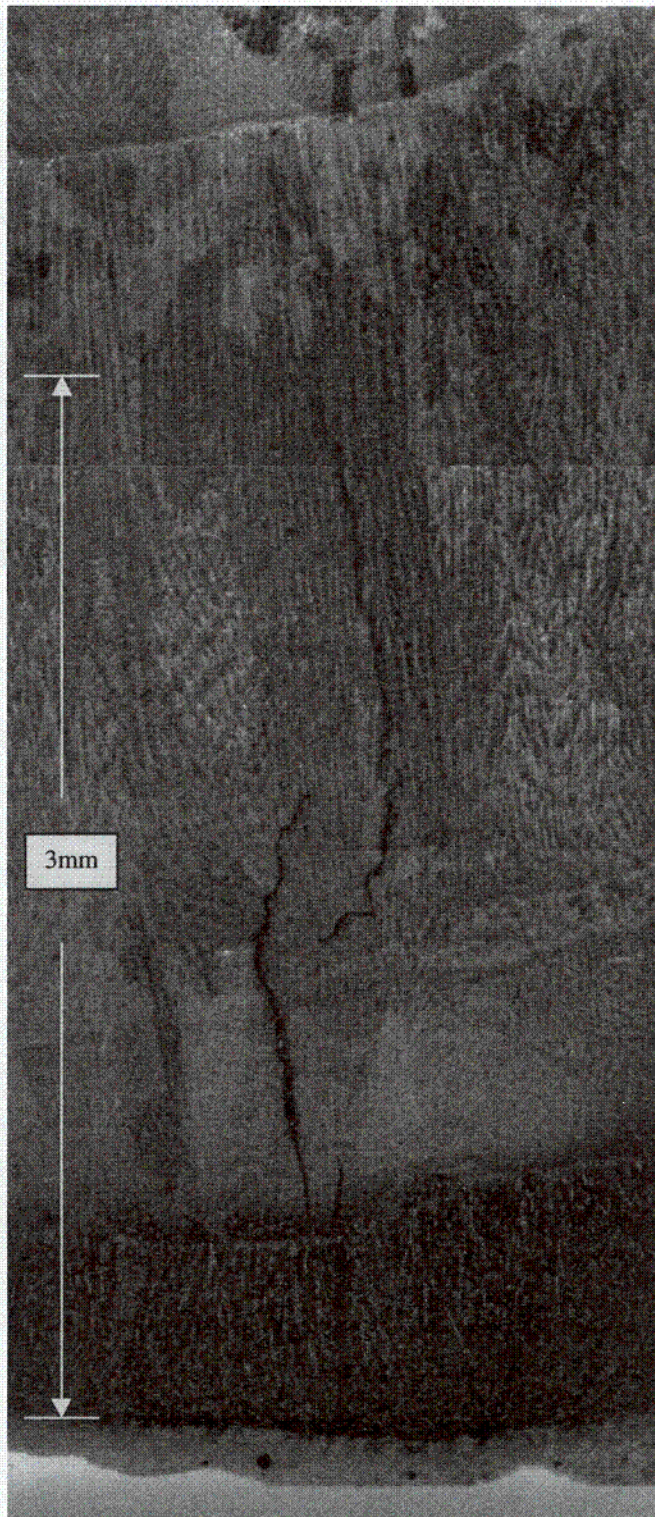
Figure 3.68 Micrograph of Crack in Flawed Weld Bead, Near Surface Zone of PVRUF

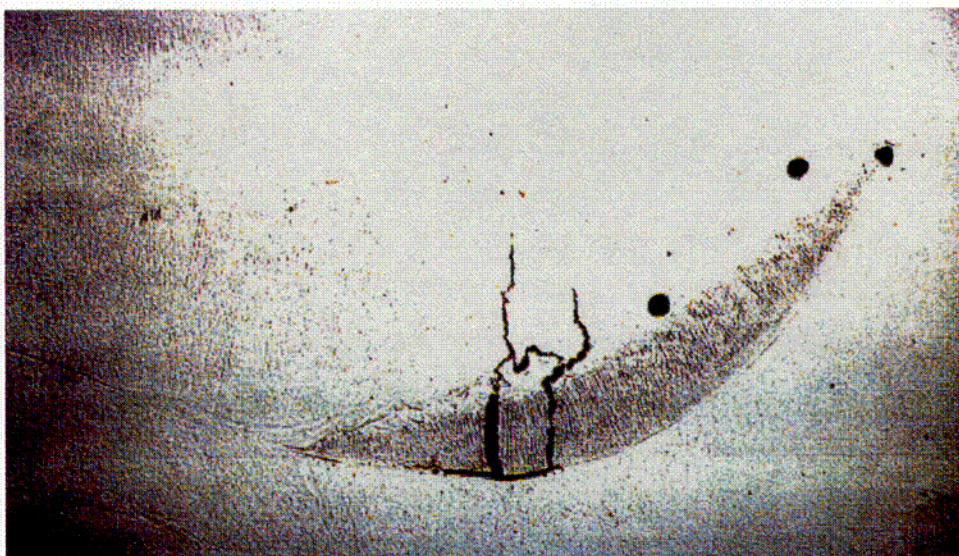
Figure 3.69 Micrograph of Cracked Weld Bead

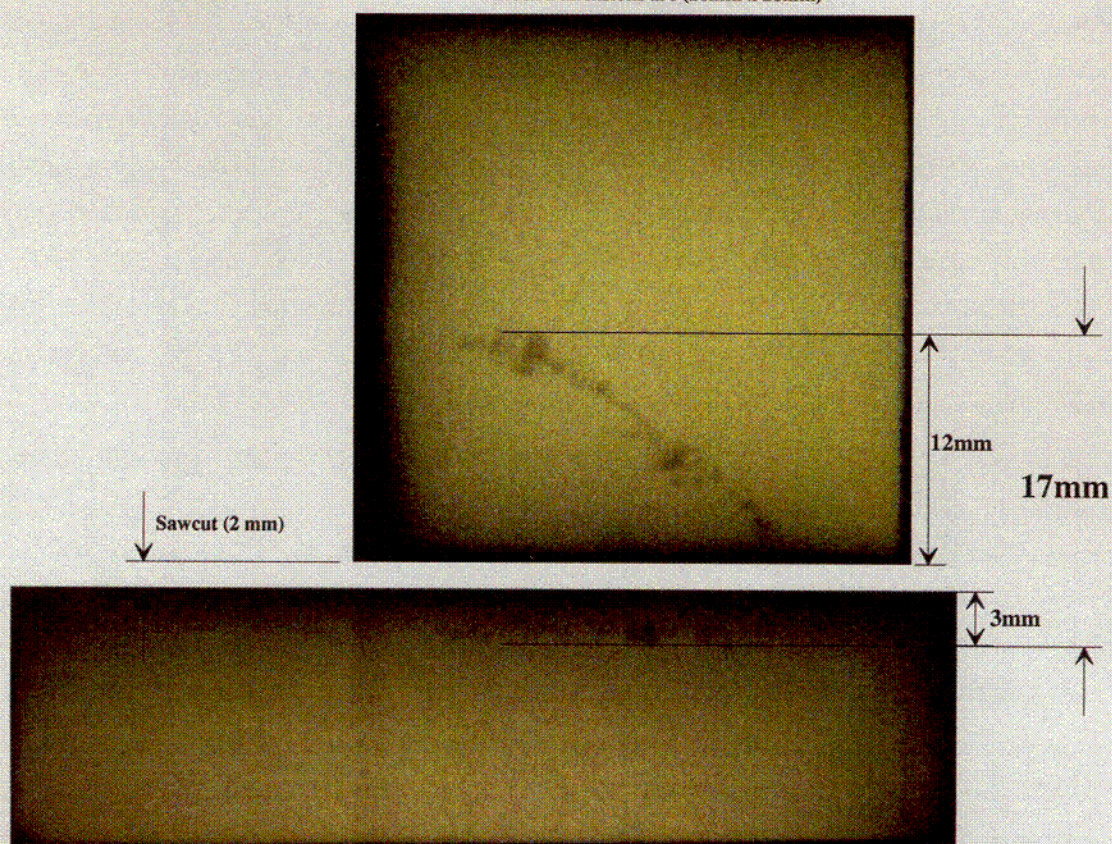
Block 5-12 AC5
Radiography View C
Block Dimensions are (13mm x 42mm)

Figure 3.71 Radiographic Images of 17-mm Flaw Indication in a Repair to the Beltline Weld of the PVRUF Vessel

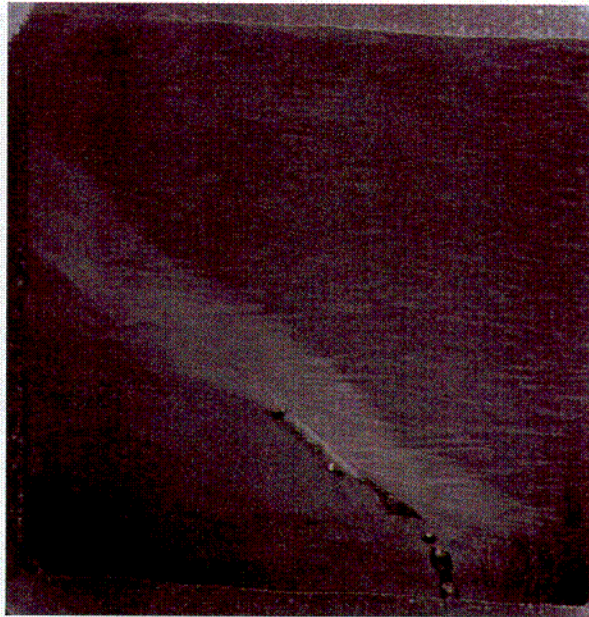
Figure 3.72 Micrograph of a Portion of the 17-mm Flaw. The composition of the flaw is taken to be slag, porosity, and contamination.

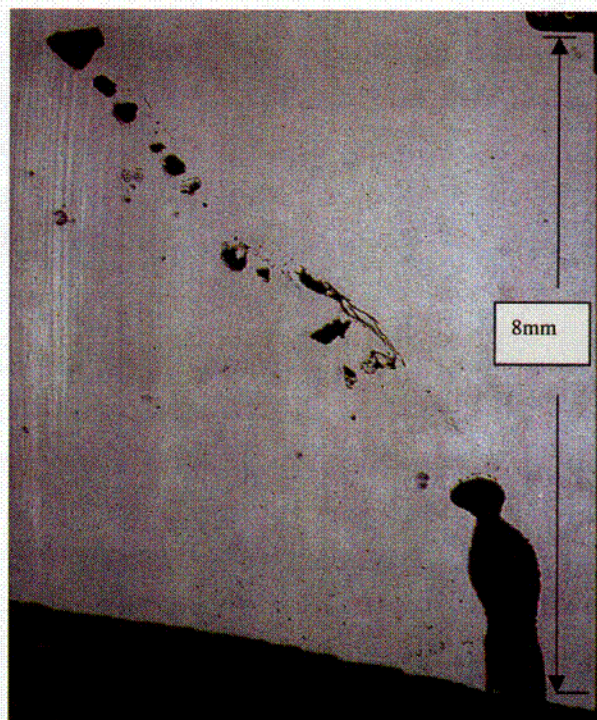
Figure 3.73 Micrograph Showing a Magnified View of a Portion of the 17-mm Flaw. A crack-like portion of the flaw is visible in this figure.

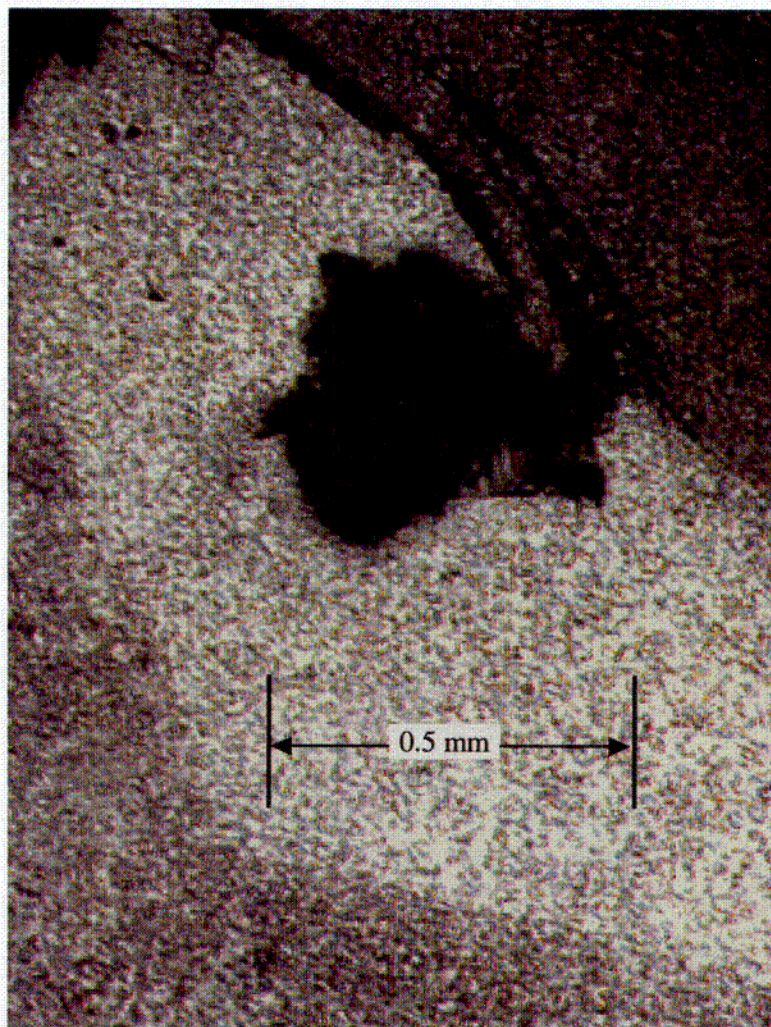
Figure 3.74 Micrograph Showing a Magnified View of the Crack-like Portion of the 17-mm Flaw. The crack originates from a small region between weld beads.

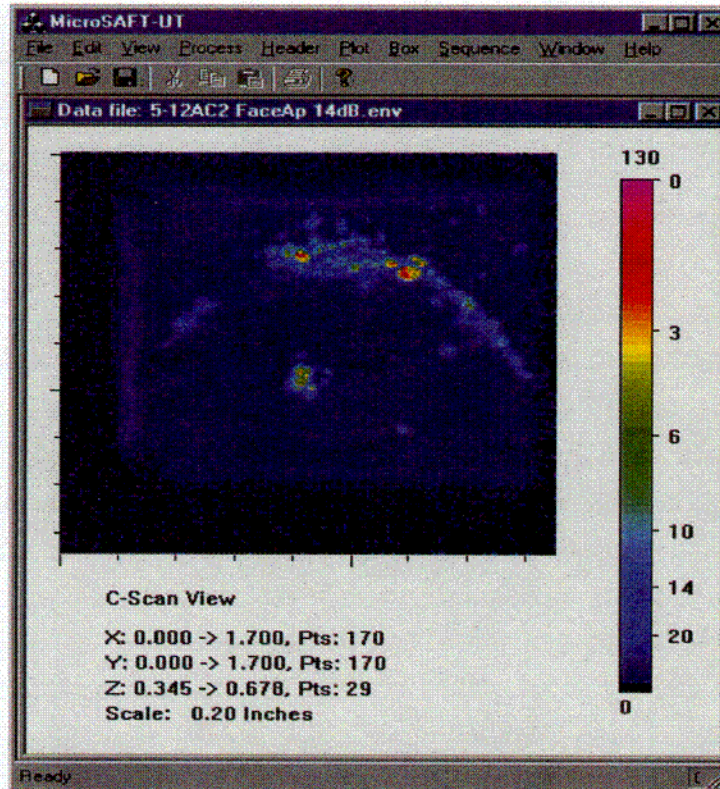
Figure 3.75 Focused Ultrasound (10-MHz Probe) Result Showing Top View of Flaw in 5-12AC2. This is a repair flaw located on the end of the repair. Vessel through-wall direction is into the page. Distance from weld center is on the abscissa. Distance along the beltline weld is on the ordinate. This image shows that the flaw is oriented principally in the axial direction.

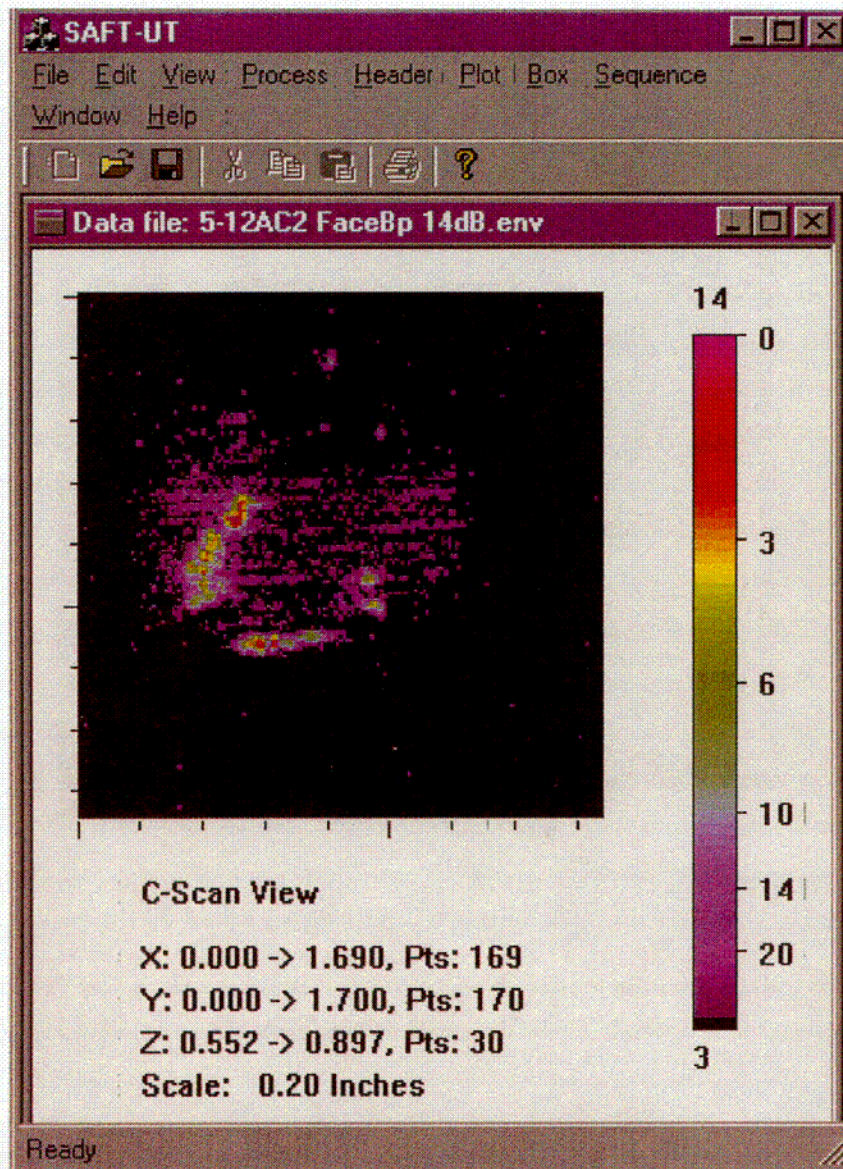
Figure 3.76 Focused Ultrasound (10-MHz probe) Result Showing Side View of Flaw in 5-12AC2. This is a repair flaw located on the end of the repair. Vessel through-wall direction is on the ordinate. Distance from weld center is into the page. Distance along the beltline weld is on the abscissa.

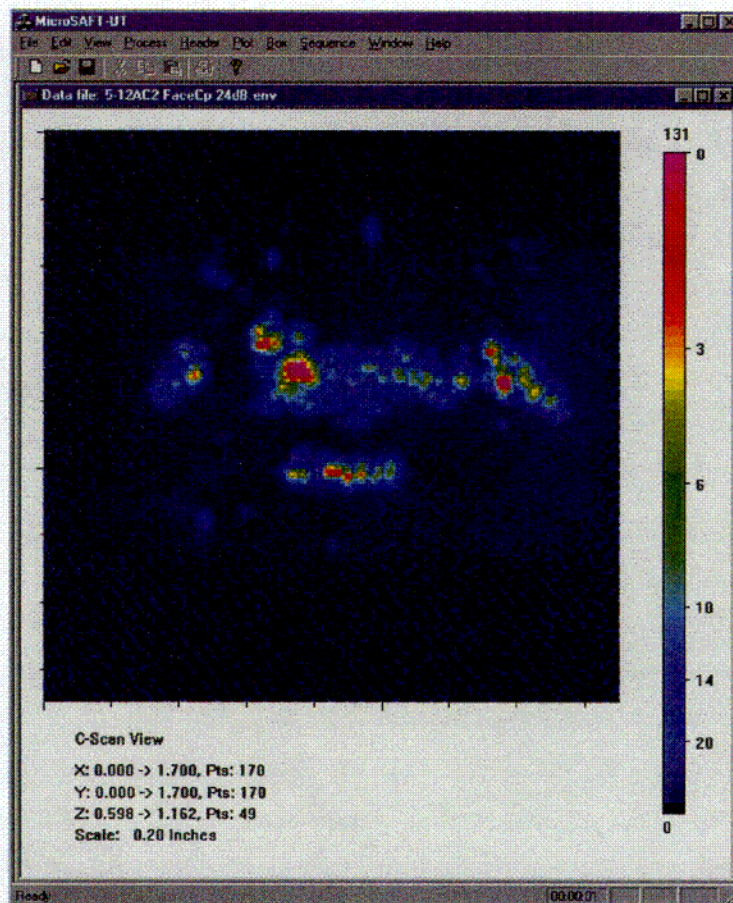
Figure 3.77 Focused Ultrasound (10-MHz probe) Result Showing End View of Flaw in 5-12AC2. This is a repair flaw located on the end of the repair. Vessel through-wall direction is on the ordinate. Distance from weld center is on the abscissa. Distance along the beltline weld is into the page.

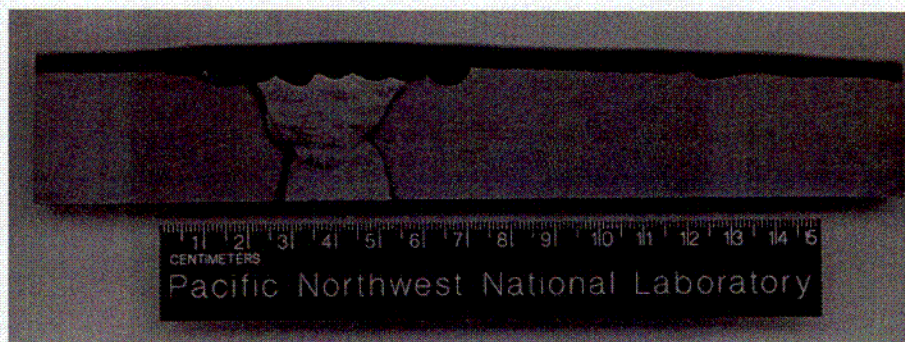
Figure 3.78 Micrograph of Upper Portion of Weld in PVRUF Specimen 5-6Eca. A weld repair, made from inside the vessel, was reported at this location. The repair was not detected.

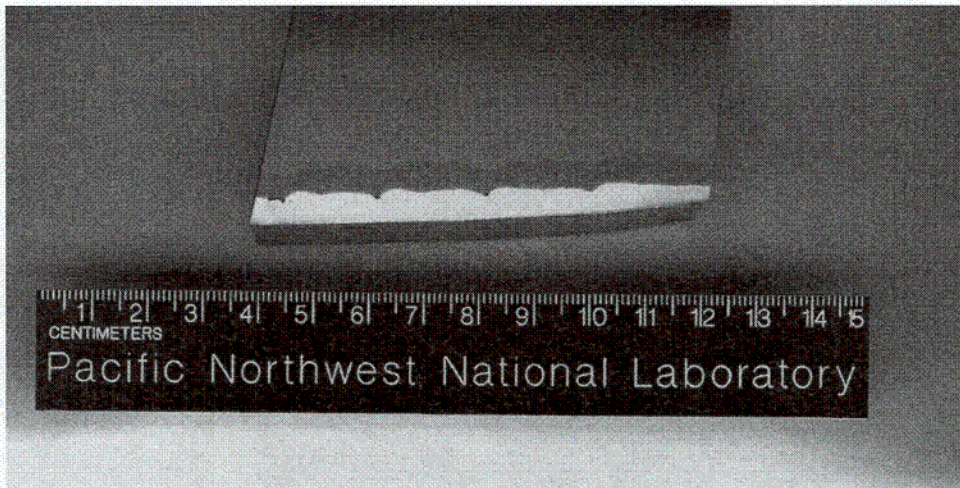
Figure 3.79 Photograph of PVRUF Specimen Showing Small Slag Inclusions at the Clad-to-Base Metal Interface.

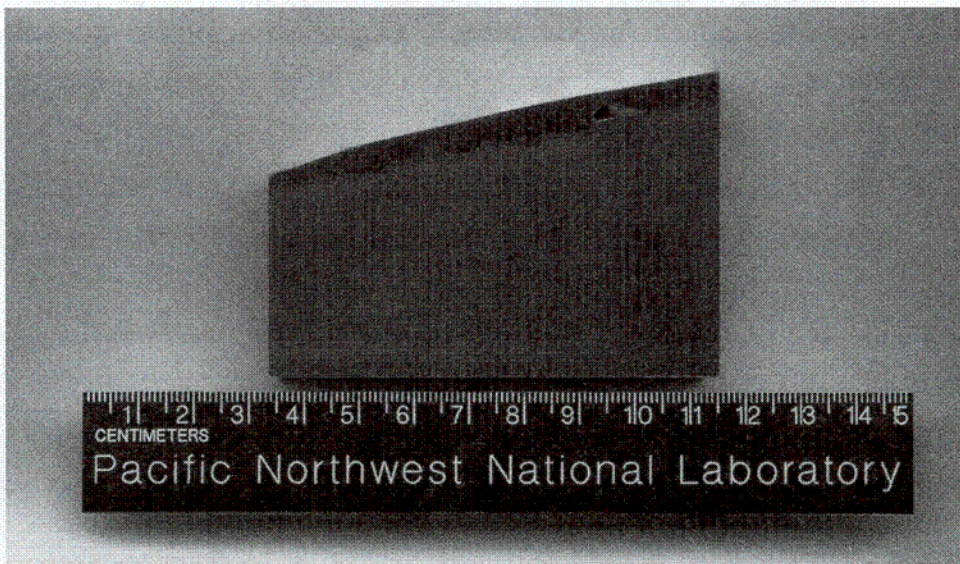
Figure 3.80 Photograph of PVRUF Specimen 4-5DBAC-Z5 as Machine Cut. The photograph shows 4-mm through-clad lack of fusion with slag.
