Docket No. 50-263
 Docket No. 50-282
 Docket No. 50-306

November 8, 1977
IE Bulletin 77-05

ELECTRICAL CONNECTOR ASSEMBLIES

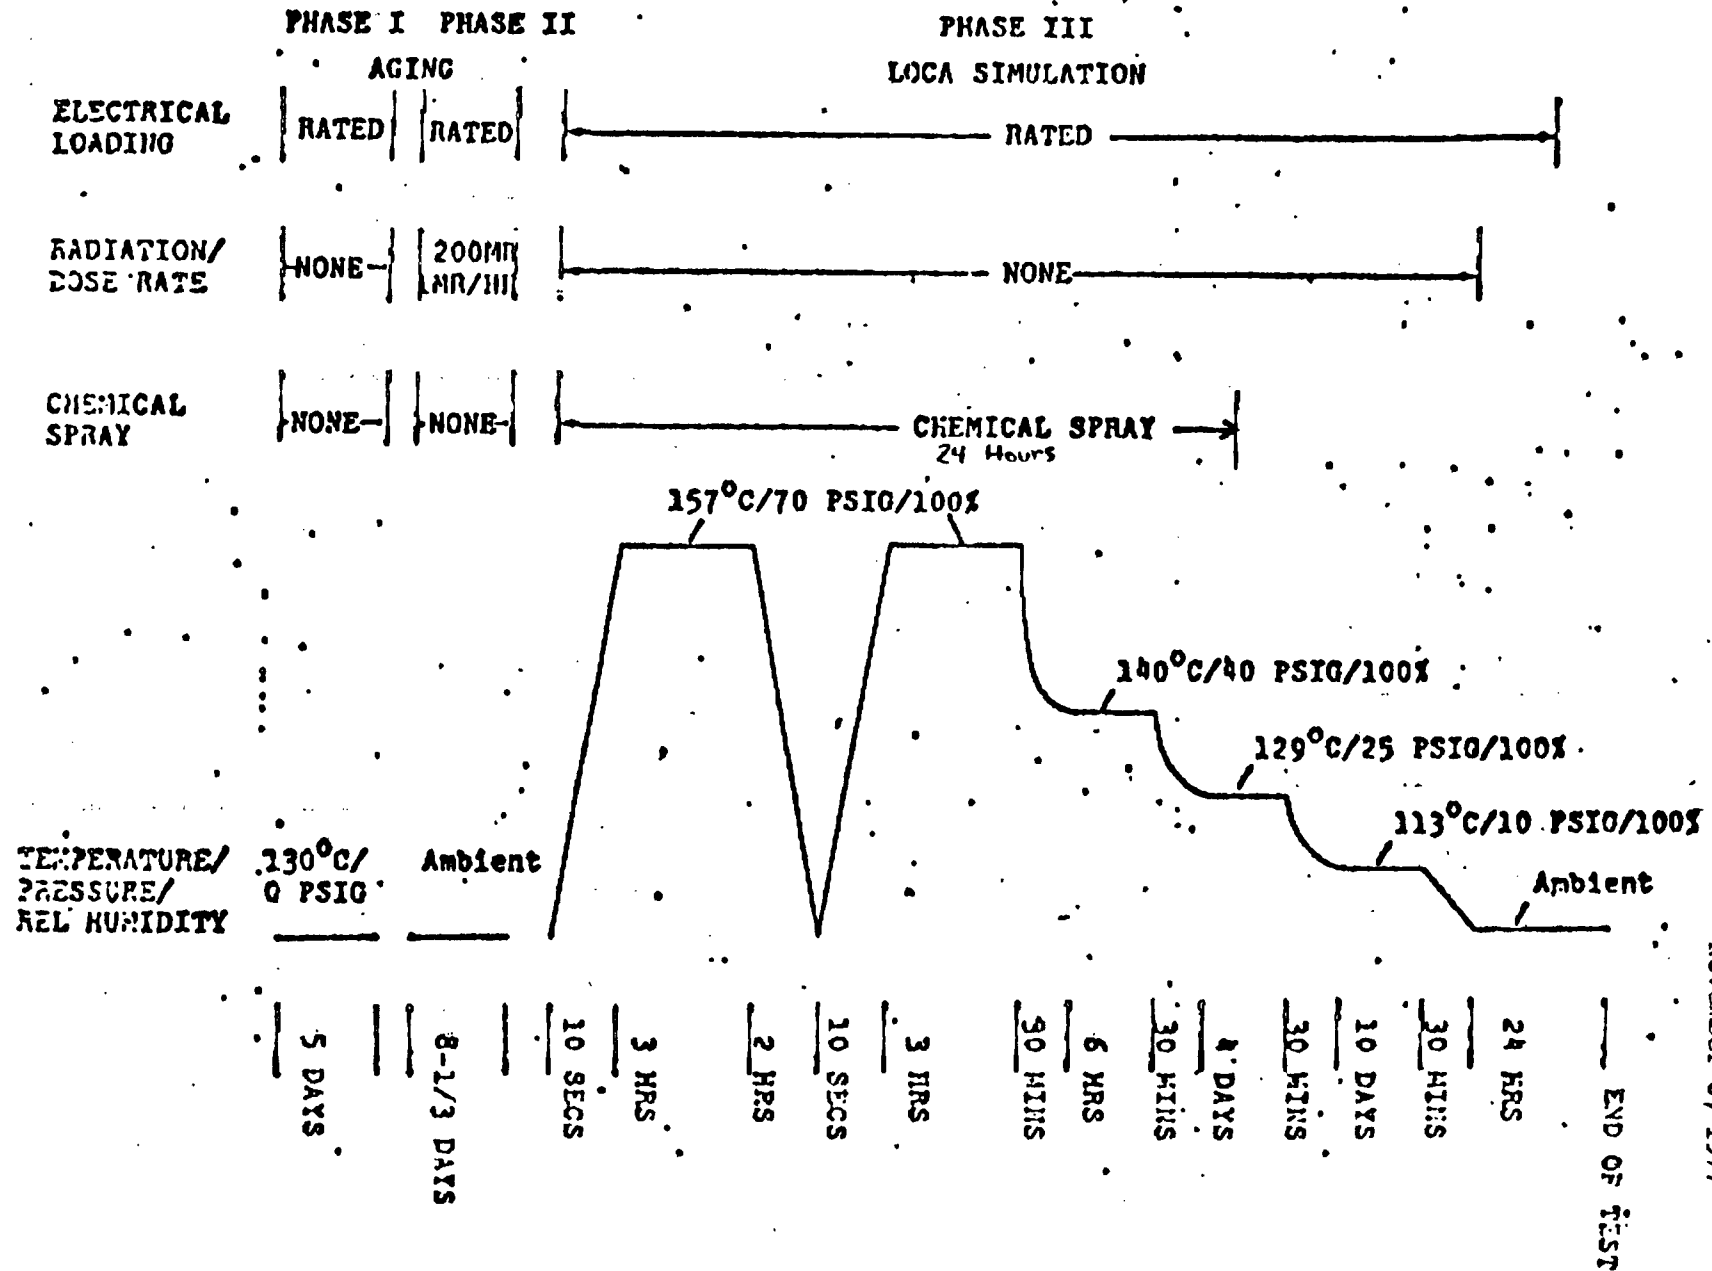
Figure 1

The three tests performed by Sandia were composed of two sequential and one simultaneous exposure to LOCA environments. In each case the equipment was exposed to radiation and thermal aging prior to operating under the simulated LOCA conditions. Figures 1 and 2 describe the test profiles for sequential and simultaneous tests respectively (Sandia tests were designed to study synergistic effects). Each of the tests satisfy the intent of IEEE 323-1974. The assemblies were electrically loaded to 20 amperes and 600 volts at the start of the tests. Insulation resistance and capacitance measurements were recorded during the tests to indicate damage.
