MONTICELLO NUCLEAR GENERATING PLANT
Docket No. 50-263 License No. DPR-22

Licensee Event Report to the NRC
Crack Indications in Recirculation Bypass Piping

Crack Indications in Recirculation Bypass Piping

1. Report Number: AO 263/75-03
- 2a. Report Date: January 30, 1975
3. Facility: Monticello Nuclear Generating Plant
Monticello, Minnesota 55362
4. Identification of Occurrence:

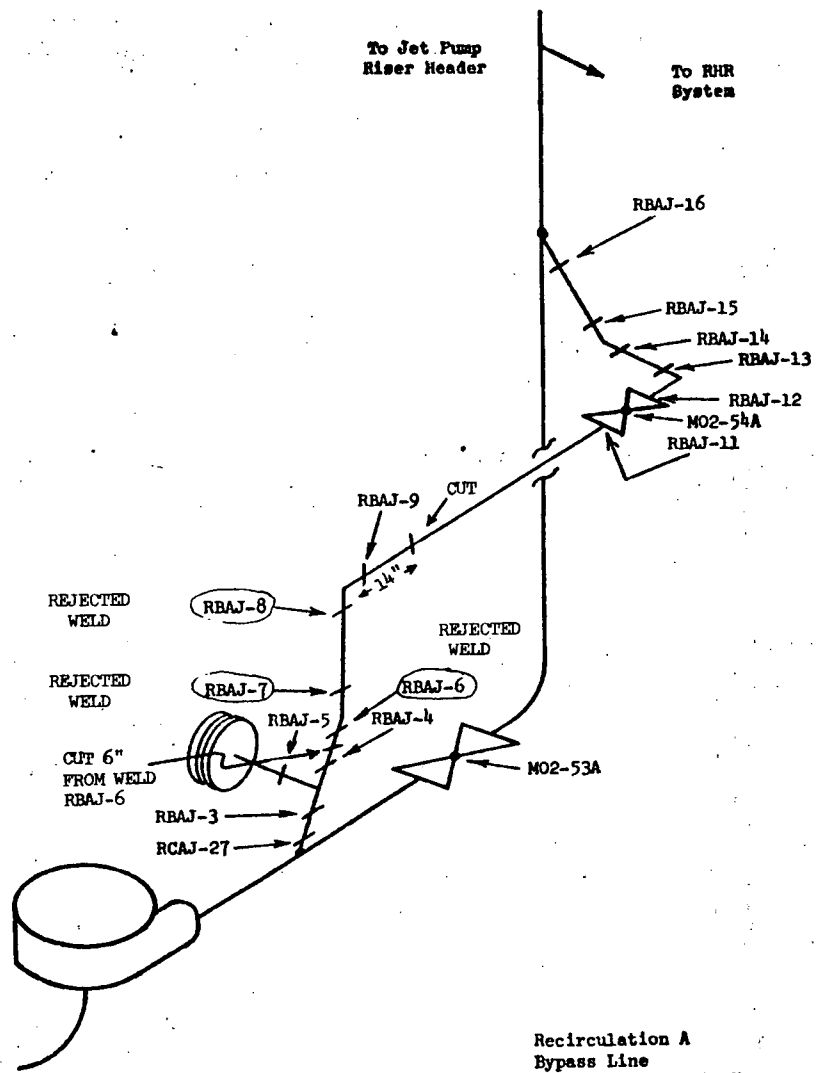
Recirculation A
Bypass Line
Modified Isometric U
Ref. FSK 382-1

On January 20, 1975, during the inservice inspection of the reactor coolant system, linear indications were detected by ultrasonic examination in two welds in loop A and one weld in loop B of the reactor recirculation system 4-inch diameter bypass lines. Radiographic examination of these three welds definitely verified the presence of a linear indication in one of these welds. The radiograph showed the indication to be located in the weld heat-affected zone.

After a thorough review and study of all of the ultrasonic recordings and comparing inspection results obtained in November, 1974, with the present results, a fourth weld became a suspect. This weld was located in loop A. Although the amplitude of the ultrasonic signal for this weld was relatively low, the signal pattern was similar to the three welds that were rejected; therefore, this weld was also rejected (see attached Figure).

The cause is unknown. It appears to be a generic problem similar to problems experienced at other BWR facilities. Identical inspections performed in November, 1974, revealed no unacceptable indications in these same welds. Indications which were detected in the November inspection were of a magnitude and nature such that they were indiscernible from the weld root I.D.

Segments of both pipe loops which contain the four rejected welds are being removed and replaced. This piping (schedule 80, type 304 stainless steel) will be sent to a laboratory for metallurgical examination.
