MONTICELLO NUCLEAR GENERATING PLANT  
Docket No. 50-263 License No. DPR-22

Licensee Event Report to the NRC  
Crack Indications in Recirculation Bypass Piping

Crack Indications in Recirculation Bypass Piping

1. Report Number: AO 263/75-03
- 2a. Report Date: January 30, 1975
3. Facility: Monticello Nuclear Generating Plant  
Monticello, Minnesota 55362
4. Identification of Occurrence:

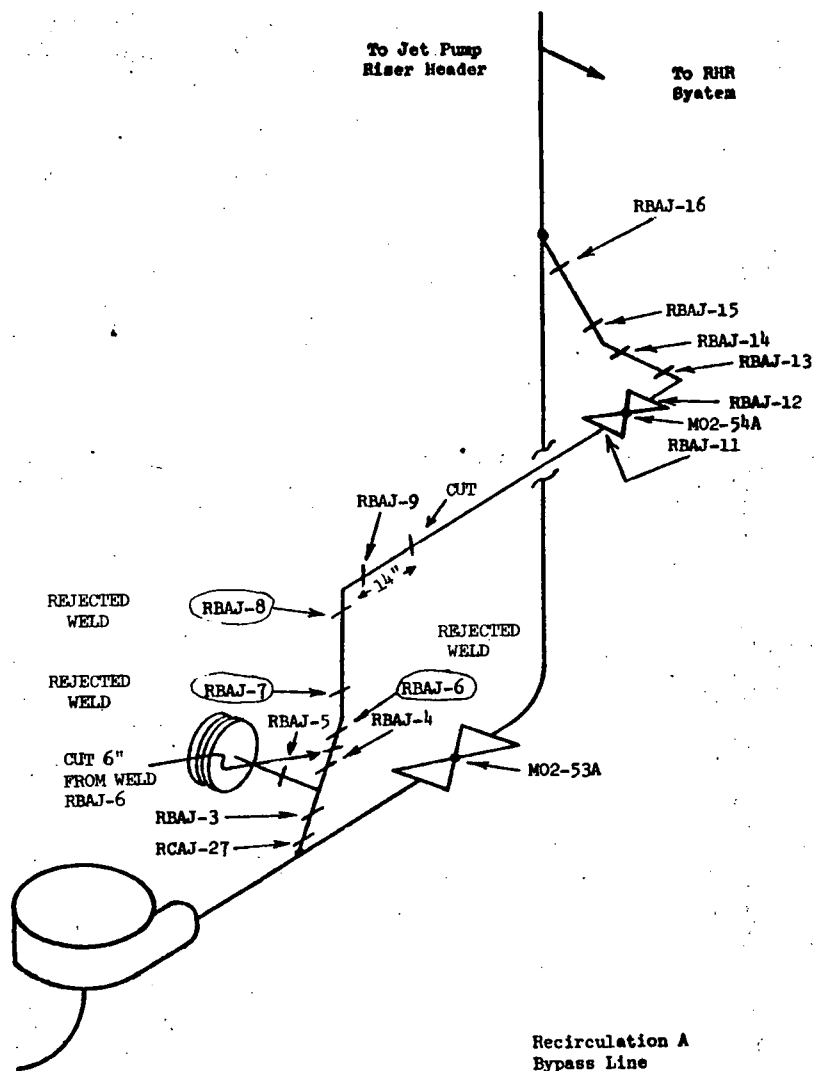
Recirculation A  
Bypass Line  
Modified Isometric U  
Ref. FSK 382-1

On January 20, 1975, during the inservice inspection of the reactor coolant system, linear indications were detected by ultrasonic examination in two welds in loop A and one weld in loop B of the reactor recirculation system 4-inch diameter bypass lines. Radiographic examination of these three welds definitely verified the presence of a linear indication in one of these welds. The radiograph showed the indication to be located in the weld heat-affected zone.

After a thorough review and study of all of the ultrasonic recordings and comparing inspection results obtained in November, 1974, with the present results, a fourth weld became a suspect. This weld was located in loop A. Although the amplitude of the ultrasonic signal for this weld was relatively low, the signal pattern was similar to the three welds that were rejected; therefore, this weld was also rejected (see attached Figure).

The cause is unknown. It appears to be a generic problem similar to problems experienced at other BWR facilities. Identical inspections performed in November, 1974, revealed no unacceptable indications in these same welds. Indications which were detected in the November inspection were of a magnitude and nature such that they were indiscernible from the weld root I.D.

Segments of both pipe loops which contain the four rejected welds are being removed and replaced. This piping (schedule 80, type 304 stainless steel) will be sent to a laboratory for metallurgical examination.
